Monkey tube

### Profiles of tube r34c51 of Steam Generator 22

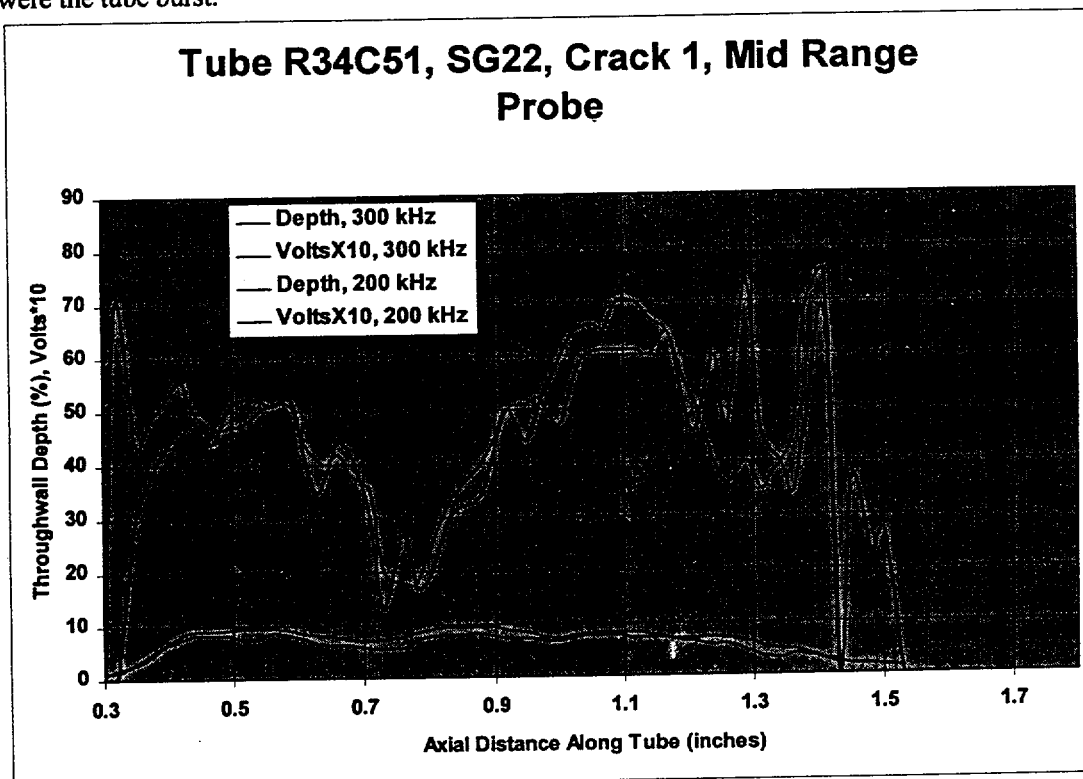
**Figure 1** Profile of crack1 in tube R34C51 of steam generator 22.

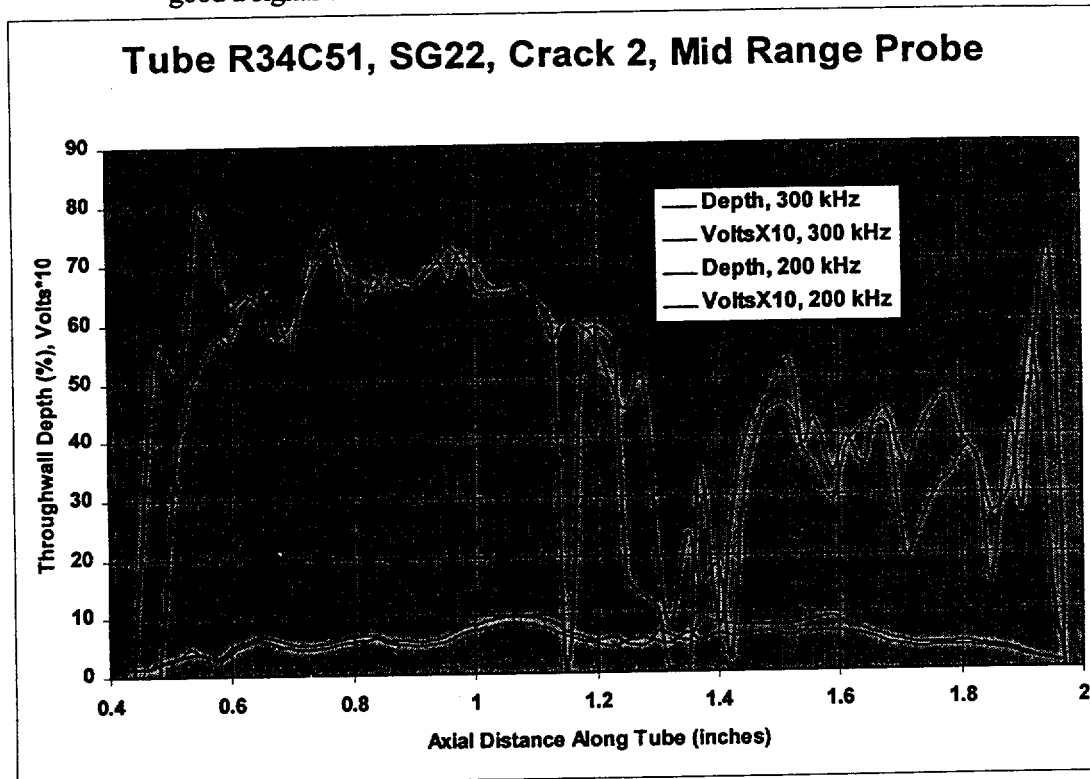
Crack 2, as shown in Figure 2, is slightly longer and slightly deeper. This is the crack that burst. The voltage amplitude of this crack is about the same, and probably averages less than that of crack one. This demonstrates that voltage is not a good measure of crack size, depth or severity. Crack 2 appeared to go through wall, and the voltage amplitude increased by a large factor. This tube also had a large voltage increase of a crevice crack due to the pressurization.

**Figure 2** Profile of crack 2 of tube r34c51 in steam generator 22.

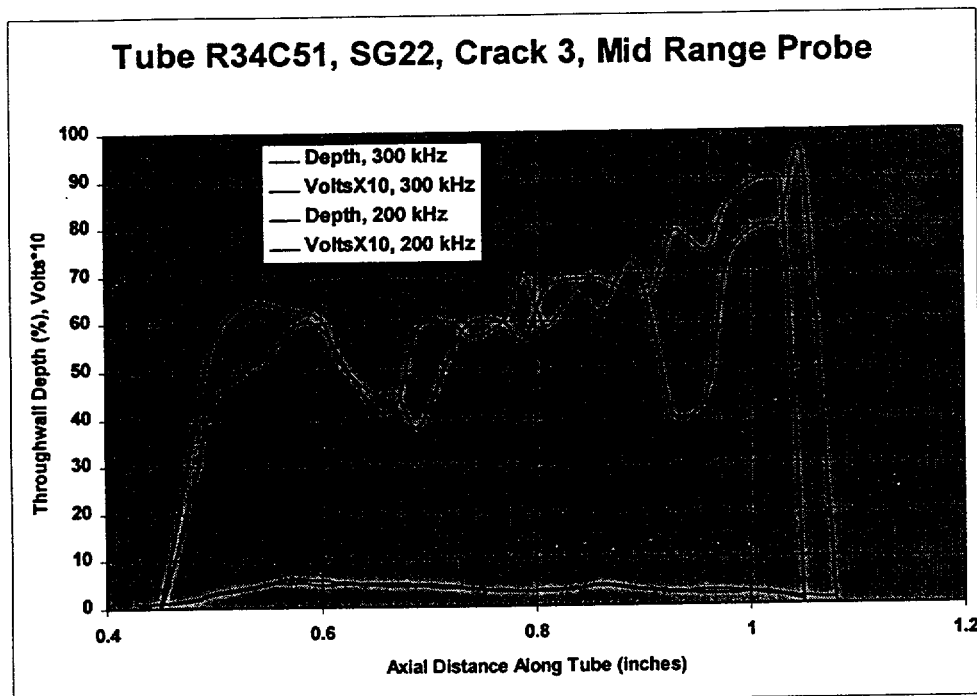
In Figure 3 and Figure 4 we show smaller cracks. In the post pressure-test scan these cracks

were still visible, but could not be profiled due to the large increase in signal from crack 2. Its signal distorted the phase of the smaller cracks, which were adjacent to it.

**Figure 3** Profile of crack 3 in tube r34c51 of Steam Generator 22.

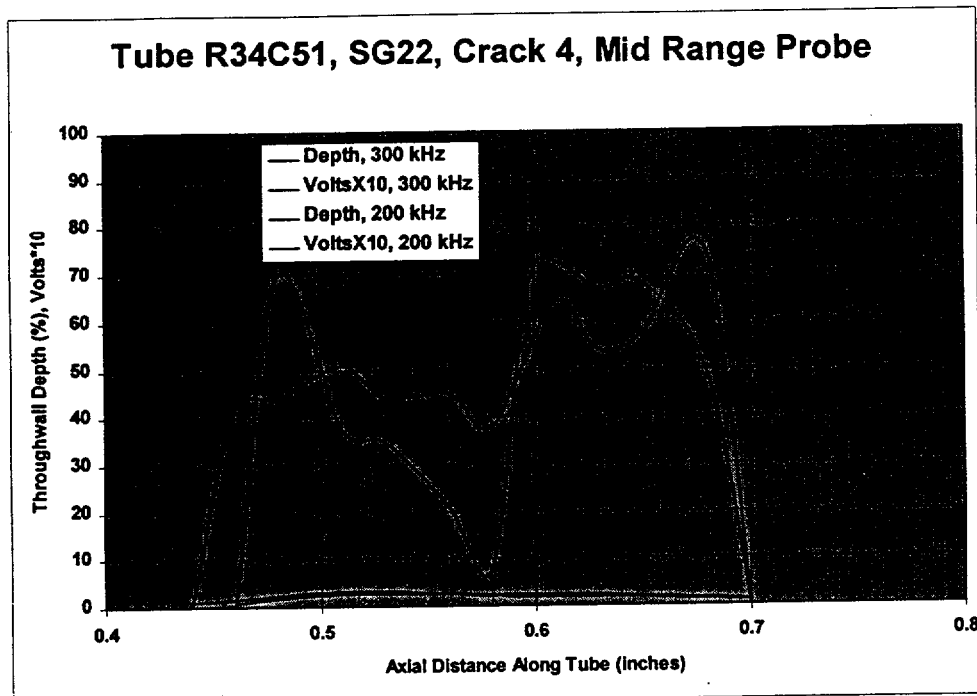
**Figure 4** Profile of crack4 in tube r34c51 of Steam Generator 22.

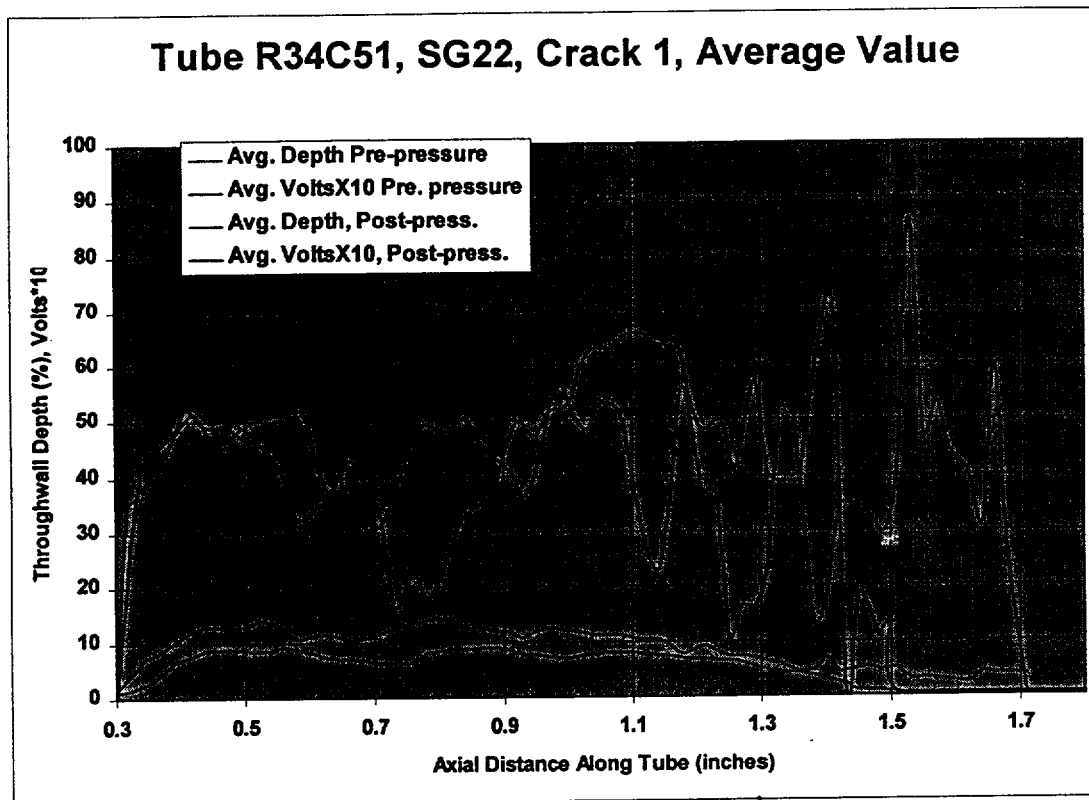
**Figure 7** Effect of pressurization on Crack 1 for tube R34C51 of steam generator 22.

In Figure 7 we show the profiles averaged for the plus-point probe for the 300 kHz and the 200 kHz frequencies. The first part of the crack nearer the tube sheet seems to be about the same. For the second part of the crack, the readings seem to have become unreliable. The signals from all the coils were reviewed. The pancake coils showed a deeper crack, but there also was evidence of increased lift-off. The crack may have spread apart somewhat, due to the pressure test, and is no longer strictly crack shaped. The amplitude of the signal increased for all of the coils. This increase was about 25% for most of the crack for the plus-point coils. There probably would have been more increase if Crack 2 had not opened up, relieving the stress.

Measurements made on this crack with the 0.080-inch high frequency probe showed a very sharp spike-like response before pressurization, and a more broad response afterwards, also indicating some spreading of the crack. A comparison of Crack1 in figures 5 and 6 show that the base of the crack is much fatter as the distance from the tube sheet has increased. Another crack parallel to Crack1 may have opened in this region, causing errors in the depth readings.

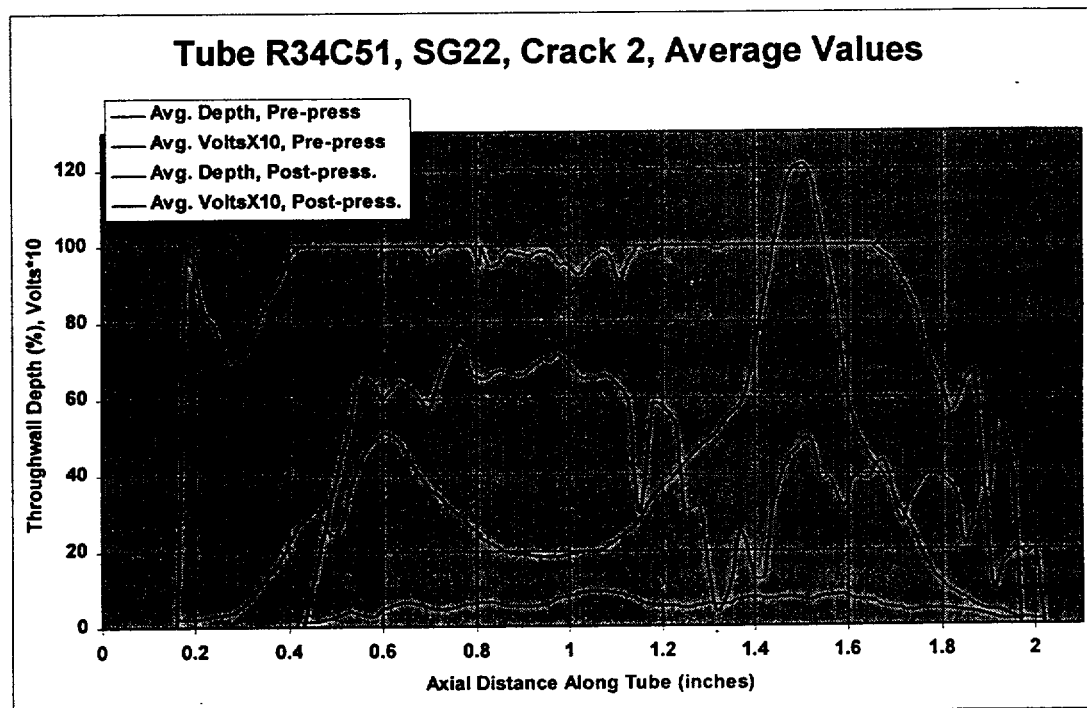
In Figure 8 we show the profiles for Crack 2, for the plus-point probe, averaged over the 300 kHz and the 200 kHz frequencies. These readings appear to be more regular, but they were also

considerably distorted. This crack reading switched from od to id a number of places along the length, and the crack signal was not the classic shape that occurs on the calibration standards. When the signal went to id, the crack was assigned a value of 100%.

The amplitude of this crack signal increased to 12 volts. The amplitude calibration was set for a 100% EDM notch to have a voltage of 20-volts. Even a through wall crack must have some current bridging across the crack face to cause the signal to decrease to this value.

**Figure 8** Effects of pressurization on Crack 2 in tube R34C51 of Steam Generator 22.
