Wayne Schmidt - Three 1997 C-scans

Growth Studies for Indian Point2 Steam Generator U-bend Defects

Tube row 2 col 69 of Steam Generator 24

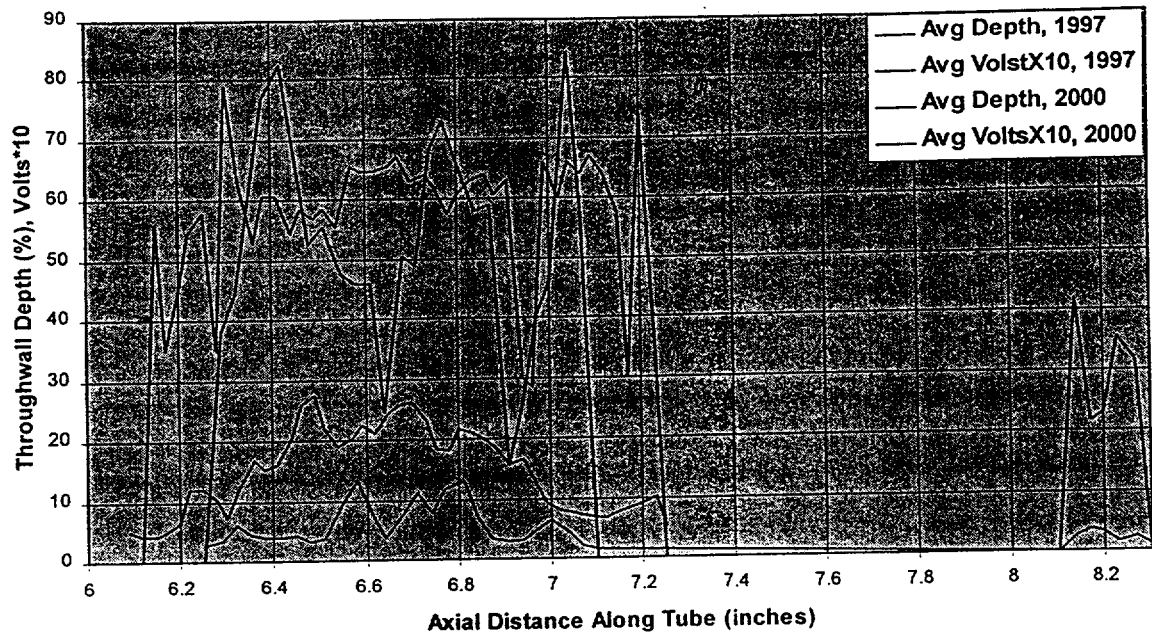
Figure 1 Profile of Growth between 1997 and 2000 for Tube R2C69 of Steam Generator 24

Figure 1 shows the profile of tube Row 2 Col 69 of Steam Generator 24. The profile of the tube taken from the high-frequency data is shown in Figure 2. Although there is considerable noise present in the C scans using the midrange probe, as shown in Figure 3, this is probably the most accurate profile of all the tubes. The noise features between the midrange scans in 1997 and 2000 are similar enough to verify that this is the same defect at the same location. The 1997 scan shows a considerable amount of noise, and much of the depth profiling is guessing. As can be seen in Figure 1, the defect voltage is only about 1 volt, and there is a considerable amount of noise on the tube, relative to the defect signal.

The signal amplitude has increased to about 2.5 volts in 2000 with the same type of probe, calibrated in the same manner. This indicates a growth in the crack, although it may well be in the widening of the crack, rather than the crack getting deeper. The crack also appears longer in 2000 than in 1997. This may be due to the increase in amplitude causing the ends of the crack which were present in 1997 but below the noise, to now become visible. There were other signals in 1997 that may have been part of the defect or part of the noise ridge that the defect was riding on.

The average defect depth was computed from the axial distance of 6.55 to 6.84-inches. The 1997 average depth this was 52.6 %, and the average 2000 depth was 62.7-inches. This results in an average growth of 10% of the wall thickness during the cycle. This crack growth rate is probably more accurate than the next two.

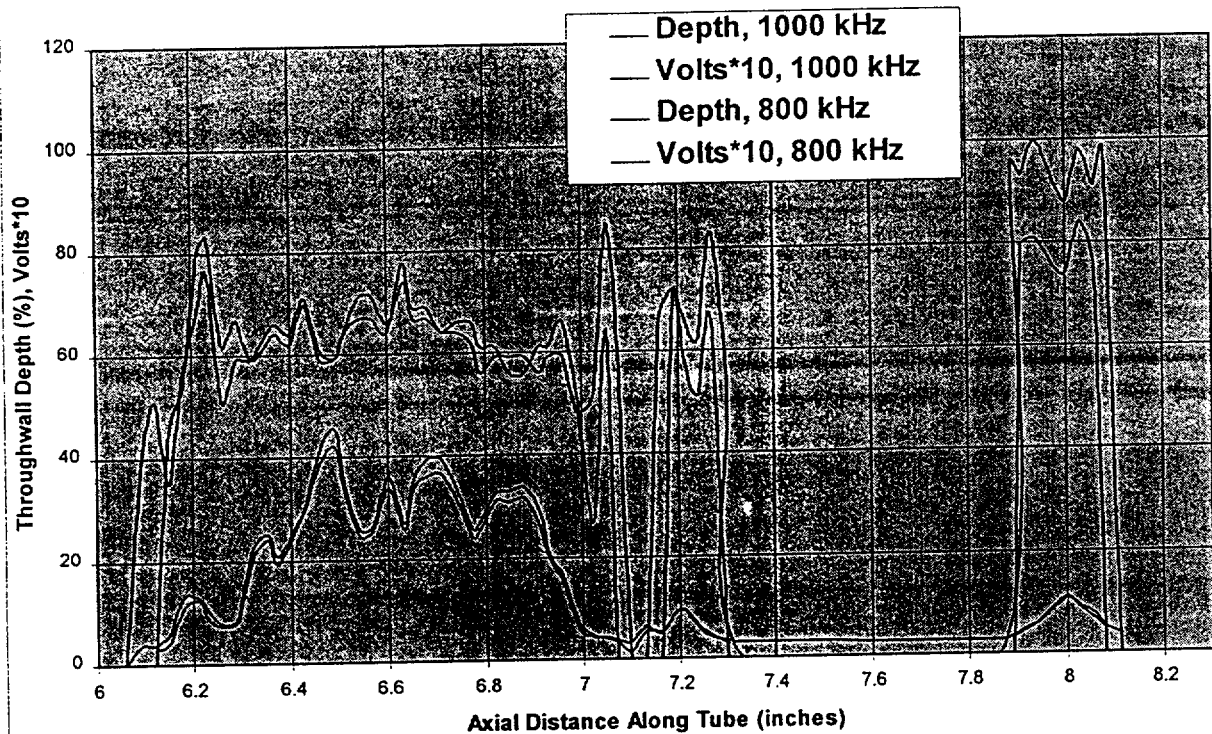
Figure 2 Profile of Tube R2C69 with the High Frequency Probe.

The signal has increased to about 4 volts in the profile shown in Figure 2, using the high frequency data. The noise has also increased, and this signal-to-noise ratio gives a much more accurate profile than either curve in Figure 1.

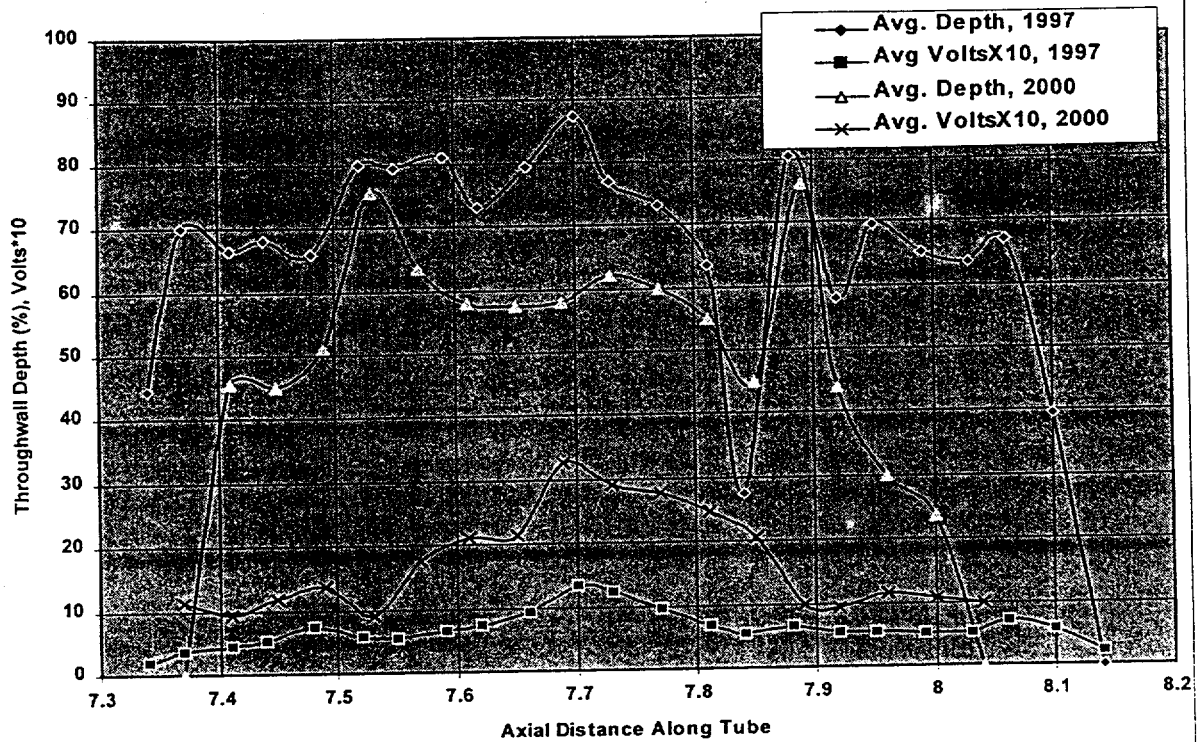
Figure 4 Profile of crack growth of tube R2 C72 of SG24 between 1997 and 2000

Figure 4 shows the profile of the crack growth in tube Row 2, Col 72 in steam generator 24 between 1997 and 2000 using the high frequency probe. The later profile done with the high-frequency probe, as shown in Figure 5 is more accurate.

The average defect depth was computed from the axial distance of 7.66 to 7.77-inches. The 1997 average depth this was 79.2 %, and the average 2000 depth was 59.3%. This results in an average decrease of 19.1% of the wall thickness during the cycle.

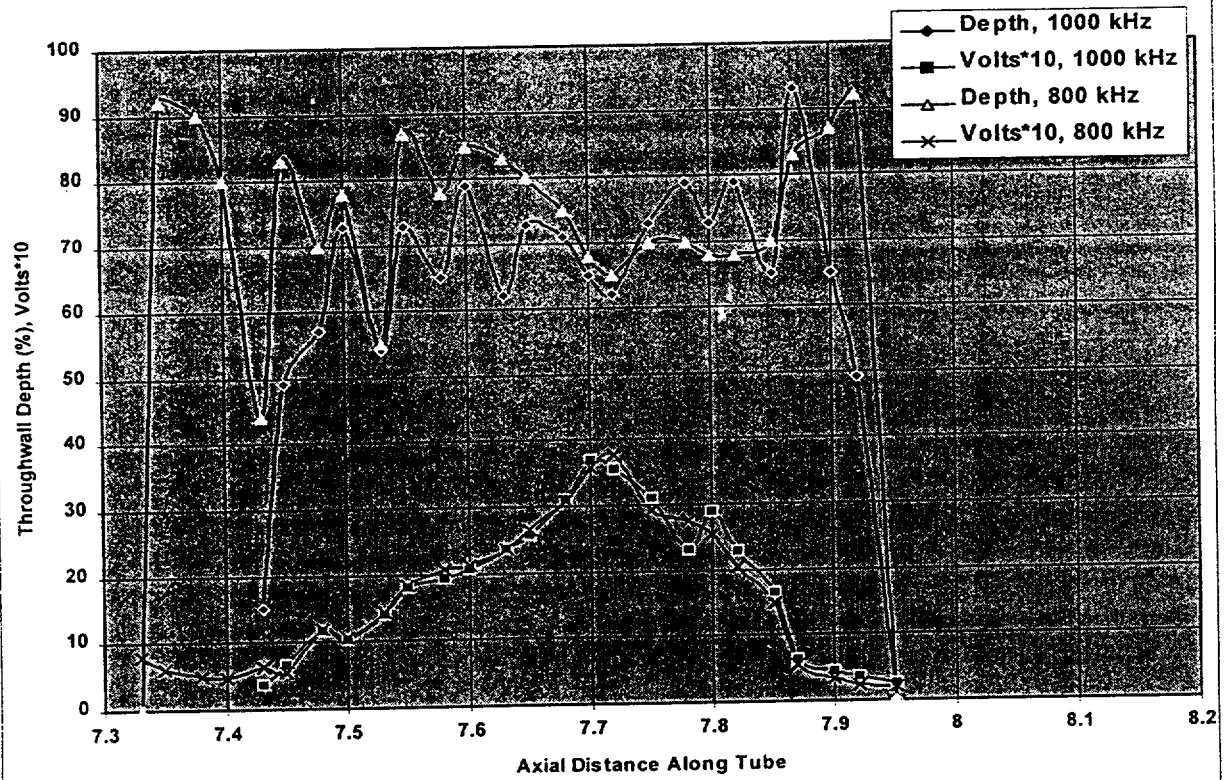
Figure 5 Profile of crack in tube R2 C72 of SG24 with the high frequency probe.

The C-scan for the high-frequency scan of this crack was taken from the opposite direction, so the features will be reversed between it and the two midrange probes. This is the most accurate profile, with the lowest signal-to-noise ratio. The maximum measured voltage is about 3.7-volts for the scan with this probe.

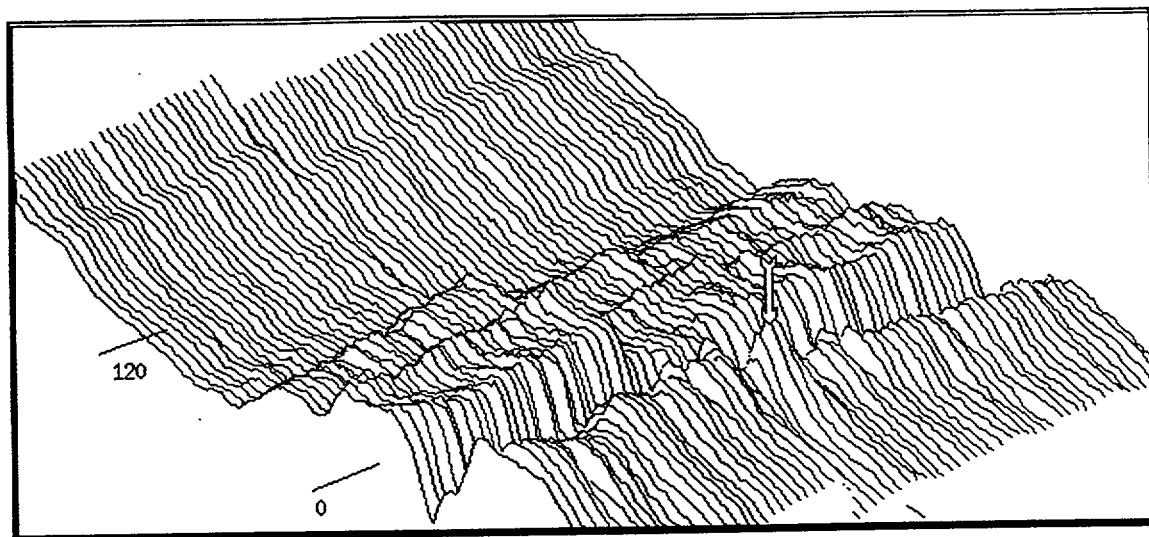
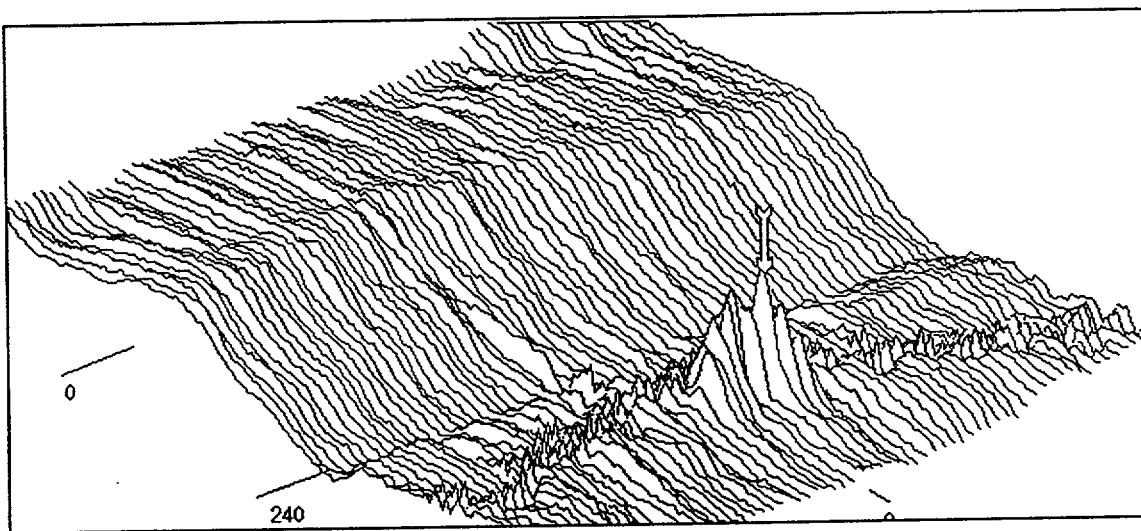
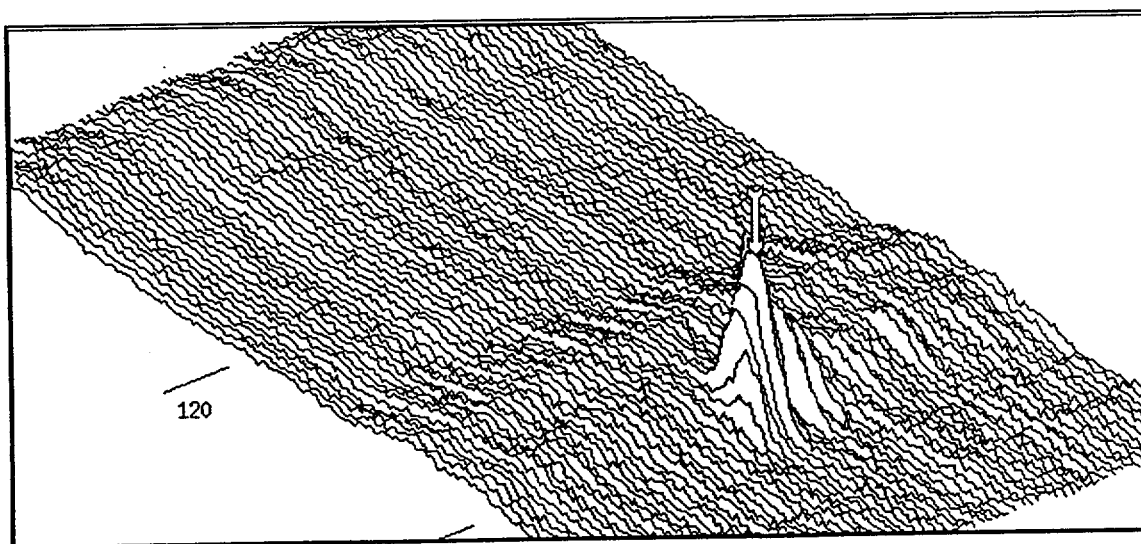
Figure 6 C-scan of tube row 2 col 12 of Steam Generator 24 in with the midrange plus-point probe in 1997 and in 2000 and with the high-frequency plus-point probe in 2000

As we can see in Figure 6, there is considerable noise present in the C- scan in 1997 with the midrange probe. The crack is sitting in a ridge of noise, and barely extends above a ridge of deposits. The crack barely extends above a 1-volt amplitude for a short length, and this is the only part of the crack that we can profile reliably.

The C-scan in 2000 with the midrange probe shows very little of the ridges present in the 1997 scan, but shows a series of spikes. These spikes are believed to be noise pulses associated with the data acquisition, possibly a problem in the slip rings. The ridges that I attributed to od deposits in the 1997 scan have vanished. There is a wave in the 1997 and 2000 scans that is similar. The signal amplitude has increased to a maximum of about 3.2-volts, making the defect easier to detect and more accurate to profile. There is a clear amplitude increase in this crack.

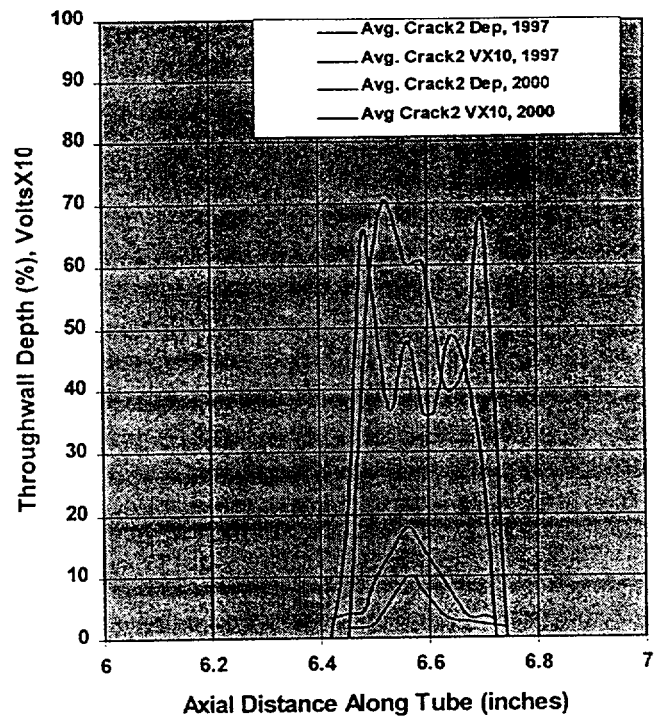
Figure 7 Profile of crack growth of tube R2 C87.

This tube was identified as having several cracks, but only one has been profiled, as shown in Figure 7. This crack was also profiled with the high-frequency probe, as shown in Figure 8.

The average defect depth was computed from the axial distance of 6.53 to 6.59-inches. The 1997 average depth this was 63.7 %, and the average 2000 depth was 40%. This results in an average decrease of 23.7% of the wall thickness during the cycle.

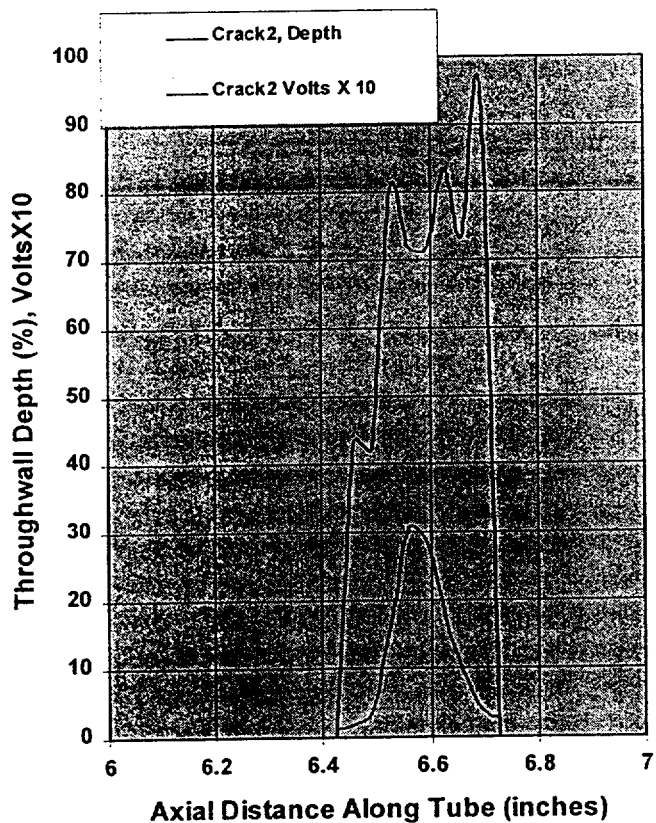
Figure 8 High-frequency profile of tube R2 C87.

In the high-frequency scan, the measured voltage increased to 3-volts, and the measured depth appears to have increased also. This is probably due to the short length of this crack. The smaller, higher frequency probe is not as susceptible to end-effects as the larger midrange probe.

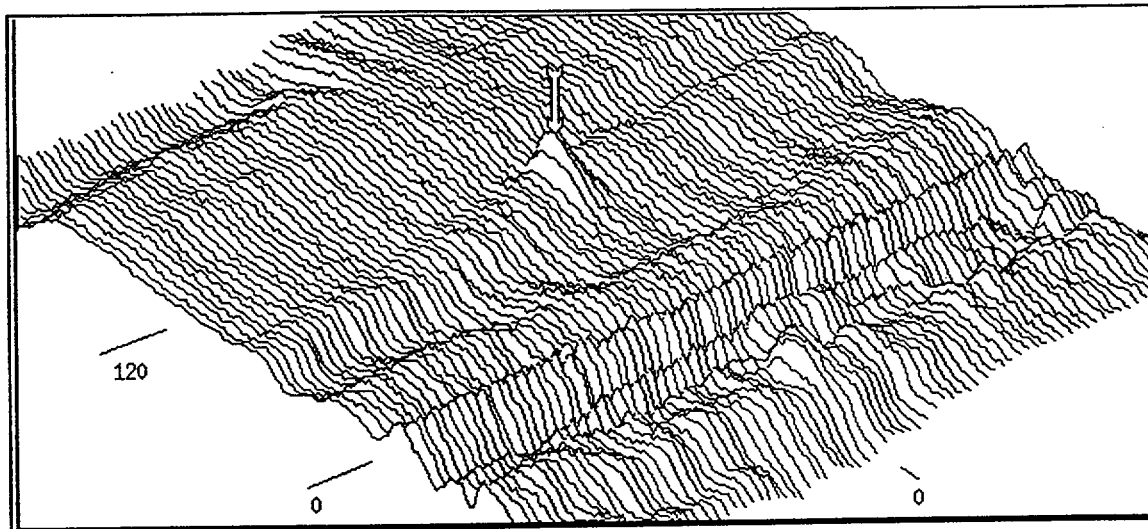
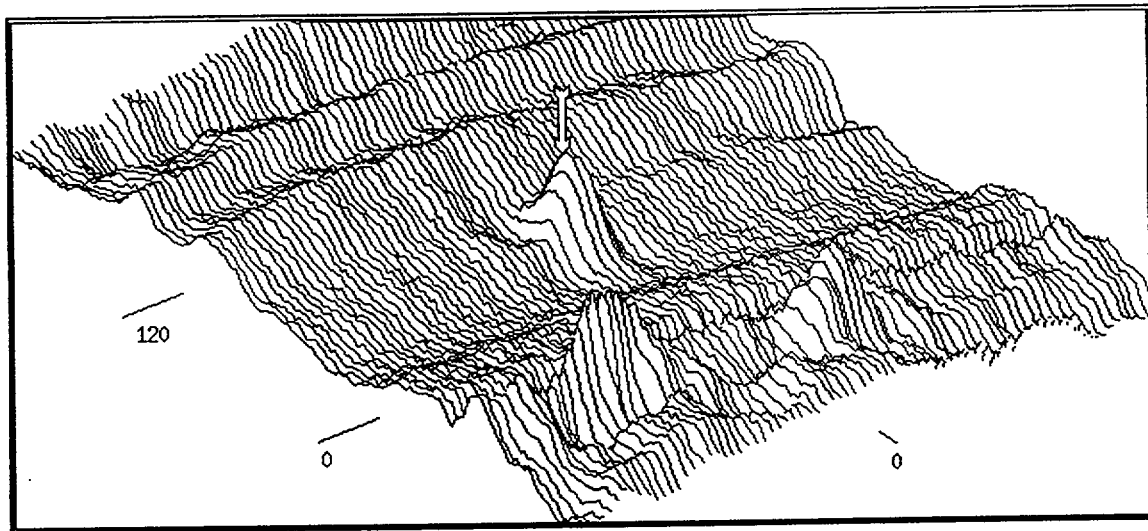
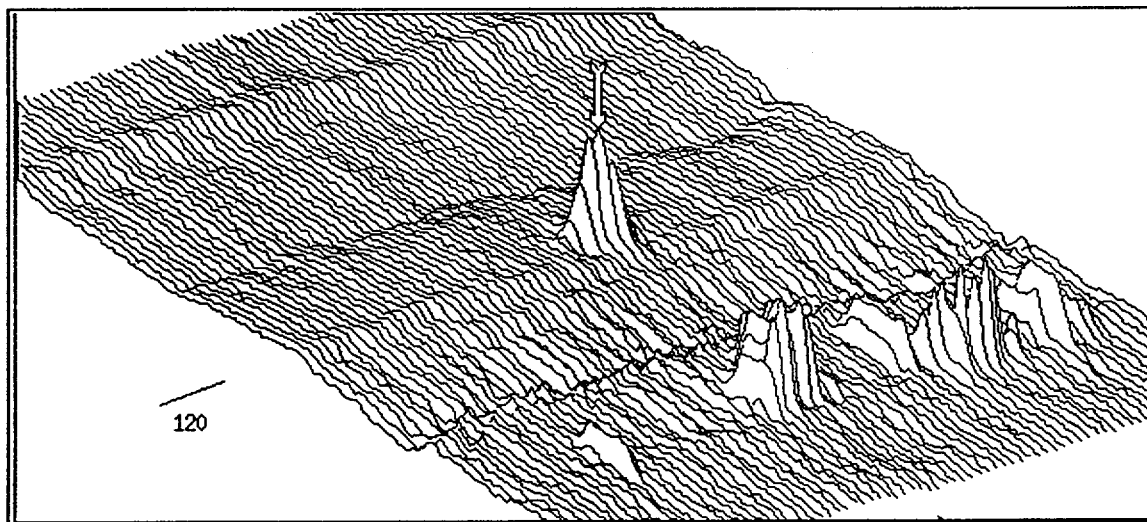
Figure 9 C-scan of tube row 2 col 87 of Steam Generator 21 in with the midrange plus-point

As we can see from the C-scans, in Figure 9, this crack is sitting in a relatively clean area of the tube. It is the crack under the arrow in all three C-scans. A small part of the crack is showing in the ridge in the 1997 scan, but the noise dominated when profiling was attempted using the 1997 data. The small, center portion of the crack is the only part that can be profiled with any accuracy.

The 2000 midrange scan is in the opposite direction as the 1997 midrange scan and the 2000 high frequency scan. The voltage amplitude increased from about 1-volt to 1.8-volts during the operating cycle. The crack depth appeared to have decreased slightly.
