UNITED STATES
NUCLEAR REGULATORY COMMISSION

SUBJECT: RESOLUTION OF DEGRADED CEQ FAN ROOM WALL

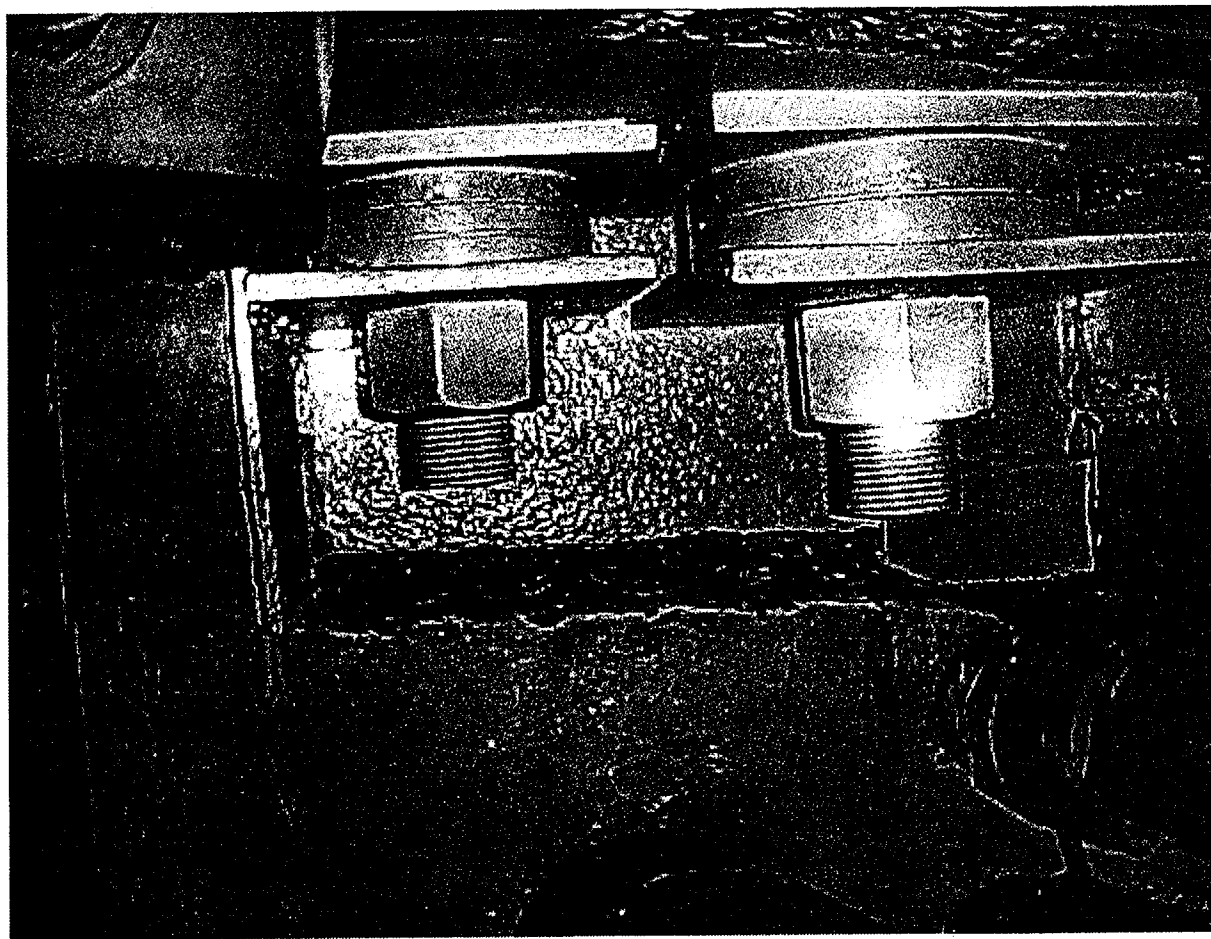
Description of the Issues: Open Pockets - Configuration of Unit 2 Ice Condenser Column Anchorage

■ Detail Showing Pocket for Anchorage Through Bolts
