SUBJECT: DONALD C. COOK - SUMMARY OF SEPTEMBER 27, 2000, PUBLIC MEETING
REGARDING UPDATE ON CONTAINMENT STRUCTURES

Update on Containment Structures

Restarting D. C. Cook Unit 1
September 27, 2000

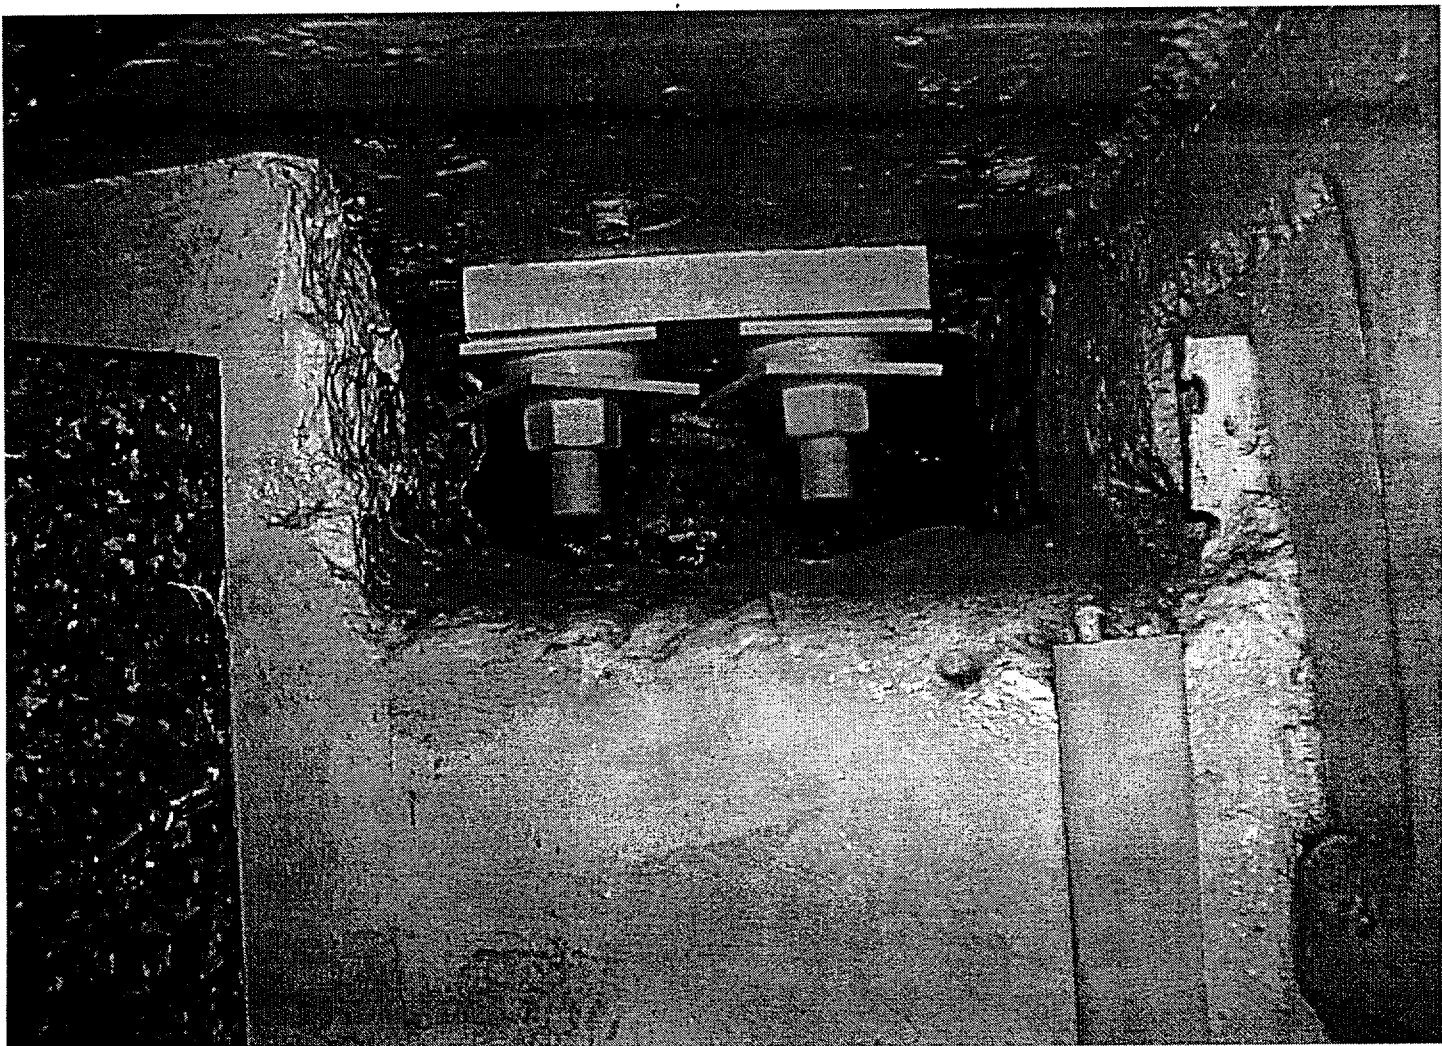
Unit 1 Status: Picture of 54° Wall Through-Hole

- **Through-Hole at Top of 54° Wall for Ice Slab Bolting**
 - Bolting required for slab redesign
 - Plate fastened to back of wall to prevent bypass
 - DCP to fill hole with grout prior to restart
 - Condition limited to this wall

- **Cut Rebar at Top of 54° Wall**
 - Required for pockets identified on design drawings
 - Not structurally significant

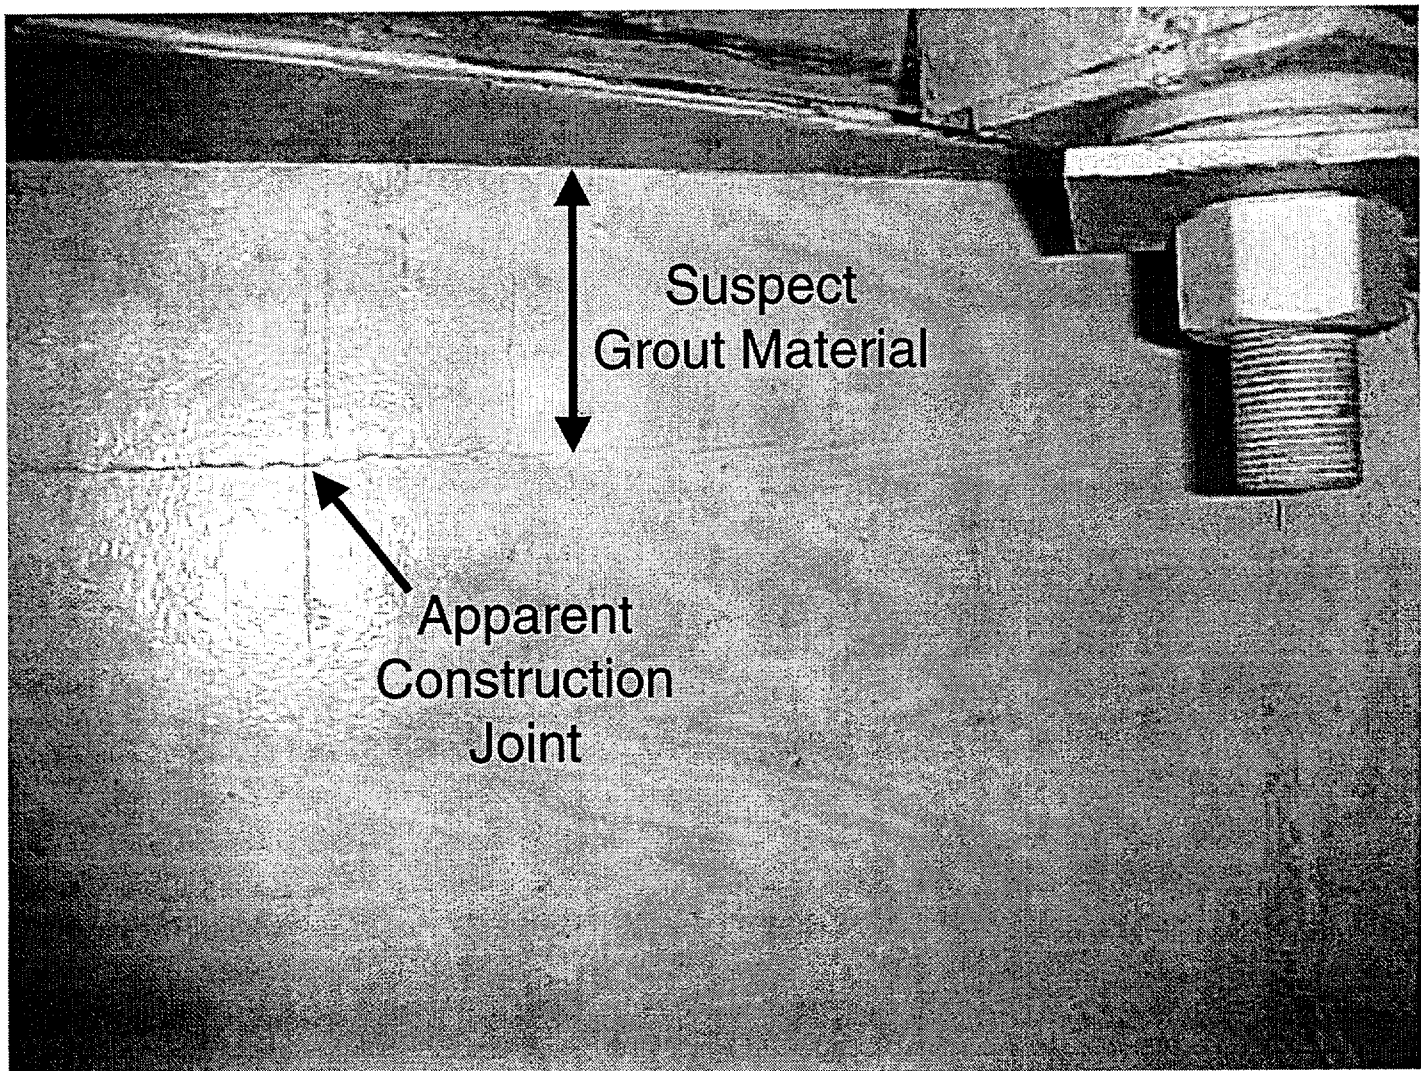
Unit 1 Status: Picture of Top of 307° Wall

- **Grout at Top of 307° Wall**
 - **Due to construction sequence**
 - » Installed after ice condenser slab poured
 - **Low strength**
 - **Condition limited to this wall**

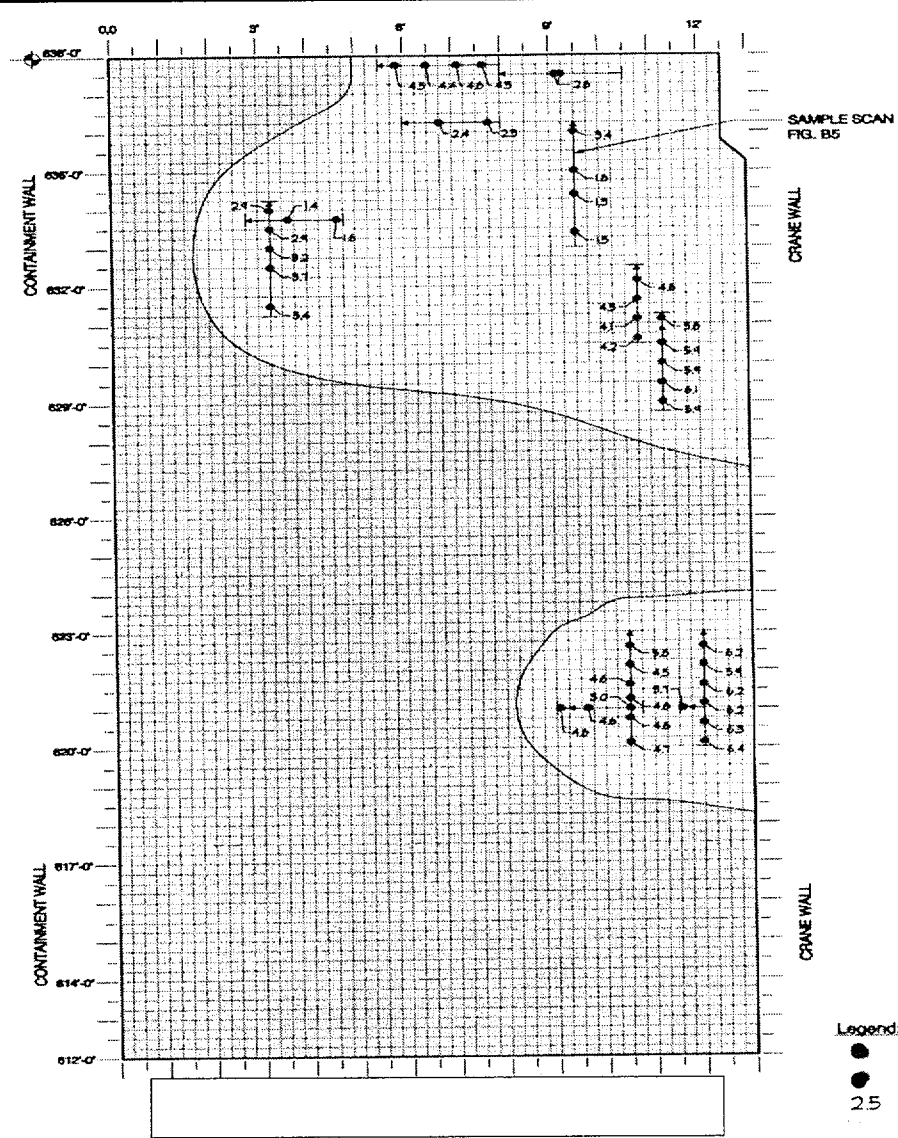
Wall Radar Mapping Example

- **Radar Mapping Complete - All Four Walls**
 - **Critical accessible areas**
 - **Both sides of each wall**
 - **Rebar placement and cover issues similar to Unit 2**
