Millstone Power Station, Unit No. 1
Issuance of Root Cause Investigation
Pertaining to Unaccounted for Spent Fuel Rods

Millstone Power Station, Unit No. 1

Root Cause Investigation

LOSS OF ACCOUNTABILITY OF TWO FUEL RODS AT MILLSTONE UNIT 1 (CR #M1-00-0548)

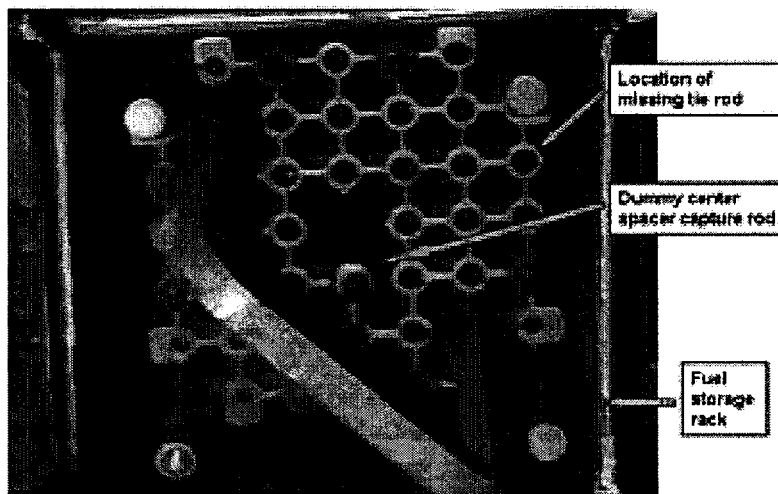
"SCRAP" MS-557 FUEL ASSEMBLY

In April 1974, GE returned to MP1 and performed a number of fuel-related inspections and assembly reconstitutions,²⁰ including the reassembly of fuel bundle MS-557.²¹ They did not, however, incorporate the damaged tie rod or the center spacer capture rod into the reconstituted assembly. The center spacer capture rod could not be reinstalled at MP1 because of its physical configuration. The damaged tie rod was not reinstalled

either. GE personnel used a dummy center spacer rod to support the "scrap" assembly, and left a vacancy where the damaged tie rod would have gone.²² See the photo above.

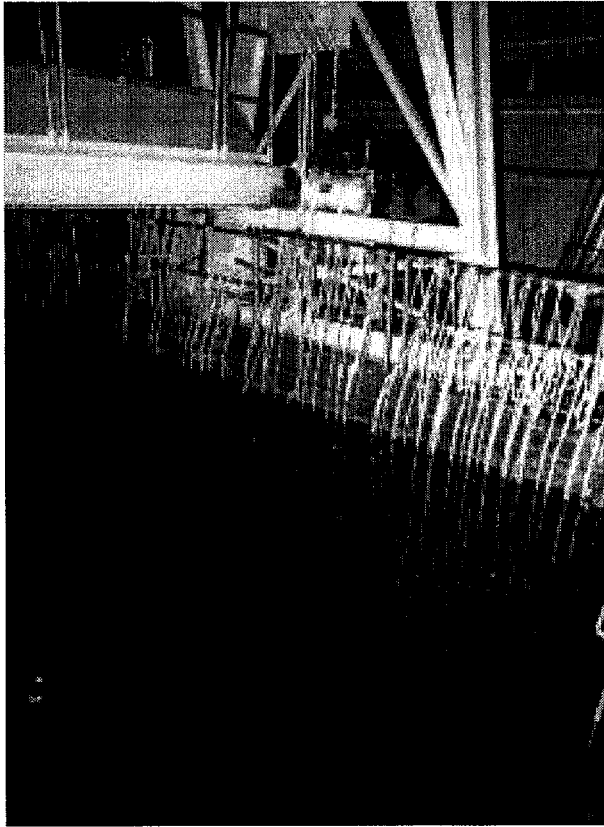
MP1 SFP, circa 1985

MP1 conducted a number of SFP clean-up activities between 1979 and 1985 to remove irradiated material and ship it to disposal sites for burial.⁴¹ Individual fuel rods may have been confused with some of the material to be shipped. The potential for such a mistake was certainly present. The individual fuel rods were stored in an "8-rod container" and tied to the SFP railing when last observed in 1979, rather than placed in the fuel racks.⁴² Interviews of individuals involved in SFP cleanup indicated that they were well aware of the need to stay away from the fuel racks while working in the SFP and did so, but considered items hanging off the SFP railings to be intended for disposal.⁴³

The picture below shows conditions of the MP1 SFP (circa 1985). Note the many ropes tied to the railing, attached to objects submerged below the water surface:

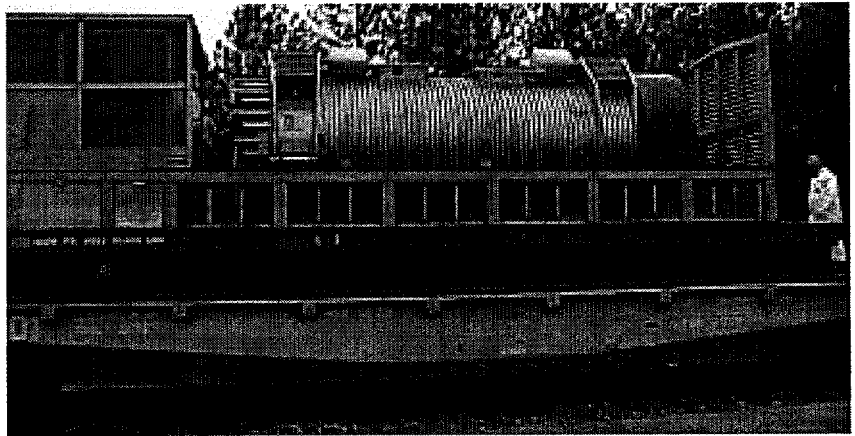
IF-300 Shipping Cask
(mounted on a rail car)

The three shipments during this period with potential to have inadvertently included cut up fuel rods in IF-300 shipping casks, occurred on March 20, May 29, and July 31, 1985, and were sent to the U.S. Ecology LLRW Facility, Richland, Washington.⁴⁵ The FRAP Final Report concluded that:⁴⁶
