**UNITED STATES
NUCLEAR REGULATORY COMMISSION**
WASHINGTON, D.C. 20555-0001

FACILITY: River Bend Station, Unit 1

SUBJECT: SUMMARY OF MEETING BETWEEN THE NUCLEAR REGULATORY COMMISSION (NRC) STAFF AND ENTERGY OPERATIONS, INC. (EOI), RIVER BEND STATION MANAGEMENT, JUNE 22, 1999

River Bend Station Fuel Recovery

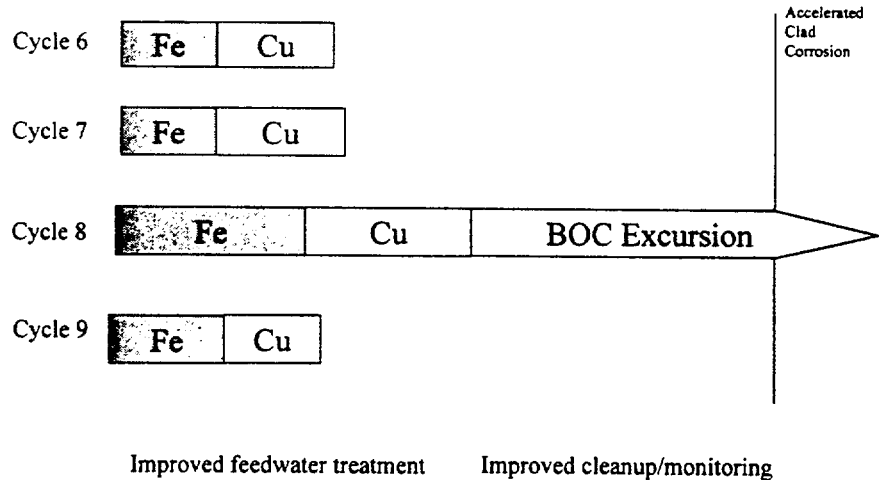
Cause of Fuel Clad Perforations

Thermally-induced accelerated corrosion,
due to the combined effects of elevated iron
and copper deposits with a chemistry
excursion early in the operating cycle

- Conservatively discharged all once burned fuel assemblies (HGE)
- Additional conservatism in core design
- Short operating cycle for Cycle 9
- Reducing metals transport to reactor
- Improving chemistry monitoring capability
- Increasing chemistry monitoring
- Performing confirmatory inspections during the ninth refueling outage
