UNITED STATES
NUCLEAR REGULATORY COMMISSION
OFFICE OF NUCLEAR REACTOR REGULATION
WASHINGTON, D.C. 20555-0001

NRC INFORMATION NOTICE 2002-06: DESIGN VULNERABILITY IN BWR REACTOR
VESSEL LEVEL INSTRUMENTATION BACKFILL
MODIFICATION

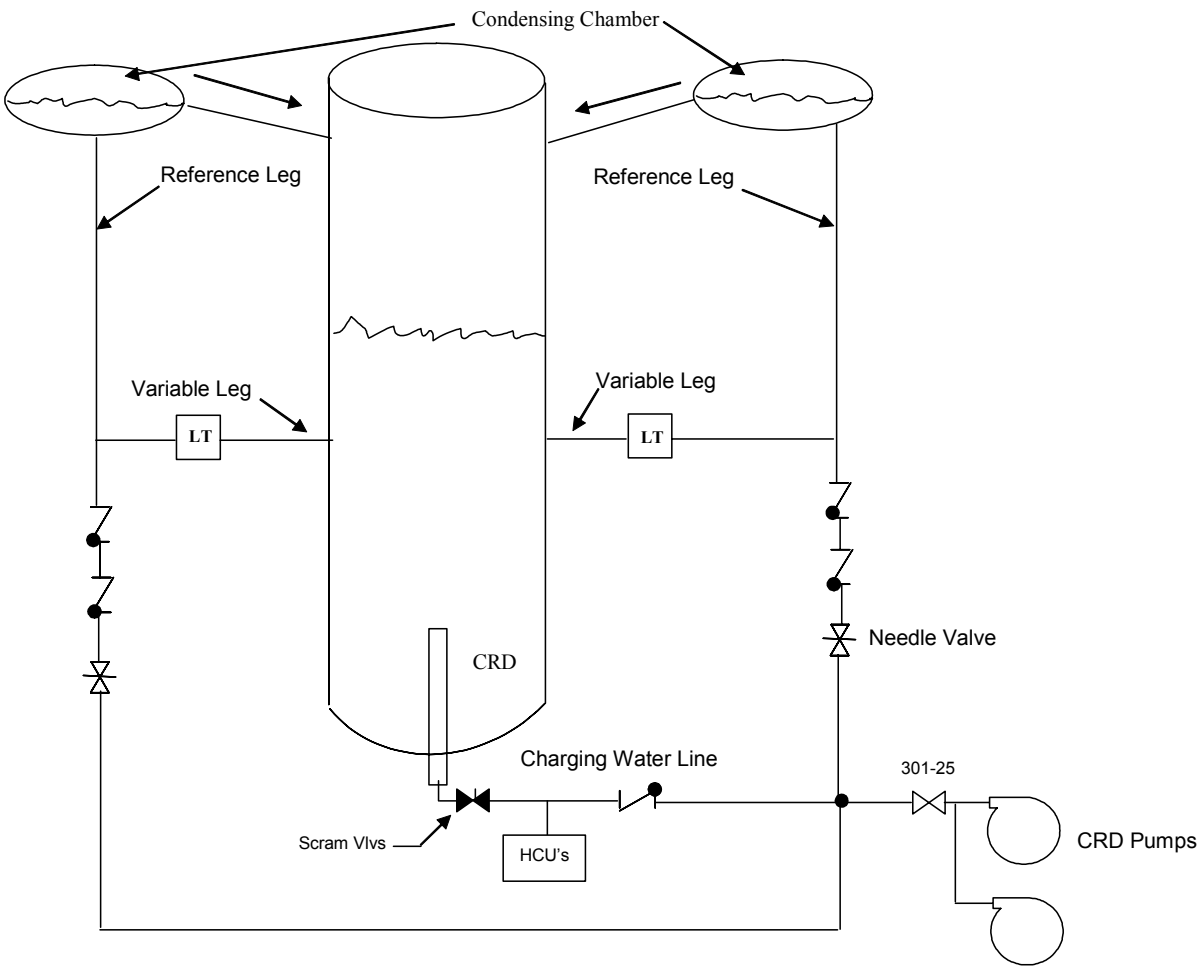
RWL Reference Leg Backfill

It was discovered that, under certain conditions, the safety-related reactor vessel water level indicators that provide certain safety-related initiation signals could give nonconservative water level readings. During a reactor trip at Pilgrim, both trains of the emergency core cooling system (ECCS) reactor water level instruments indicated higher than actual levels. These instrument inaccuracies were noted after operator actions were taken to isolate the CRD system charging water header supply valve, CRD 301-25, to insert a control rod that had not settled at position 00. Closure of the charging water header isolates the ECCS level indicator reference-leg backfill system (see Attachment 1). The erroneous readings were attributed to

the reference legs draining back through the reference-leg keepfill system to the CRD hydraulic control units (HCUs). With the CRD charging header valve shut, the reactor scram reset, and reactor pressure rising, the reference legs drained back to the HCUs. This occurs when the CRD system pump is secured or the charging header isolation valve is closed, the source of the reference-leg keepfill system, is at a slightly lower pressure than the reactor so that the differential pressure across the keepfill system check valve is not sufficient to fully seat the check valves. The draining of the reference legs results in a transient false reference-leg indication until the check valves seat and the reference legs refill via the condensate pots or flow is reestablished through the CRD reference leg backfill system. Pilgrim concluded that this phenomenon can occur with either the isolation of the reference leg backfill system or possibly with the loss of the running CRD pump.

During the reactor scram at Pilgrim, this event resulted in both the wide-range vessel level instruments indicating higher than actual water level with the A train reaching a maximum deviation of 26 inches and the B train reaching a maximum of 11 inches. These erroneous high readings occurred for approximately 30 minutes. During this time, the automatic emergency core cooling system initiation function would not have occurred on low-low water level as designed. This false reading is due to the relative locations of the reactor vessel instrument nozzles and the differential pressure corresponding to the ECCS initiation setpoint.
