Tabern of IP2 (Cameron) ^(?)

MS-1-24 DISC TO SEAT CLEARANCES IN INCHES

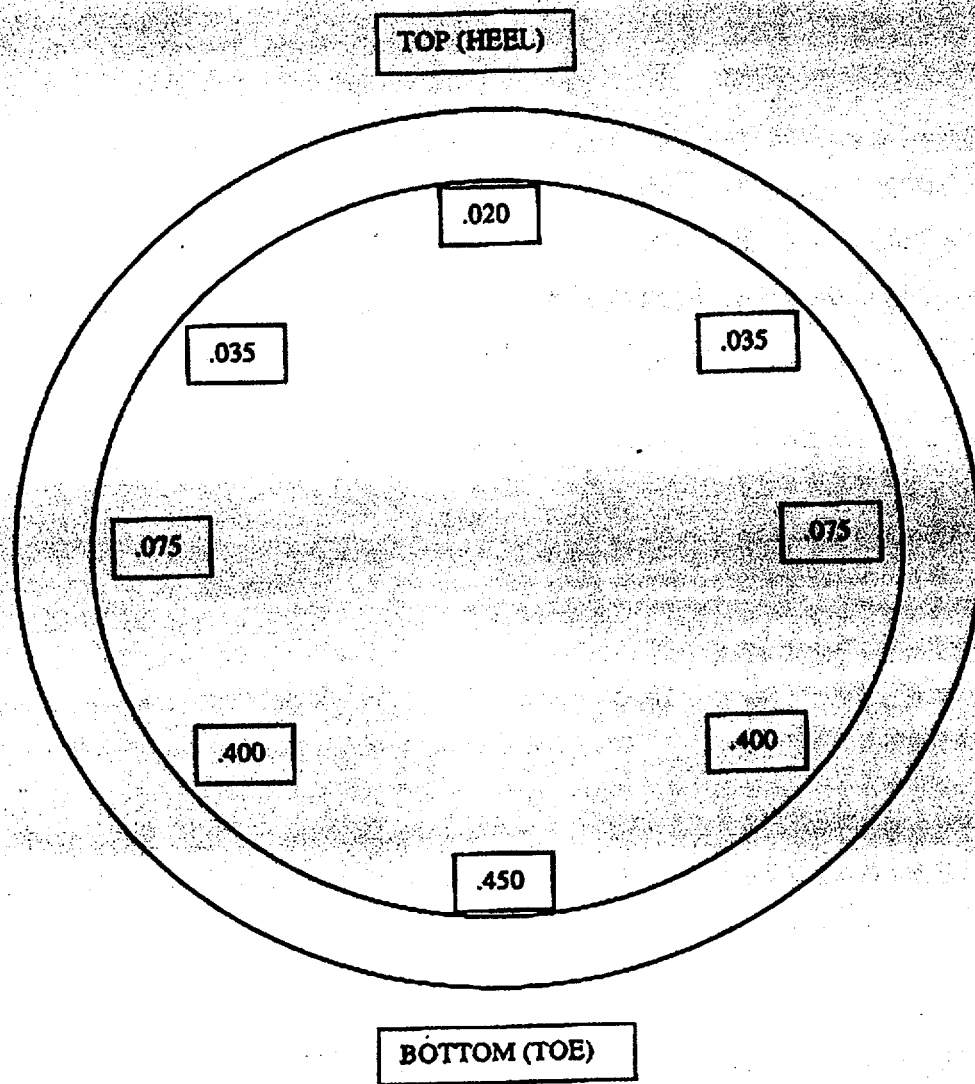
24 MSIV majority (disk was inch off seat)
bypass valve (double disk) - non-preferred
direction

Loss than 10mils average around seat & between
7-8 mgs was measured at front
circumference in

~ 14 in² opening
