### Profiles of tube r34c51 of Steam Generator 22

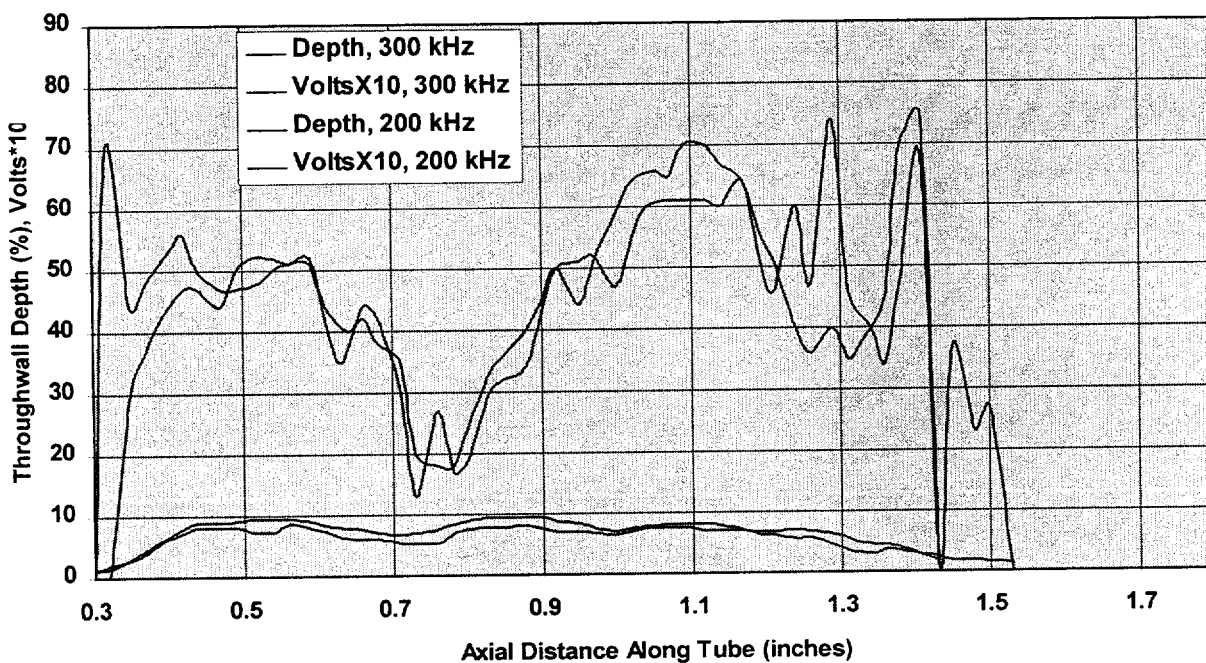
### Tube R34C51, SG22, Crack 1, Mid Range Probe

Tube r34c51 was profiled in the sludge region. This tube had two rather long cracks and two shorter cracks. All four were profiled, and are given in the figures below. All of the cracks were just above the tube sheet. The profiles were done using the 200 kHz and the 300 kHz test frequencies of the plus-point probe. Data were taken at 10 kHz, 100 kHz, 200 kHz and 300 kHz with both the plus point and the 0.115-inch diameter pancake coil. The 0.080-inch diameter high-frequency pancake coil was also used at 600 kHz and 300 kHz. The plus-point had the best signal-to-noise ratio for the tubes that I examined in the sludge pile region. The 0.080-inch diameter probe gave a sharp spike-like signal for the cracks. This coil may give better signal-to-noise at 800 kHz, where the noise should be rotated horizontal. Crack 1, as shown in Figure 1

**Figure 1** Profile of crack1 in tube R34C51 of steam generator 22.

was one of the larger ones, and had a voltage signal close to one volt. While this crack appeared to grow about 25% in voltage amplitude due to the pressurization, this is not the point where the tube burst.

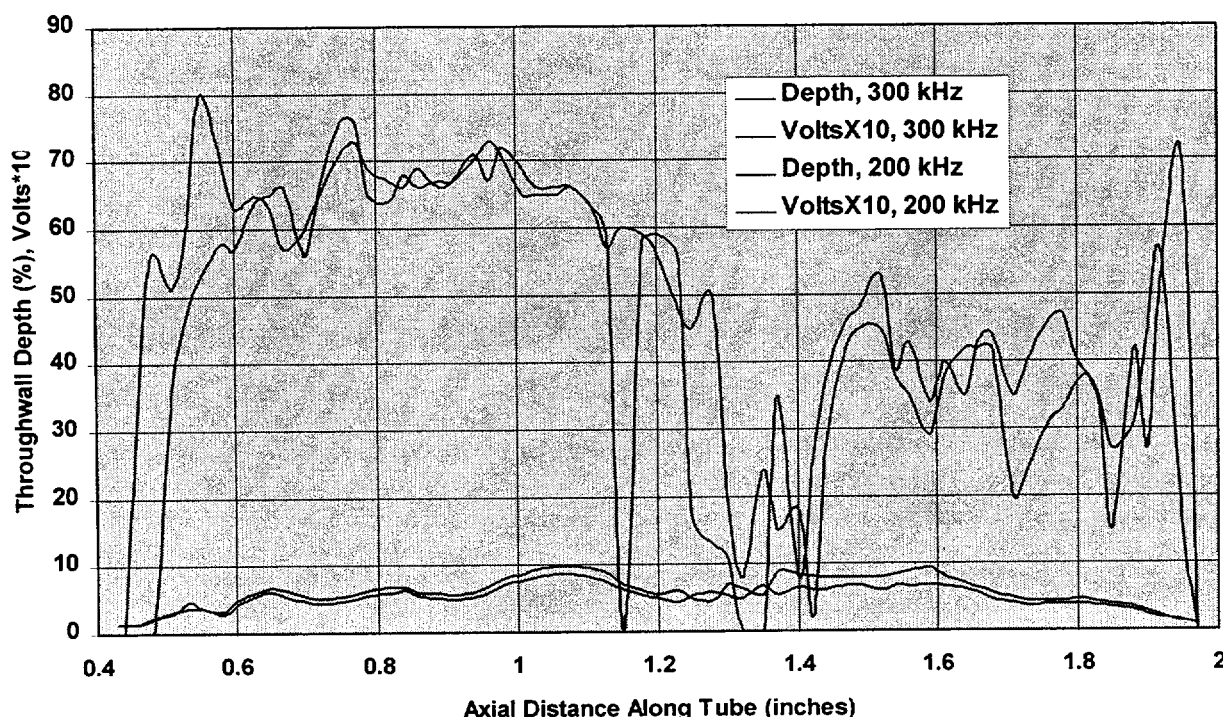
## Tube R34C51, SG22, Crack 2, Mid Range Probe

Crack 2, as shown in Figure 2, is slightly longer and slightly deeper. This is the crack that burst. The voltage amplitude of this crack is about the same, and probably averages less than that of crack one. This demonstrates that voltage is not a good measure of crack size, depth or severity. Crack 2 appeared to go through wall, and the voltage amplitude increased by a large factor. This

**Figure 2** Profile of crack 2 of tube r34c51 in steam generator 22.

tube also had a large voltage increase of a crevice crack due to the pressurization.

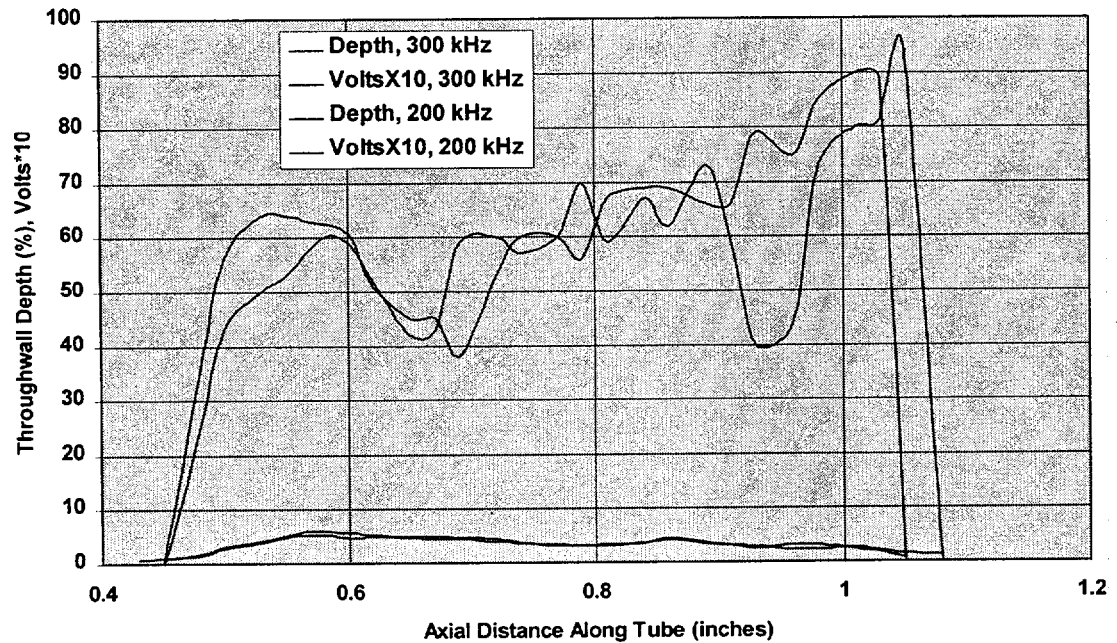
### Tube R34C51, SG22, Crack 3, Mid Range Probe

In Figure 3 and Figure 4 we show smaller cracks. In the post pressure-test scan these cracks were still visible, but could not be profiled due to the large increase in signal from crack 2. Its signal distorted the phase of the smaller cracks, which were adjacent to it.

Figure 3 Profile of crack 3 in tube r34c51 of Steam Generator 22.

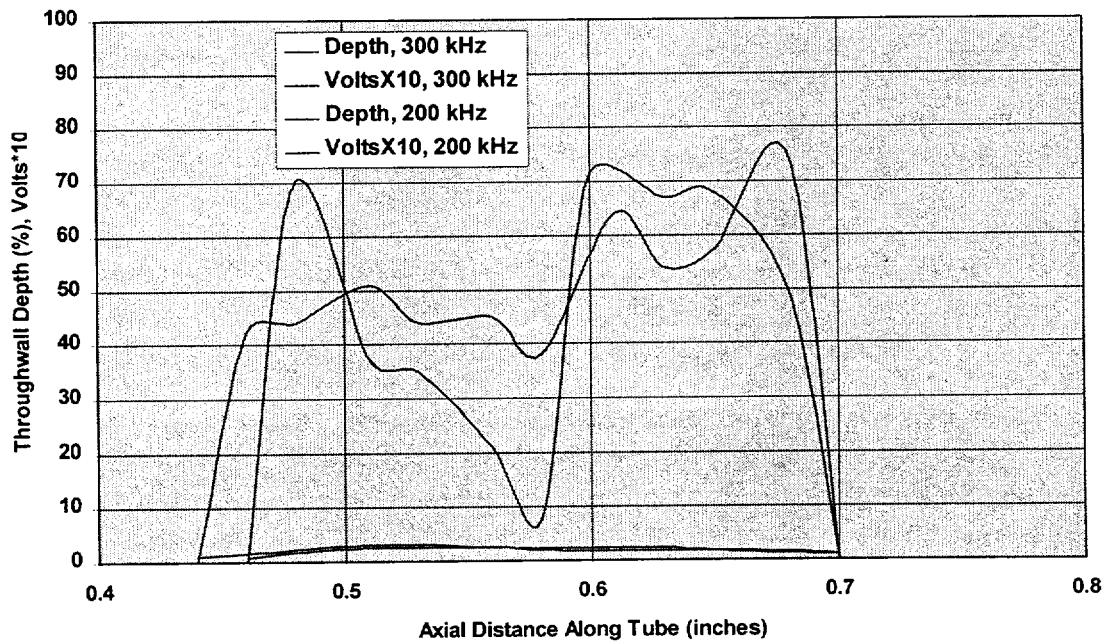
### Tube R34C51, SG22, Crack 4, Mid Range Probe

Figure 4 Profile of crack4 in tube r34c51 of Steam Generator 22.

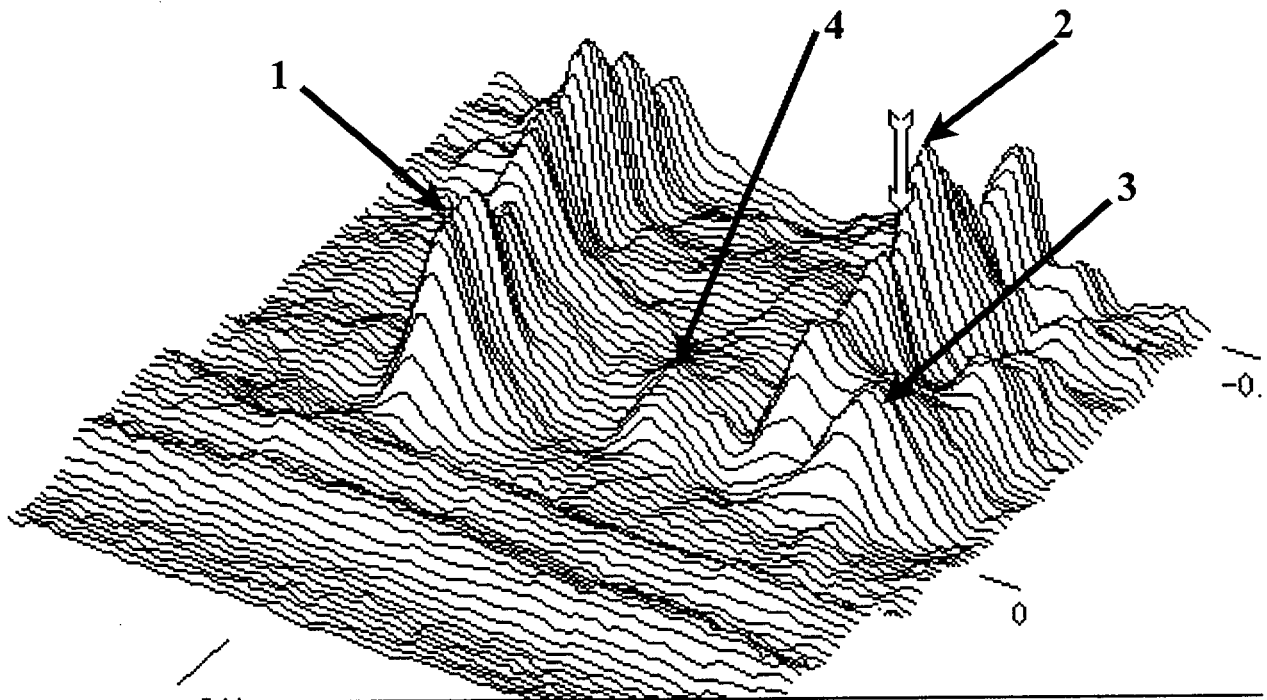
The positions of each of the cracks is labeled in the C-scan that is shown in Figure 5. Note the large voltage signal from the cracks in this tube, and the low noise. Other tubes do not have as good a signal-to-noise ratio and are more difficult to inspect in this region.

**Figure 5** C-scan to tube r34c51 of steam generator 22 before pressurization.

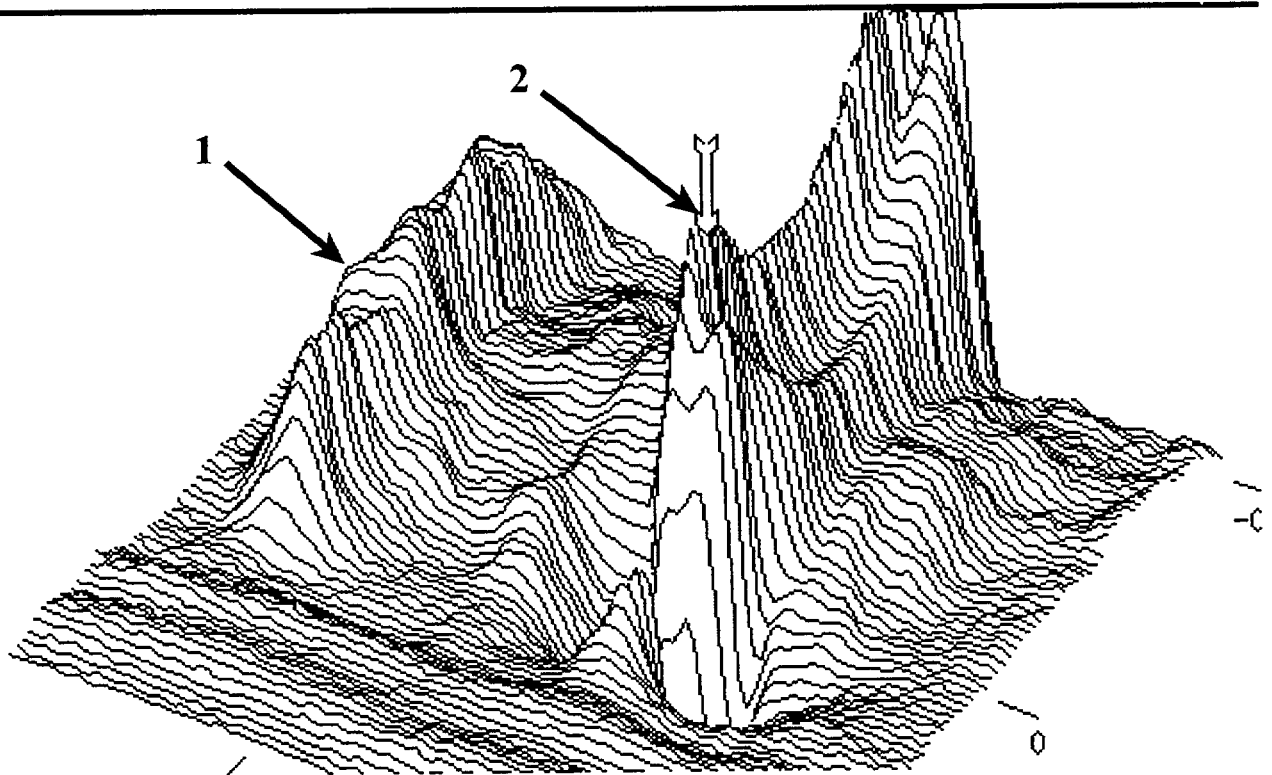
In Figure 6 we show the post pressurization scan of this tube. The signal from crack 2 is now much greater than the other cracks, indicating that this was the crack where the tube leaked. It appears that the crack opened to within about 0.3-inches of the tube sheet, and the voltage increased from near 1-volt to over 10-volts in places.

**Figure 6** C-scan of tube r34c51 of steam generator 22 after pressurization.

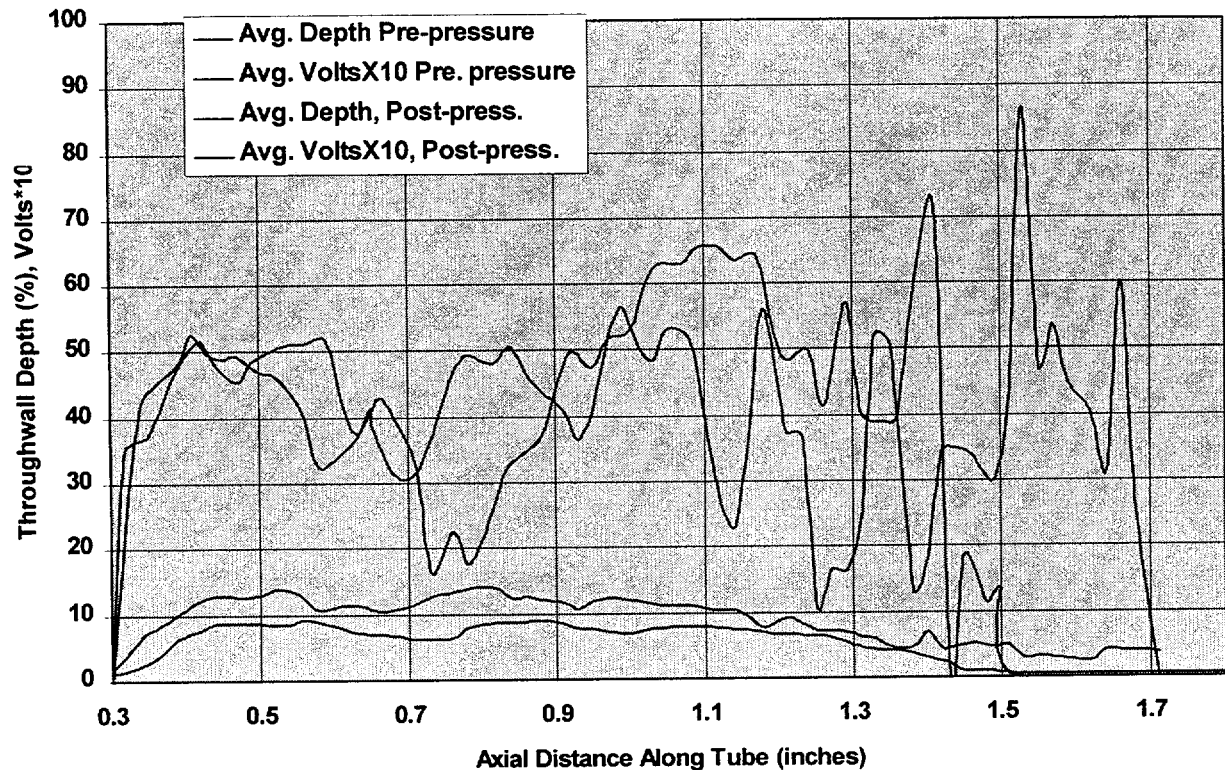
## Tube R34C51, SG22, Crack 1, Average Value

**Figure 7** Effect of pressurization on Crack 1 for tube R34C51 of steam generator 22.

In Figure 7 we show the profiles averaged for the plus-point probe for the 300 kHz and the 200 kHz frequencies. The first part of the crack nearer the tube sheet seems to be about the same. For the second part of the crack, the readings seem to have become unreliable. The signals from all the coils were reviewed. The pancake coils showed a deeper crack, but there also was evidence of increased lift-off. The crack may have spread apart somewhat, due to the pressure test, and is no longer strictly crack shaped. The amplitude of the signal increased for all of the coils. This increase was about 25% for most of the crack for the plus-point coils. There probably would have been more increase if Crack 2 had not opened up, relieving the stress.

Measurements made on this crack with the 0.080-inch high frequency probe showed a very sharp spike-like response before pressurization, and a more broad response afterwards, also indicating some spreading of the crack. A comparison of Crack1 in figures 5 and 6 show that the base of the crack is much fatter as the distance from the tube sheet has increased. Another crack parallel to Crack1 may have opened in this region, causing errors in the depth readings.

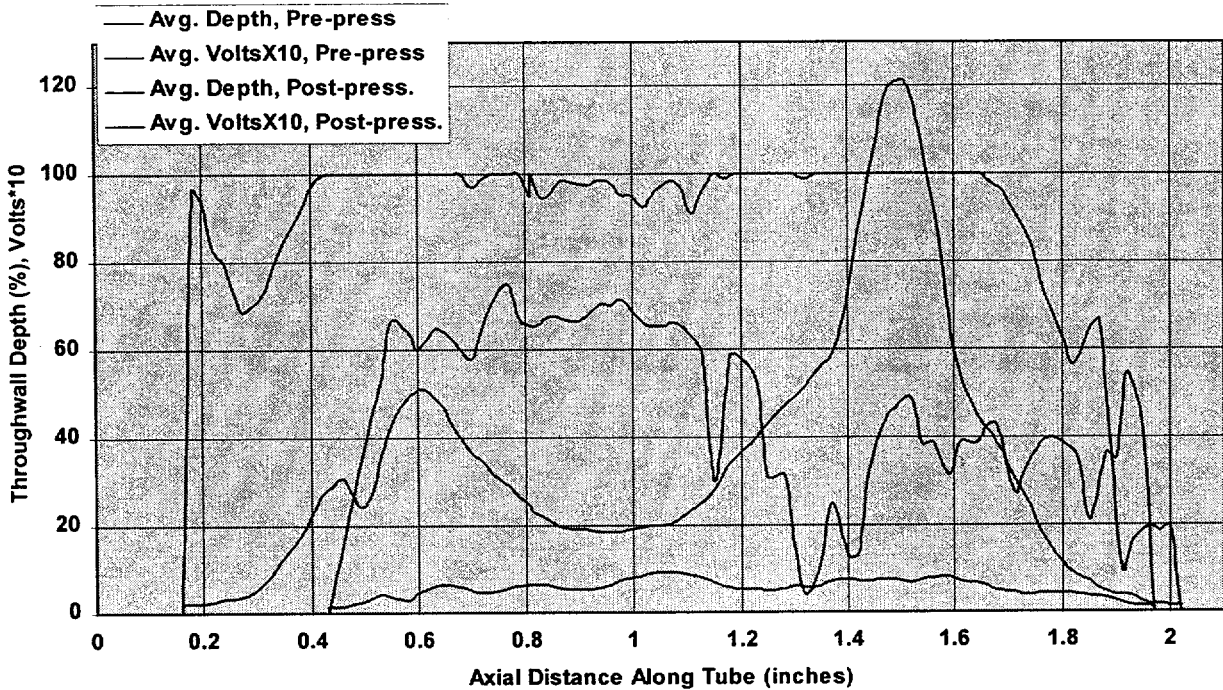
### Tube R34C51, SG22, Crack 2, Average Values

In Figure 8 we show the profiles for Crack 2, for the plus-point probe, averaged over the 300 kHz and the 200 kHz frequencies. These readings appear to be more regular, but they were also considerably distorted. This crack reading switched from od to id a number of places along the

**Figure 8** Effects of pressurization on Crack 2 in tube R34C51 of Steam Generator 22.

length, and the crack signal was not the classic shape that occurs on the calibration standards. When the signal went to id, the crack was assigned a value of 100%.

The amplitude of this crack signal increased to 12 volts. The amplitude calibration was set for a 100% EDM notch to have a voltage of 20-volts. Even a through wall crack must have some current bridging across the crack face to cause the signal to decrease to this value.
