UNITED STATES
NUCLEAR REGULATORY COMMISSION
OFFICE OF NUCLEAR REACTOR REGULATION
WASHINGTON, D.C. 20555-0001

NRC INFORMATION NOTICE 2002-04: WIRE DEGRADATION AT BREAKER CUBICLE
DOOR HINGES

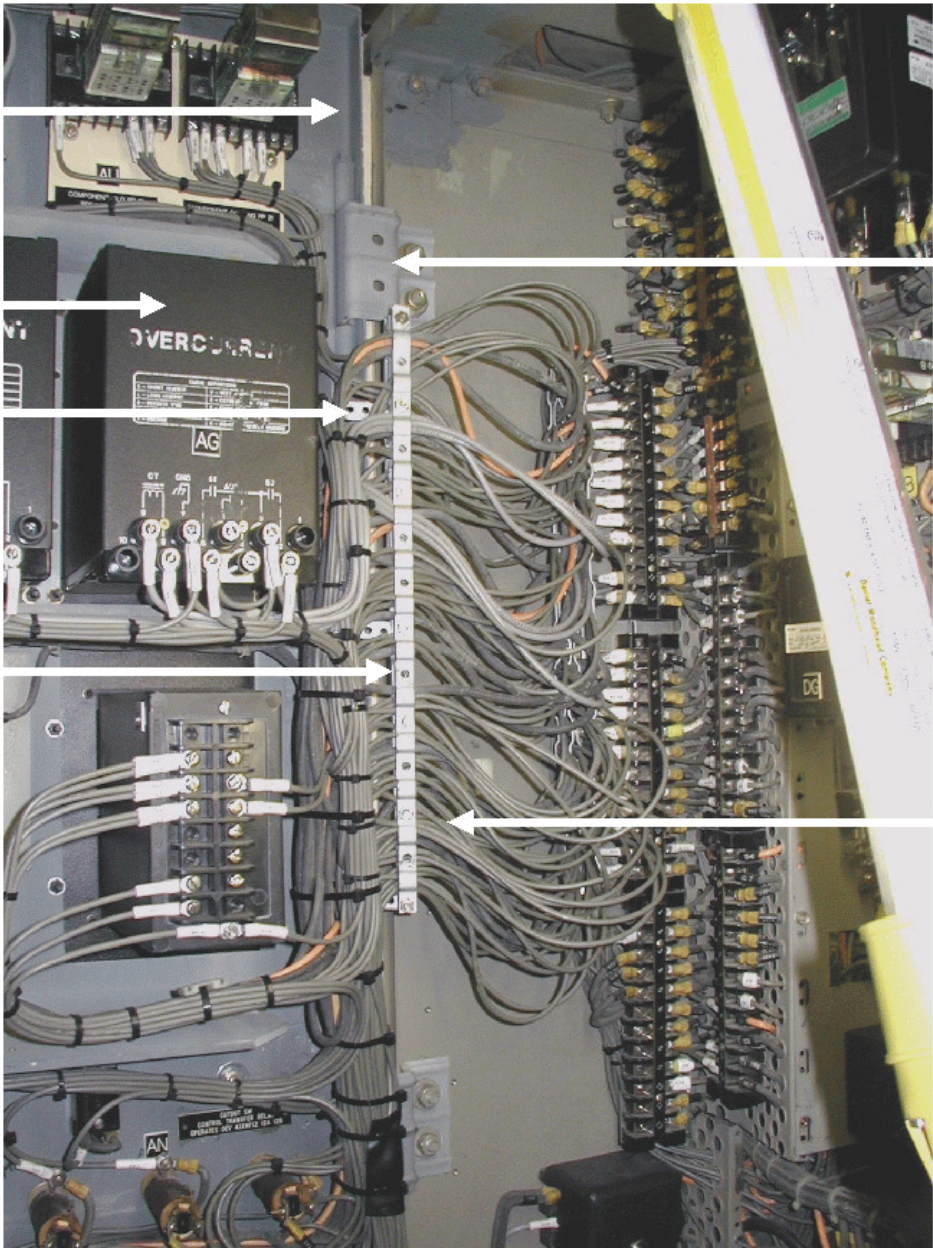
Breaker Cubicle Interior

The wires connecting the door-mounted equipment with terminals inside the cubicle are supported by two vertical wire braces (also called wire looms) as shown in Attachment 1. The purpose of the wire looms is to prevent the wires from becoming pinched in the door hinge when the breaker is opened and closed. One wire loom is mounted on the swingout door approximately 6 inches off the door surface and 2 inches from the door hinge. The other wire loom is mounted inside the cubicle approximately 10 inches from the door hinge and approximately 2 inches off the inner cubicle wall. The figure shows the construction and the location of the wire loom in relation to the door, door hinge, and other breaker components. When the door is fully opened, there is approximately 2 to 10 inches of wire slack between the two wire braces.

- (1) Cold Working
In a wire loom layout, in certain cases the wires are forced into the side of the breaker cubicle when the cubicle door is closed. This can force the wire on the inside of the bend to exceed the minimum bend radius for a dynamic bend, resulting in cold-working of the strands. Subsequent cycling of the door eventually results in wire failure.
- (2) Age-related degradation of the wires
Over time, the plasticizer leaches out of the PVC insulation, resulting in embrittlement. Flexing of the wire causes the insulation to break. The loss of the mechanical support provided by the insulation focuses the bending at the break, speeding the cold working of the wire strands and causing eventual failure.

**Bend
Area
When
Door
Closes**

- (1) Redesign the breaker cubicle wire looms and/or wire loom supports to eliminate excessive bending at the door hinge area.
- (2) Replace the wires that span the breaker cubicle hinge areas with standing class K or S wire that uses contemporary insulation (non-PVC).
