UNITED STATES
NUCLEAR REGULATORY COMMISSION
OFFICE OF NUCLEAR REACTOR REGULATION
WASHINGTON, D. C. 20555-0001

January 8, 2002

NRC INFORMATION NOTICE 2002-01: METALCLAD SWITCHGEAR FAILURES AND
CONSEQUENT LOSSES OF OFFSITE POWER

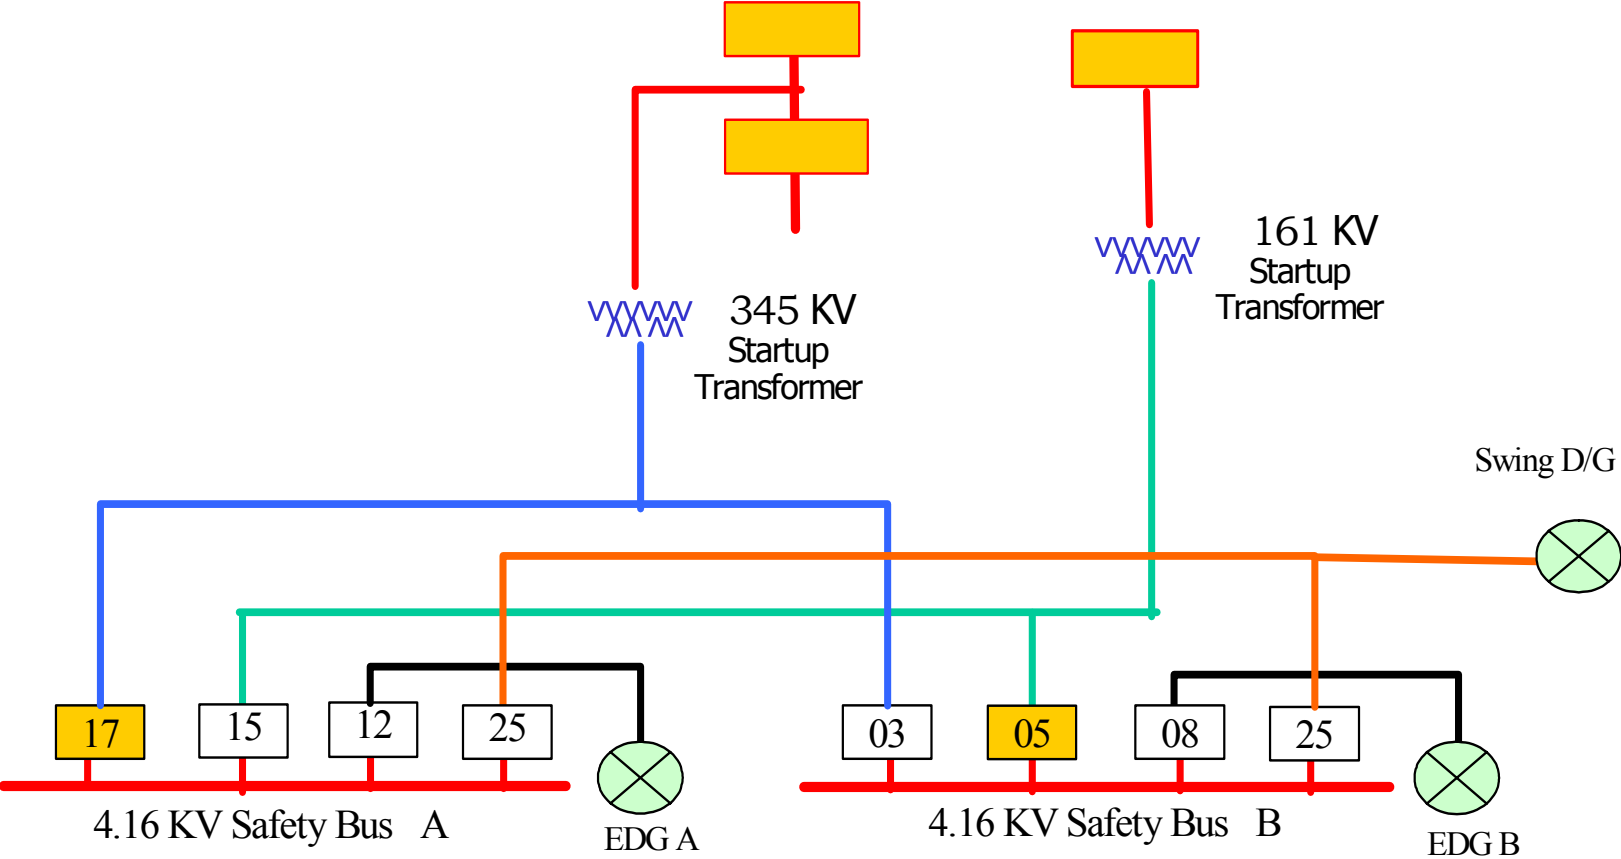
AC Power
Distribution System
with Y Connection
to Safety Buses

This foreign plant is a PWR in commercial operation since the mid 1980s. Offsite power is provided by two independent circuits from the transmission network (see Attachment 1). The circuit from the 345 kV transmission network is the normal source of offsite power to each of the two redundant 4.16 kV safety-related trains. The circuit from 161 kV transmission network provides a backup offsite source to each train.

An electrical fault occurring in medium voltage switchgear enclosure can cascade, causing collateral damage within the switchgear and consequent loss of multiple circuits. When both safety trains are supplied from the same offsite supply with a common upstream circuit breaker (see Attachment 1), one fault in the supply circuit can disable offsite power to both redundant trains. Operators ought to be aware of such a vulnerability and to have considered means to isolate the faulted feeder if both offsite power sources could be affected by a fault in the feeder circuit.
