Prairie Island Nuclear Generating Plant

Regulatory Conference
November 27, 2001

D6 Condition

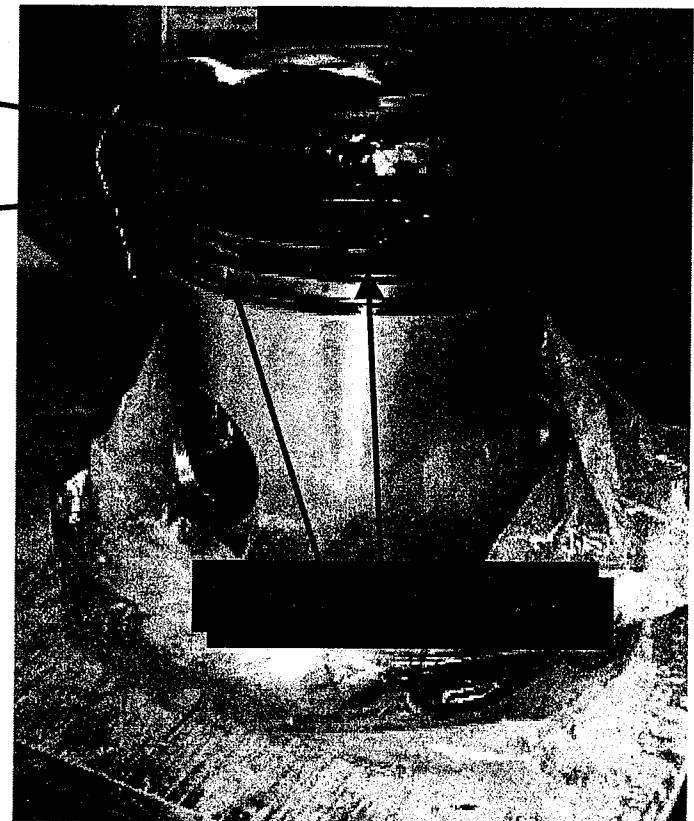
D6 E2B1 - Piston & Top Ring

- Piston E2B1 – rated 1
- Majority of pistons rated as 1
- Eight rated as 2
- One piston E1A5 – rated at 3 over one third of circumference, second and third rings would be rated 1

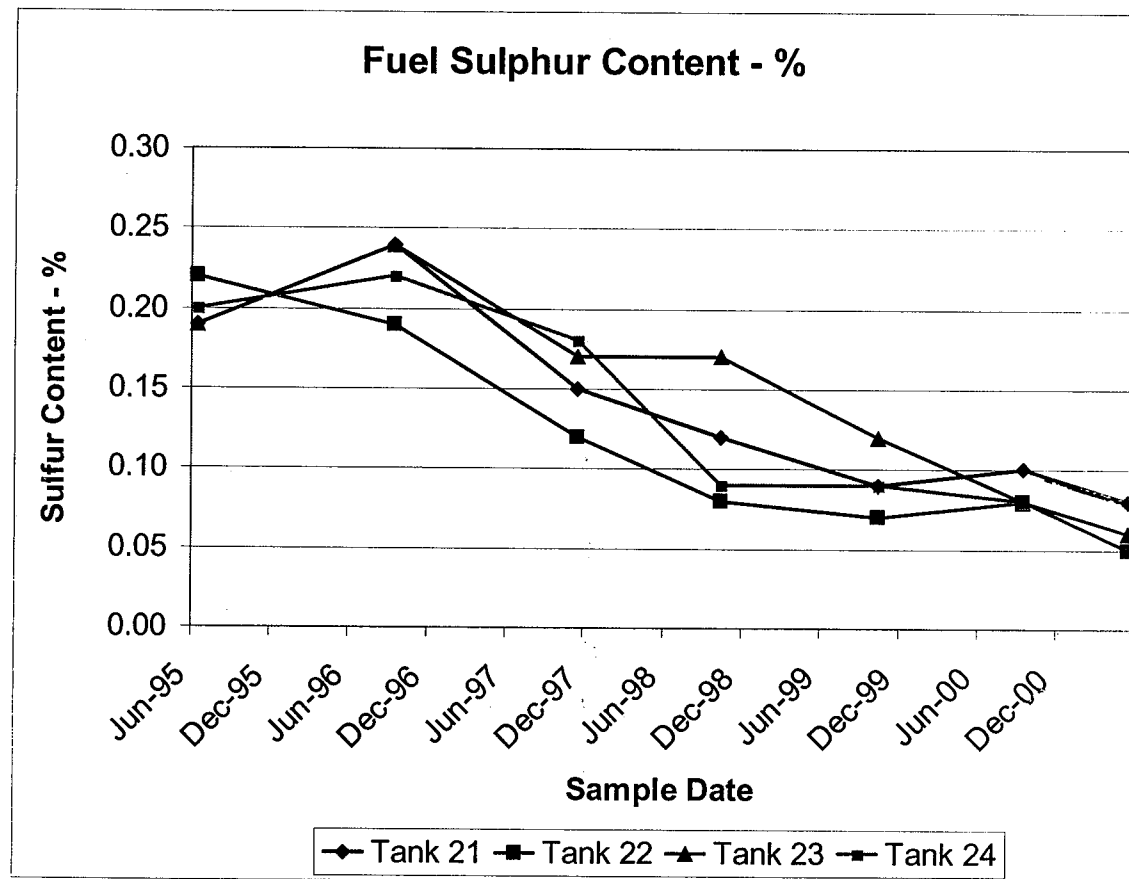
FO Sulfur

- Carbon build-up or carbon flakes on the top land and in the ring grooves causing sticky rings
- Carbon accumulation due to unreacted salts and carbon formation in the top land region.
- Combination of operating regime, oil chemistry, fuel sulfur and engine design required for the situation to occur.

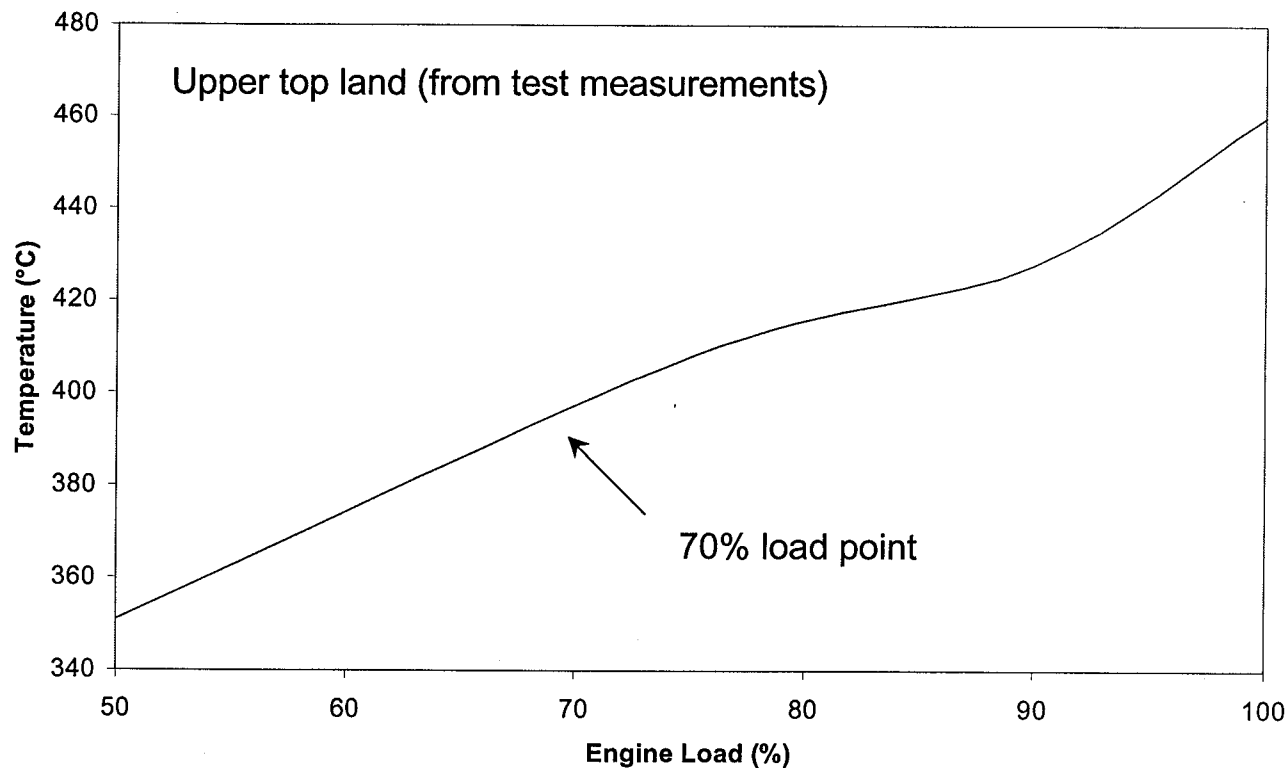
Piston Temperature

- Temperature load dependant
- Note rapid increase towards 100% load
- 110% load increases temperatures significantly

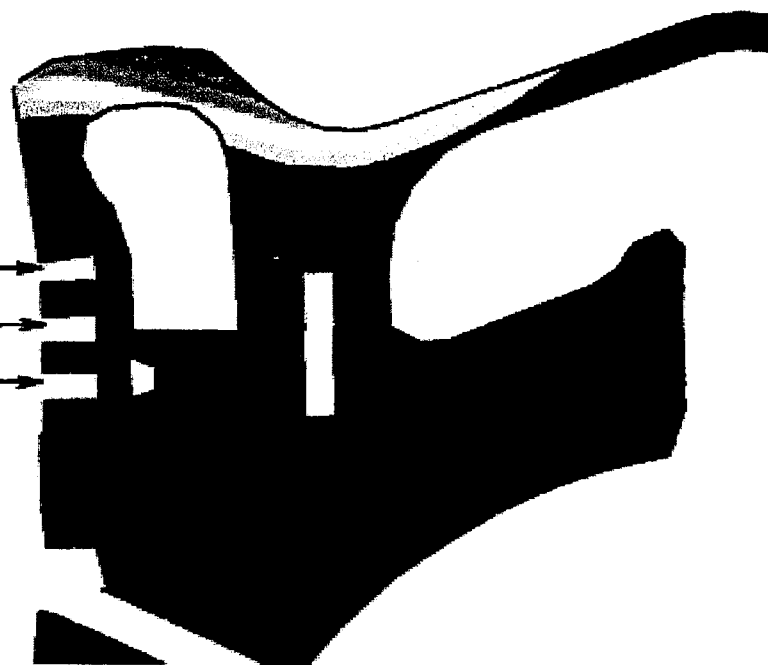
Piston Distortion

- Typical FE Analysis results at high power
- Shows effect on ring operating clearance
- Carbon/lacquer further reduces clearance

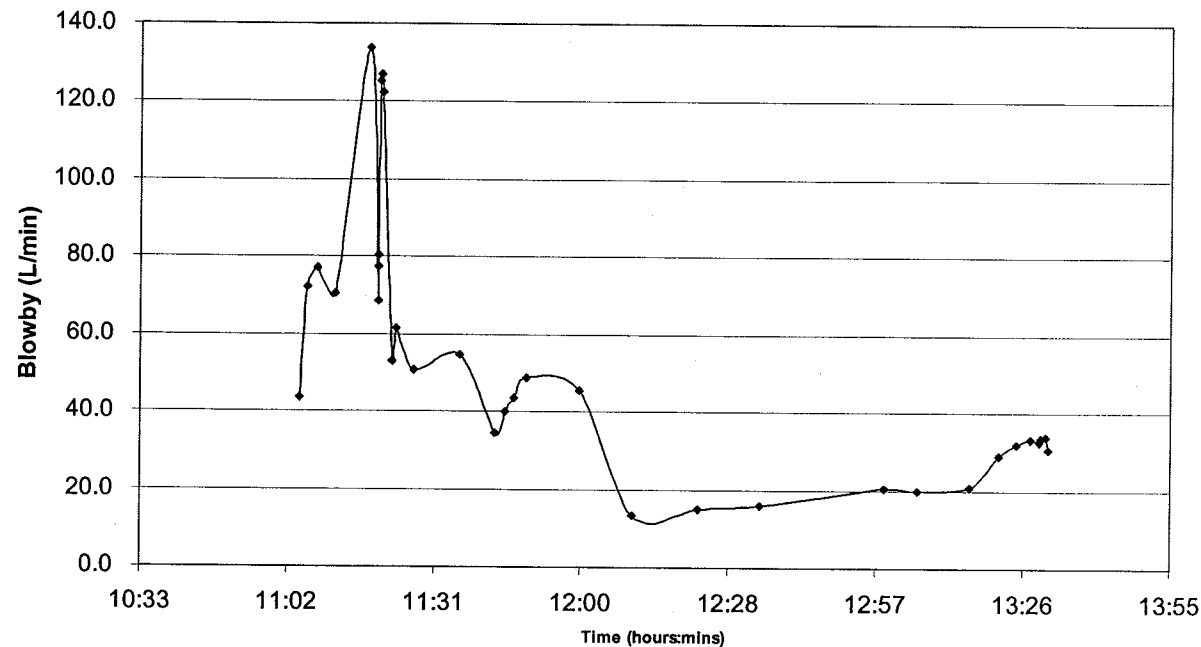
Peak Torque Final Test

- Temporary spikes in blow-by flow not unusual
- Example shown below from Ricardo tests
- Engine stripped and no fault found

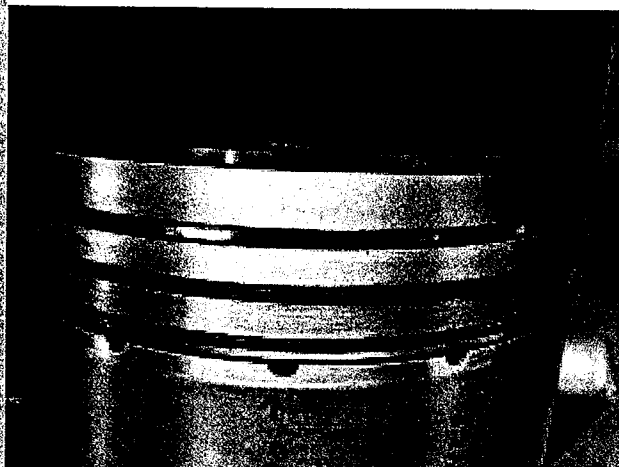
- D5 fuel oil sulfur higher than D6
- D5 had less run time
- D5 borescope and investigation of two cylinders indicates good condition
- Physical examination of D5 E1A1:
