Subject: **Docket Nos. 50-361 and 50-362**
60-Day Report
Licensee Event Report No. 2001-003
San Onofre Nuclear Generating Station, Units 2 and 3

TITLE (4): One Train of CREACUS Inoperable Due To Unlatched Circuit Board													
EVENT DATE (5)			LER NUMBER (6)			REPORT DATE (7)			OTHER FACILITIES INVOLVED (8)				
MONTH	DAY	YEAR	YEAR	SEQUENTIAL NUMBER	REVISION NUMBER	MONTH	DAY	YEAR	FACILITY NAME	DOCKET NUMBER			
10	22	2001	2001	-- 003 --	00	12	19	2001	SONGS Unit 3	05000-362			
									FACILITY NAME	DOCKET NUMBER			
OPERATING MODE		1	THIS REPORT IS SUBMITTED PURSUANT TO THE REQUIREMENTS OF 10 CFR §: (Check One or More) (11)

Plant: San Onofre Nuclear Generating Station, Units 2 and 3
 Discovery Date: October 22, 2001

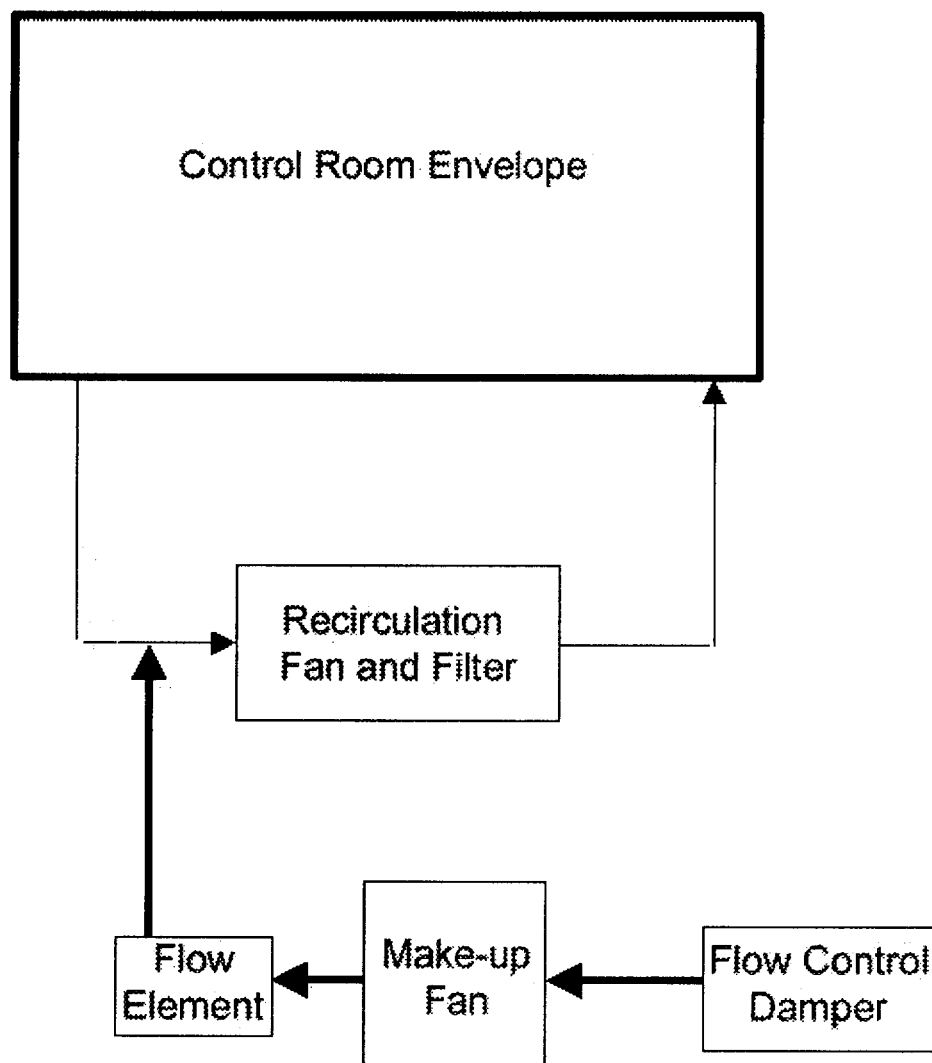
Figure 1 – Simplified Diagram of CREACUS

A flow controller (flow element, transmitter, controller and recorder) controls inlet damper position to maintain the desired makeup flow rate. If the flow controller fails "high," the makeup damper closes, decreasing air flow to the control room. Loss of makeup air could result in the loss of control room pressurization.

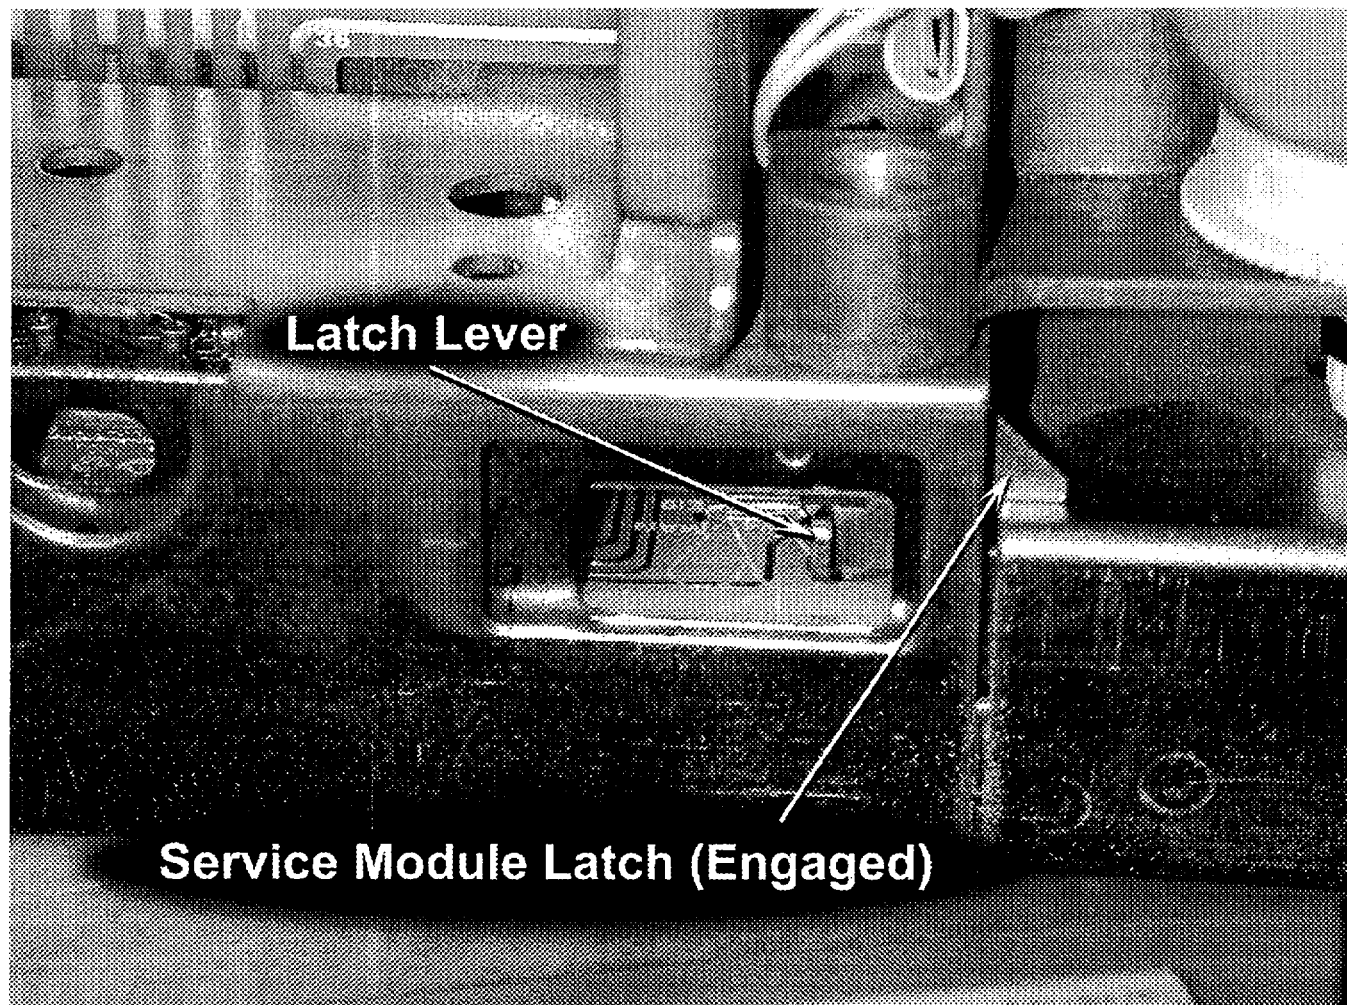
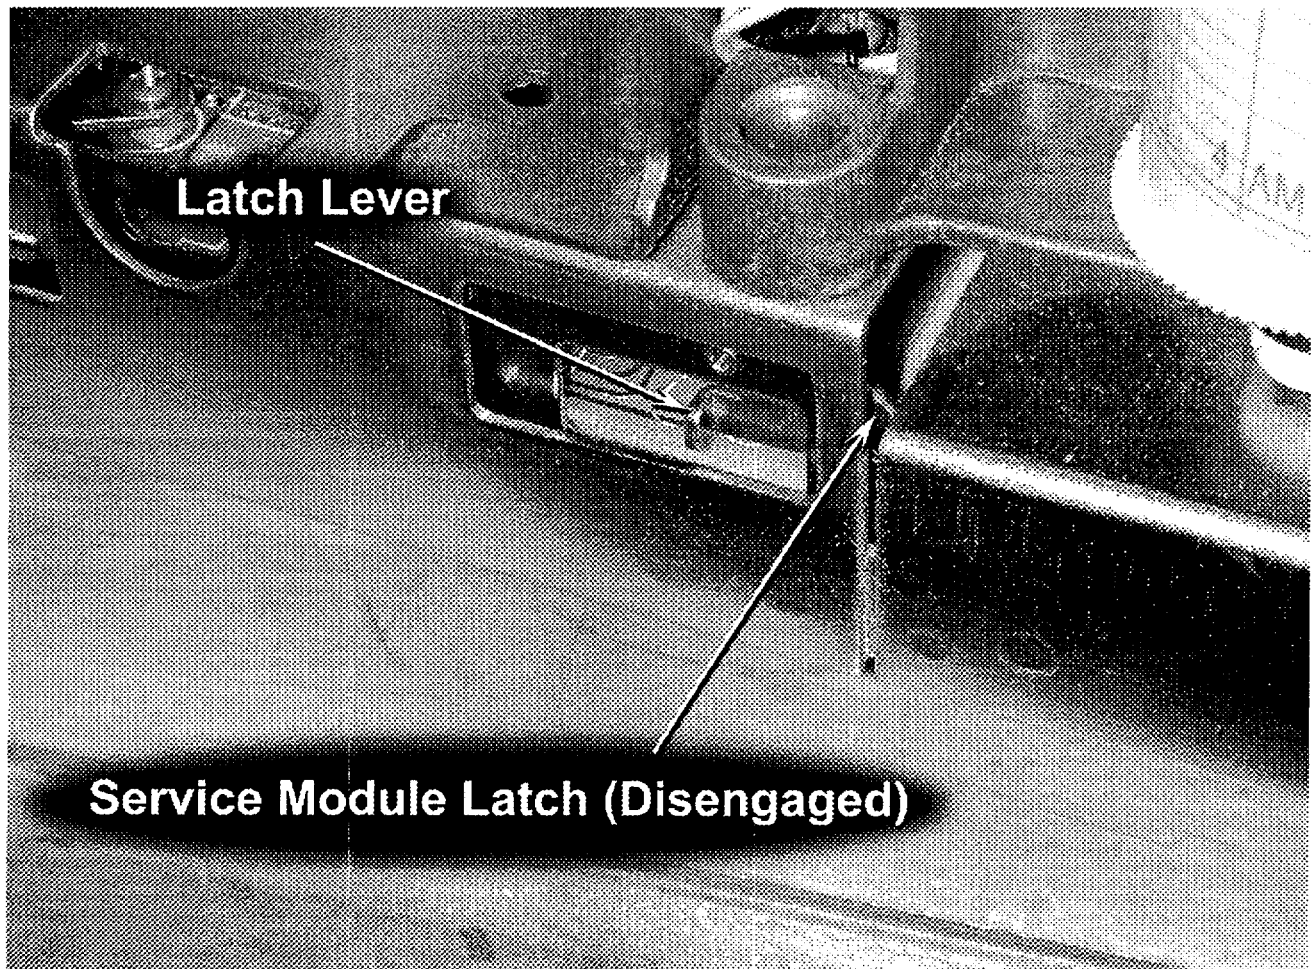
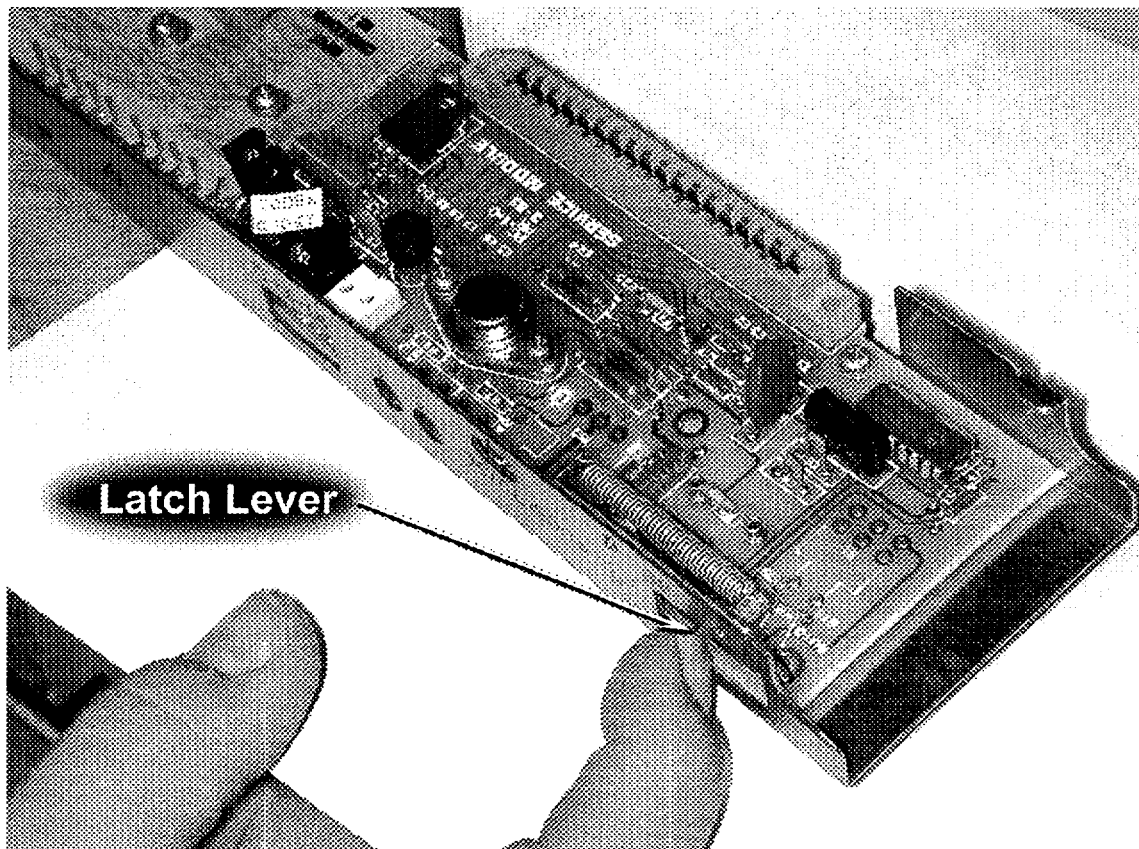
Figure 2 – Recorder Service Module Latching Mechanism

The cause of the failure was determined to be a dislodged circuit board in the Train B flow recorder (Westinghouse Veritrak Model 75RE2010). When dislodged (neither fully inserted nor fully removed), the power supplies to different pins on the card can become mixed, causing controller and/or indicator failures. SCE reviewed the recorder's paper record and determined the associated controller failed "high" at about 0645 PDT on the discovery date (October 22, 2001). The dislodged circuit board caused the indicated train air flow rate to go to 100 percent. If the CREACUS train were operating, the flow control system, sensing the erroneous high flow, would close the makeup flow control damper to reduce flow to

SCE's investigation concluded the flow recorder's service module was likely inadvertently unlatched when the recorder paper was last changed on October 4, 2001. The latch sits at the bottom of the recorder chassis below the recorder paper. See Figures 2, 3 and 4. While changing the paper, the latch securing the service module containing the circuit board can be accidentally released. Because the service module must be latched to be seismically qualified, SCE conservatively declared Train B inoperable from October 4, 2001 to the discovery date even though recorder and controller were functioning normally until 0645 on October 22, 2001.

- The dislodged card was immediately resealed, bringing both units into full compliance with TS LCO 3.7.11.
- SCE provided a Priority Reading Assignment for operators that specifically addressed the latching mechanism and alerting them to this problem. The priority reading also specified how to detect an unlatched service module when changing the recorder paper and how to detect a non-functioning controller when marking the recorder's paper during daily rounds.
- As an interim action while reviewing and implementing long term corrective actions, an independent verification that the service module is properly latched will be required following each recorder paper change.
