VIRGINIA ELECTRIC AND POWER COMPANY
SURRY POWER STATION UNITS 1 AND 2
NRC SPECIAL INSPECTION REPORT NOS. 50-280/01-06 AND 50-281/01-06
TRANSMITTAL OF TECHNICAL REPORTS

REPORT NUMBER 87360-FA

FAILURE ANALYSIS
FOR (1) ONE
POWER ASSEMBLY, FORK ROD
EMD P/N 8470863

FAILURE ANALYSIS
FOR (10) TEN
POWER ASSEMBLY, FORK ROD
EMD P/N 8470863
& (10) TEN
POWER ASSEMBLY, BLADE ROD
EMD P/N 8470864

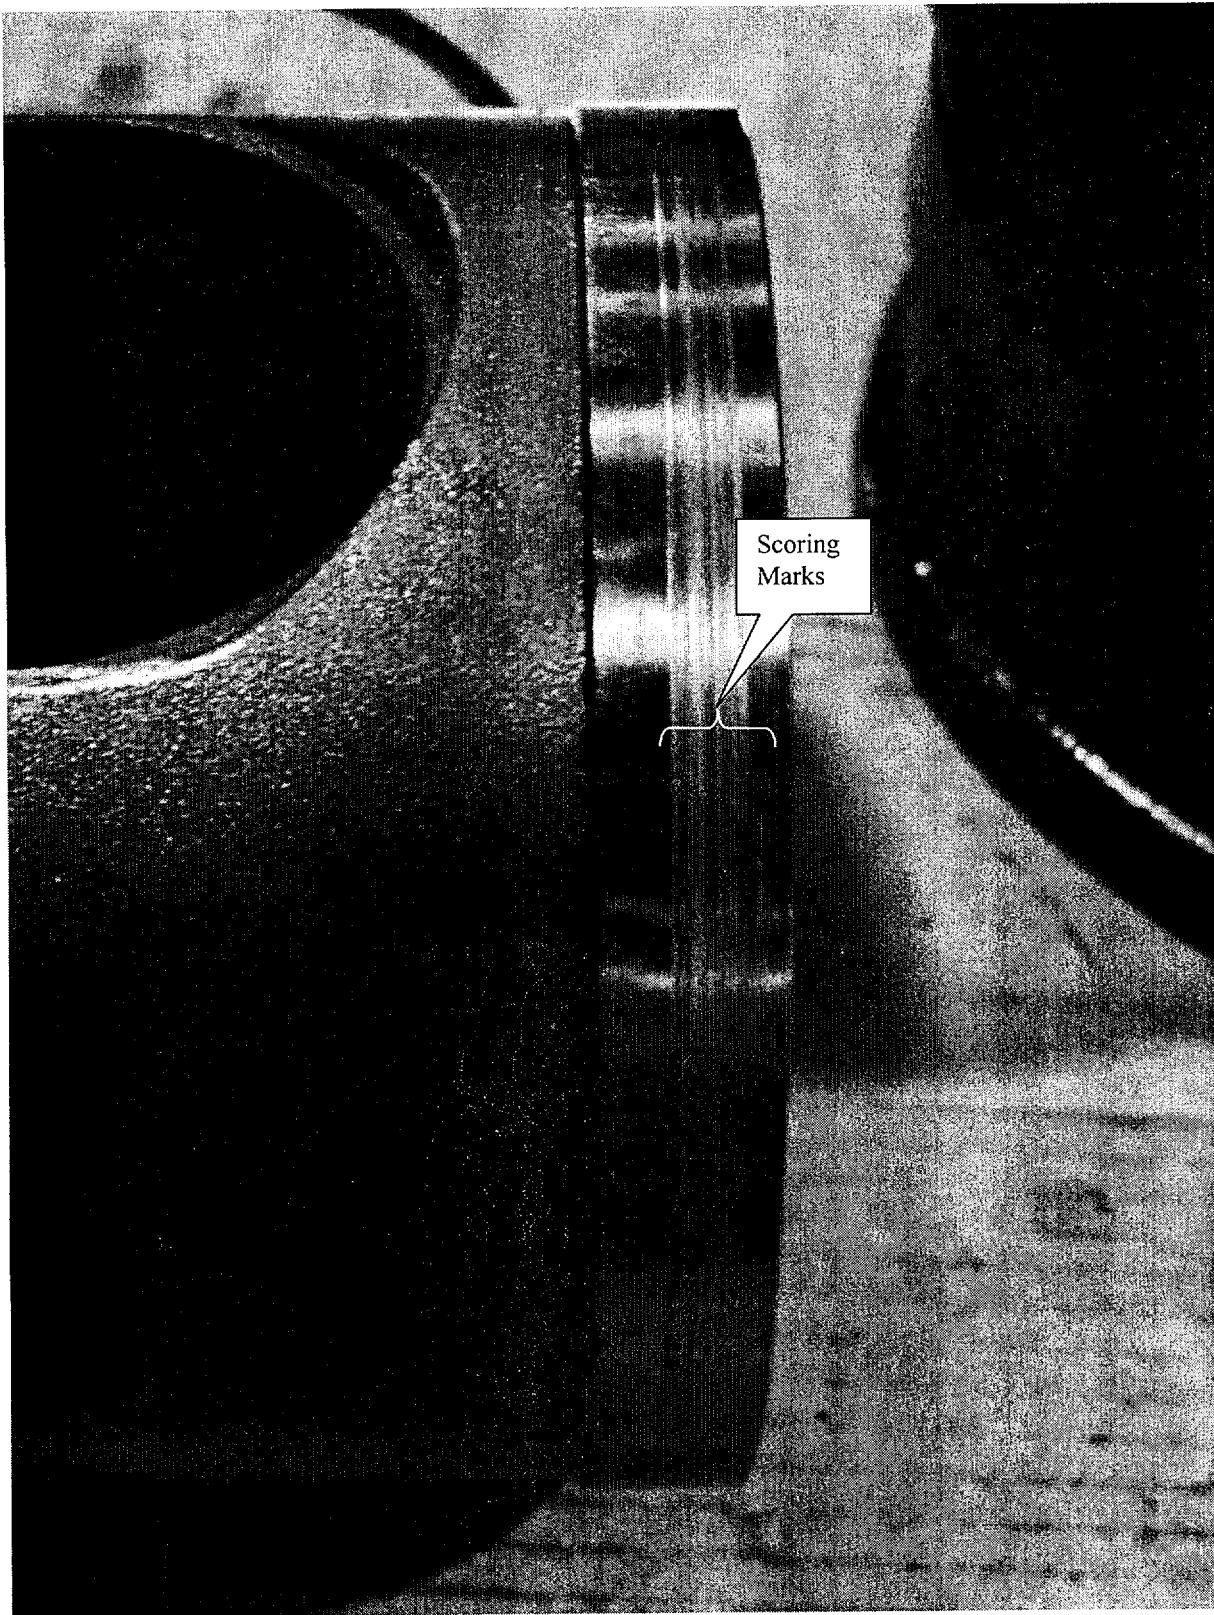
Figure 2
Carrier Skirt

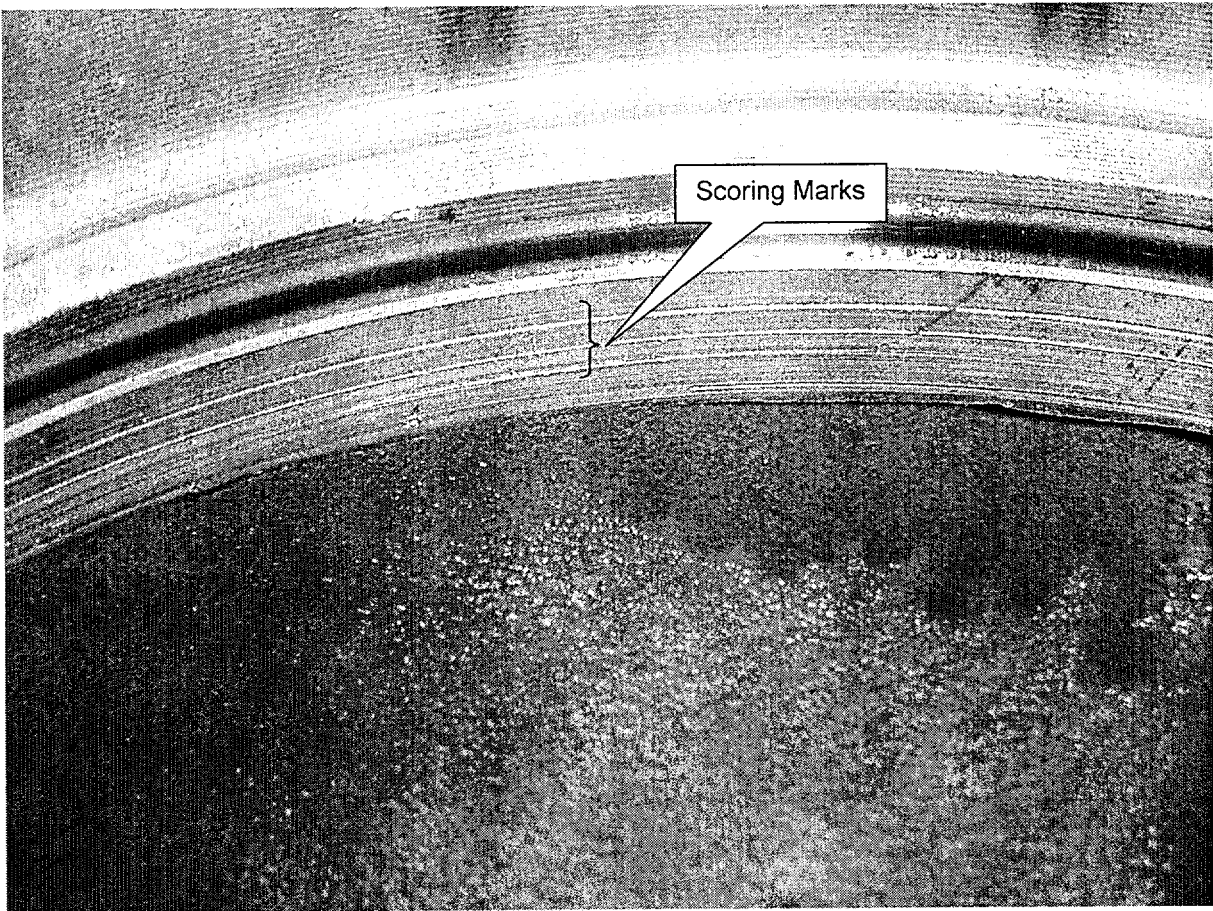
Figure 3
Piston Internal Surface, Region of Carrier Skirt Interface

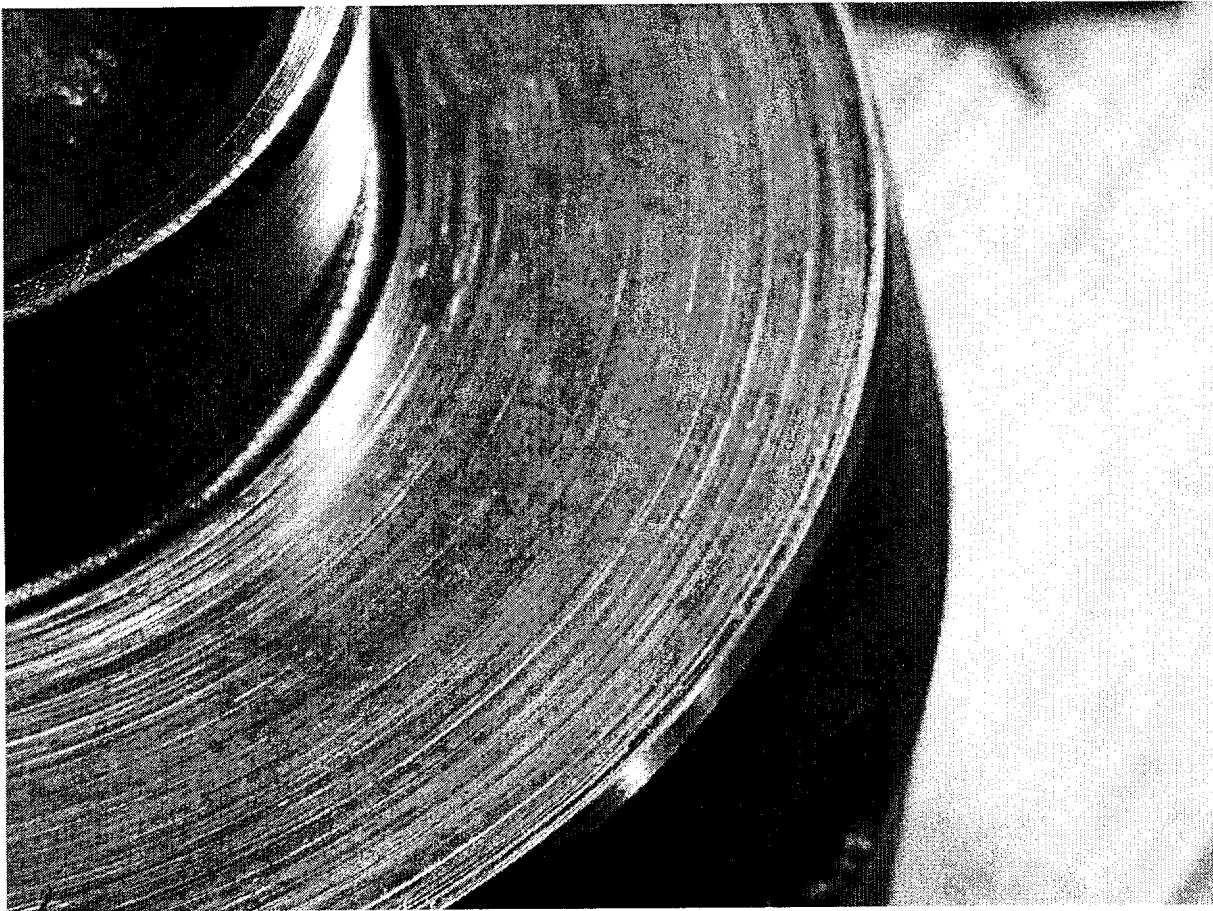
The snap rings were removed and the carrier/rod assemblies were separated from the pistons. The oil holes in the pilots of the carriers were free of obstruction. The following observations apply to the #16 power assembly condition: Two of the three bearing surfaces on the carrier were found to be scored. See Figure 1 and Figure 2. The corresponding lower bearing surface of the piston also showed evidence of scoring. See Figure 3. The thrust washer bearing surface of the carrier appeared to be "machined" by its interface with the thrust washer. See Figure 4.

Figure 4
"Machined" Bearing Surface of Carrier,
Thrust Washer Interface

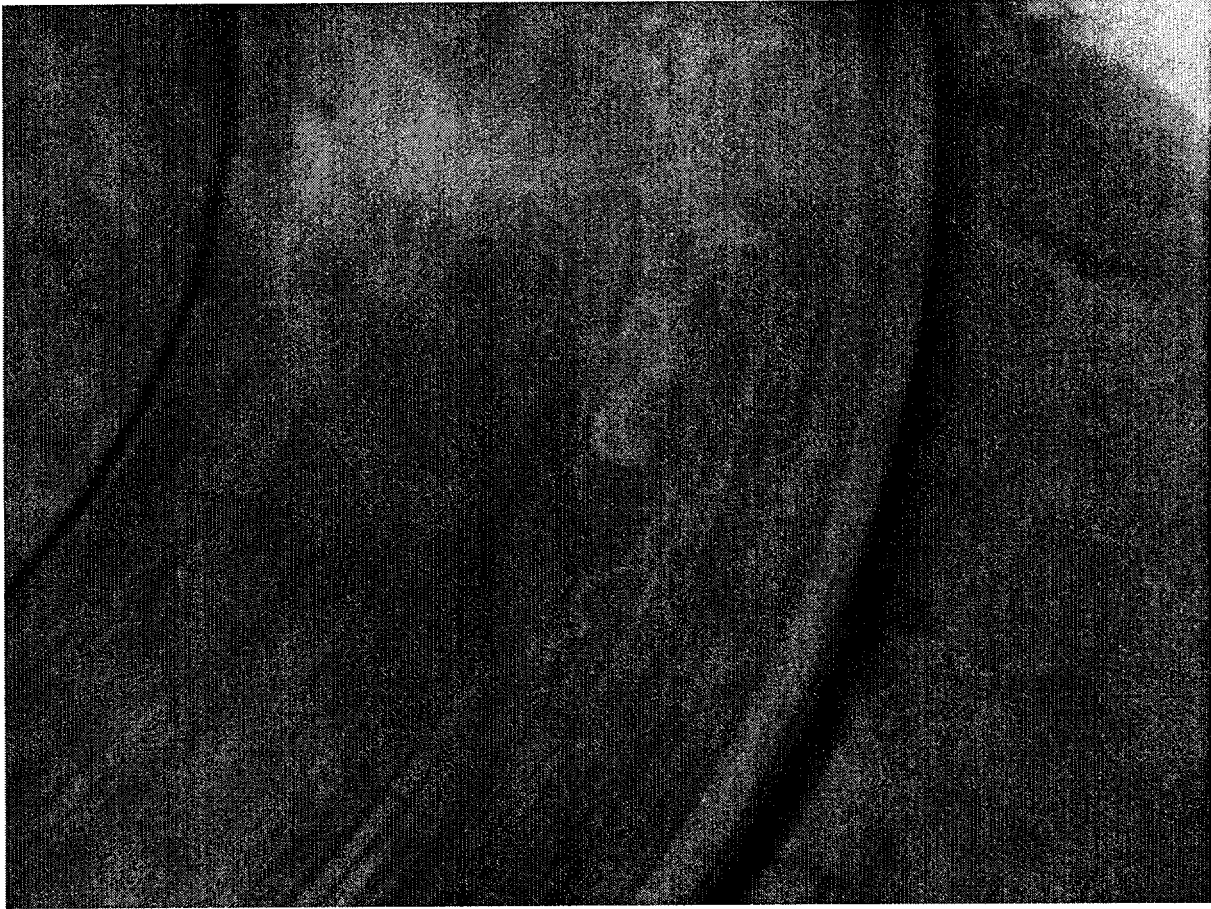
Both faces of the thrust washer exhibited evidence of either oil channeling or scratches from foreign material. These signatures are largely radial in their direction. The inner diameter of the thrust washer has a wear step at the edge of the loaded and unloaded region of the washer's bearing surface. See Figures 5 and 6.

Figure 6
Top Face of Thrust Washer

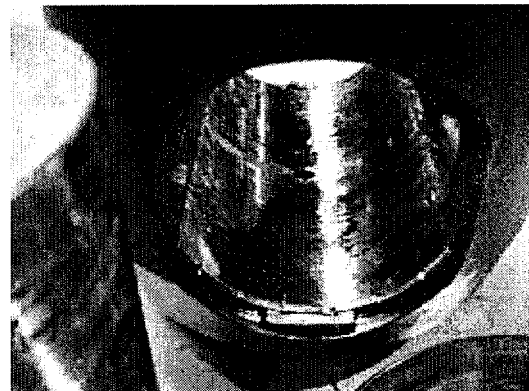
90342-10 Bearing in Carrier

The damage identified in specimen 90342-10 is consistent with failures resulting from lack of lubrication. The failed insert bearing and distressed piston pin appear to be directly related to lube oil starvation. The connecting rod from this cylinder is also condemned as a result of the damage to the carrier insert bearing.

With a bearing in the catastrophic state found in specimen 10, the concern would be that oil temperatures in that localized region would be rapidly increasing, with little or no lubricating oil present between the piston pin and the insert bearing. Resultant damage to the connecting rod/bearing interface would also trend towards failure. Metal temperatures would likewise increase as was indicated by the bluing marks found on the piston pin. Continued operation at the high temperatures present could lead to piston pin to bearing seizure, catastrophic failure of the power assembly, and a potential to ignite the crankcase vapors (crankcase explosion).

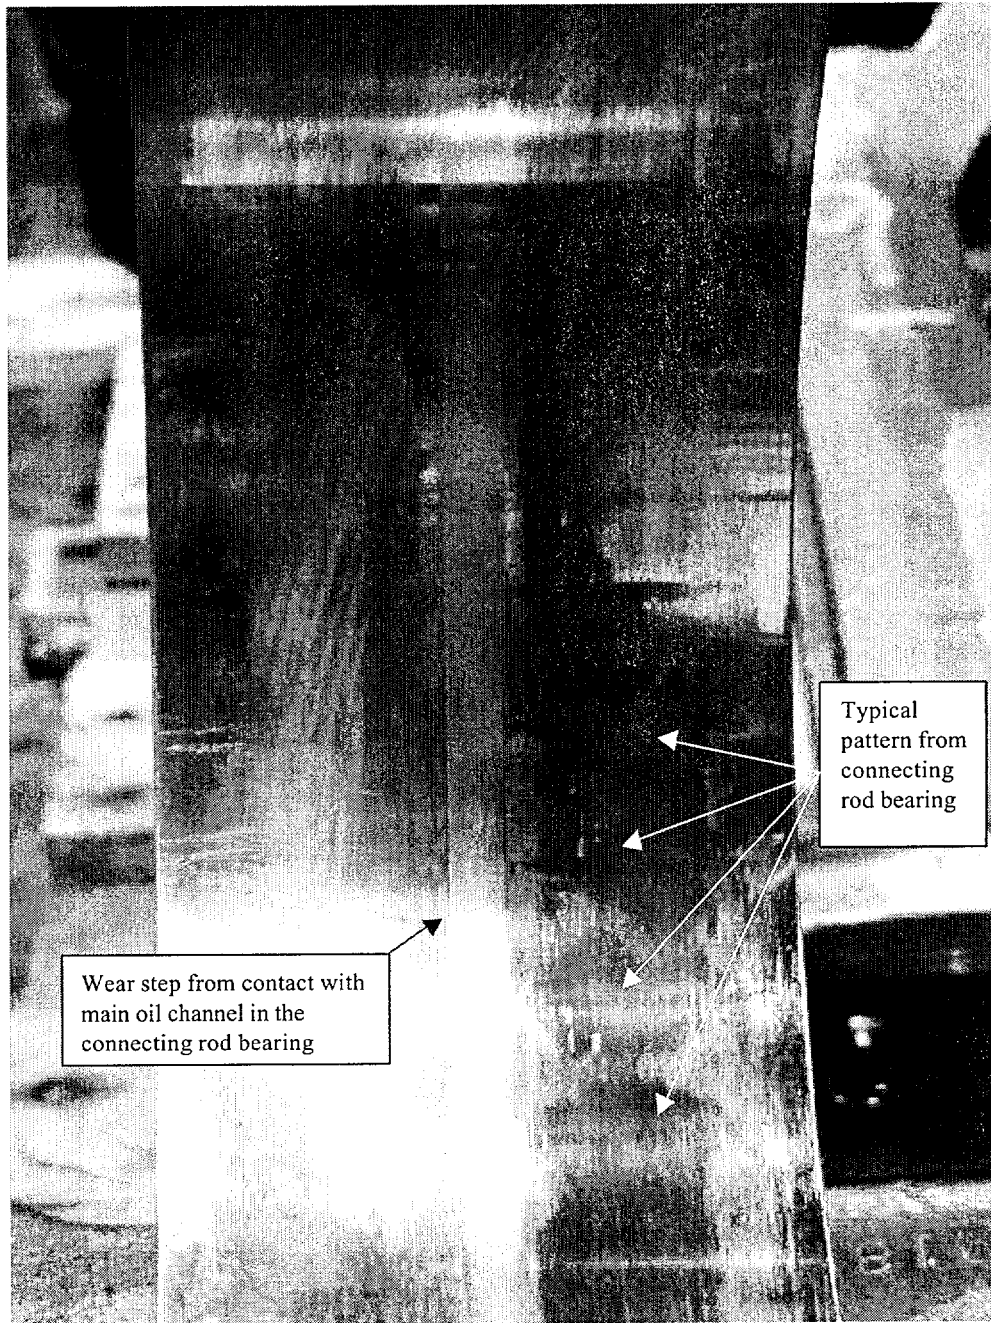
According to the EMD engine maintenance manual, "The glazed finish and the bearing pattern oil stain usually found on the blade rod slipper surface is considered normal..." As can be seen on the photograph that follows, the slipper surface of specimen 90342-10 includes a pattern matching the back side of a typical connecting rod upper bearing shell. However, considerable scuffing of the slipper surface is evident, as well as an abnormal wear step from contact with the main oil channel in the bearing.

It is ESI's opinion that the scuffing and wear are results from the previous damage to the piston carrier insert bearing found in this cylinder. As the bearing and piston pin wear increased to the catastrophic damage found in this cylinder, it is likely that heavy loading/unloading cycles occurred in this cylinder. The clearances in the piston pin to insert bearing were such that each combustion cycle pounded the piston carrier assembly down onto the pin. These forces were transferred through the rod to the slipper surface/connecting rod bearing interface. The normal oil film that is present between the slipper surface and the bearing was being pushed out of the space, with the result being higher impulse pressures and higher oil temperatures in that zone. This is evidenced by the wear step in the slipper surface and by the abnormal scuffing.

90342-10 Rod Slipper Foot
