Client Name: Dominion Virginia Power
Project No.: H0829
Archive: D01-1740
Client Confidential

Ricardo Inc.

Ricardo has undertaken an examination of components, reports and laboratory data from Surry Station following the failure of the wrist pin bearings on two EMD 645 engines. The engines were found to have severely or partially degraded wrist pin bearings. Ricardo were engaged to review the failure mode and determine if it were possible to predict when the EDG3 engine entered a degraded condition such that it could not operate for a period of 24 hours supplying emergency power.

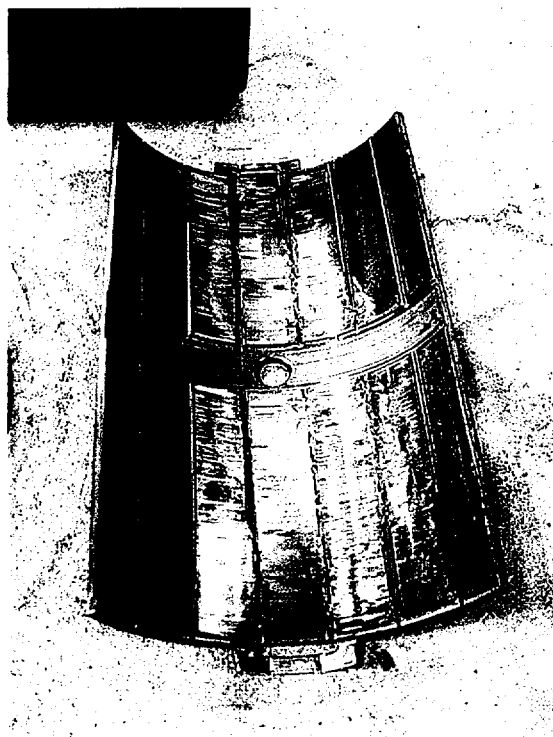
Figure 1 – Damaged Wrist Pin Bearing

The substantial damage to the wrist pin bearing on EDG 3 cylinder #15 had allowed piston pin to bearing shell contact that would be considered in Ricardo's opinion to render the engine at risk in any further operation. Although other OE indicates it is unlikely the engine would have seized, the risk of a crankcase explosion increases with further damage. No evidence of foreign material contamination could be found in either the wrist pin bearings or the piston thrust washer. The material that was found in the thrust washer was ferrous in nature with traces of silver suggesting the material originated from the failure of the wrist in bearing.

The fully or partially blocked oil channels would have prevented normal oil flow across the bearing surface resulting in increased bearing temperatures and further wiping of the bearing material into the oil grooves – see photograph below, from ESI Reports (Refs 8.1 and 8.2).

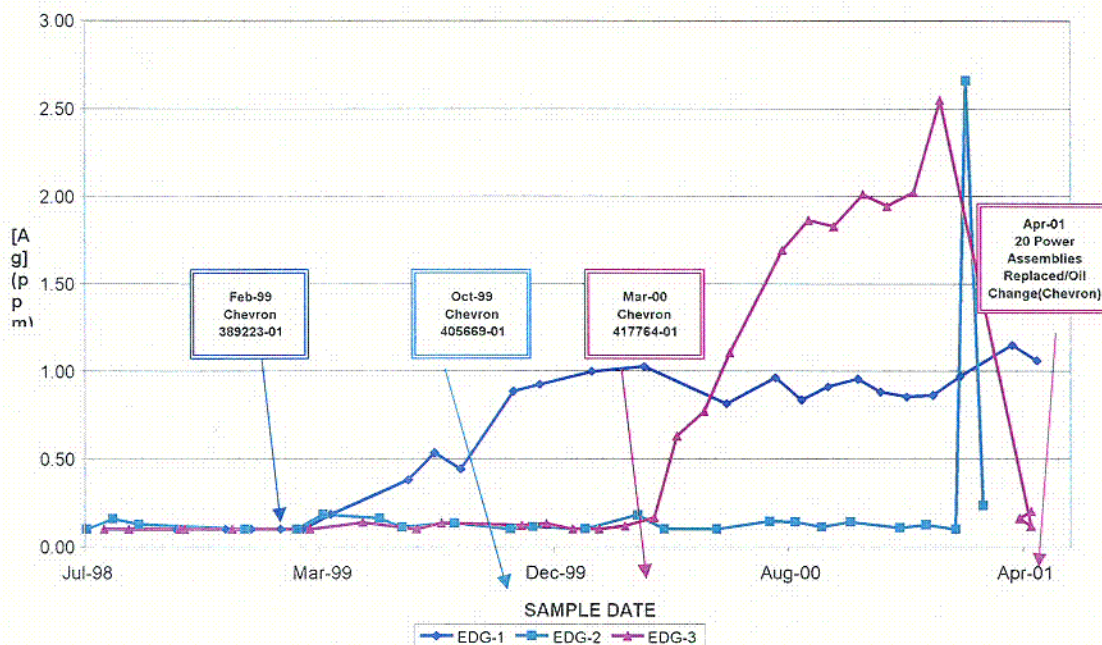
Figure 2 – Emergency Diesel Generator Lube Oil Results

In addition, the change of oil from an AMOCO Super Diesel 13 product to the Chevron DELO 6170 caused concern for SPS as the increasing silver levels in the oil correlated with the change to the Chevron product– See Figure 1. EDG2 did not adhere to the trends shown by EDG1 and EDG3 and remained almost consistent in Silver levels in the oil. The one high data point for EDG2 was erroneous data and subsequently determined to be a mislabeled sample from EDG3– see below.

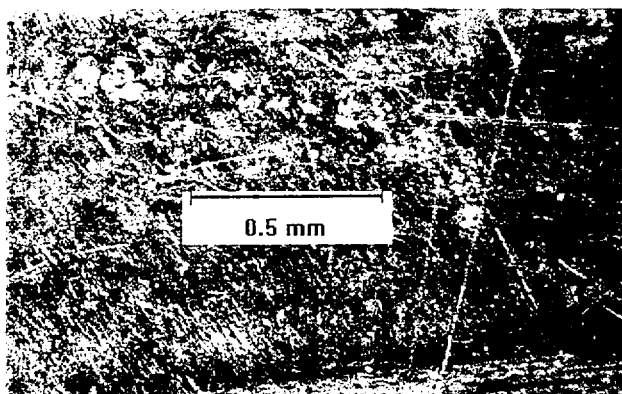
Figure 3 – Worm Track Under a Stereo Microscope

Upon visual inspection by Ricardo and ESI (report 87360-FA pg. 6), small "worm" tracks were seen in the thrust washer (Figure 3) of a failed piston. As ESI stated these were either "oil channeling or scratches from foreign material." The "worm" tracks were evident on both washers inspected, however the failed washer had many more "worm" tracks evident, while the un-failed washer showed only two smaller "worm" tracks. Figure 3 is from the thrust washer of a piston which did not suffer a wrist pin failure, and is an example of one of the smaller "worm" tracks found it is barely visible with out visual aide. The washer from the failed piston exhibited a higher density of "worm" tracks than a washer from a wrist pin that remained in-tact.

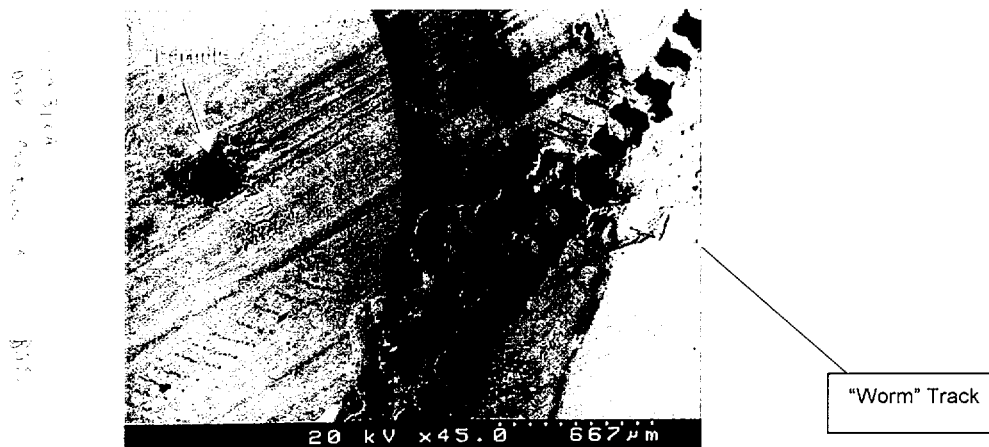
Figure 4 – "Worm Track With Embedded Particle"

Upon SEM investigation of the thrust washer, particles were found embedded near the worm tracks. As seen in Figure 4 the size and shape of the particle are approximately the same. The worm track also follows a distinct pattern of repetition.

The type of marking as seen in Figure 4 was apparent without visual aid and was widely dispersed on the failed parts. There were also a significant number of particles elsewhere on the thrust washer. Upon further SEM investigation they were determined to be of the same material, iron with trace amounts of silver and copper. There was also many more "worm" tracks seen and they continued to exhibit the pattern and distinct shape made from one particle being repeatedly stamped on the thrust washer.

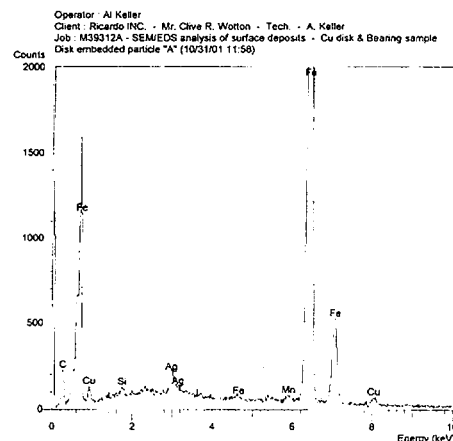
Figure 5 – Elemental Make-Up of Particle A

The particle was examined elementally and was found to consist mostly of iron with trace amounts of silver and copper. The full spectrograph is shown in Figure 5. The copper found was most likely the surrounding material. The iron and silver found is in line with the construction of the wrist pin bearing. The bearing did not have any lead left on it only steel with slight amounts of silver this correlates with the particle found on the washer, which would give evidence that the particles and "worm" tracks result from entrapment of the material from a failed bearing.

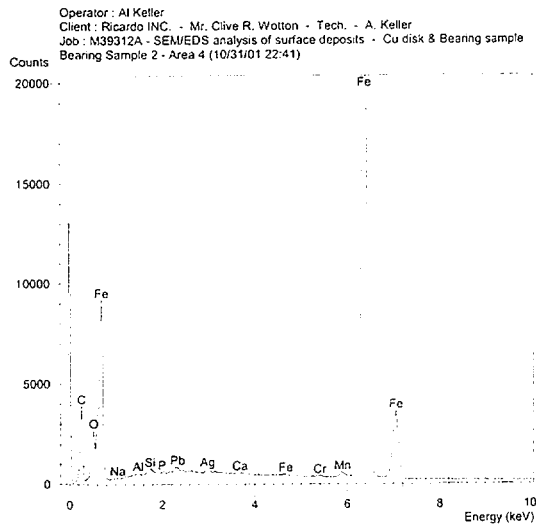
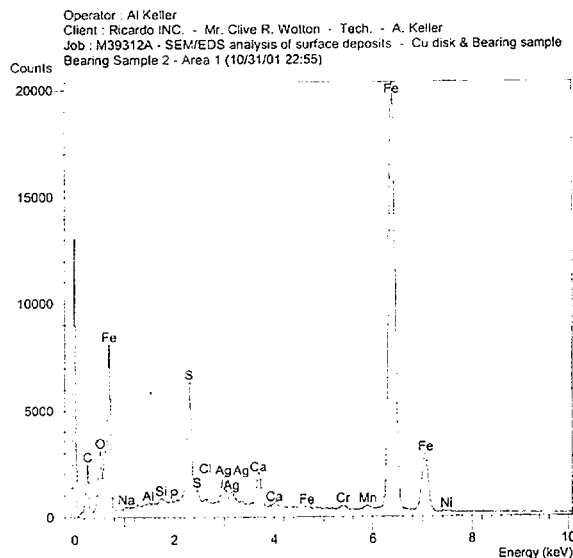
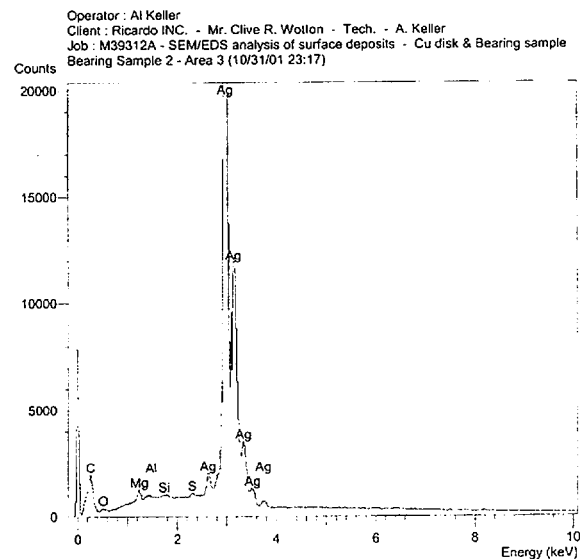
EDG #3 cylinder 15 bearing showing signs of "heavy distress" was also examined with the SEM. It was viewed at four positions on the sectioned bearing. The bearing was severely wiped with all oil channels blocked and no visible lead overlay, there appeared to be silver in one area while the rest seemed to have "wiped" to the steel. After being examined in the SEM and undergoing elemental analysis the piece exhibited, as expected, three areas that were almost completely steel and one sample that was mostly silver. It should be noted that extremely low levels of lead were detected in only one of the samples, while the other three did not have any lead. The material found on the failed bearing surface was consistent with the particles found on the failed thrust washer as steel and silver particles were predominantly found on the surface of the washer. The elemental analysis of the silver section, iron-lead section and iron-silver section are shown in figures 8, 9 and 10.

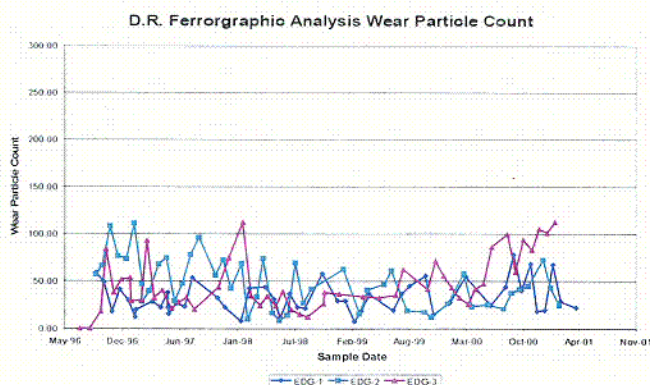
Figure 15 - Wear Particle Count

SPS had been trending the ferrography results for several years. Although this gives a long term view of trends, it also includes oil changes and oil replenishments that affect the dilution of particles and result in a noisy data set. It is difficult to extract the trends related to the Chevron oil from this data set - See below.

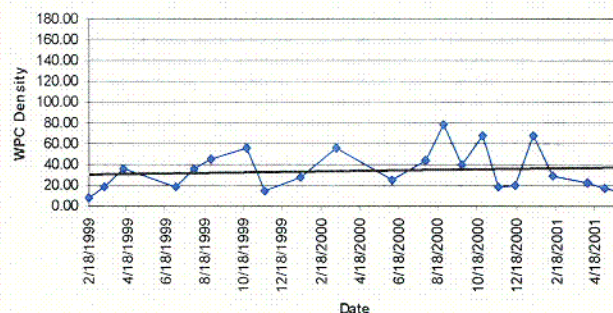
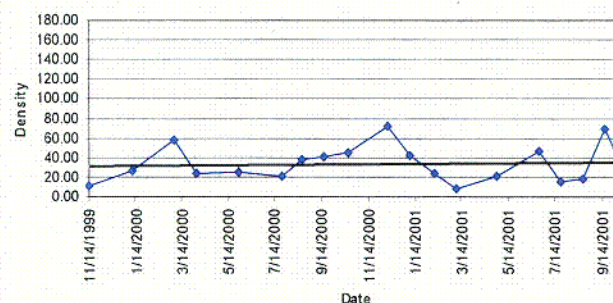
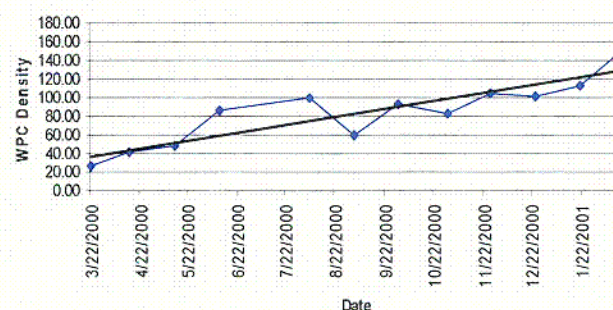
Figure 19 - DR Ferrographic Analysis - Wear Particle Count (WPC)

Examination of Figures above which contain the ferrography results extracted for just the Chevron oil and excludes data from oil changes, reveals some apparently contradictory trends. The graphs are all plotted on similar scales with a linear trend-line put through the data set. EDG3 clearly shows a trend in increasing large and small particle counts resulting in the increase in wpc. Conventional ferrographic trending data states that a growth in Lp density is a sign of abnormal wear. However, the %LP is very consistent, around 40% for the 4 months up to Feb 2001 (the last oil sample taken from the engine) and, indeed, has hovered around that reading since May 2000. Thus the DR ferrography results give no clear indication of when a bearing started to fail catastrophically but the increase in small and large particle densities indicate wear was occurring, probably since the oil was changed to Chevron. A similar trend could not be detected for EDG1 and EDG2. The percentage of large particles seen for EDG2 is generally higher than for EDG3 and EDG1, however the silver concentration in the oil did not correlate with the apparent high concentration of large particles, but for the reasons discussed below, the ferrography may not be detecting all issues associated with the failure mechanism.
