Crystal River Nuclear Plant
Docket No. 50-302
Operating License No. DPR-72

Subject: Crystal River Unit 3 - Special Report 01-01, Once Through Steam Generator (OTSG) Notifications Required Prior to MODE 4

SPECIAL REPORT 01-01

ONCE THROUGH STEAM GENERATOR NOTIFICATIONS REQUIRED PRIOR TO MODE 4

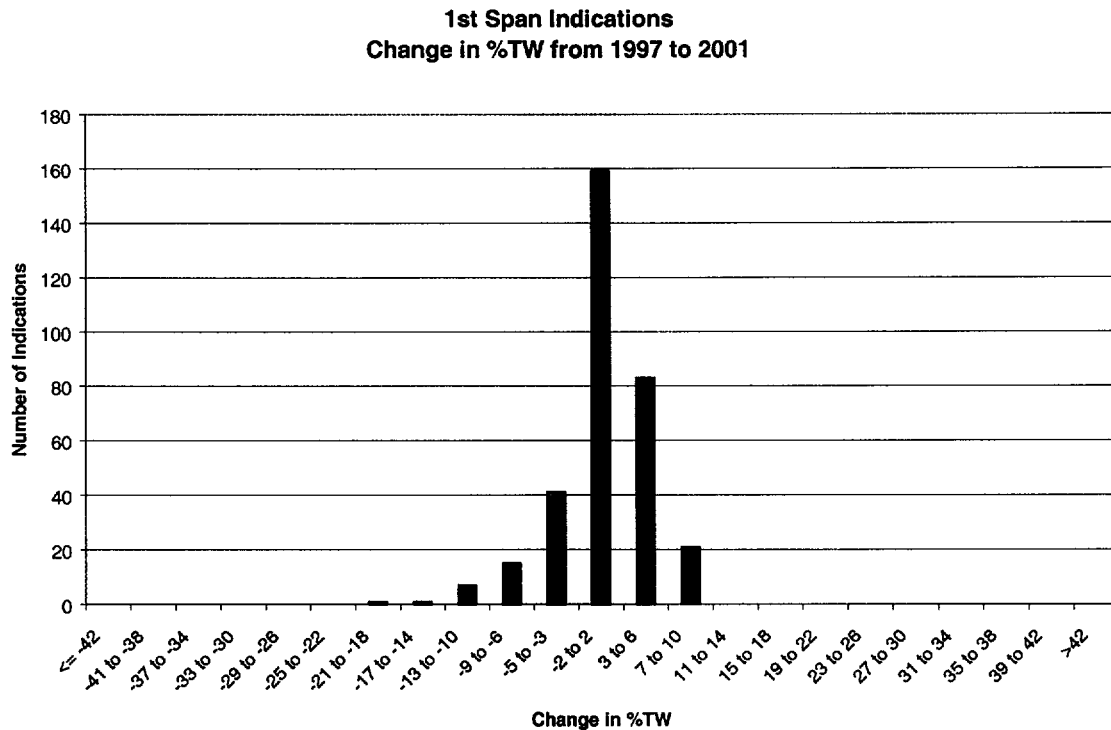
As required by technical specification 5.6.2.10.4.c, inservice tubes with pit-like intergranular attack (IGA) have been monitored for growth by using a test probe equivalent to the high frequency bobbin probe used in 1997. For the tubes with known first span IGA in the “B” OTSG (154), the percent through-wall (%TW) change for these indications was determined. Regression data for the current and the 1997 inspection were compared for the growth evaluation. Figure 1 contains this evaluation. The range was from -18%TW to 9%TW, with the average change at 0.61%TW. This demonstrates the continued dormancy of these indications relative to their depth. None of these tubes were plugged due to %TW greater than 40% and none were plugged due to change of greater than 10%. No tubes were plugged due to multiple volumetric IGA indications. As a result of the inspections performed in 2001, additional tubes were located in “B” OTSG containing first span IGA indications. Their evaluation will be presented in the 90-day report. Of the 154 tubes affected by IGA prior to the inspection, 154 remain in service in “B” OTSG.

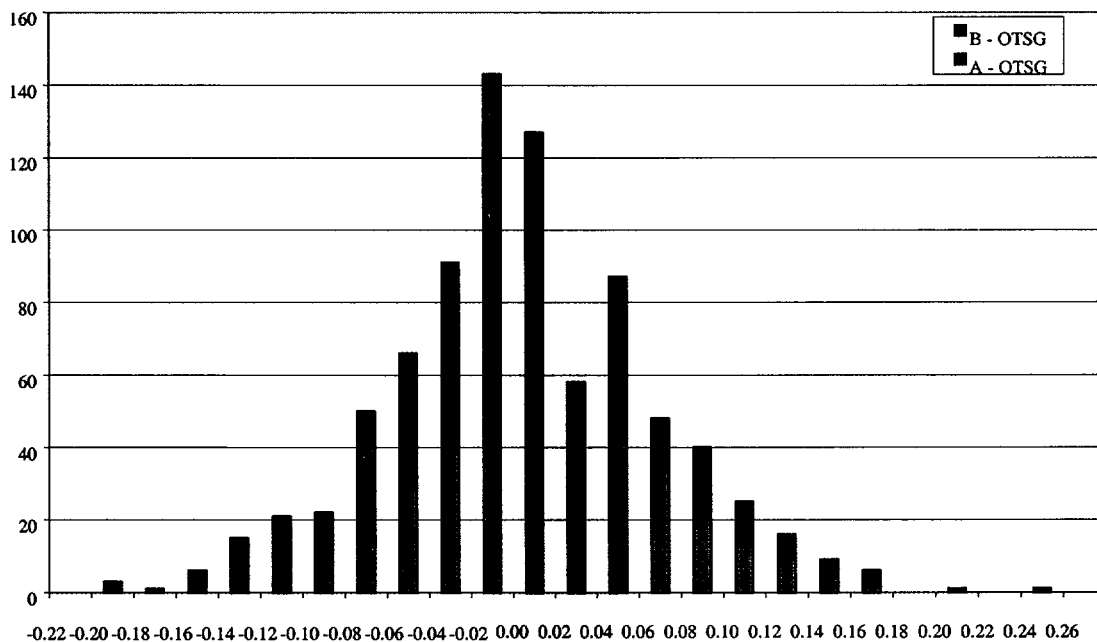
**Figure 1: Both - OTSGs
Change in Flaw Tip Location
1999 to 2001**

During the 1999 inspection, CR-3 implemented an alternate repair criteria (ARC) for tube end cracking, documented in BAW-2346P, Revision 0. During the 2001 inspection, an assessment of growth of TEC indications that remained inservice was performed for the indicated location of the flaw tip relative to the upper tubesheet carbon/clad interface (CCI). This evaluation confirmed that the indications did not show significant growth toward the interface. Table 1 provides the results of that evaluation. Figure 1 provides a graphical representation of the results of the assessment. The results demonstrate that growth towards the CCI is not significant with the average change in flaw tip location of -0.01 for both OTSGs. Table 2 provides the number of tubes, and indications returned to service under the ARC for cycle 13. As part of the ARC, the total projected leak rate under postulated accident (MSLB) conditions is provided in Table 3.

Table 1: TEC Flaw Tip Change Relative to CCI

OTSG	Maximum Positive Change (inches)	Maximum Negative Change (inches)	Average Change (inches)
A	0.15	-0.21	-0.01
B	0.25	-0.19	-0.01
