**From:** <Doddcv@aol.com> *C. Dodd, NRC Contractor*  
**To:** OWFN\_DO.owf2\_po(ELM), OWFN\_DO.owf4\_po(SMC1) *E. Murphy, S. Coffin NRC*  
**Date:** Thu, Apr 20, 2000 8:33 AM  
**Subject:** IP5 report

## Comparison of tube scans before and after pressure testing

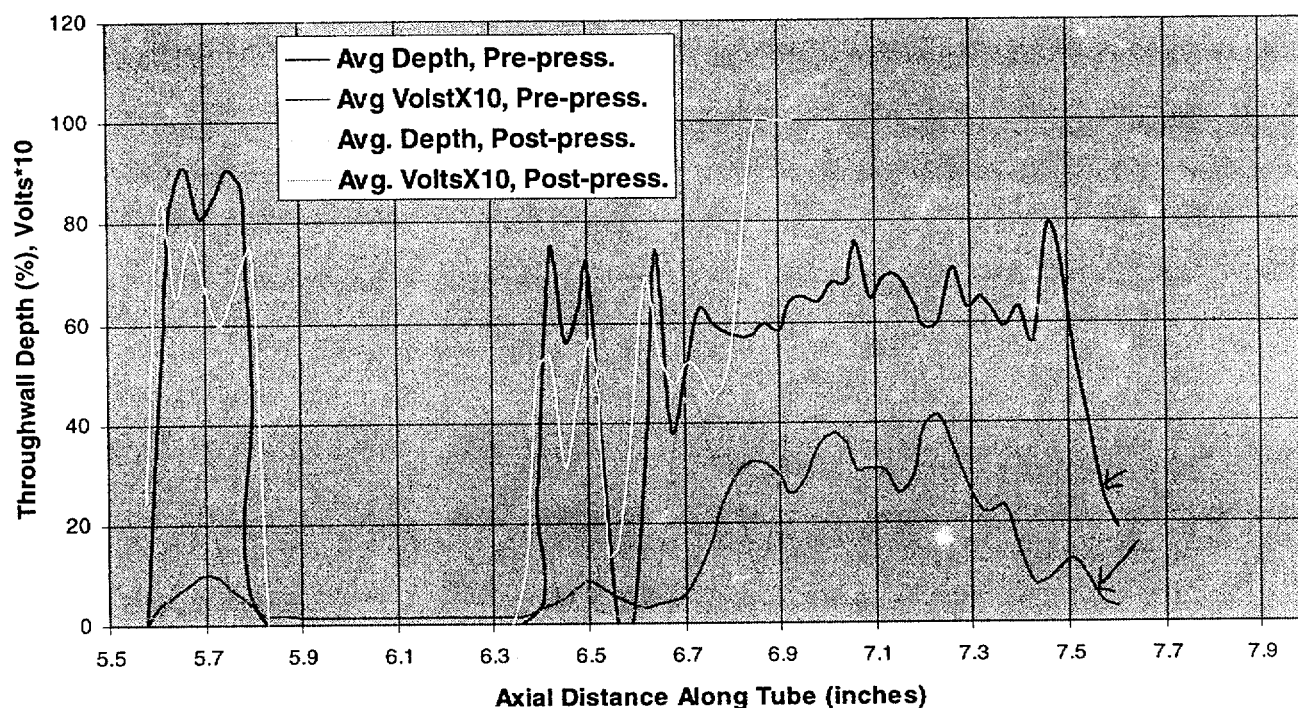
### Tube R2C69, SG24, High Frequency Probe

Scans were made on the three leaking tubes in Steam Generator 24 after the pressure tests. These scans revealed a considerable change in the eddy-current response. Of most interest is the scan of 2-69. In Figure 1 we show the pre-pressure test scan of this tube, with the post-pressure test of the tube superimposed. The region on the right has only the pre-pressure test scan, since the probe would not run through the tube after the test. The amplitude of the scan is large enough to be more accurately measured. Figure 2 has the pre-scan graphics and Figure 3 has the post-scan graphics. The defect on the left was not included in the profile of this tube, but it was reported on the data sheets. In Figure 4 we show the profile of tube R2C74 of steam generator 24, and in

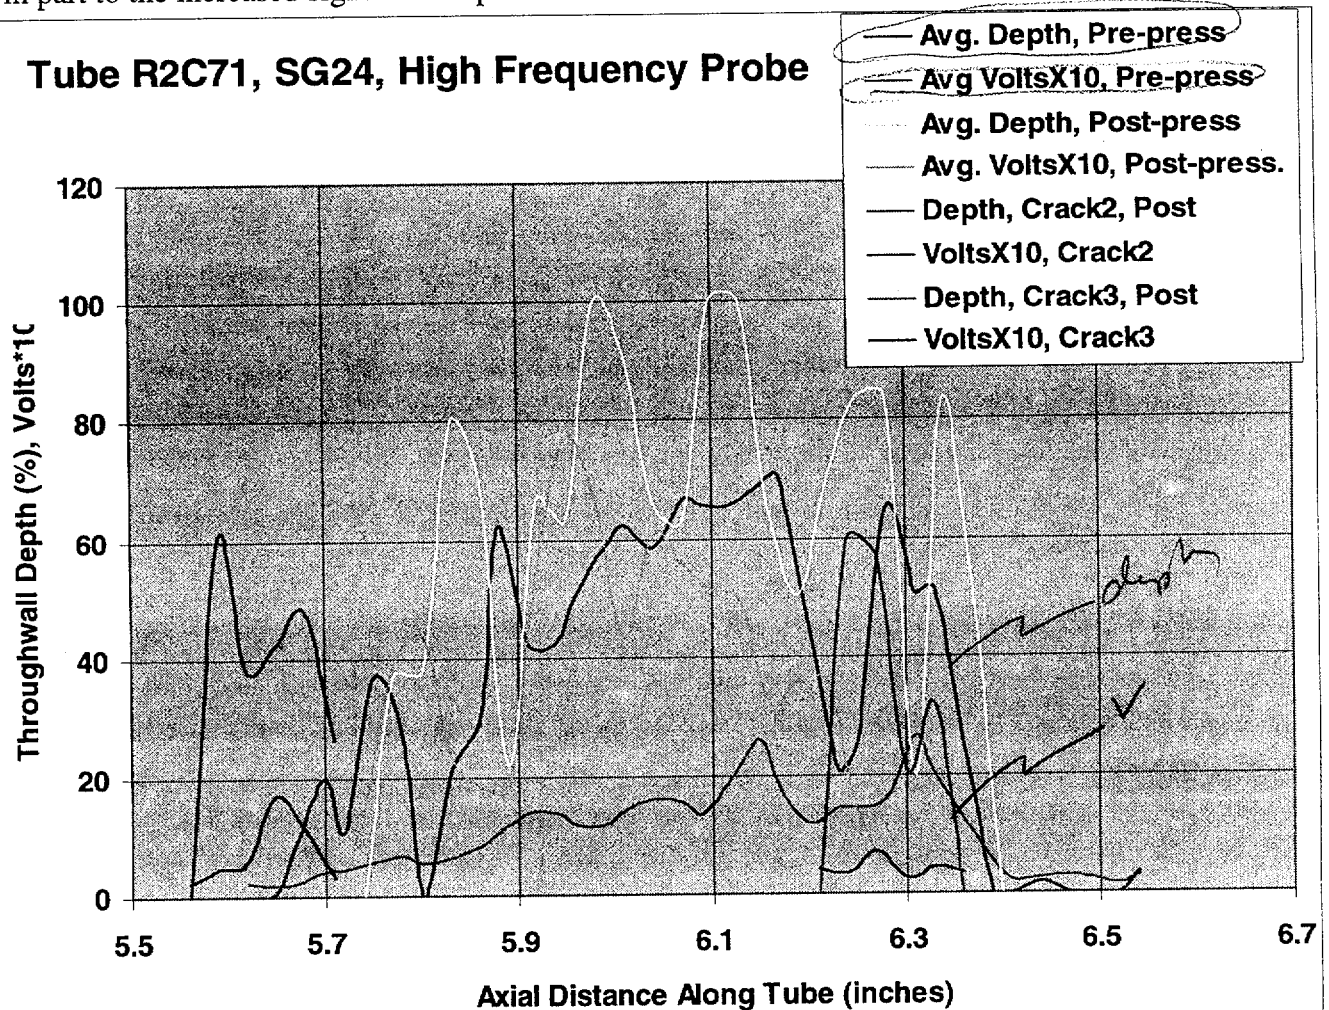
**Tube R2C71, SG24, High Frequency Probe**

The pressure testing of tube R2C71 of steam generator 24 shows the presence of two new cracks that were not visible on the scan of the pre-pressure test scan. It is unknown if the cracks were there previously or were created by the pressure testing. However, they are clearly visible now, and they are profiled as crack2 and crack3 in Figure 7. If these cracks were present before the testing their amplitude was too small for them to be detected and sized. In Figure 9 these cracks appear in the foreground, where they were not visible in the scan in Figure8.

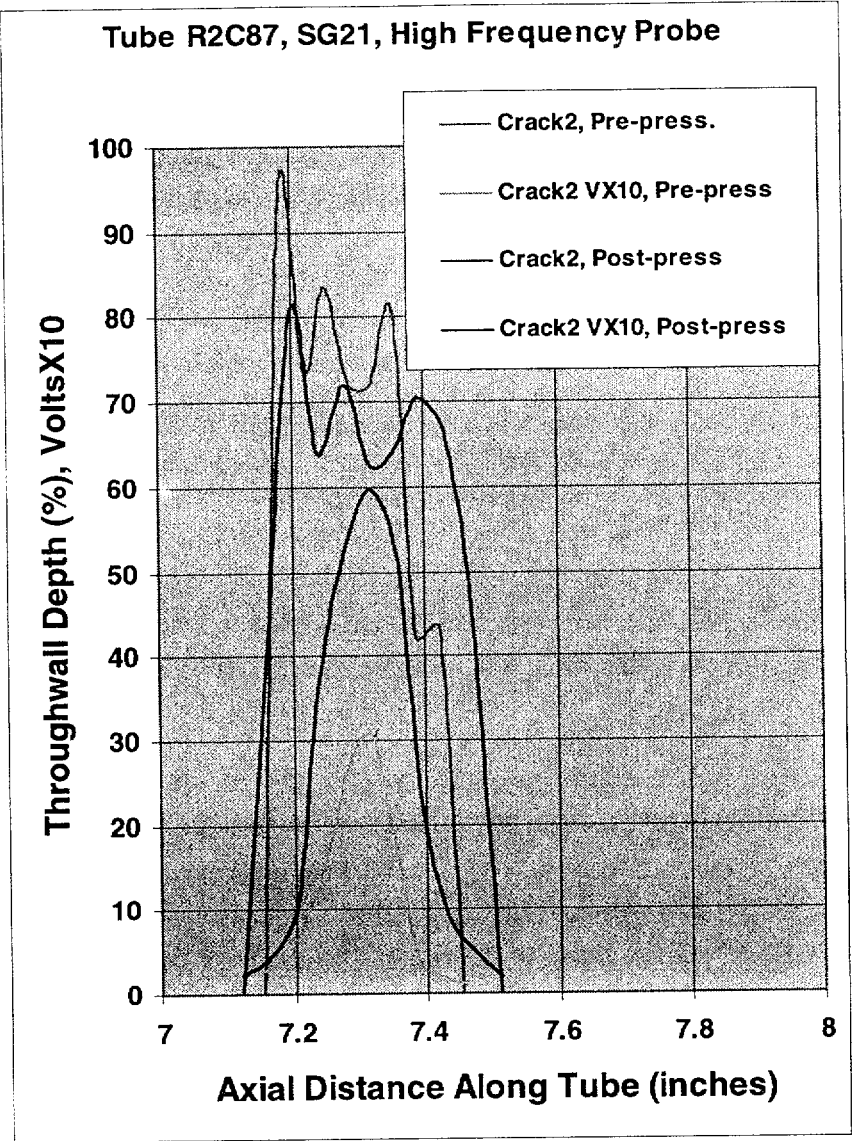
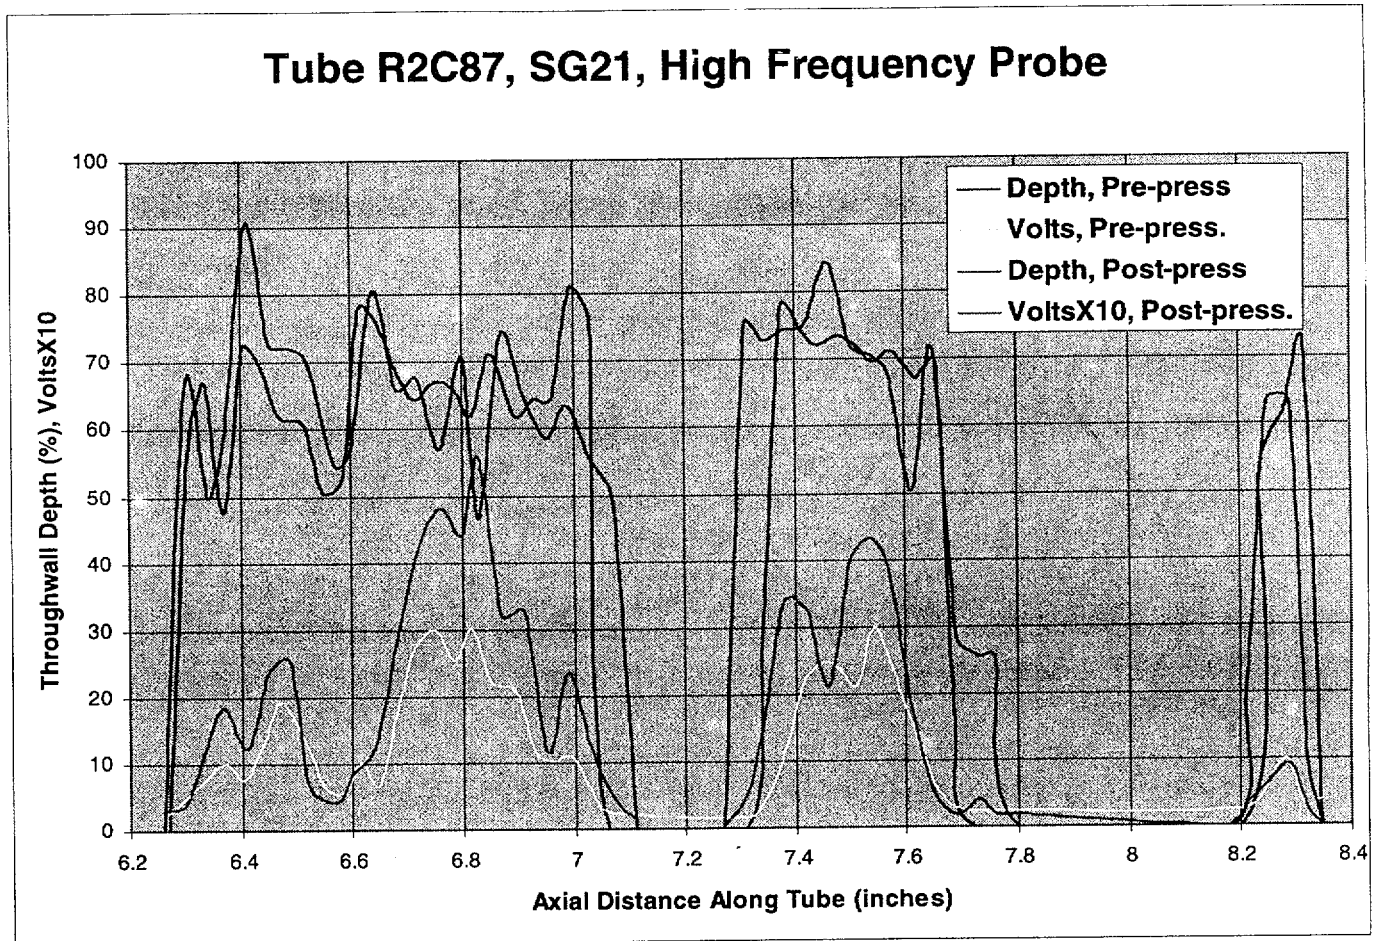
In Figure10and in Figure 11 we show the profile of cracks found in tube R2C87 of steam generator 21. This tube had a secondary crack about 0.35-inches long with a depth of about 70% of the wall. The voltage amplitude of this crack has approximately doubled with the pressurization. The depth appears slightly less and the length appears slightly longer after pressurization, but this is probably due to the crack being easier to detect at the edges, and the measurement is probably more accurate with the larger voltage.

The primary crack shows a similar change with pressurization. It appears to be between 60 to 70% deep, with two ligaments of conducting material across the crack face. The overall length of the crack is about 2-inches. There is a bridge from about 7.1-inches to 7.3-inches and another from about 7.8-inches to 8.2 inches. The crack depth probably does not go to zero along these bridges, but down to a value (20% or less, after pressurization) small enough not to be detected. In Figure 12 we show the pre-scan of tube R2C87, showing both of the cracks and Figure 13 shows the post-scan of the tube. It appears that the defect was scanned from different directions (the pull on one scan and the push on the other scan) between the two scans. The scans can be made to have the same axial orientation, but this results in the secondary crack being on

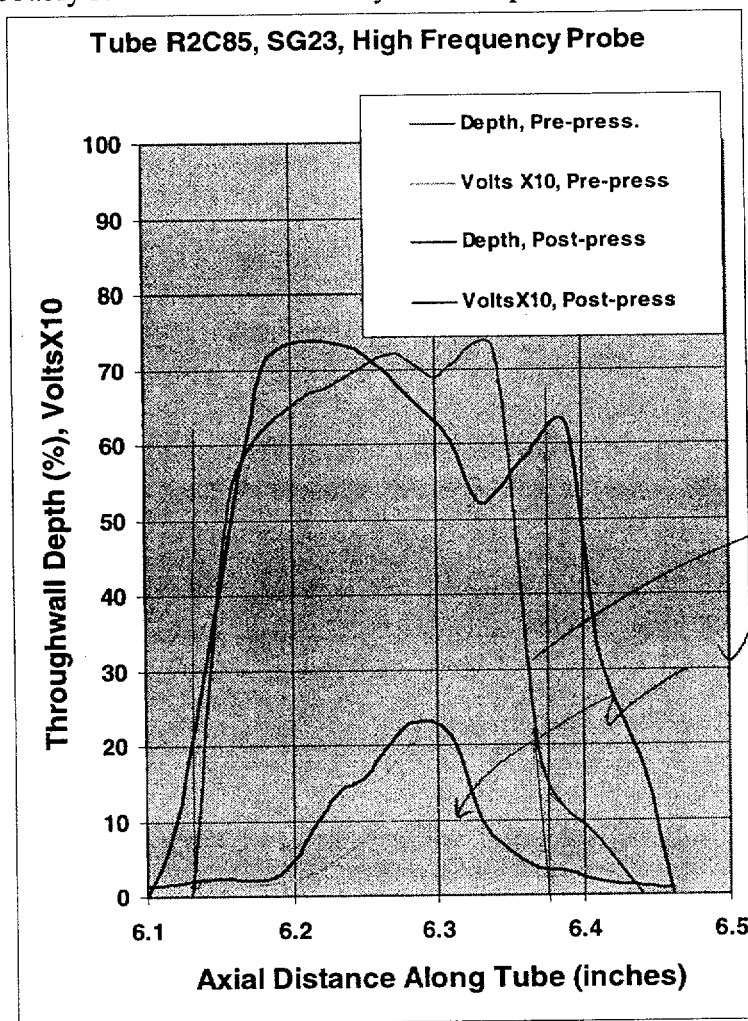
In Figure 14 we show the effects of pressure testing on the crack found in tube R2C85 of steam generator 23. This crack showed the same phenomenon as the others, to a lesser extent. The depth appears to be about the same and the length appears to increase slightly. In Figure 15 we show a C-scan of the tube before pressure testing and in Figure 16 we show a scan of the tube after pressure testing. The scans in this case are quite similar, with no new cracks appearing.

In some cases the post-pressure test scan shows a deeper crack than the pre-scan test. This probably reflects the uncertainty in the depth measurements of the low amplitude signals more

than anything else. However, it could be due to the inner portions of the crack producing a larger amplitude signal than the outer portions, due to the inner portion opening more. The vector result of the combined signal, which is what the eddy-current probe sees is therefore biased to the more shallow portion of the crack, and the result appears as a more shallow crack. This same phenomenon was observed for the IGA on the inner surface of the tube after pressurization at Three Mile Island, Unit 1.
