7/10/2000
Item 12

Growth Studies for Indian Point2 Steam Generator U-bend Defects

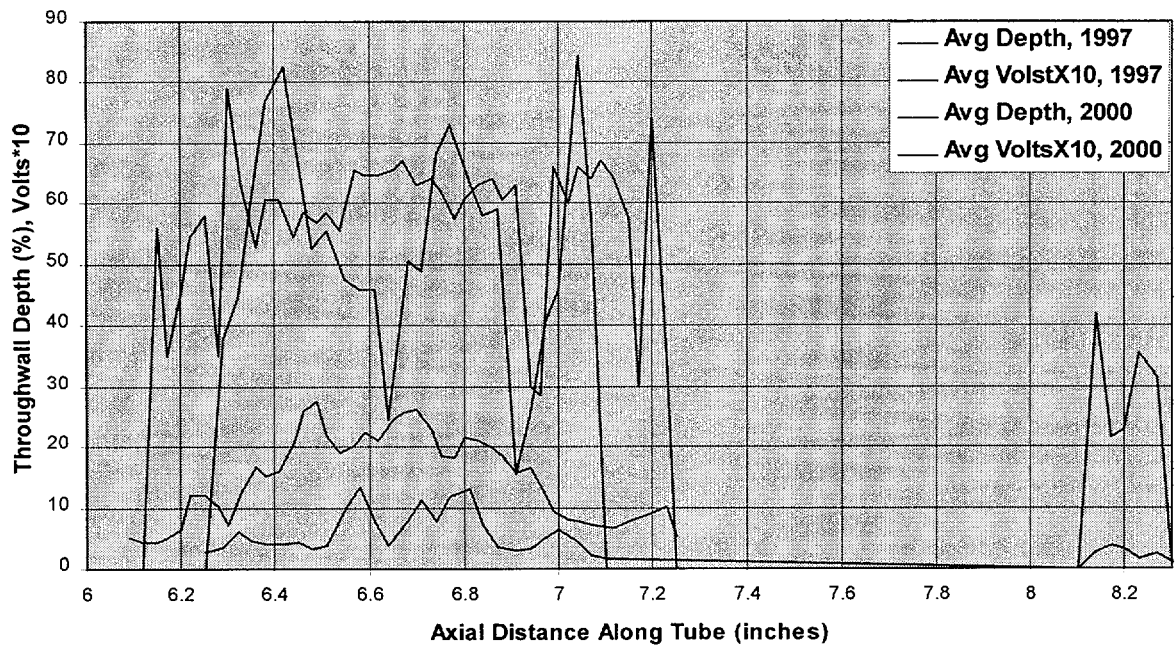
Figure 1 shows the profile of tube Row 2 Col 69 of Steam Generator 24. The profile of the tube taken from the high-frequency data is shown in Figure 2. Although there is considerable noise present in the C scans using the midrange probe, as shown in Figure 3, this is probably the most accurate profile of all the tubes. The noise features between the midrange scans in 1997 and 2000 are similar enough to verify that this is the same defect at the same location. The 1997 scan shows a considerable amount of noise, and much of the depth profiling is guessing. As can be seen in Figure 1, the defect voltage is only about 1 volt, and there is a considerable amount of noise on the tube, relative to the defect signal.

The signal amplitude has increased to about 2.5 volts in 2000 with the same type of probe, calibrated in the same manner. This indicates a growth in the crack, although it may well be in the widening of the crack, rather than the crack getting deeper. The crack also appears longer in 2000 than in 1997. This may be due to the increase in amplitude causing the ends of the crack which were present in 1997 but below the noise, to now become visible. There were other signals in 1997 that may have been part of the defect or part of the noise ridge that the defect was riding on.

Figure 1 Profile of Growth between 1997 and 2000 for Tube R2C69 of Steam Generator 24

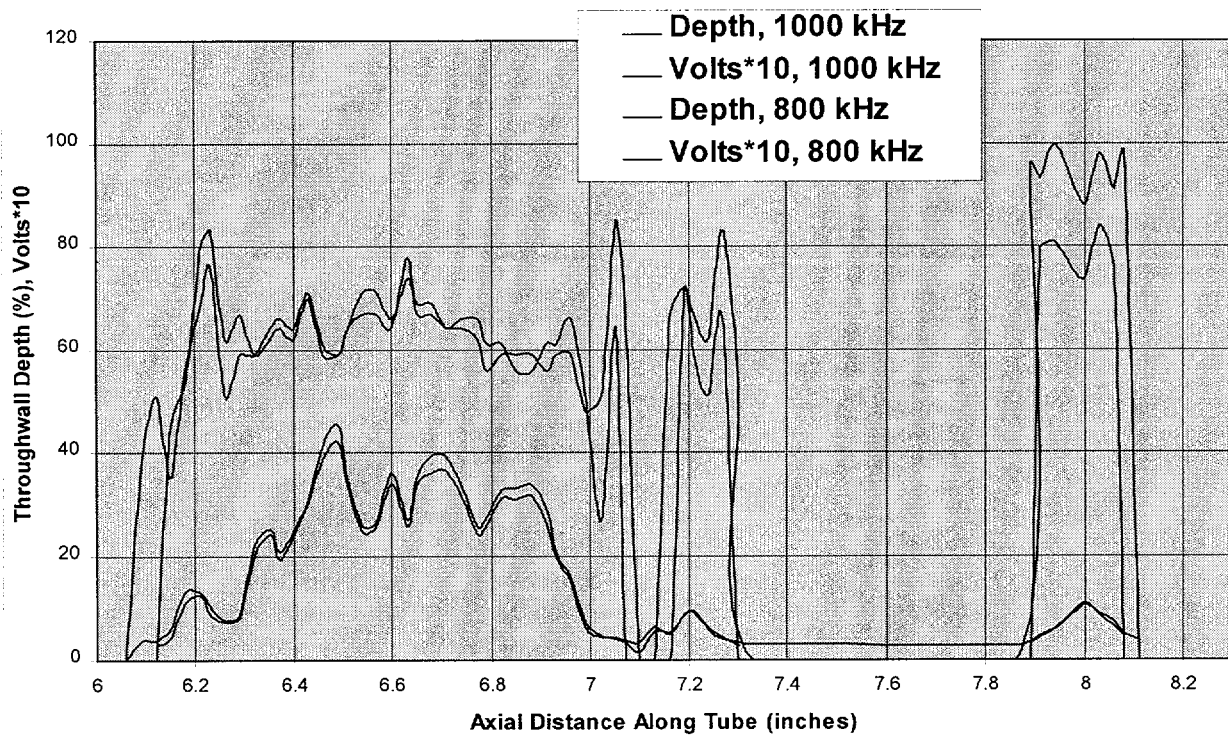
The signal has increased to about 4 volts in the profile shown in Figure 2, using the high frequency data. The noise has also increased, and this signal-to-noise ratio gives a much more accurate profile than either curve in Figure 1.

Figure 2 Profile of Tube R2C69 with the High Frequency Probe.

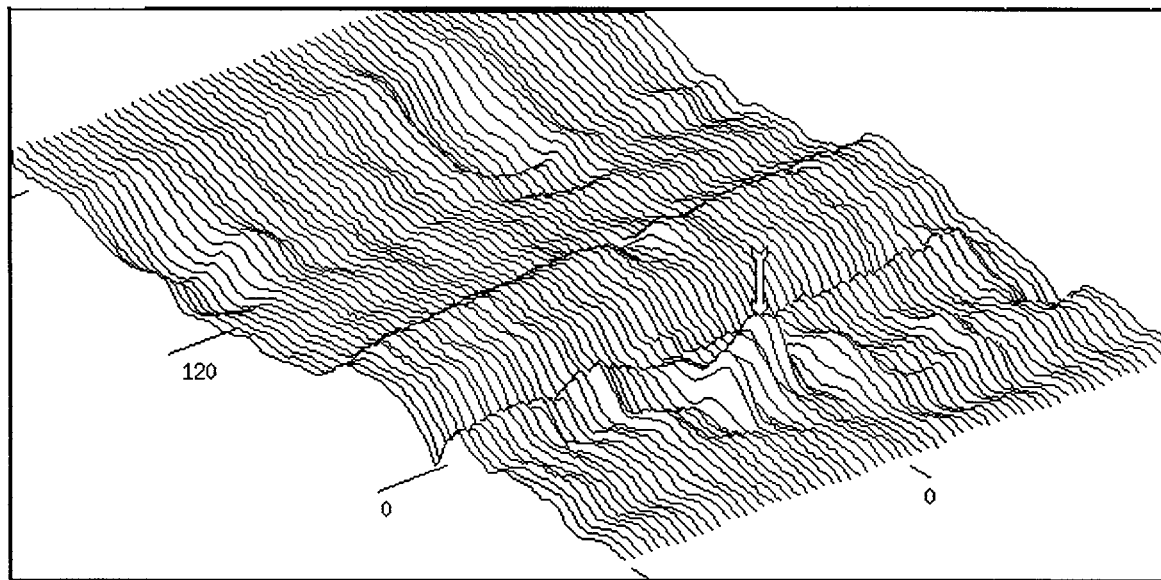
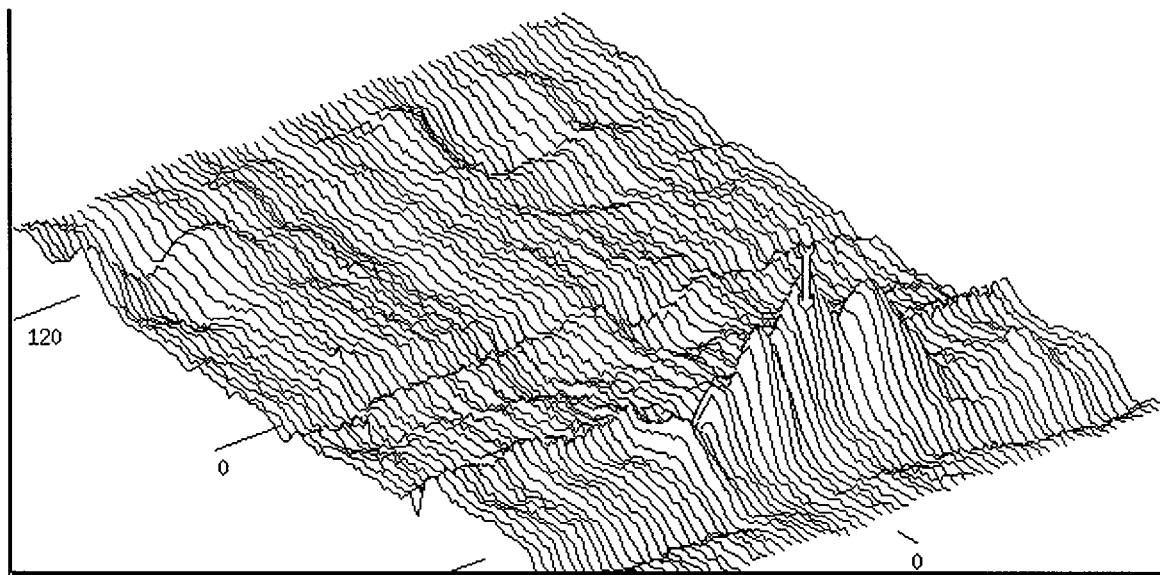
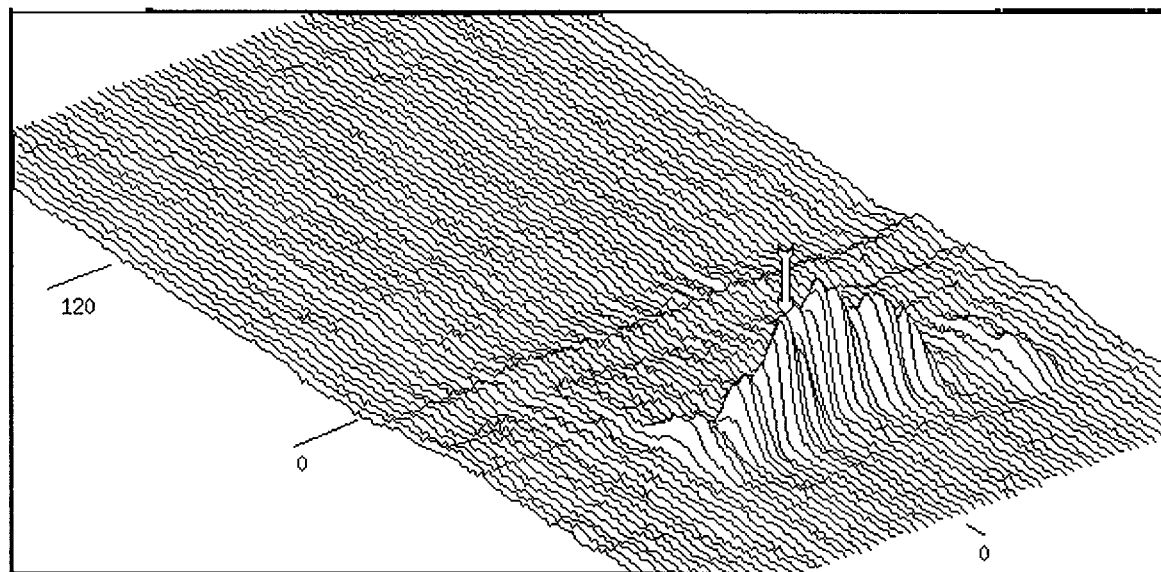
Figure 3 C-scan of tube row 2 col 69 of Steam Generator 24 in with the midrange plus-point probe in 1997 and in 2000 and with the high-frequency plus-point probe in 2000

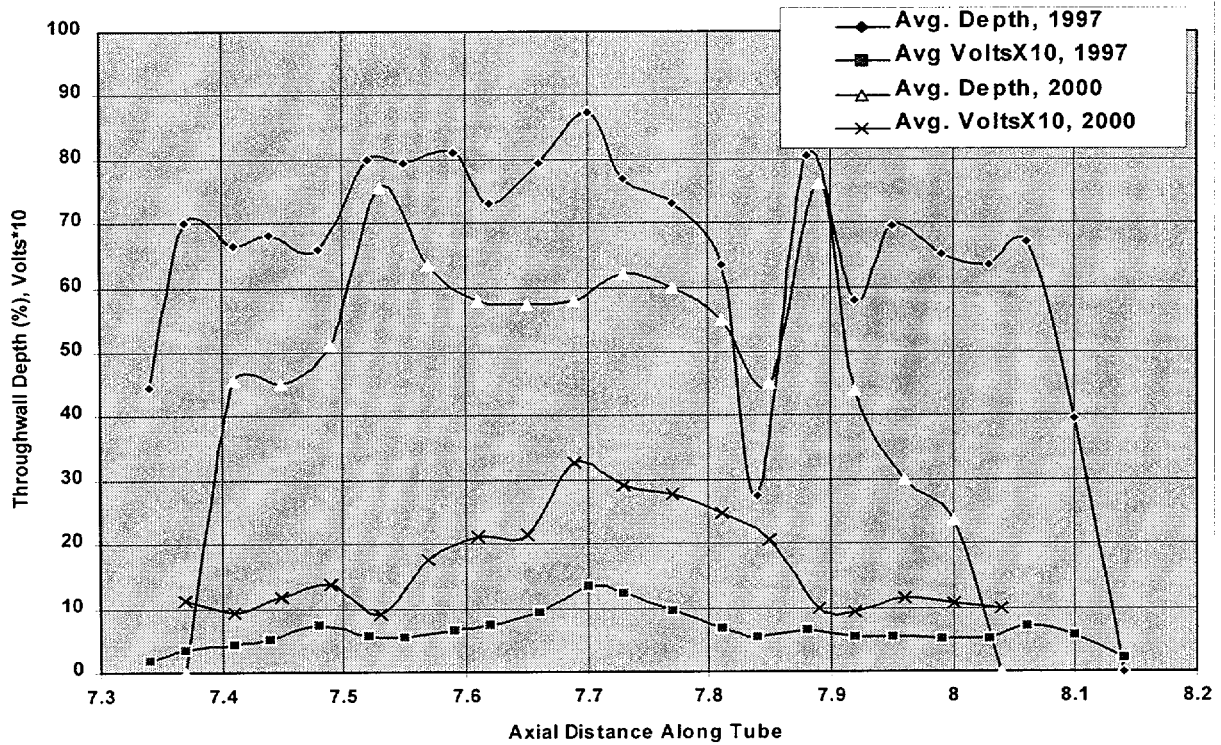
Figure 4 shows the profile of the crack growth in tube Row 2, Col 72 in steam generator 24 between 1997 and 2000 using the high frequency probe. The later profile done with the high-frequency probe, as shown in Figure 5 is more accurate.

Figure 4 Profile of crack growth of tube R2 C72 of SG24 between 1997 and 2000

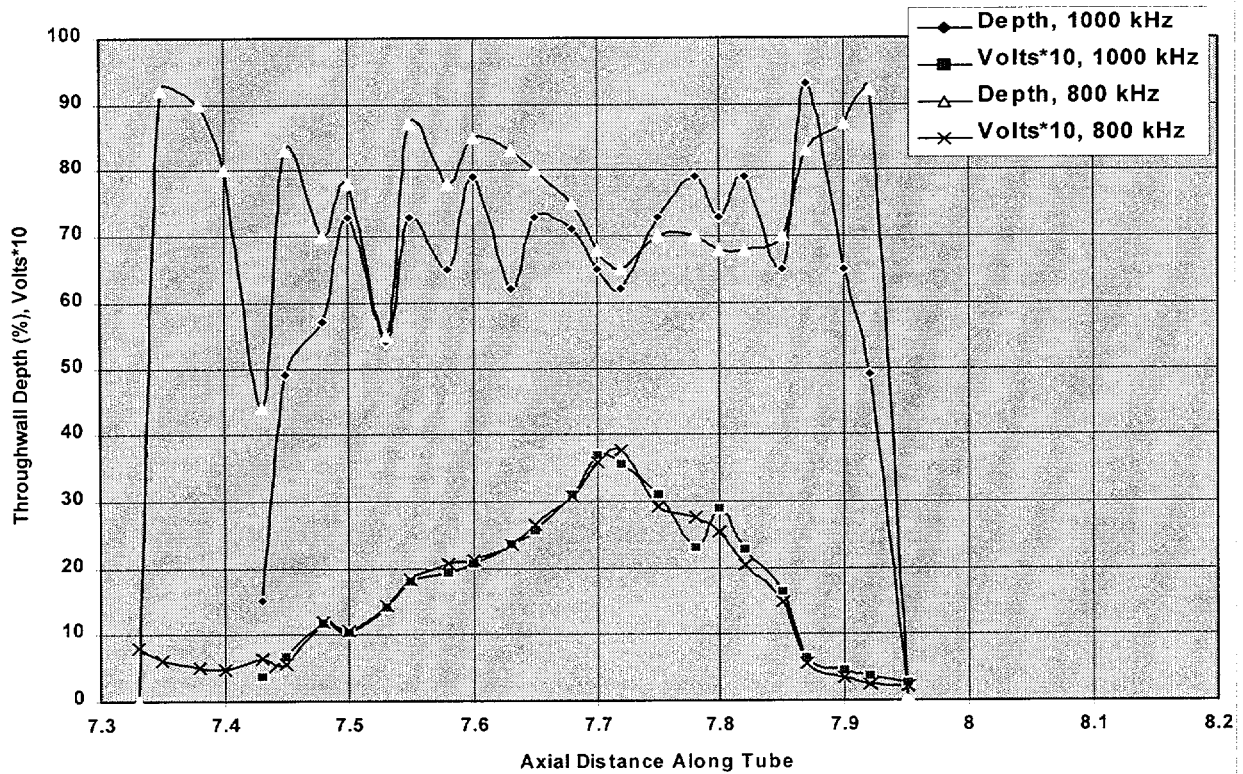
Figure 5 Profile of crack in tube R2 C72 of SG24 with the high frequency probe.

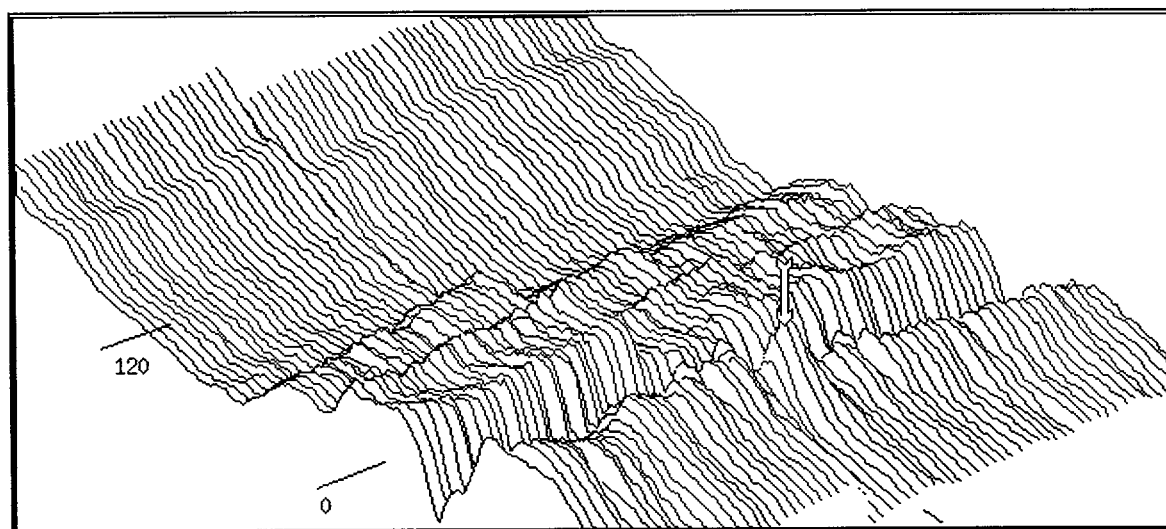
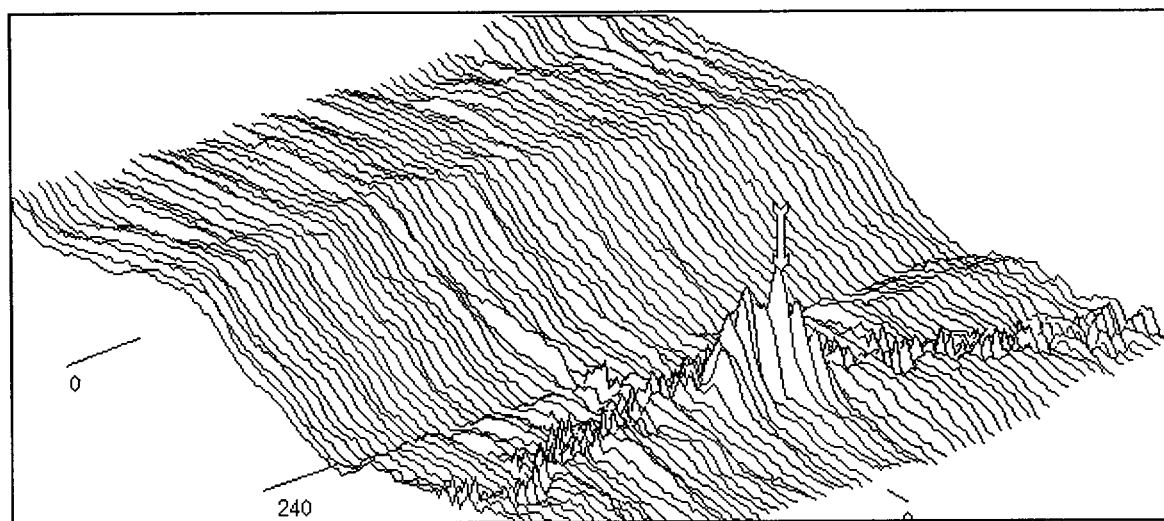
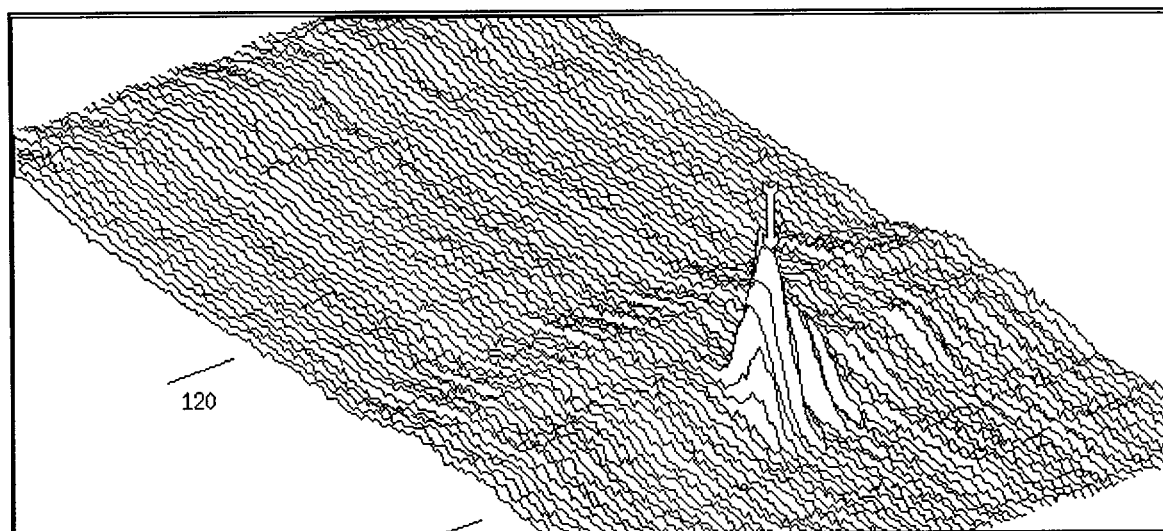
As we can see in Figure 6, there is considerable noise present in the C- scan in 1997 with the midrange probe. The crack is sitting in a ridge of noise, and barely extends above a ridge of deposits. The crack barely extends above a 1-volt amplitude for a short length, and this is the only part of the crack that we can profile reliably.

The C-scan in 2000 with the midrange probe shows very little of the ridges present in the 1997 scan, but shows a series of spikes. These spikes are believed to be noise pulses associated with the data acquisition, possibly a problem in the slip rings. The ridges that I attributed to od deposits in the 1997 scan have vanished. There is a wave in the 1997 and 2000 scans that is similar. The signal amplitude has increased to a maximum of about 3.2-volts, making the defect easier to detect and more accurate to profile. There is a clear amplitude increase in this crack.

The C-scan for the high-frequency scan of this crack was taken from the opposite direction, so the features will be reversed between it and the two midrange probes. This is the most accurate profile, with the lowest signal-to-noise ratio. The maximum measured voltage is about 3.7-volts for the scan with this probe.

Figure 6 C-scan of tube row 2 col 72 of Steam Generator 24 in with the midrange plus-point probe in 1997 and in 2000 and with the high-frequency plus-point probe in 2000

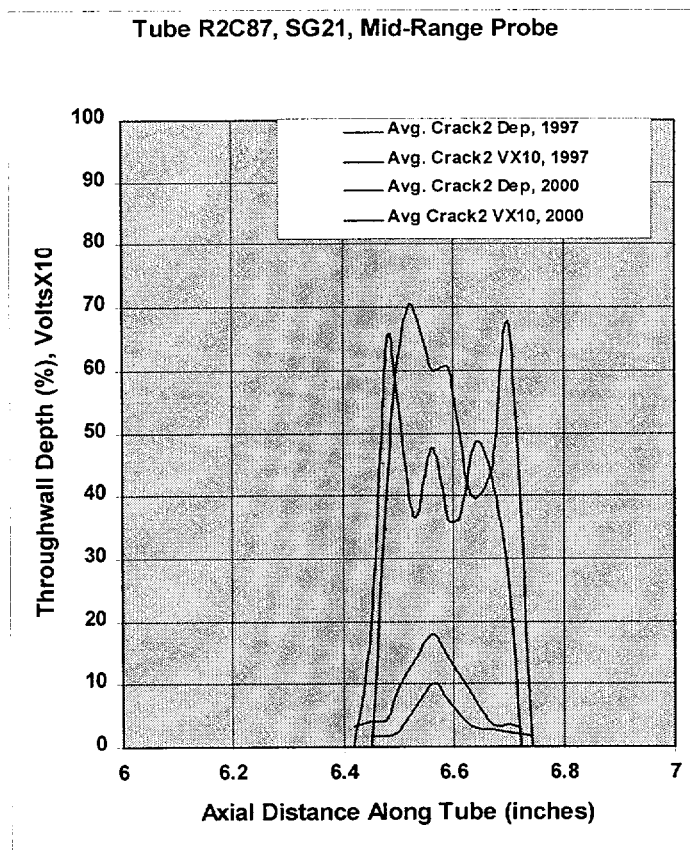
This tube was identified as having several cracks, but only one has been profiled, as shown in Figure 7. This crack was also profiled with the high-frequency probe, as shown in Figure 8.

Figure 7 Profile of crack growth of tube R2 C87.

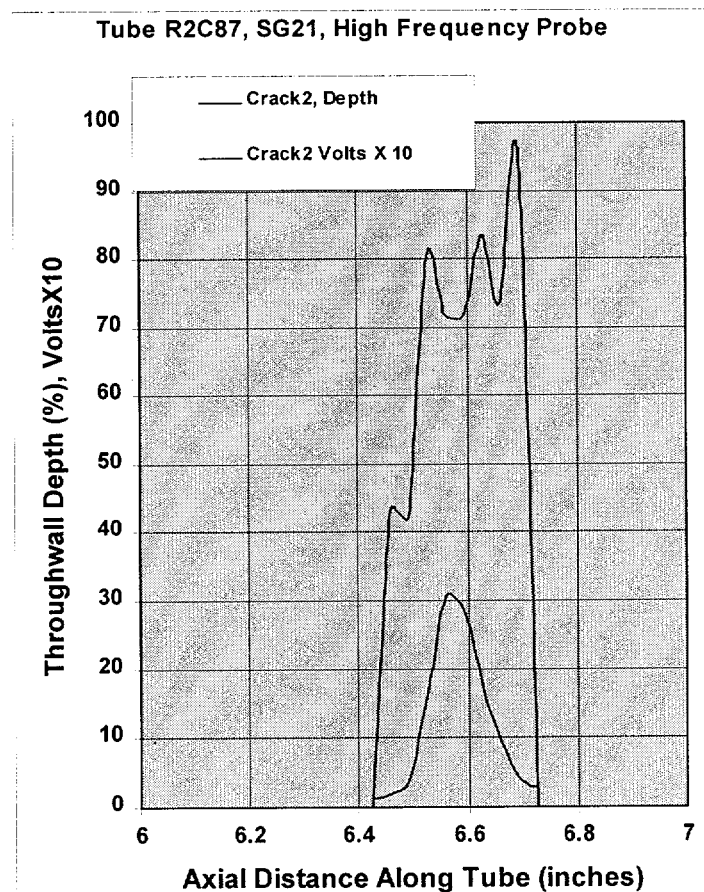
In the high-frequency scan, the measured voltage increased to 3-volts, and the measured depth appears to have increased also. This is probably due to the short length of this crack. The smaller, higher frequency probe is not as susceptible to end-effects as the larger midrange probe.

Figure 8 High-frequency profile of tube R2 C87.

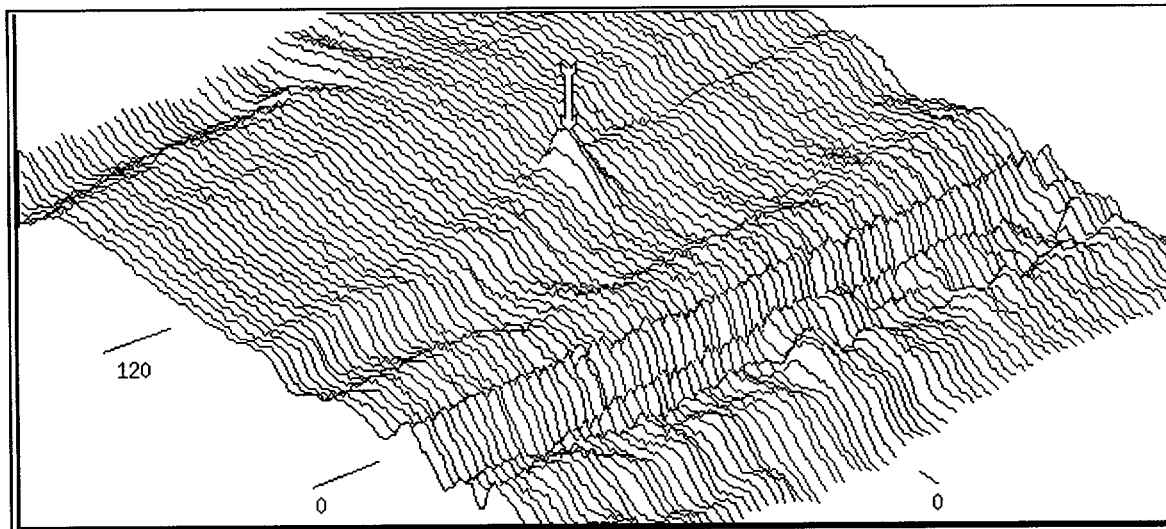
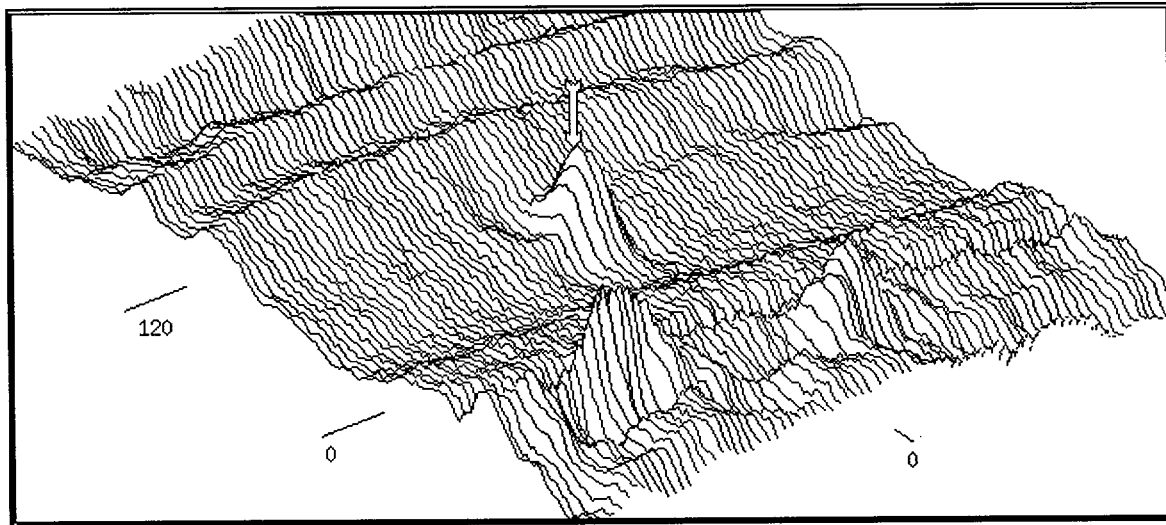
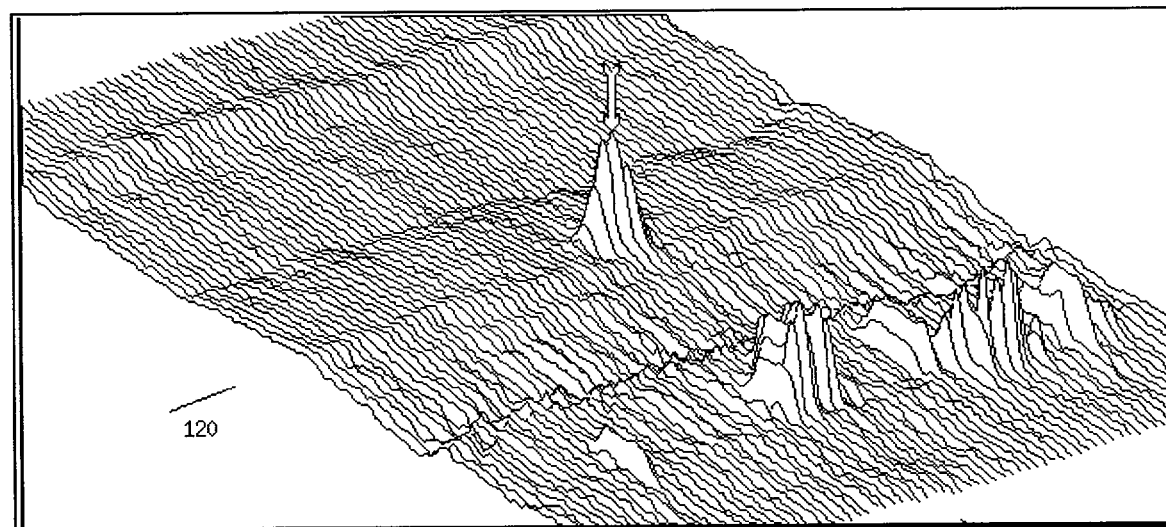
As we can see from the C-scans, in Figure 9, this crack is sitting in a relatively clean area of the tube. It is the crack under the arrow in all three C-scans. A small part of the crack is showing in the ridge in the 1997 scan, but the noise dominated when profiling was attempted using the 1997 data. The small, center portion of the crack is the only part that can be profiled with any accuracy.

The 2000 midrange scan is in the opposite direction as the 1997 midrange scan and the 2000 high frequency scan. The voltage amplitude increased from about 1-volt to 1.8-volts during the operating cycle. The crack depth appeared to have decreased slightly.

Figure 9 C-scan of tube row 2 col 87 of Steam Generator 21 in with the midrange plus-point probe in 1997 and in 2000 and with the high-frequency plus-point probe in 2000
