**WATTS BAR NUCLEAR PLANT (WBN) UNIT 1 - AMERICAN SOCIETY OF  
MECHANICAL ENGINEERS (ASME) SECTION XI, INSERVICE INSPECTION -  
REQUEST FOR RELIEF 1-RR-4**

### WATTS BAR NUCLEAR PLANT (WBN) UNIT 1 FIRST 10-YEAR INTERVAL REQUEST FOR RELIEF 1-RR-4

COMPONENTS: Six-inch NPS, Schedule 40, Carbon Steel Pipe

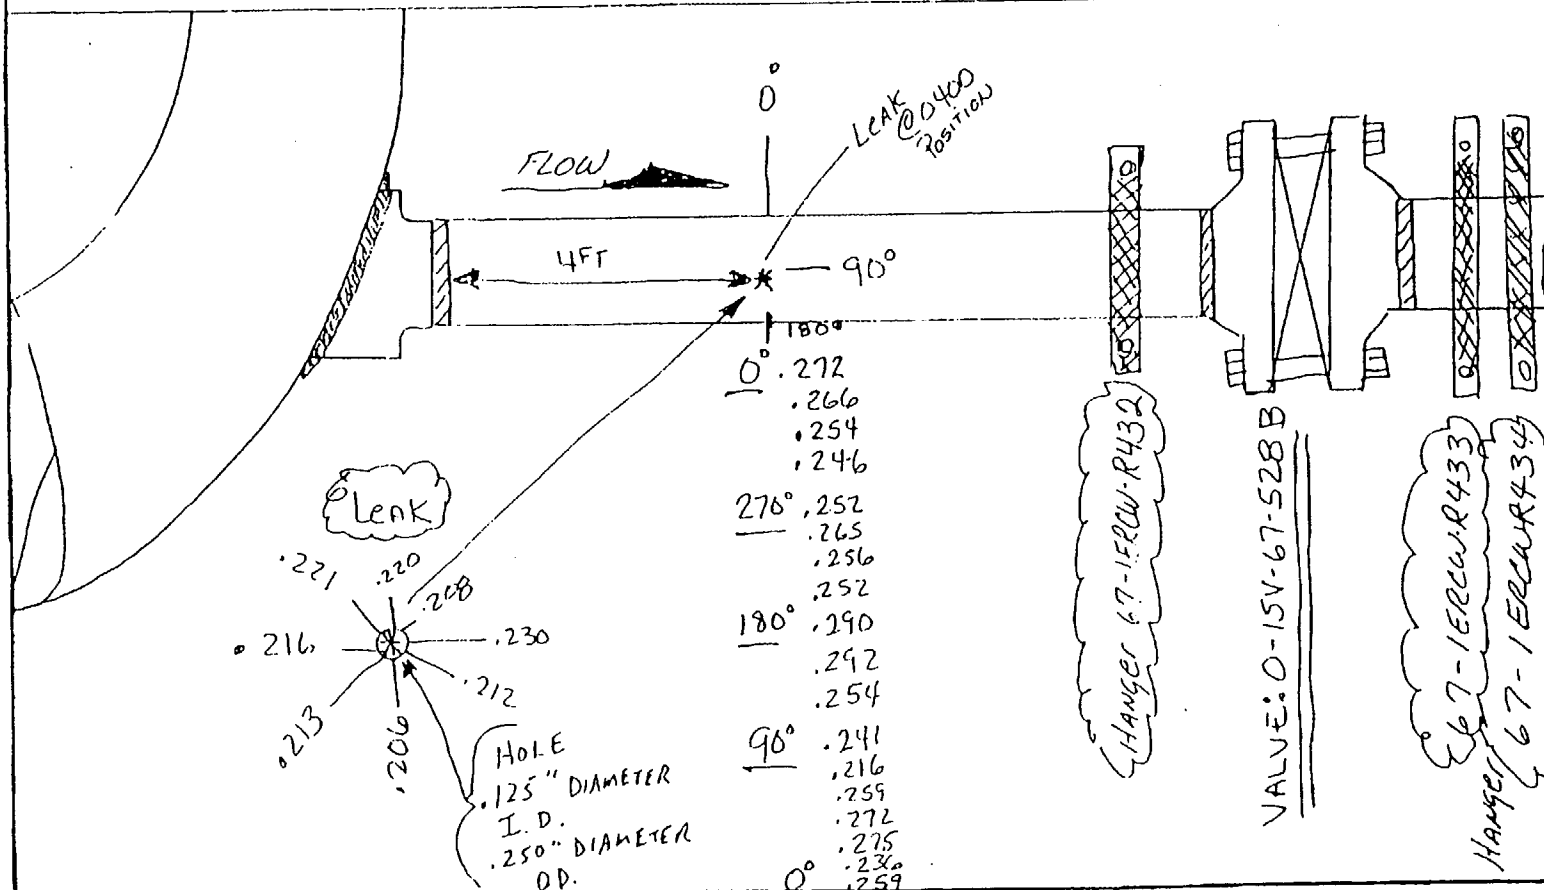
PROJECT: WATTS BAR SYSTEM: 067Unit: 2WELD NO.: Piping

On July 28, 2001, a through-wall leak was discovered in the ERCW system. The leak is located in a low energy six-inch NPS diameter carbon steel pipe between the ERCW Train B main discharge header and valve 0-ISV-067-528-B which cannot be isolated from the discharge header for repair. The design pressure and temperature for this section of piping is 35 pounds per square inch gauge (psig) and 130 degrees Fahrenheit (F). The water is stagnant in this section of the pipe. Problem Evaluation Report (PER) 01-012757-000 has been written to document and correct this condition.

The leakage from the piping was characterized as a steady stream approximately ¼-inch diameter. Since this is the last branch off the discharge header before leaving the

Auxiliary Building, the leak does not affect system operability. Ultrasonic examinations were performed to determine structural integrity. As a stop gap measure to minimize spraying concerns, a clamp and rubber gasket were installed over the leak. At this time, no leakage is occurring.

The guidance of Generic Letter 90-05 was used. The structural integrity of the flawed piping was assessed and found acceptable. The root cause for the piping degradation is considered to be due to microbiological induced corrosion (MIC). An ultrasonic examination was performed one pipe diameter upstream and downstream of the leak for use in evaluating structural

At this time, TVA plans to leave the piping as is with a temporary non-Code repair using a clamp with rubber gasketing. The flaw evaluation shows that this piping still has sufficient strength to perform its design function.

TVA is conducting weekly walkdowns to assess the operability and leakage through the temporary non-Code repair. Any changes will be evaluated which could affect operability or structural integrity. An ultrasonic examination will be performed every three months to assess the piping degradation rate. Based upon the weekly walkdowns and ultrasonic examinations, an engineering evaluation will be performed to determine if further remedial measures or corrective actions are needed. An ASME Section XI repair or replacement will be performed before the completion of the U1C4 refueling outage which is currently scheduled in the Spring 2002. These corrective actions are being tracked by PER 01-012757-000.
