Subject: Beaver Valley Power Station, Unit No. 1
Docket No. 50-334, License No. DPR-66
Bulletin 2000-01 Circumferential Cracking of Reactor
Pressure Vessel Head Penetration Nozzles

**Evaluation Report for 1R14 Visual Inspection of
Beaver Valley Unit 1 CRDM Penetrations**

Summary Report for Beaver Valley Unit 1 RVH CRDM Penetration Visual Inspection

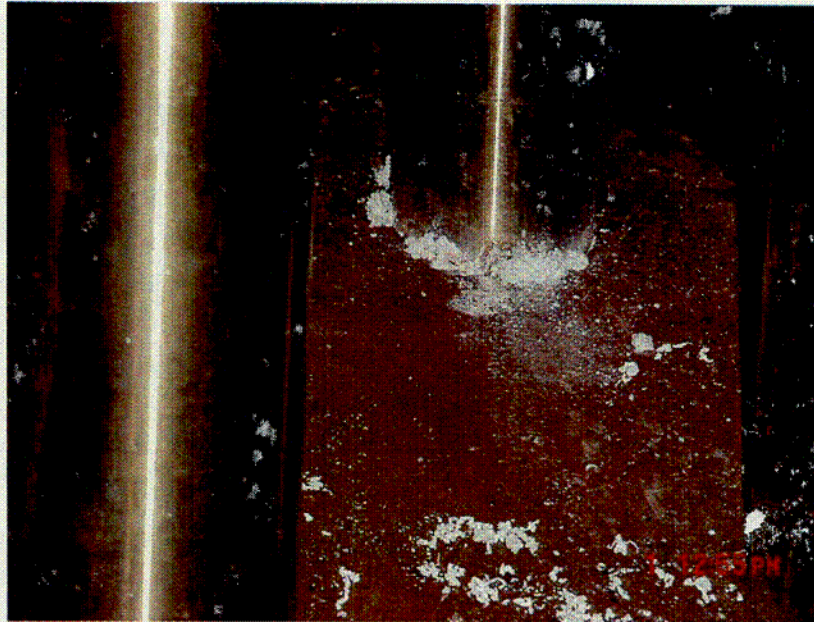
shown in Figure 1 (shown below). This picture illustrates the configuration of boric acid accumulation that is associated with through wall leakage from a CRDM Tubing. None of the penetrations on the Beaver Valley Unit 1 displayed boric acid accumulations of a similar configuration. Additionally all indications of boric acid accumulations were associated with previously identified Conoseal leakage, as a result it is concluded that no penetrations at Beaver Valley Unit 1 contain a leaking through wall flaw.

Figure 1 – Typical Boric Acid Accumulation Around a Failed CRDM

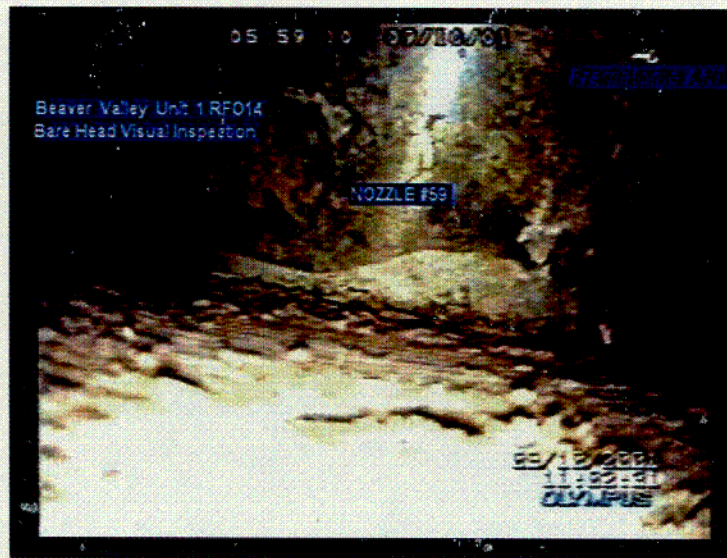
Figure 2 – Penetration #59

The two (2) locations, CRDM penetration numbers 59 and 65, identified as having boric acid deposits on and around the CRDM tubing are shown on the next page.

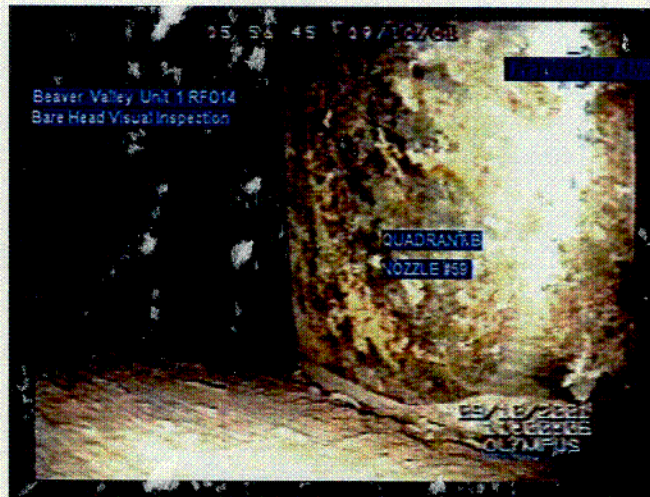
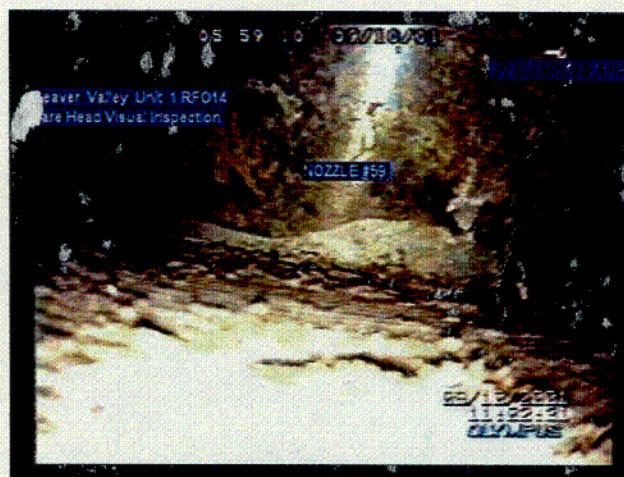
Figures 4(a) and 4(b) show the area around the base of Penetration #59 where it meets the Reactor Vessel Head. As can be observed, very little accumulation of boric acid residue can be seen at the base of the penetrations. The accumulation around the base of the penetration is light dry boric acid no more than 1/16 inch in thickness in the form of a film or coating rather than distinct accumulations of boric acid "puff balls". These film like accumulations of this type are not similar in any way to that shown in Figure 1.

Figure 4 (a) – Penetration #59

Figure 4 (b) – Penetration #59

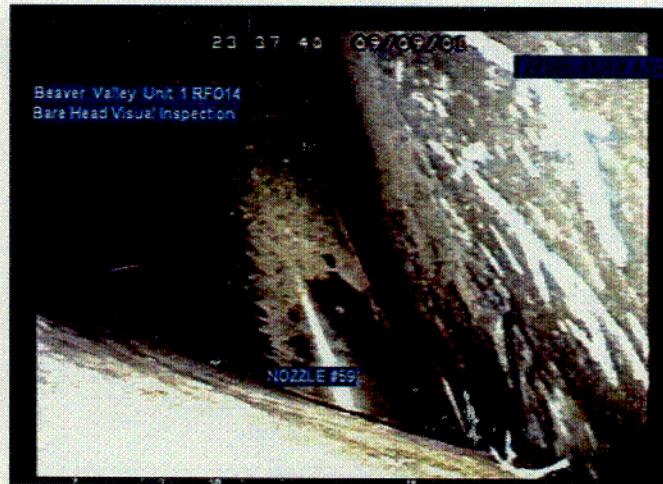
Figure 5 – CRDM #59

The residue pattern that can be observed on the sides of the penetration are consistent with leakage from above (like that of a Conoseal leak). The distinct spray pattern (shown in Figures 5 and 6) across the CRDM tubing is well above the intersection of the CRDM tube and the Reactor Vessel Head and is also displayed on the surrounding insulation panels. A review of the Unit 1 Refueling Logs indicates that leakage from a conoseal occurred during 1R04 (October of 1984). The Log noted that boric acid residue was removed from the head, there was no indication that the area around the CRDM was cleaned. Penetration #59 is located near Conoseal #1 and leakage from this Conoseal would spray onto and run down around the insulation opening at Penetration #59. The appearance of the spray pattern on CRDMs #53 and #59 is one of liquid being dropped into a high velocity air flow and then splattered on the surrounding surfaces.

Figure 7 shows that there is a gap of nearly 1/8 inch or more at the base of the insulation package where it meets the Reactor Vessel Head near Penetration #59. During plant operations the CRDM Cooling Fans pull approximately 440 CFM of air through the Reactor Vessel Head area. Figures 5, 6 and 7 show the accumulation of the boric acid spray on the surrounding areas consistent with leakage from above being carried by high velocity air on to the CRDM tubing. This fact coupled with the lack of boric acid accumulation around the base of Penetration #59, as displayed in Figures 4(a) and (b), provides sufficient evidence that the boric acid residue is a result of Conoseal leakage and not from a through wall leak of the CRDM tubing.

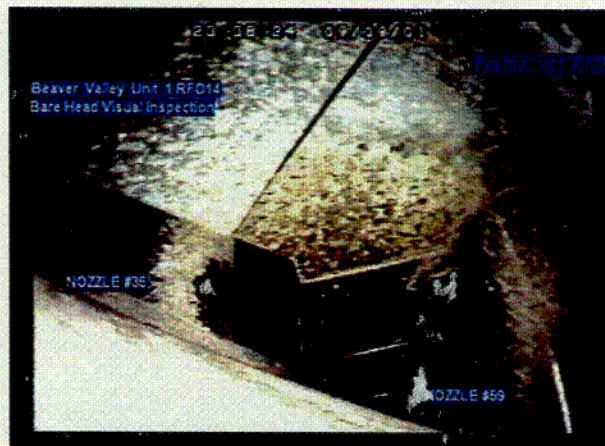
Figure 6 – Penetrations #59 and #35

In the case of nozzle penetration #59, the visual inspection shows a distinct spray pattern across the nozzle above the intersection of the CRDM and reactor vessel head onto the surrounding insulation and onto nozzle #35. The boric acid was deposited in a rooster tail pattern that seems to reflect a bottom-up direction. However, the conoseal leakage would have yielded a top-down flow of boric acid. The spray effect resulted from the high upward air flow of the CRD cooling ventilation, which will form air jets in gaps between the insulation and the head around the periphery locations. The high flow air picks up and atomizes the boric acid running down the shroud and throws it across the face of the nearest nozzle and insulation. This conclusion is bolstered by the fact that no streaming stains or deposits are present anywhere on the head surface. If the boric acid at nozzle 59 were from a penetration leak, it should have run down to the shroud as was seen at the Oconee and ANO leaks.

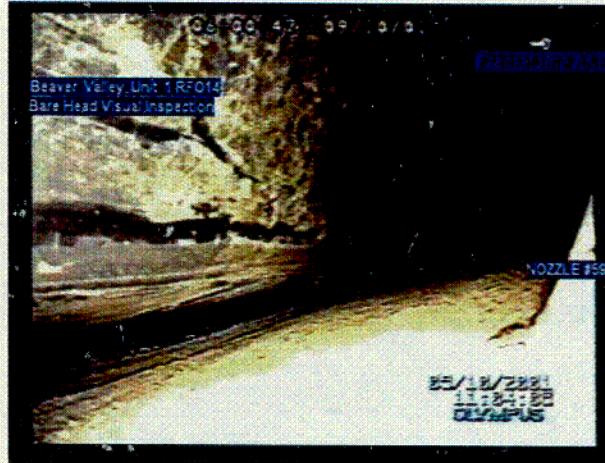
Figure 7 – Insulation Gap at Penetration #59

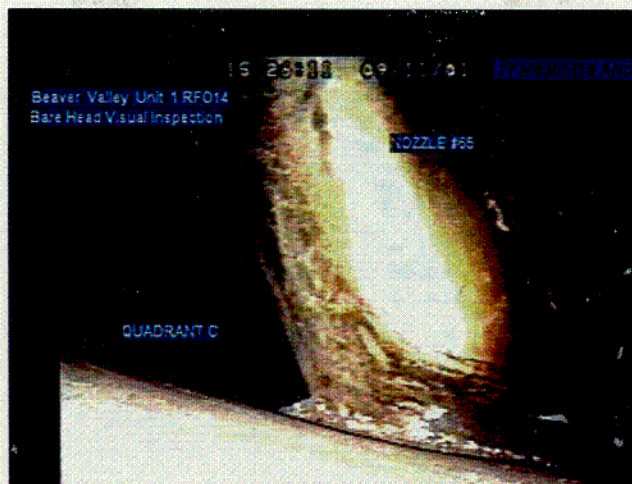
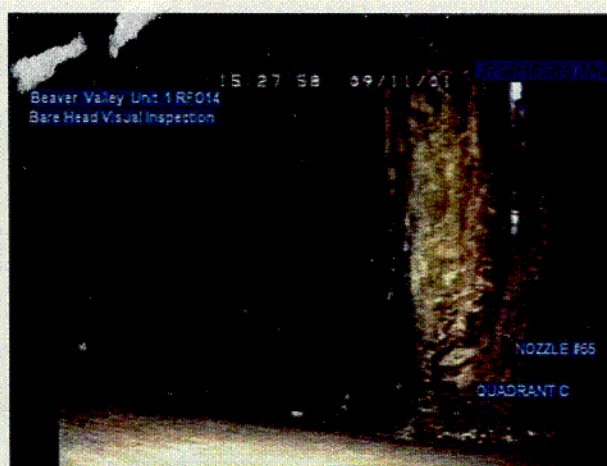
Figure 8(a) and 8(b) show the base of Penetration #65 where it meets the Reactor Vessel Head. As can be observed there is some slight accumulation of boric acid residue around the penetration. None of the accumulation has the fluffy appearance like that displayed in Figure 1. There is some small amount of gradual residue that has accumulated on the up hill side of this penetration as can be observed in Figure 8(a). It should also be noted that the staining on the sides of the penetration indicate that leakage from above has occurred in the past (see Figures 8(a) and 8(b)).

Figure 8 (a) – Penetration #65

Figure 8 (b) – Penetration #65

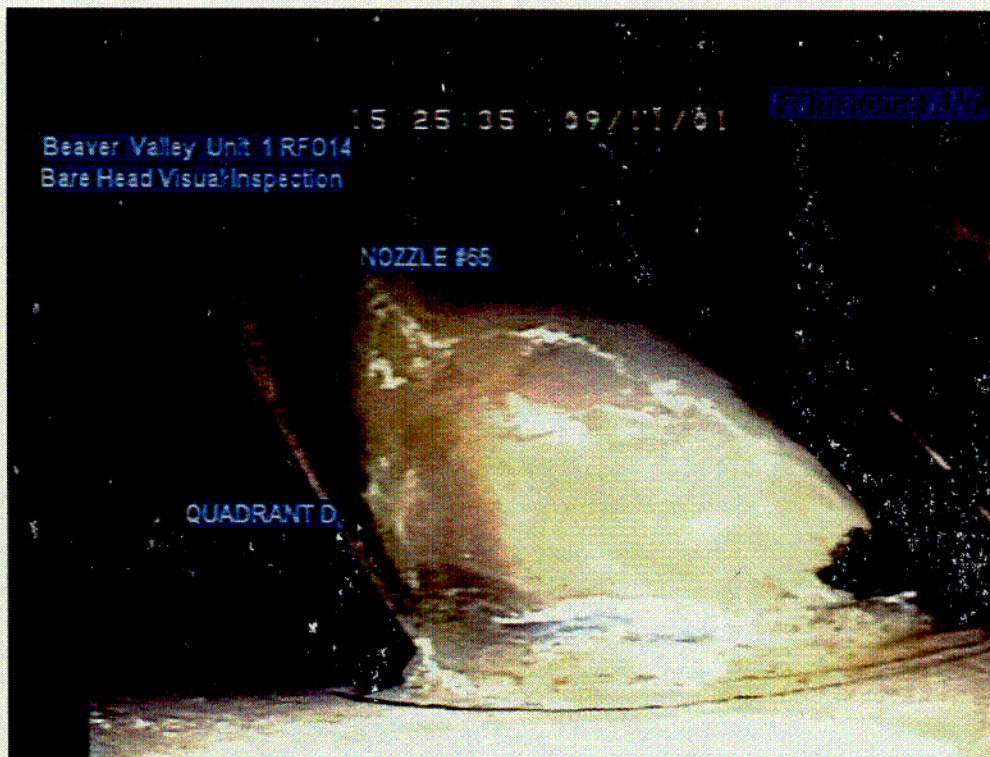
A closer inspection of the area around the base of Penetration #65, as shown in Figure 9, indicates that some corrosion wastage of the Reactor Vessel Head has occurred. The depth of this corrosion is between 1/16 inch and 1/8 inch in depth and approximately 1/2 inch in width. Wastage of this type is consistent with the damage one would expect from a borated fluid coming in contact with a hot carbon steel surface. It is concluded from the photographs of the extent of boric acid accumulations (Figure 11) found around the #2 Conoseal upon shutdown for 1R07 Refueling Outage that a significant amount of reactor coolant came in contact with the surface of the Reactor Vessel Head during the end of the power operation cycle and during shutdown prior to depressurization. It is further concluded that the corrosion wastage occurred during the shutdown process, when there was insufficient heat to boil off the water in the leaking reactor coolant prior to it coming in contact with the carbon steel Reactor Vessel Head. During this period the wastage occurred to the wetted Reactor Vessel Head surface. A review of the design analysis for the Reactor Vessel Head indicates that a minimum wall thickness for the head is 6.188 inches. During ISI inspections the actual head thickness was determined to be 6.78 inches using a straight beam Ultrasonic probe. This minor localized corrosion (0.125 to 0.200 inches) does not infringe upon the specified minimum wall thickness use for design, which includes the design margins; therefore it is concluded that this area of localized corrosion wastage does not present a structural concern.

Figure 9 – Penetration #65
Corrosion at Base of Penetration

The second conoseal leak occurred near the reactor vessel stud location #57. As a result, the #65 nozzle was affected by a flow of boric acid. Refer to the attached map for stud and nozzle location data. In this case, the boric acid seems to flow directly down the nozzle on the uphill side. As the acid flowed around the nozzle, at operating temperatures, the carbon steel of the head was affected. Erosion to a depth of less than .125 inches for about 1/2 inch around the base of the

nozzle was noted and present only at the #65 nozzle location. This does not appear to be an active mechanism.

It was recommended that following the inspection of the CRDM penetrations no cleaning of the as found condition be performed. This recommendation is based upon the following rationale; first the as found condition was recorded and can be used as a baseline for inspections to be performed during the next refueling outage; secondly, to remove the boric acid residue would result in unnecessary man-rem exposure and finally the dried boric acid residue presents no corrosion concerns and will not affect the function of the components adversely.

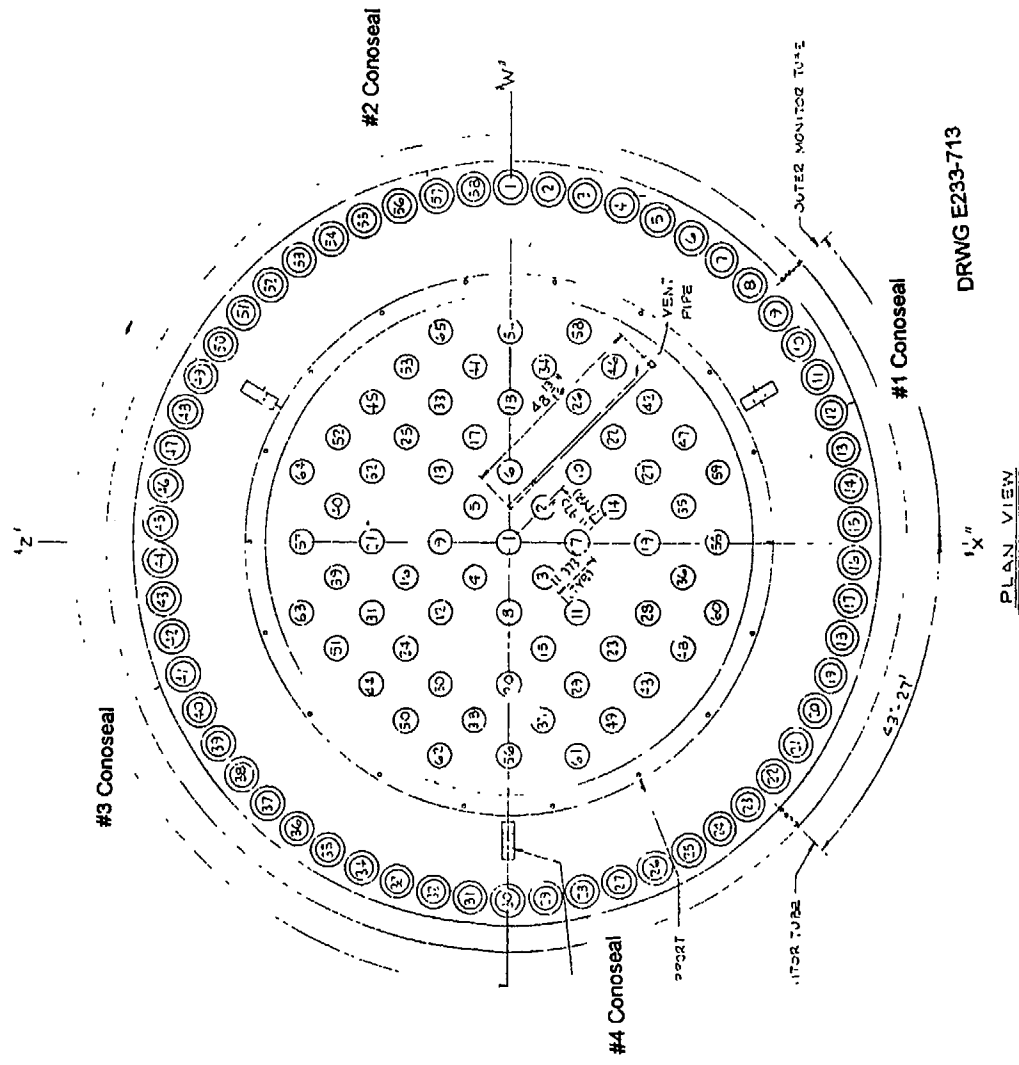
The boric acid accumulations around and on Penetrations #59 and #65 are discussed in this section. Pictures of the penetrations and the surrounding area are identified as Figures 4 thru 9. These figures will be used to illustrate the conclusions and evaluations described. Figure 10 describes the location of the Conoseals relative to the Penetrations #59 and #65. This sketch on Figure 10 shows that Penetration #59 is located near Conoseal #1 and Penetration #65 is located near Conoseal #2.
