South Texas Project Electric Generating Station P.O. Box 289 Wadsworth, Texas 77483

South Texas Project
Unit 2
Docket No. STN 50-499
Response to Request for Additional Information Regarding the
2RE08 Steam Generator Tube Voltage-Based Repair Criteria 90-Day Report

RESPONSE TO NRC REQUEST FOR ADDITIONAL INFORMATION

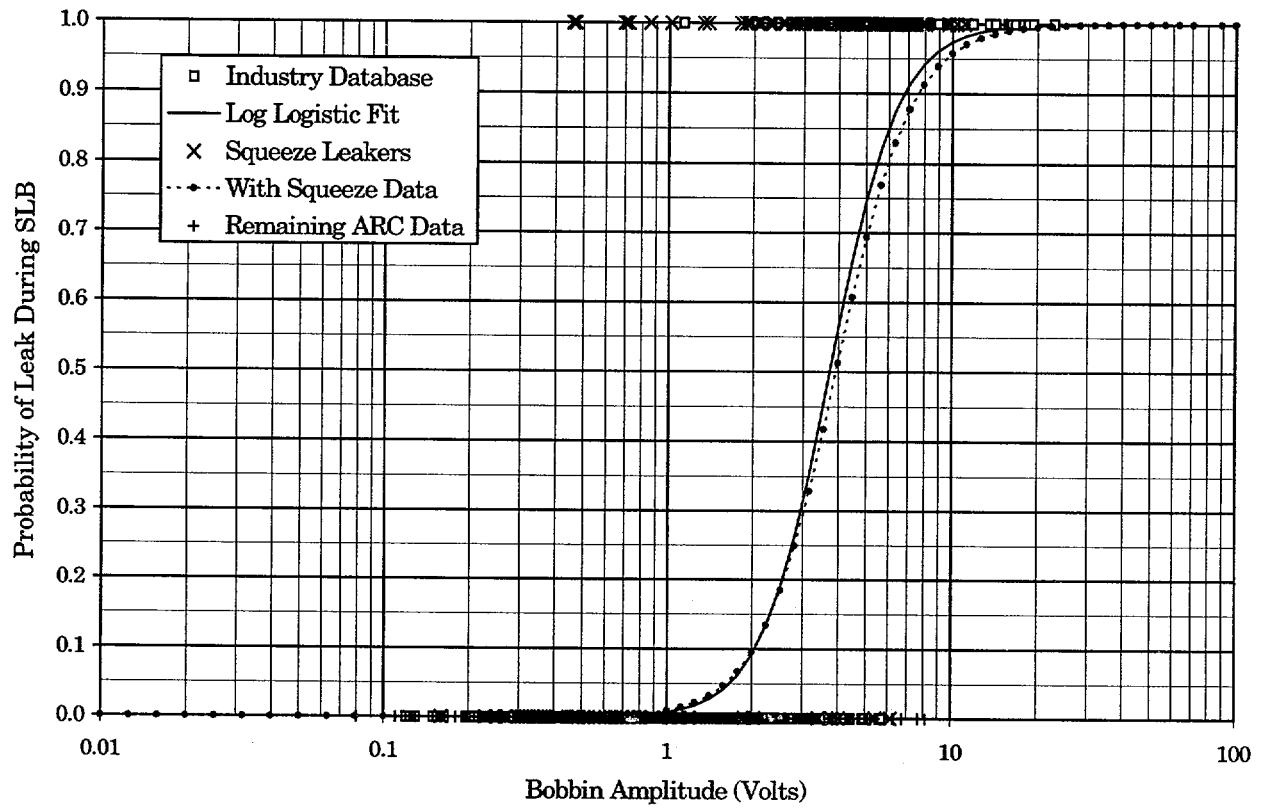
Figure 2-1: Comparison of POL Curves Using ODSCC Data

A very conservative POL evaluation was performed assuming that all tubes implied to be leaking were indeed tubes that would leak during operation, i.e., "squeeze leakers". The remaining indications found during the inspection are considered to be non-leakers. A POL regression analysis was performed using this database and the analysis results were compared to the result using the EPRI generic database of test results. Figure 2-1 illustrates the data and the results of the analysis. The specified squeeze leakers are shown with a POL of 1. The remaining indications used in the ARC analysis are shown as "+" symbols with a POL of 0. The solid line on the figure illustrates the EPRI database solution and the solution using the STP ODSCC data is shown using a dashed line. The results from this analysis support the use of the POL curve

obtained from the generic database. The two curves are in quite good agreement up to bobbin amplitudes of 2 volts. The ARC data beyond that indicate that a POL lower than that of the EPRI generic curve might be expected. A second analysis was initially considered that would assume that only the tubes actually observed to drip during the secondary side pressure test were leakers. However, given the result from the first analysis, the need for the second analysis is obviated, i.e., the match to the generic curve would only be expected to improve or confirm that the generic curve is conservative.
