THREE MILE ISLAND, UNIT 1 (TMI UNIT 1)
OPERATING LICENSE NO. DPR-50
NRC DOCKET NO. 50-289

SUBJECT: Response to NRC Staff Follow-Up Questions 1 through 4 from
November 9, 2001 Meeting Regarding a TMI Unit 1 Steam Generator
Severed Tube

**Response to NRC Follow-Up Questions from November 9, 2001 Meeting
Regarding the TMI Unit 1 Steam Generator Severed Tube**

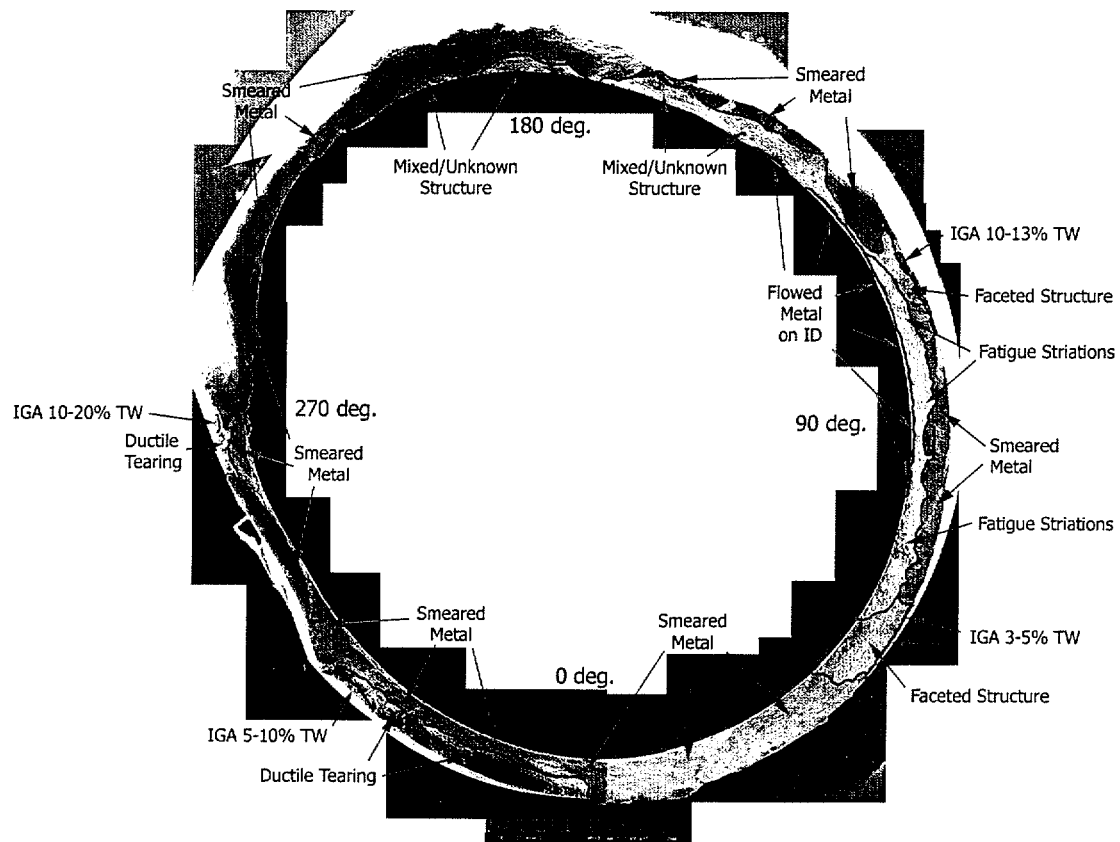
A low-magnification Scanning Electron Microscopy (SEM) mosaic of the entire fracture surface is shown in Figure 1. As can be seen in Figure 1, much of the fracture surface was smeared, or burnished, by the rubbing of the fracture surfaces against each other during the failure process. After the tube separated, additional fracture surface was lost by abrasion when the tube rubbed against the adjacent tubes. Nevertheless, it was possible to identify several regions of OD intergranular attack (ODIGA), fatigue damage, and ductile tearing. These regions of interest are identified in Figure 1. In the discussion that follows, reference is made to several SEM fractographs to illustrate the regions of specific damage. In all of the fractographs presented, the vertical orientation of the images is preserved with respect to Figure 1; i.e., the 0° reference is toward the bottom of the figure, and the 180° reference is toward the top of the figure. Rotational orientation is counterclockwise from the 0° reference.

Figure 1. SEM mosaic of fracture face of TMI-1 tube no. B66-130

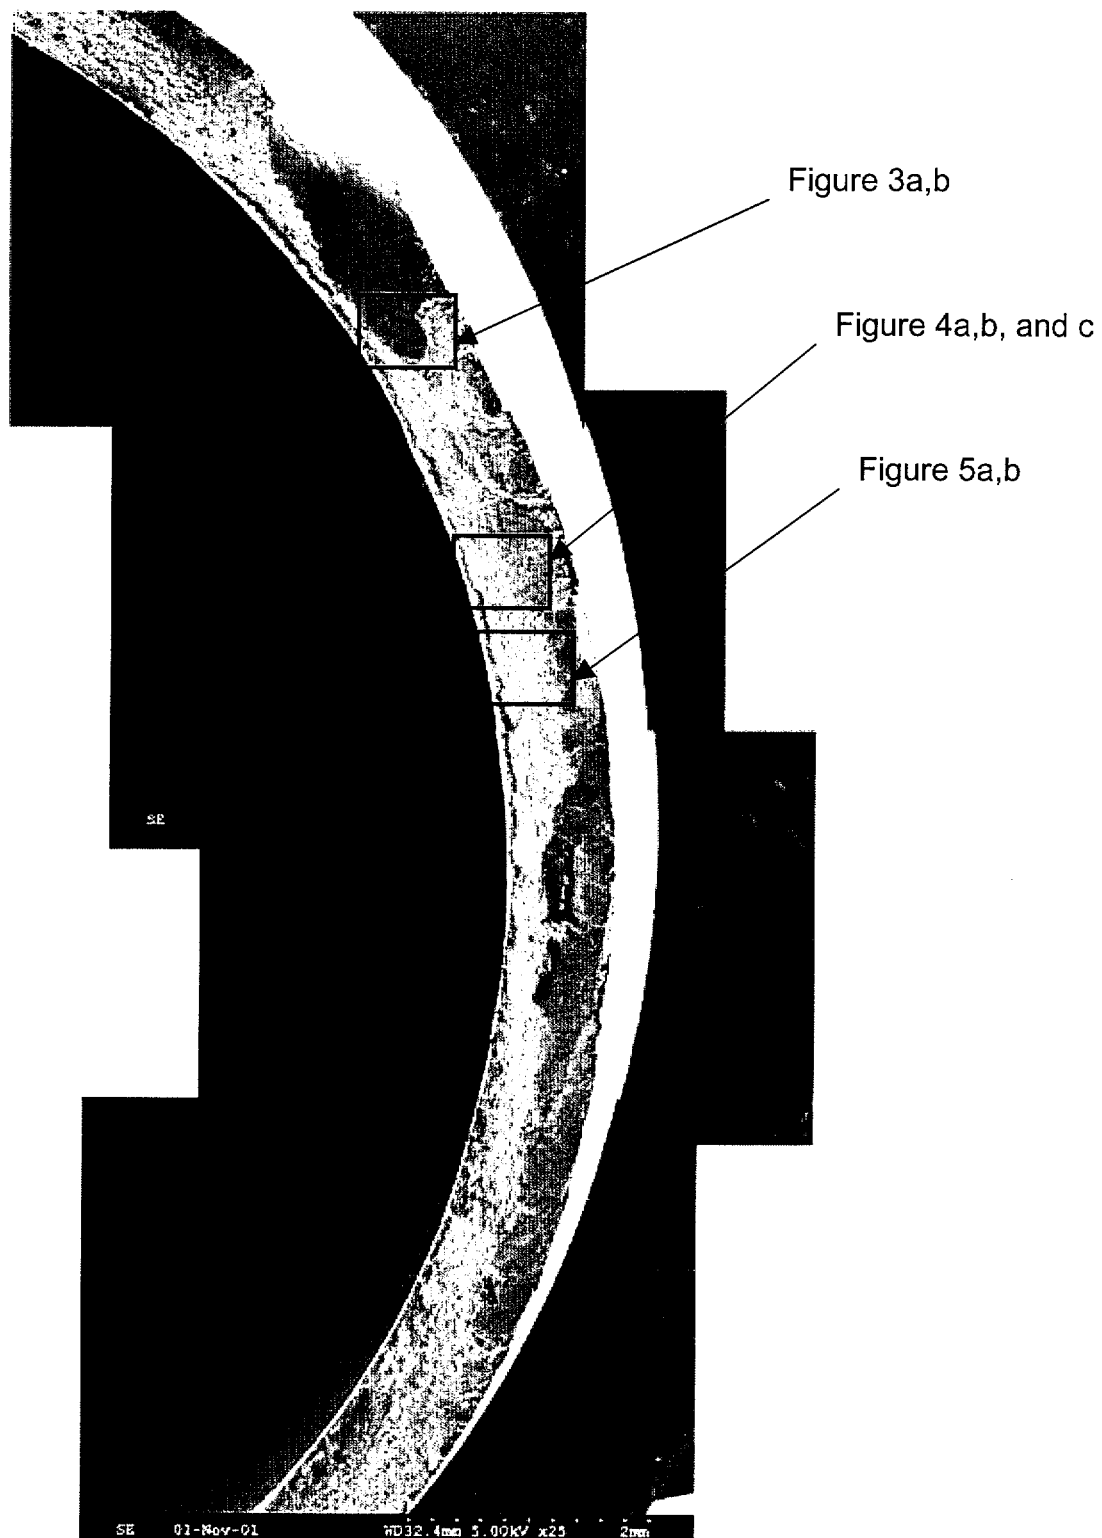
Figure 2 is an SEM mosaic of a portion of the fracture surface from ~ 45° to 135°. In this region of the fracture surface, intermittent regions of ODIGA ranging from 10 to 13% through wall were observed. A typical area of smeared, or burnished, metal can also be seen in Figure 3a. All of the areas of smeared metal are nearly featureless.

Figure 2. SEM mosaic of fracture surface from ~45 to 135 degrees

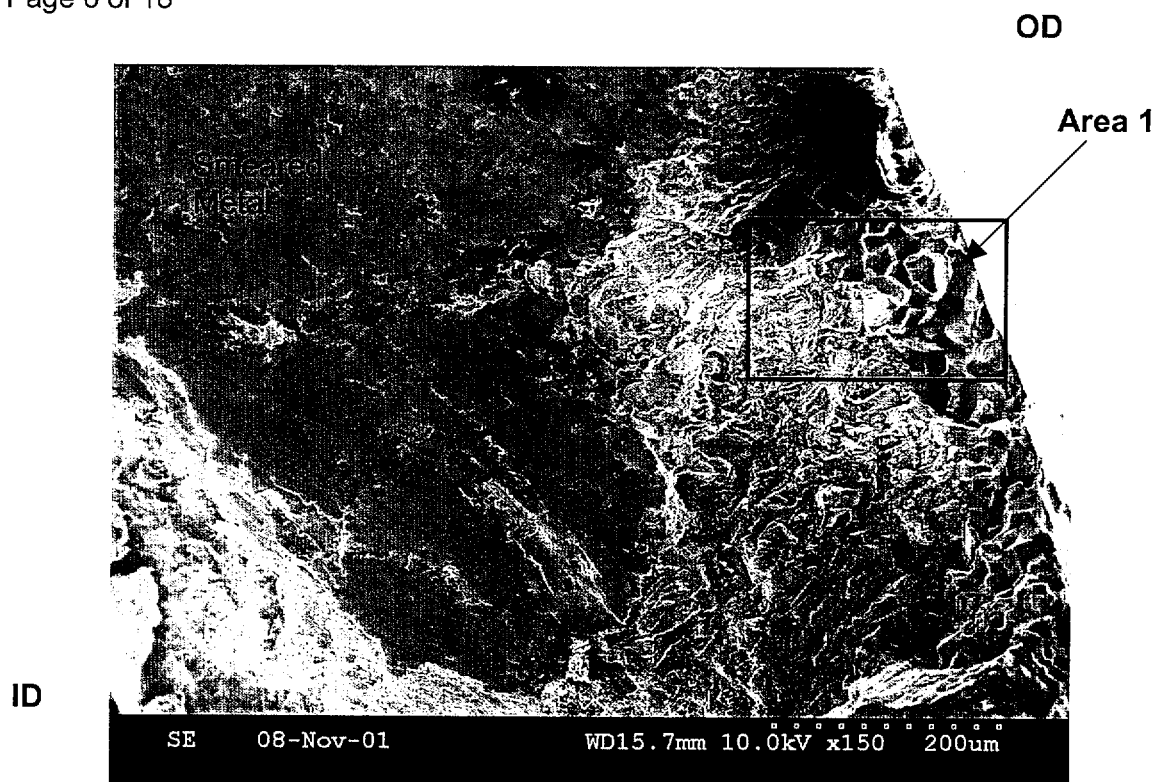
Figure 3a. Fracture surface at ~120 degrees, showing ODIGA, Stage I fatigue, and a region of smeared, or burnished, metal (150X)

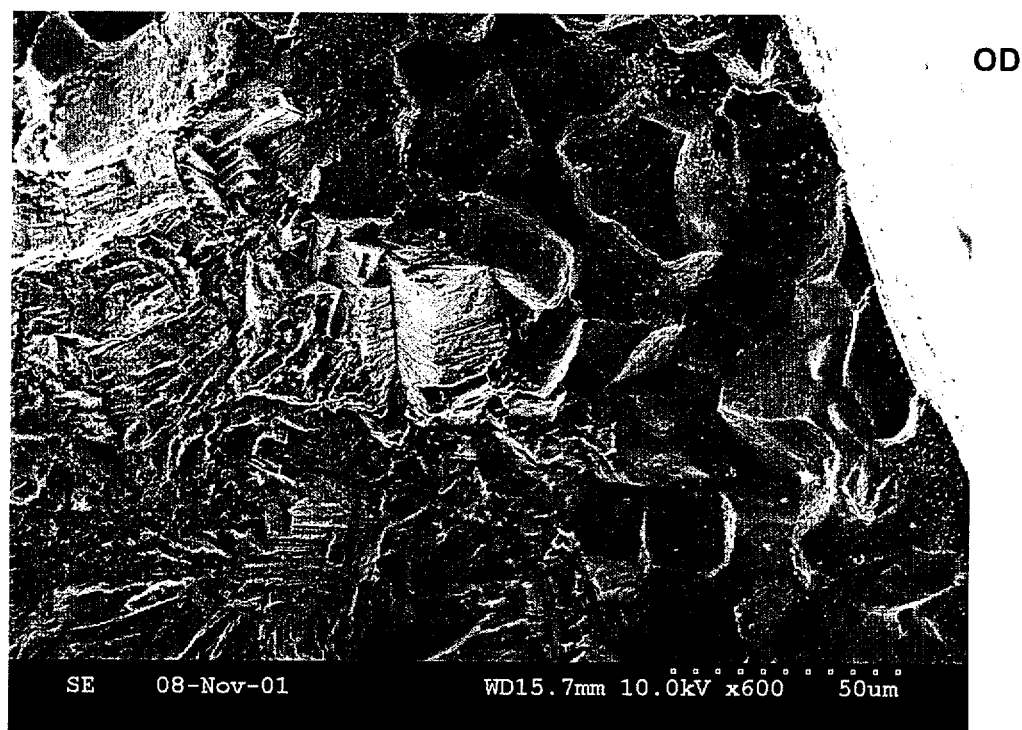
Figure 3b is a higher magnification image of Area 1 in Figure 3a, showing the ODIGA more clearly. It is postulated that this IGA was present prior to the hydraulic swelling that was experienced, as is typical for OTSG tubing in the steam space of the steam generator. The grains and adjacent fracture surface were also covered with deposited material, primarily aluminum, silicon, magnesium, and titanium. No species, such as chloride, sulfur or lead, which are known to be detrimental to Inconel 600, were detected.

Figure 3b also shows very clearly the transition from classical IGA to a blocky, faceted surface (previously described as a pueblo structure), features that are

typically associated with Stage I fatigue. In addition to a crystallographic fracture topography, another characteristic of Stage 1 fatigue is the presence of a smooth or burnished surface caused by rubbing of the bottom and top of the crack. Such rubbing would account for the areas of smeared metal mentioned earlier.

Figure 3b. Area 1 in Figure 3a, showing transition from ODIGA to Stage I fatigue (600X)

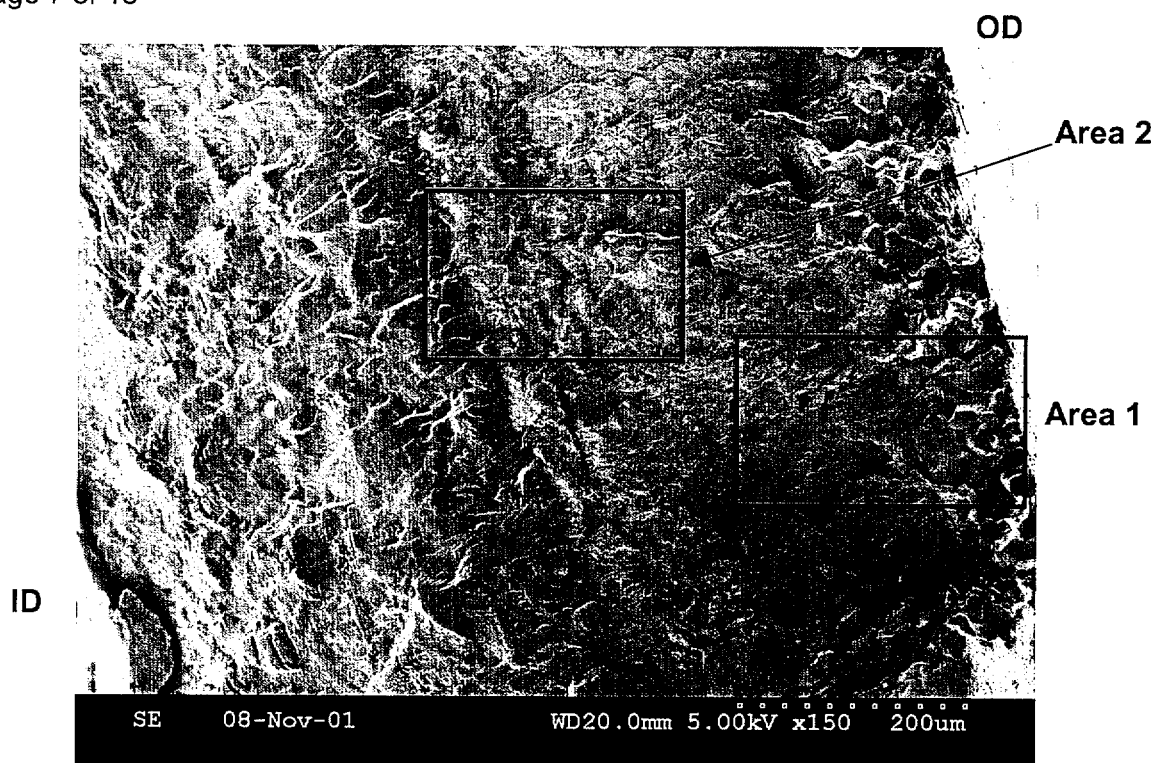
A similar transition from IGA to Stage I fatigue can be seen in Figures 4a – c, from an area of the fracture surface at ~100 degrees. These observations are strong evidence that fatigue cracking initiated from regions of ODIGA where the stress intensity was at or near the threshold stress intensity factor. This initial fatigue crack was propagated initially by a high cycle, low stress fatigue mechanism. The rate of propagation during this stage of fatigue is not known, but is typically slow as compared to Stage II fatigue. The full circumferential extent of Stage I fatigue is also not known due to the extensive mechanical damage experienced; however, it is likely that the regions of smeared metal were also Stage I fatigue.

Figure 4a. Fracture surface at ~100 degrees (150X)

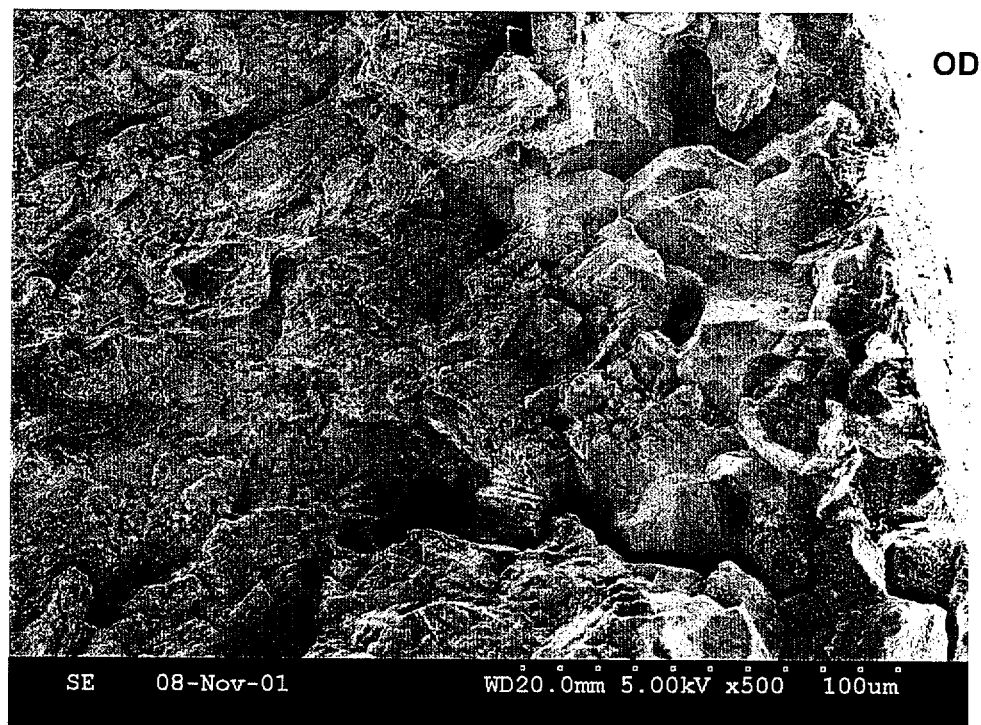
Figure 4b. Area 1 in Figure 4a, showing transition from ODIGA to Stage I fatigue (500X)

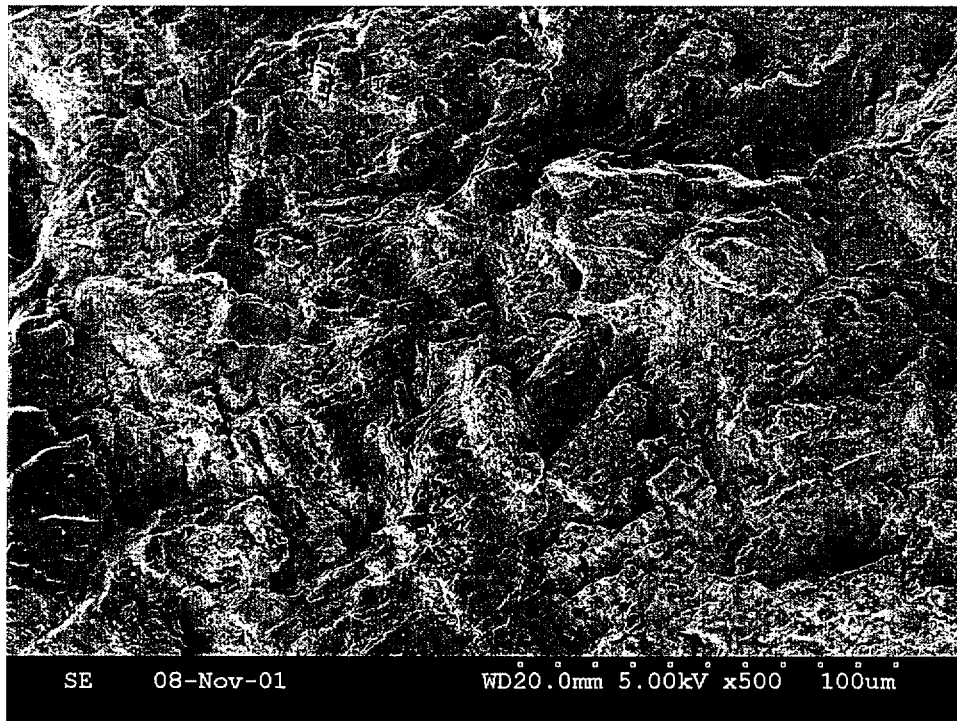
Figure 4c. Area 2 in Figure 4a, showing features of Stage I fatigue (500X)

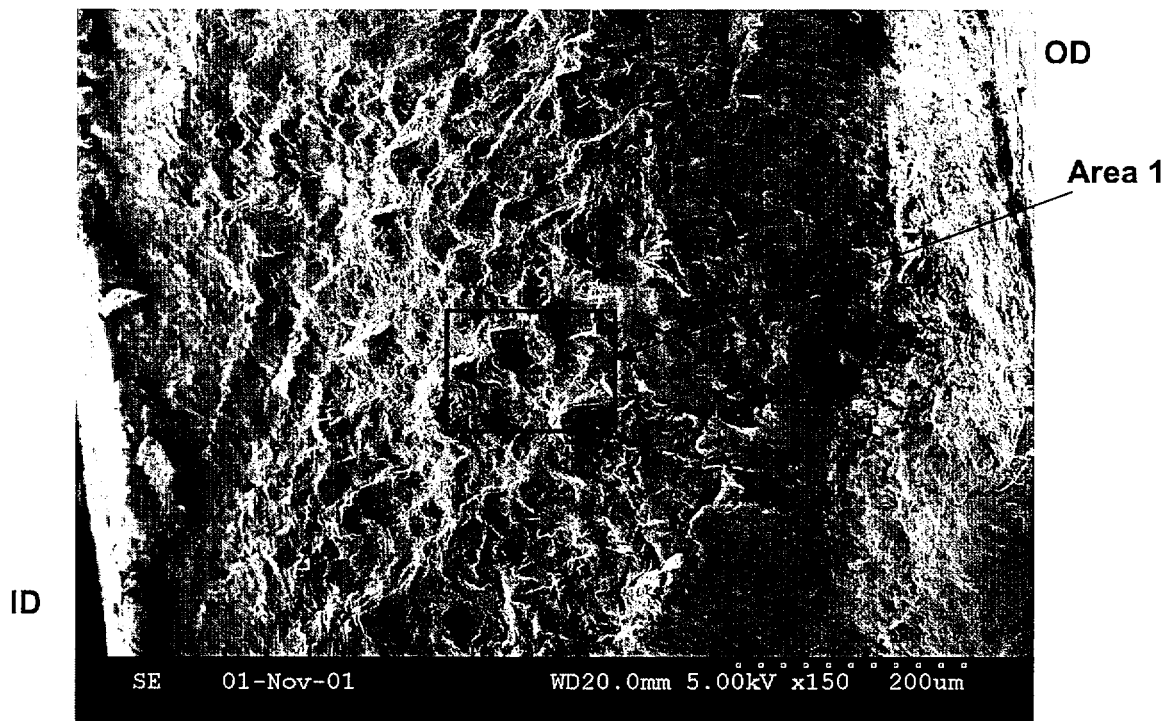
As can be seen in Figures 4a and 5a, the appearance of the fracture surface changes at approximately mid-wall from the granular, faceted surface characteristic of Stage I fatigue to a rippled, clamshell surface typical of Stage II fatigue. A higher magnification image of this area is shown in Figure 5b. Within these clamshell areas, or beachmarks, are numerous fatigue striations spaced on the order of 1.7 – 2.4 microns apart. These features are typical of Stage II fatigue, where each striation represents a step advance in the crack front under the influence of alternating and increasing tensile stress. As indicated in Figure 5b, the direction of crack propagation was radially inward toward the ID. The reduced cross sectional area of the tubing would have caused the increase in applied stress as the crack grew during the initial Stage I fatigue. The rate of propagation in this regime of fatigue would be quite rapid, progressing to the ID in seconds.

Figure 5a. Fracture surface at ~95 degrees, showing change in fatigue propagation from Stage I to Stage II (150X)

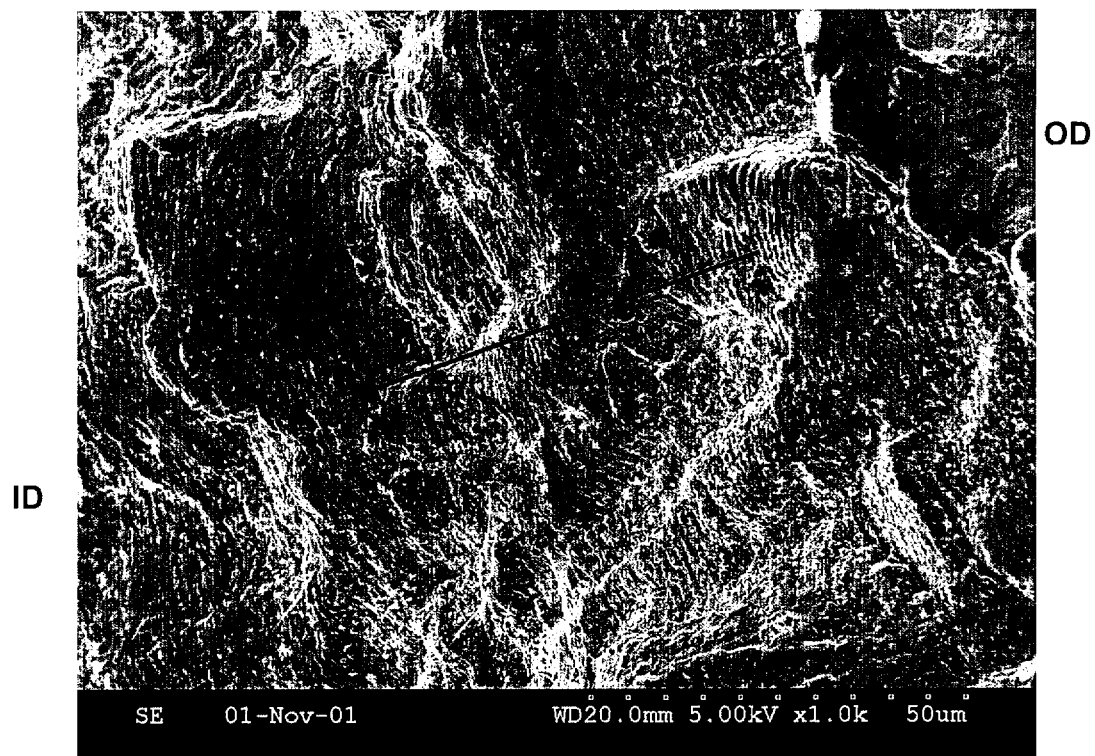
**Figure 5b. Area 1 in Figure 5a showing Stage II fatigue striations (1000X).
The arrow indicates the direction of fatigue crack propagation.**

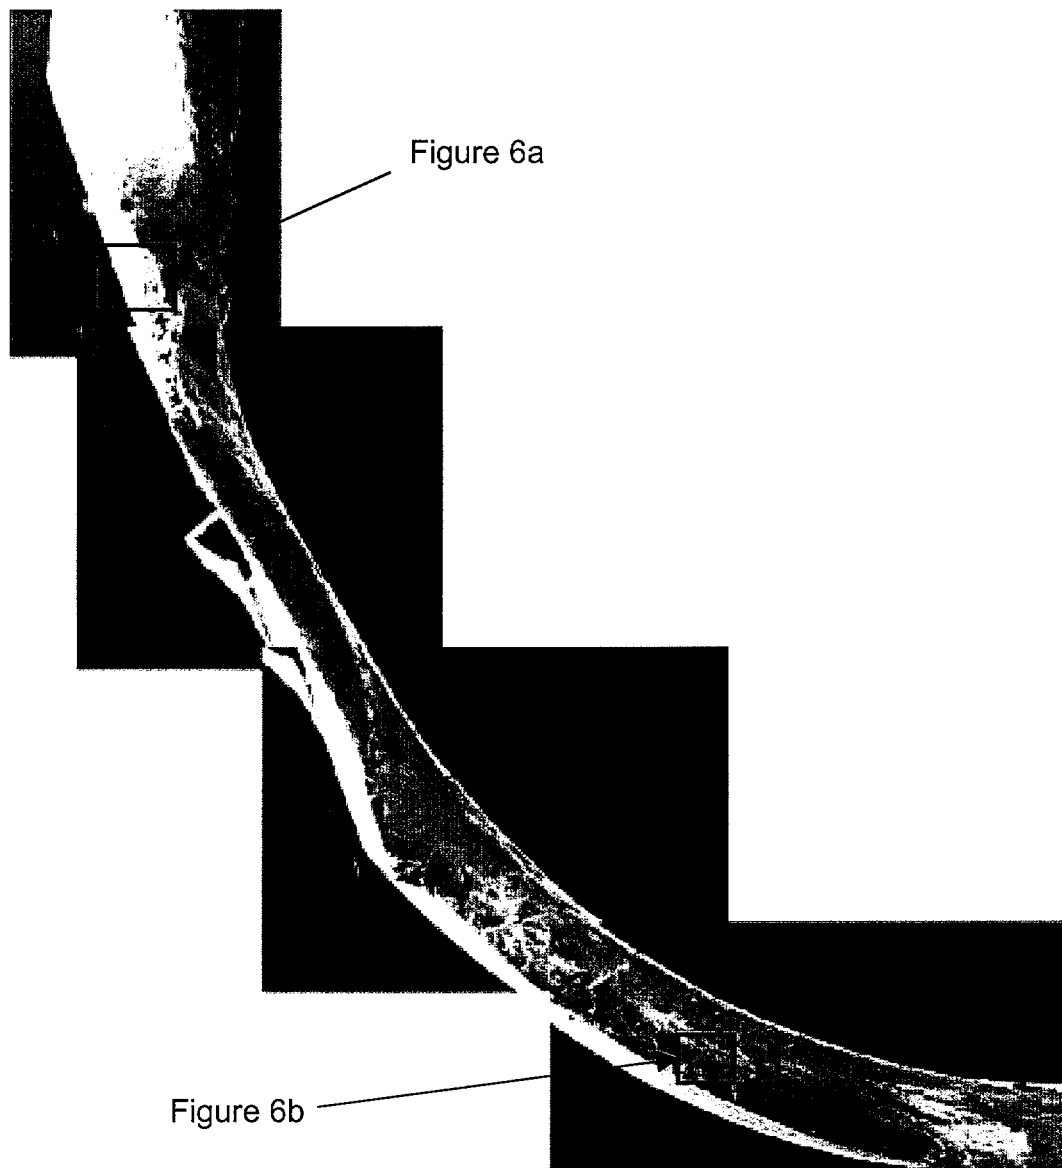
The ultimate failure that resulted in separation of the tube was by tensile overload of remaining ligaments as the tensile strength was exceeded. Two clear areas of ductile failure were observed on the fracture surface between ~270 to 360 degrees (Figure 6). One of these regions was located adjacent to ODIGA at ~250 – 270 degrees, as shown in Figure 6a. The dimensions of this ductile area were 1 mm x 0.2 mm. The most prominent observable ductile region occurred from essentially the tube OD to the tube midwall from ~330 to 360 degrees. This area is shown in Figure 6b. Smeared metal obscured the area between the midwall and the tube ID.

Figure 6. SEM mosaic of fracture surface from ~270 to 360 degrees

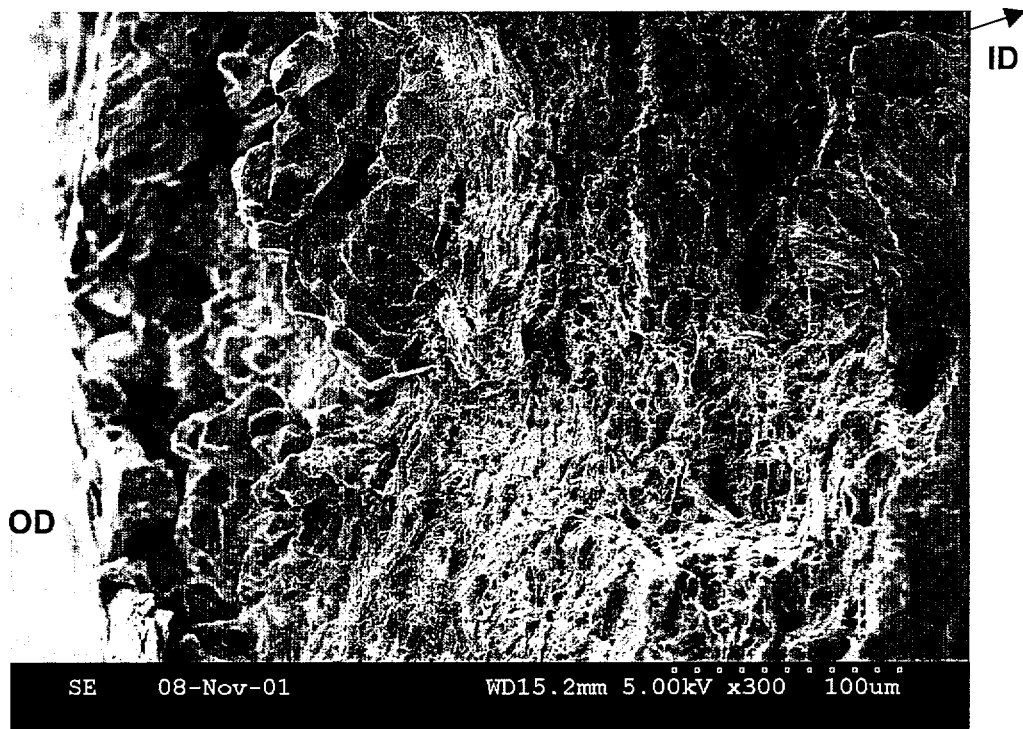
Figure 6a. Region of ODIGA (~20% TW) and adjacent area of ductile tear 300X)

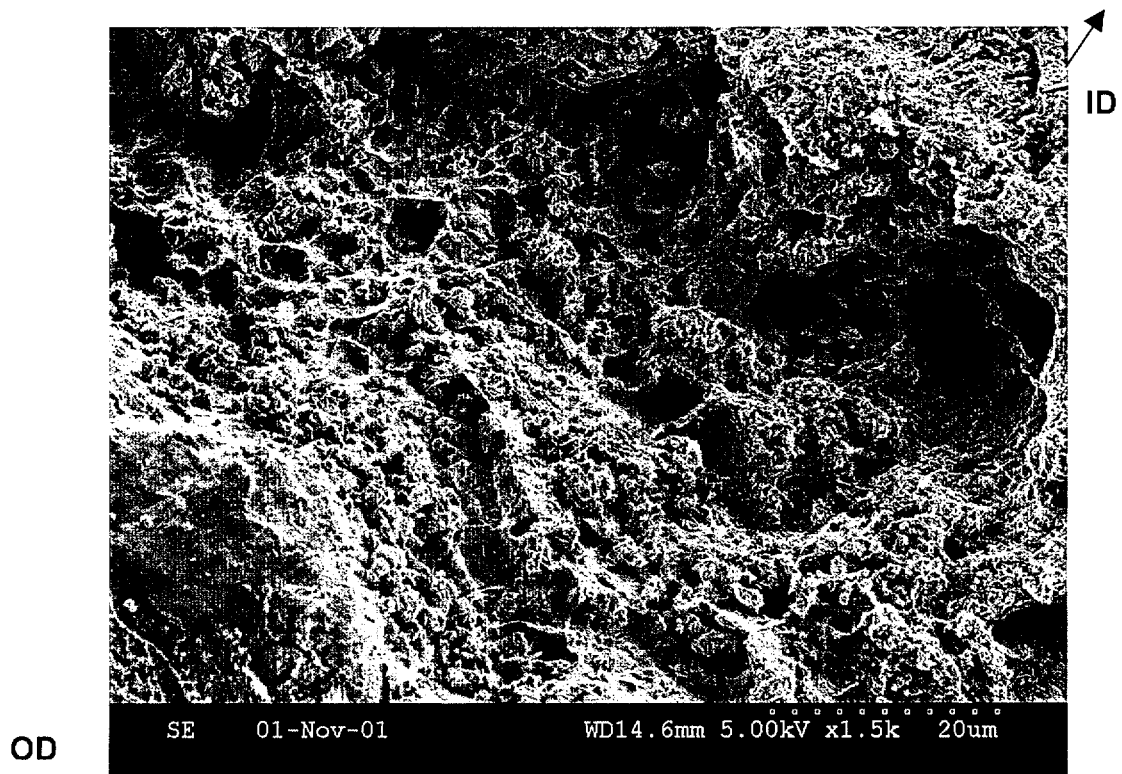
Figure 6b. Region of ductile failure at ~330 degrees (1500X)

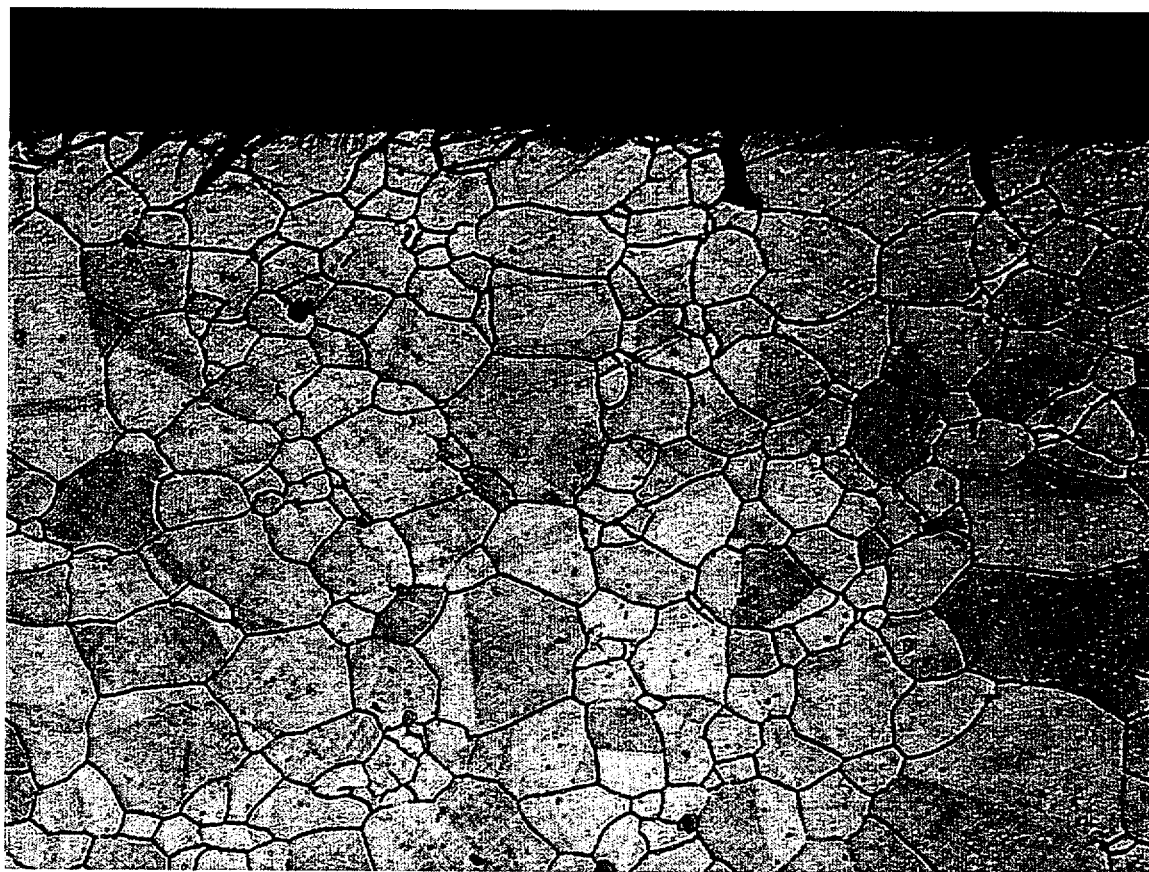
A sample of tubing removed from approximately 13 – 27 inches below the upper tube sheet face, tube 65-130, was hydraulically swelled approximately 8.6% from 0.626 to 0.680 inches OD at a pressure of 9,784 psi. A photomicrograph of the expanded portion of the tube shows shallow ODIGA 1-2 grains deep (Figure 1). This is typical for tubing in the steam space of B&W OTSGs. No other microstructural anomalies were observed and the microstructure is typical of sensitized Alloy 600 tubing, with carbide decoration of the grain boundaries.

Figure 1. Etched cross-section of expanded section of tube no. 65-130 showing the presence of ODIGA (500X)

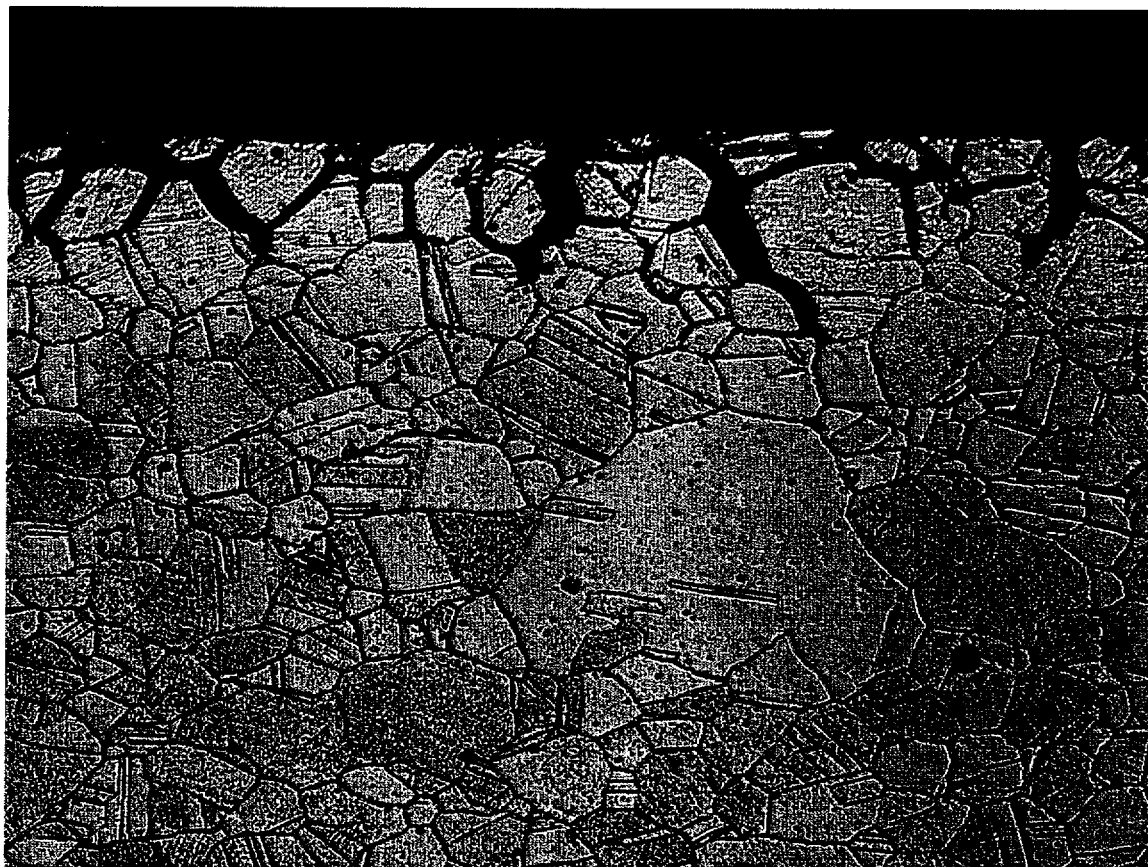
- ODIGA on the non-severed tubes was typical for OTSG tubing in the steam space and was approximately 1-2 grains deep, as described above.
- ODIGA of the severed tube was also 1-2 grains deep with an occasional penetration to 3-4 grains deep (Figure 2). As can be seen in Figure 2, some "twinning" of grains occurred as a result of plastic deformation caused by the over-pressurization event. Such twinning can occur during a high rate of stress loading and increases the resistance of the material to further plastic deformation.

Figure 2. Etched cross-section of severed tube no. 66-130 showing grain twinning and the presence of ODIGA (500X).
