Florida Power
A Progress Energy Company

Crystal River Nuclear Plant
Docket No. 50-302
Operating License No. DPR-72

Subject: LICENSEE EVENT REPORT (LER) 50-302/01-004-00

1. FACILITY NAME				2. DOCKET NUMBER			3. PAGE		
CRYSTAL RIVER UNIT 3				05000 302			1 OF 9		
4. TITLE									
Reactor Pressure Vessel Head Leakage Due to Control Rod Drive Mechanism (CRDM) Nozzle Degradation

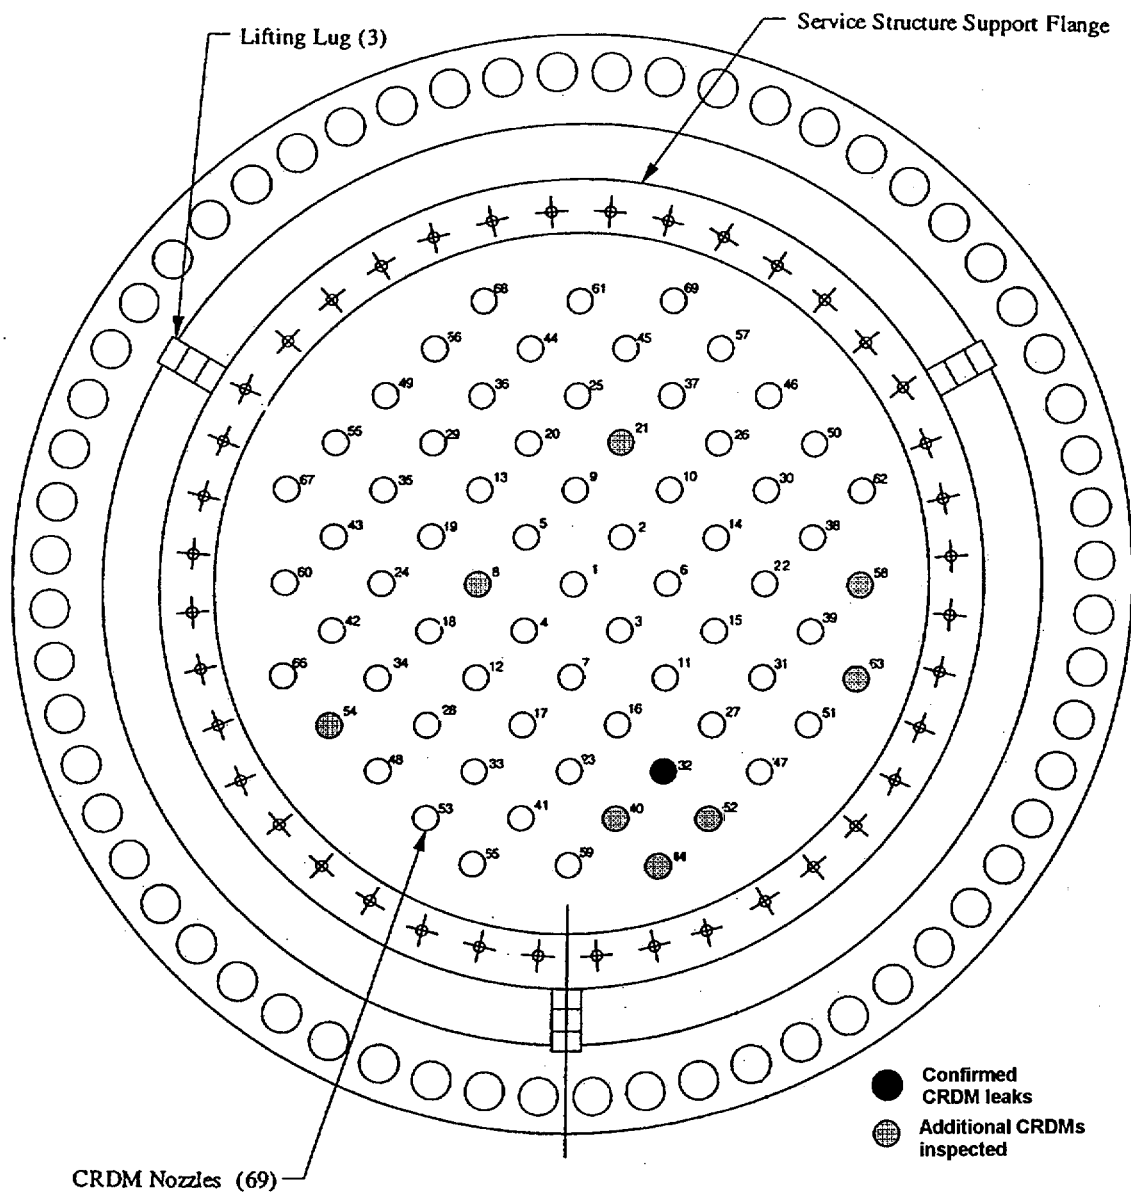
Figure 1

There are 69 Control Rod Drive Mechanism (CRDM) nozzles [AB, NZL] that penetrate the Reactor Vessel Head (RVH) [AB, RCT] (see Figure 1). The CRDM nozzles are approximately 5 feet long and are welded to the RVH at various radial locations from the centerline of the RVH. The nozzles are constructed from 4 inch outside diameter (OD) alloy 600 material. The lower end of the nozzle extends about 6 inches below the inside of the RVH.

At 1300, on October 1, 2001, Florida Power Corporation's (FPC's) Crystal River Unit 3 (CR-3) was in MODE 5 (COLD SHUTDOWN) at 0 percent RATED THERMAL POWER. While performing a qualified^[1] visual inspection of the RVH, FPC personnel identified one potential leaking CRDM nozzle (nozzle #32), as evidenced by a buildup of boric acid crystals at the intersection of the nozzle with the RVH. No other CRDM nozzles inspected revealed a similar buildup. The RVH inspection was performed as part of Generic Letter 88-05, "Boric Acid Corrosion of Carbon Steel Reactor Pressure Boundary Components in PWR Plants," program and to satisfy a commitment made by FPC in response to NRC Bulletin 2001-01, "Circumferential Cracking of Reactor Pressure Vessel Head Penetration Nozzles."

At approximately 1748, on October 8, 2001, CR-3 was in MODE 6 (REFUELING) at 0 percent RATED THERMAL POWER. Ultrasonic testing (UT) examination performed on nozzle #32 revealed two through-wall axial cracks extending from the bottom of the nozzle, terminating above the J-groove weld. These cracks confirm that the boron deposits around CRDM nozzle #32 were indicative of a Reactor Coolant System (RCS) [AB] pressure boundary leak. This condition is consistent with industry experience with primary water stress corrosion cracking (PWSCC) in similar components that have been evaluated as part of Generic Letter 97-01, "Degradation of Control Rod Drive Mechanism Nozzle and Other Vessel Closure Head Penetrations," and NRC Bulletin 2001-01. The results of the UT examination of CRDM nozzle #32 are provided in the table below:

As indicated in the above table, the UT data indicated the presence of five recordable indications including two (2) axially oriented cracks (flaw 3 and 4) that were through-wall, and extended from the bottom of the nozzle through and above the J-groove weld. These cracks originated at the weld-to-nozzle interface, propagated downward to the end of the nozzle, and upward through the weld into the annular space between the nozzle and the head. These two axial cracks were the primary source of leakage. These two cracks then joined a circumferential crack (flaw 5) on the OD of the nozzle above the weld. The circumferential crack (flaw 5) above the weld extended about 90 degrees and was approximately 50% through-wall. The UT identified one circumferential crack (flaw 1) below the weld. Flaw 1 extended for about 30 degrees and was within 0.15 inch of the inner diameter (ID) (approximately 75% through-wall).

The cause for the cracks observed in CRDM nozzle #32 is due to PWSCC. This conclusion is based on previous material, fabrication, and operating evaluations that have been performed, the results of the visual and ultrasonic examinations, and comparison of the flaws in nozzle #32 to similar flaws at other units. Alloy 600 and alloy 182 materials are susceptible to PWSCC.

Eight (8) CRDM's that were removed to support CRDM maintenance activities were inspected using UT. The locations of the eight additional nozzle inspections were 8 (L2), 21 (G5), 40 (G13), 52 (E13), 54 (O11), 58 (B8), 63 (B10), and 64 (F14). The results of the additional UT's indicated that there were no recordable indications in the eight CRDM nozzles inspected.

Nozzle #32 was repaired using the ambient temperature temper bead repair technique as described in CR-3 Relief Request 01-0002-RR. The final weld was examined using liquid dye penetrant and UT. No recordable indications were found. An in-service leakage test was performed in accordance with plant procedures. The plant conditions were normal operating pressure and temperature. No evidence of leakage was noted following a four-hour hold. Operability of the CRDM in nozzle #32 was confirmed during plant start-up in accordance with existing plant procedures.
