SHEARON HARRIS NUCLEAR POWER PLANT UNIT 1  
DOCKET NO. 50-400  
LICENSE NO. NPF-63  
LICENSEE EVENT REPORT 2001-003-00

<b>TITLE (4)</b> 1A-SA Residual Heat Removal Suction Line Debris - Nonconforming Condition											
<b>EVENT DATE (5)</b>			<b>LER NUMBER (6)</b>			<b>REPORT DATE (7)</b>			<b>OTHER FACILITIES INVOLVED (8)</b>		
MO	DAY	YEAR	YEAR	SEQUENT IAL NUMBER	REV NO	MO	DAY	YEAR	FACILITY NAME	DOCKET NUMBER	
10	8	01	2001	- 03	- 00	11	27	2001		05000	
<b>OPERATING MODE (9)</b>			<b>THIS REPORT IS SUBMITTED PURSUANT TO THE REQUIREMENTS OF 10 CFR '': (Check all that apply) (11)</b>								
0			20.2201(b)			20.2203(a)(3)(i)			50.73(a)(2)(i)(C)		
0			20.2201(d)			20.2203(a)(3)(ii)			50.73(a)(2)(ii)(A)		
0			20.2203(a)(1)			20.2203(a)(4)			50.73(a)(2)(ii)(B)

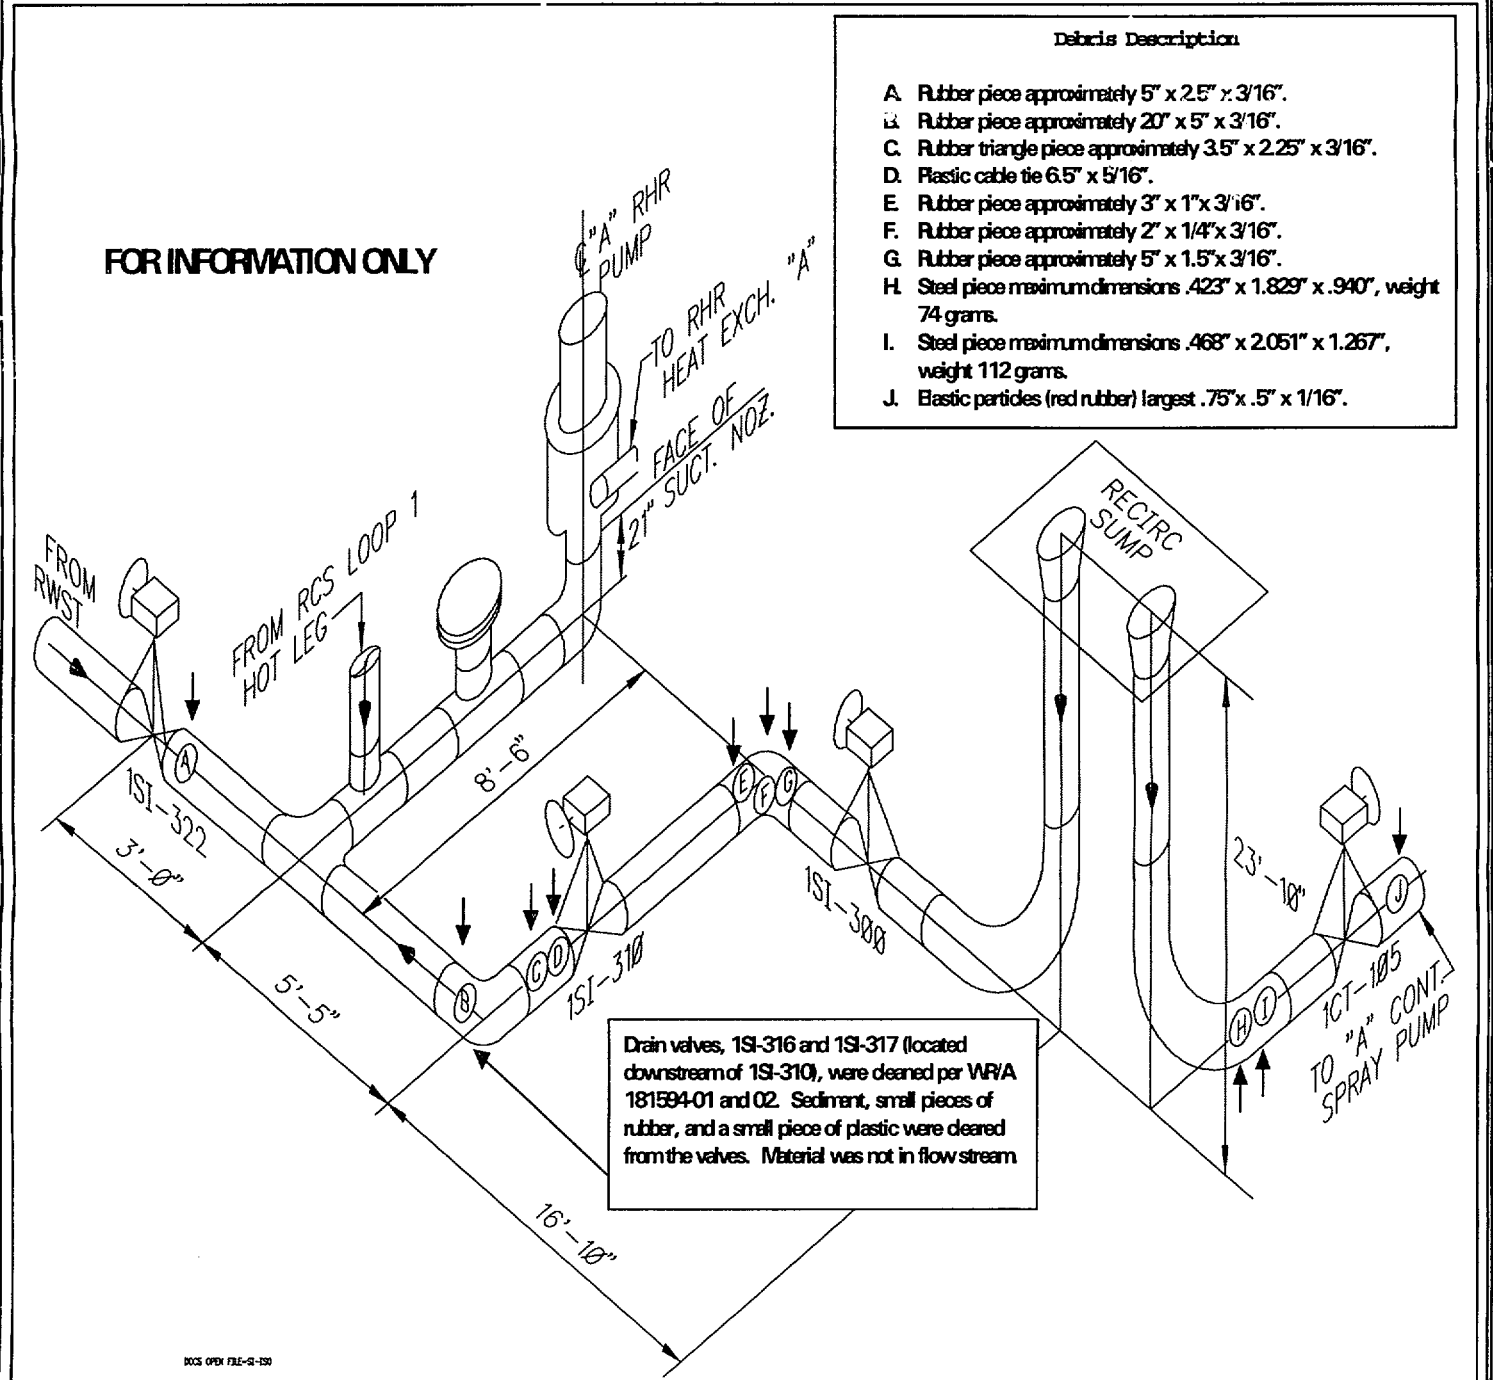
Figure 1

Additional piping inspections requested by the Root Cause Investigation (RCI) Team discovered additional rubber pieces, two pieces of metal, and some small elastic particles in A RHR and A CT Systems (see Figure 1). All foreign material was removed and system piping was inspected by a video camera. A past operability determination of A RHR resulted in the system being inoperable with the debris in the piping. A separate operability determination concluded that Containment Spray (CT) system operability was not affected. The redundant Containment recirculation sump for 1B-SB train was also inspected and no significant debris was found in that sump or the suction lines for the 1B-SB RHRP or 1B-SB CT Pump. Laboratory analysis, and RCI Team research could not determine the exact time or event that introduced this foreign material. Five entry opportunities were identified from construction of plant (1987) to time of discovery in RFO-10 (2001).
