Crystal River Nuclear Plant
Docket No. 50-302
Operating License No. DPR-72

Subject: Crystal River Unit 3 - Information Requested in Item 5 of NRC Bulletin 2001-01,
"Circumferential Cracking of Reactor Pressure Vessel Head Penetration Nozzles"

**Crystal River Unit 3
Information Requested in Item 5 of NRC Bulletin 2001-01,
“Circumferential Cracking of
Reactor Pressure Vessel Head Penetration Nozzles”**

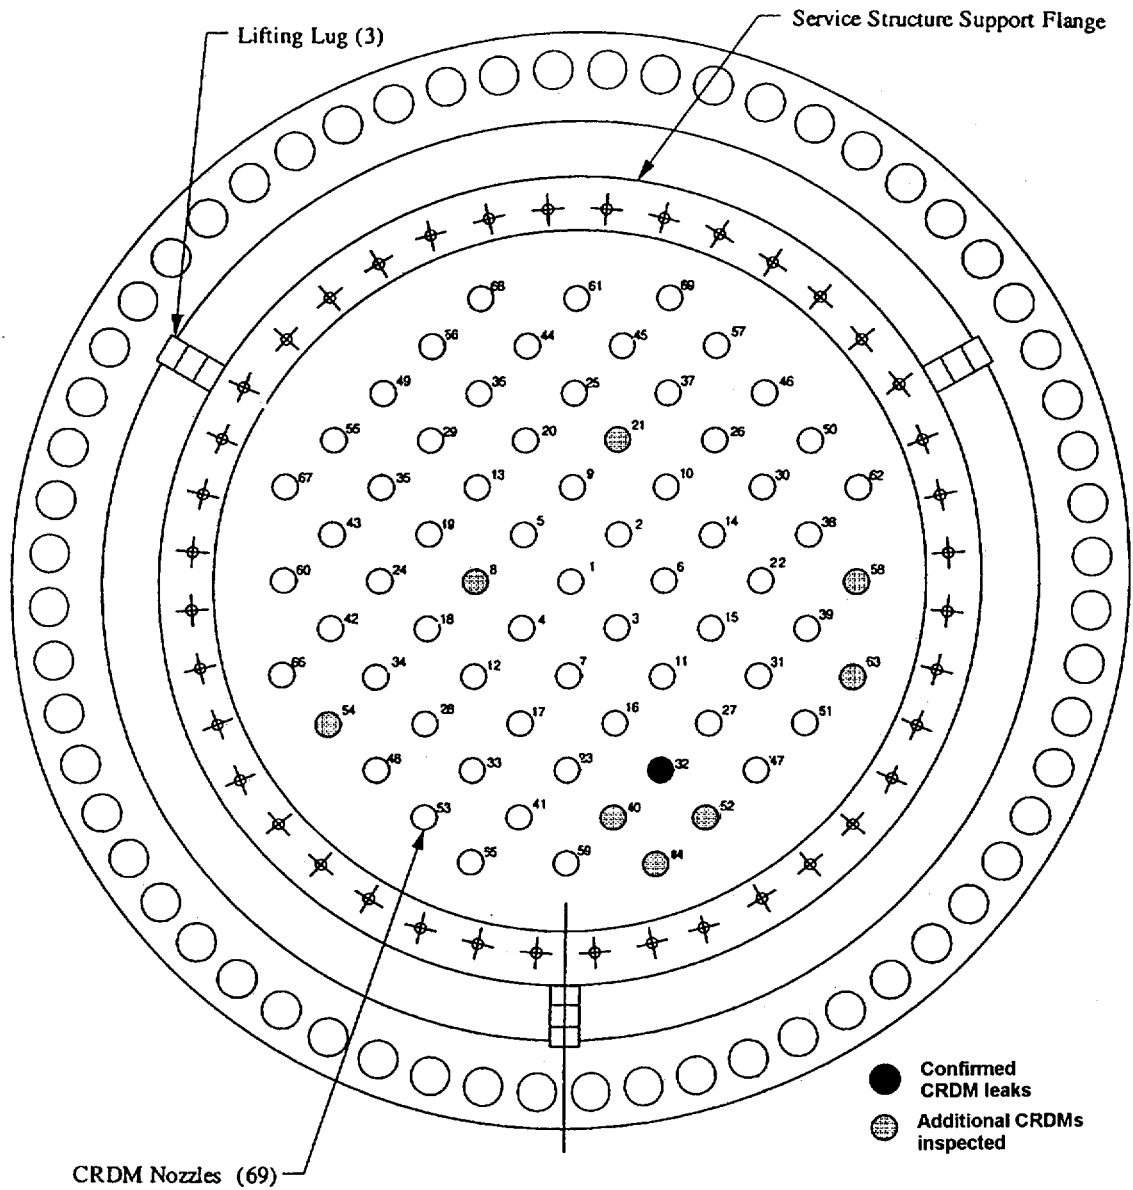
FIGURE 1

The results of the visual inspection indicated that there was one nozzle (#32) with a potential through-wall crack based on boric acid crystal accumulation. As a result of the visual inspection, the CRDM mounted on nozzle #32 was removed to support an Ultrasonic Examination (UT) of the CRDM nozzle base material. The UT probes were deployed using the Babcock & Wilcox Owners Group (B&WOG) Top-down tooling.

- 1) All nozzles on the CR3 head are the same material type, heat, and batch number (M1228-3).
- 2) Three nozzles (#40, #52 and #64) are located adjacent to the affected nozzle (#32). This will determine if there is a local phenomena affect. Two of these three nozzles (#52, #64) are also located on the peripheral row that has a greater residual stress component.

- 3) There are two other nozzles (#54, #63) located on a peripheral row and one nozzle (#58) in the same row, which would sample nozzles in different quadrants.

- 4) One nozzle (#8) is located within one row of the center and the final nozzle location (#21) is located in the third row from the center. These locations would sample different residual stress levels, different quadrant locations, different radial location, and therefore different stress components.

Reactor Vessel Closure Head Map
