DOCKET 50-305
OPERATING LICENSE DPR-43
KEWAUNEE NUCLEAR POWER PLANT
REPORTABLE OCCURRENCE 2001-005-00

LICENSEE EVENT REPORT (LER)

Unanalyzed Condition: Non-Safety Related Service Water Header Flows Affects Safety Related Components

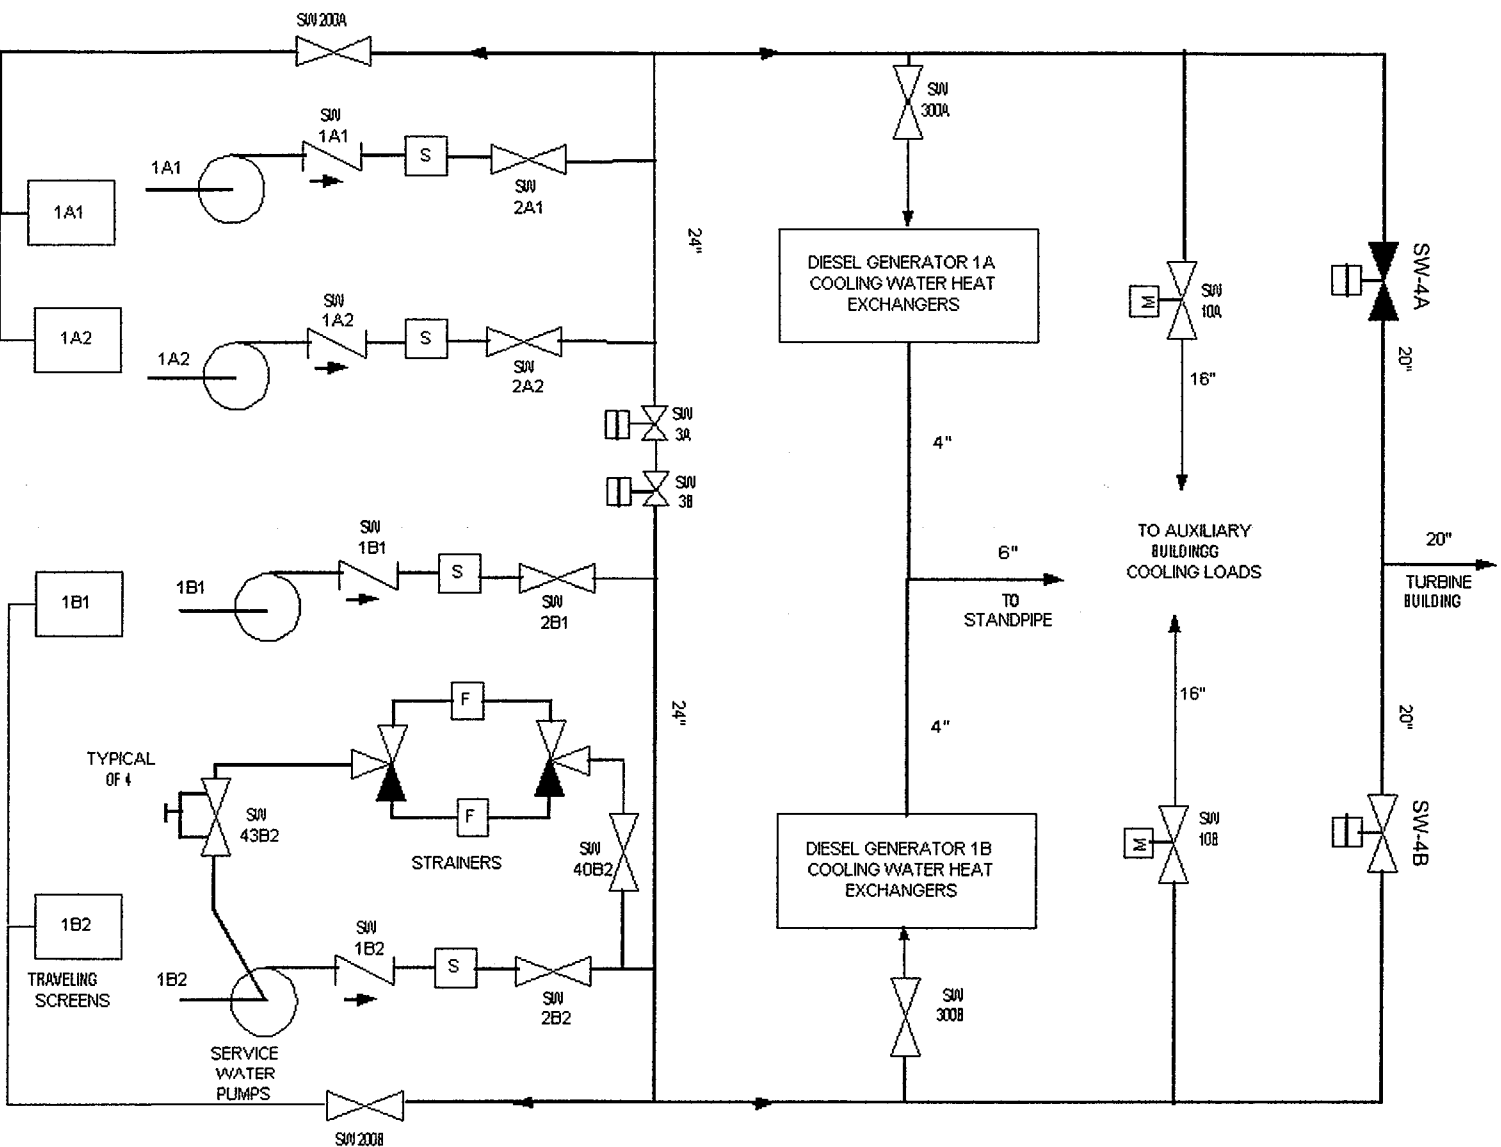
Figure 1: Simplified SW Sketch

As shown in Figure 1, the turbine building SW header is supplied through one of two remotely operated butterfly valves, SW-4A and SW-4B from the 'A' and 'B' SW header, respectively. During normal operation, only one valve may be open at a time; however, both valves can be in the closed position concurrently. The turbine building service water header valves are arranged such that they fail as-is on loss of instrument air. Sufficient compressed air is stored within a Class I accumulator for each turbine building header valve to permit valve closure following a loss of instrument air. Additionally, under a loss of off-site power (LOOP) condition, the ability to close valves SW-4A and SW-4B remains operable since power to the valve control circuit is provided by safety related battery backed instrument inverters and buses.

Prior to entering the scheduled refueling outage, and while the plant was removed from service on September 23, 2001, operating flow and temperature data was obtained for the non-safety related Service Water (SW) system [KG] header in the turbine building. However, after reviewing the 2001 test data, Nuclear Management Company (NMC) personnel determined that the analyzed SW flow of 2000 gpm to the turbine building may be exceeded under postulated accident conditions. As a result of this testing, NMC concluded that during a LOCA-LOOP the turbine building demand on the SW system could be significantly greater than the flows assumed for previous tests and analyses. The increased turbine building SW flow (and subsequent decreased safety related SW flow) could have impacted the ability of the safety related SW flow to remove the design basis heat loads from safety related components.

- NMC tested the SW system including postulated accident conditions in the turbine building SW header.
- Following the testing, NMC installed a design change on the SW-4A and SW-4B valves to automatically isolate the turbine building SW header on a Safety Injection (SI) sequence signal concurrent with low SW header pressure.
- In conjunction with the design change, NMC implemented compensatory administrative controls to require appropriate plant configuration in the event a required component becomes inoperable.
