**VIRGINIA ELECTRIC AND POWER COMPANY**  
**NORTH ANNA POWER STATION UNIT 2**  
**ALTERNATIVE REPAIR TECHNIQUES-RELIEF REQUESTS NDE-048 and NDE-049**  
**REQUEST FOR ADDITIONAL INFORMATION**

**Response to NRC Request for Additional Information  
Relief Request NDE-048 and NDE-049  
North Anna Power Station Unit 2**

## **REQUEST TO USE EMBEDDED FLAW REPAIR TECHNIQUE NORTH ANNA POWER STATION UNIT 2 RELIEF REQUEST NDE-048**

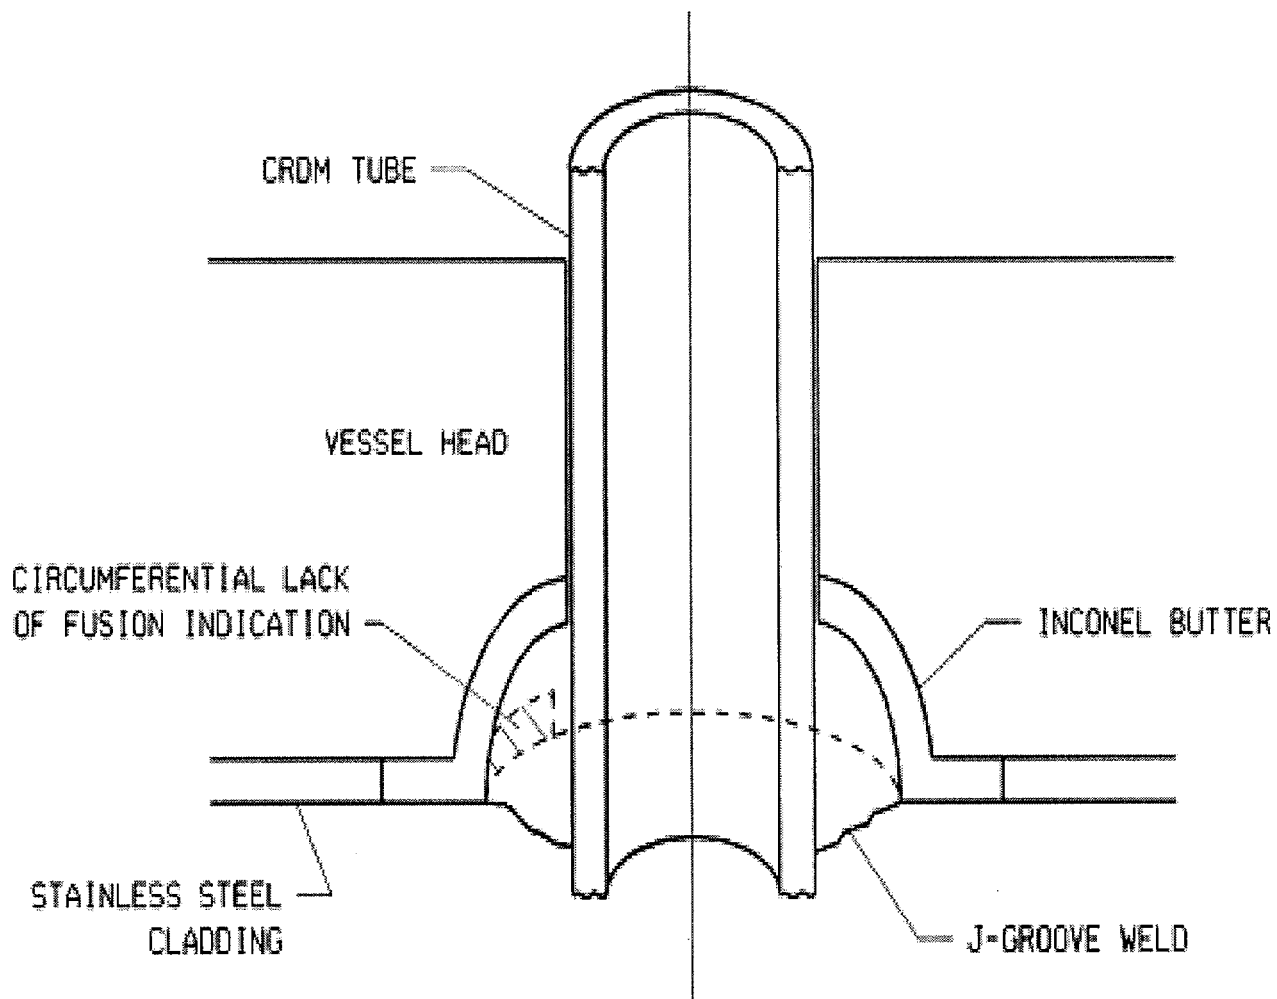
In Section V (page 4) of the submittal, there is a discussion on a postulated circumferential OD flaw in the J-groove weld. Provide a sketch of this crack configuration.

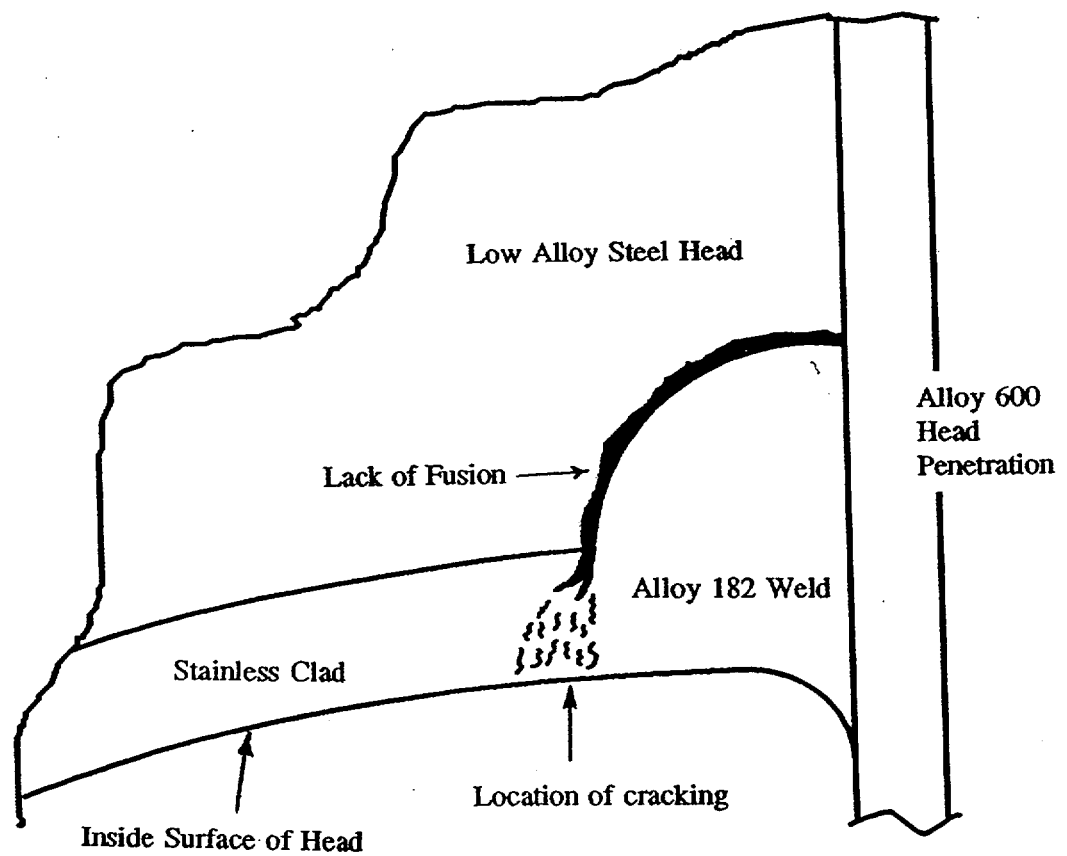
Figure 2. Location of Surface Indications at Penetration 62

In addition to the inspections of the penetrations, surface inspections of the attachment welds were carried out. In 1992, three attachment welds were inspected with liquid penetrant, and no indications found. In 1993, six penetrations were inspected, and indications were found in the cladding at one of the six, penetration number 62, shown schematically in Figure 2. Shallow boat samples were removed and the cracks were confirmed to be very shallow, but extended intermittently through the thickness of the cladding, about 5 mm (0.188 in).

The penetrant test was supplemented by ultrasonic tests, which were very difficult to accomplish because of the geometry, as seen in Figure 2. The UT results indicated an area of lack of fusion in the attachment weld just above the surface cracks, as shown in Figure 2. Because of the difficulty of the UT exam, it was decided to remove larger boat samples to examine the weld fusion zone. The boat samples confirmed the lack of fusion identified by the UT, and plans were made to determine the extent of lack of fusion which might exist on all 65 of the head penetrations of Ringhals Unit 2.

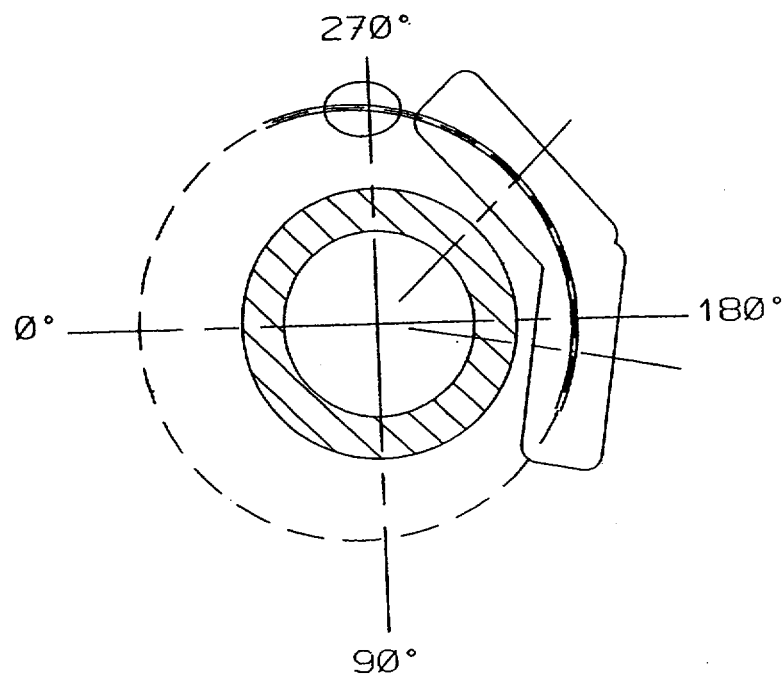
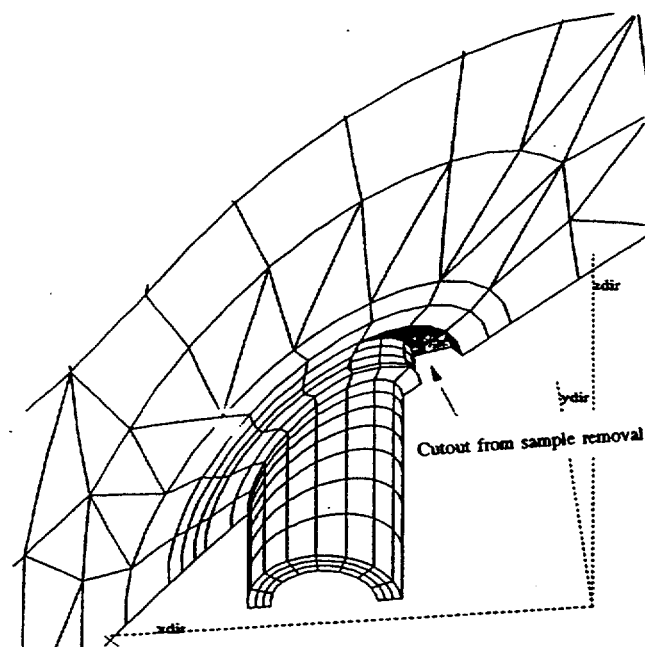
Figure 3. Schematic of the Boat Sample Excavation on Penetration 62, and the Finite Element Model.

The stress analysis considered a number of thermal transient conditions in addition to the steady state condition. Results showed that the internal pressure generates the majority of the stresses. The boat sample cavity only alters the stress pattern in a very localized area. The stresses in the weld and the penetration tube are controlled by the displacement of the vessel head, which in turn is controlled by the internal pressure.

The stress results were compared with the code design allowables, and found to be acceptable at virtually all locations around the periphery of the cutout. The fatigue analysis considered all the design transients for the plant, and resulted in the conclusion that the excavation would not initiate any new flaws in the surrounding materials, either the Alloy 600 or the SA533 ferritic base metal. The maximum calculated usage factor was 0.05 in the Alloy 600, and 0.34 in the ferritic steel. These usage factors included a stress concentration factor of 2.0 imposed on the finite element peak stresses.

These analyses led to the conclusion that the boat sample excavations did not require repair, since all the design rules were met. The only requirement coming from this analysis was that the excavations must be sealed, to ensure no leak path existed through any of the areas of lack of fusion uncovered by their presence. The other key element of the integrity evaluation was the acceptability of the areas of lack of fusion.

The boat sample excavation region of penetration 62 was carefully analyzed to determine its structural acceptability. The excavation introduces a structural discontinuity, but the analysis showed that its presence would not lead to the initiation of other cracks, and that the stresses in the vicinity continue to meet the design stress limits of the ASME Code Section III. The divot was sealed by installing a non-structural cover with a seal weld, to ensure that none of the areas of lack of fusion are exposed to the water reactor environment.

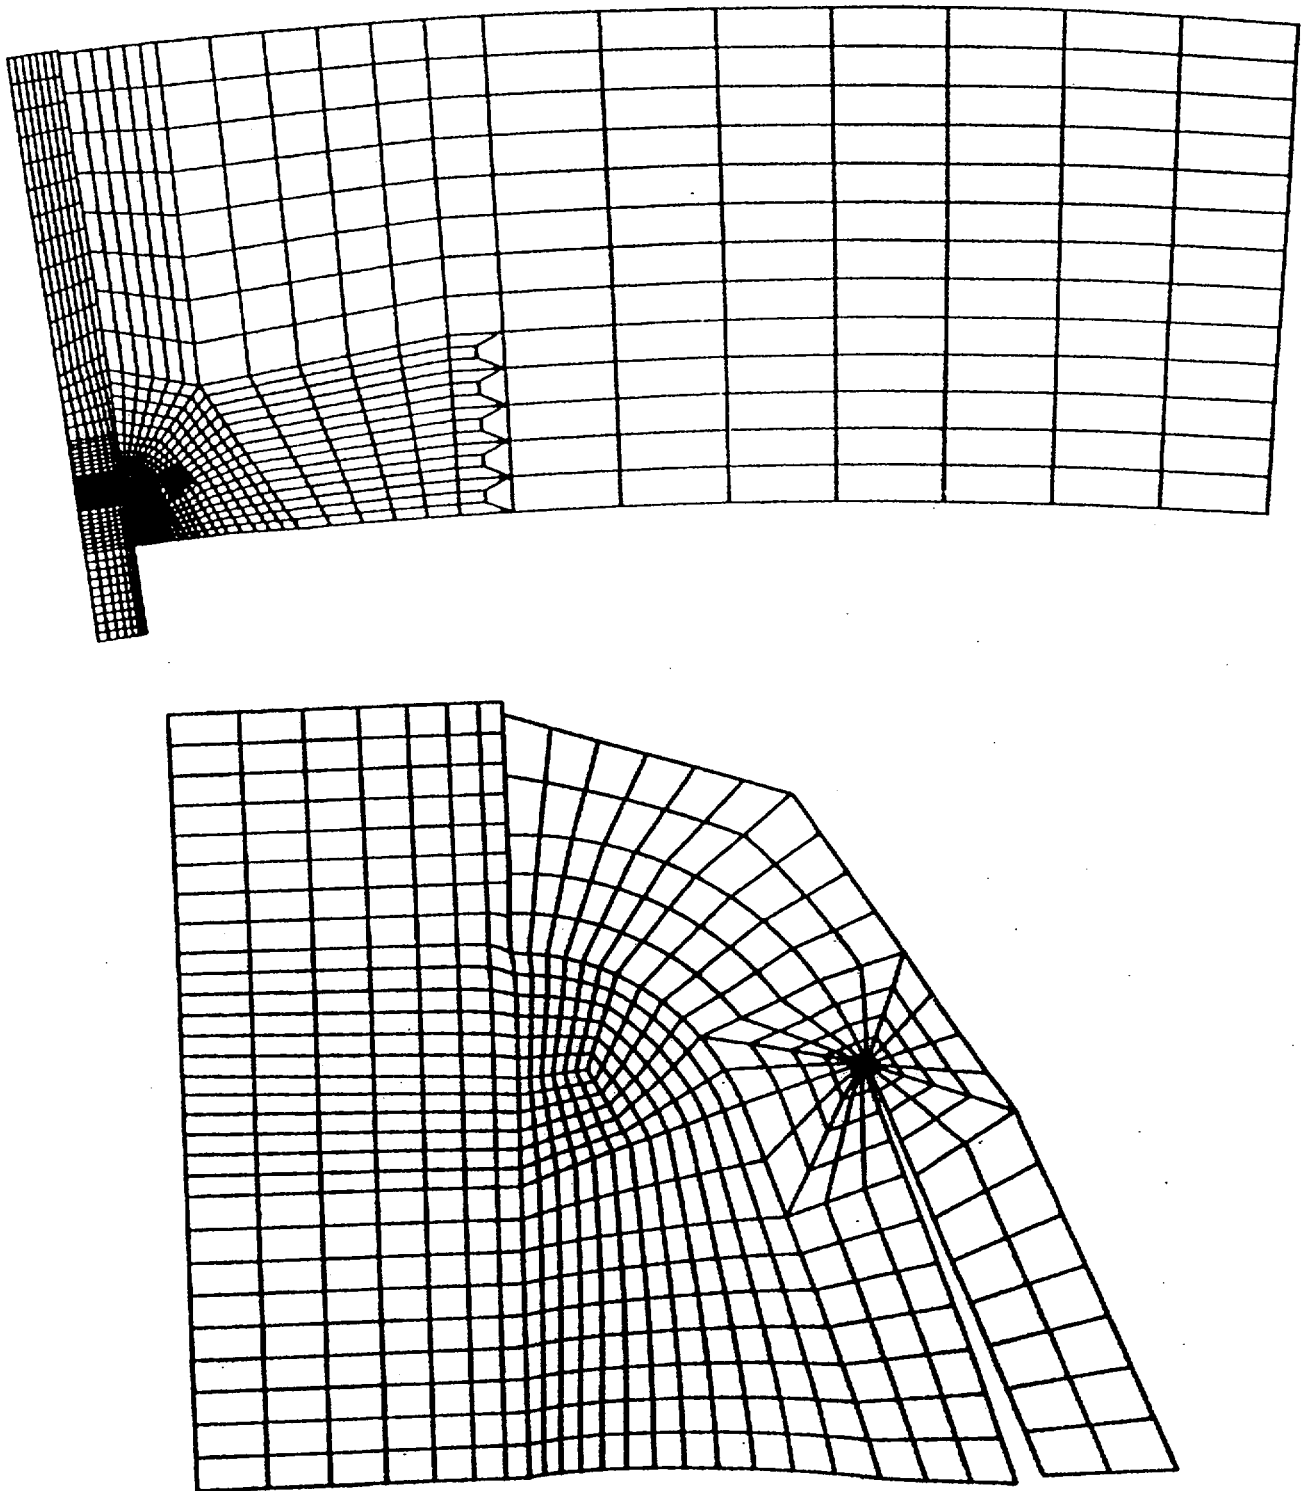
**Figure 4. Finite Element Model of Lack of Fusion in the Weld to the Ferritic Head**

The allowable lack of fusion for the weld fusion zone to the head may be somewhat in doubt, because of the different geometry, where one cannot ensure that the failure would be due to pure shear. To investigate this concern, additional finite element models were constructed with various degrees of lack of fusion discretely modelled, ranging from 30 to 65 percent. The stress intensities around the circumference of the penetration were calculated, to provide for the effects of all stresses, as opposed to the shear stress only, as used above. When the average stress intensity reaches the flow stress (53.7 ksi), failure is expected to occur. The code allowable stress intensity is 1.5  $S_m$ , or 35 ksi, using the lower of the Alloy 600 and ferritic allowables at 320°C (610°F).

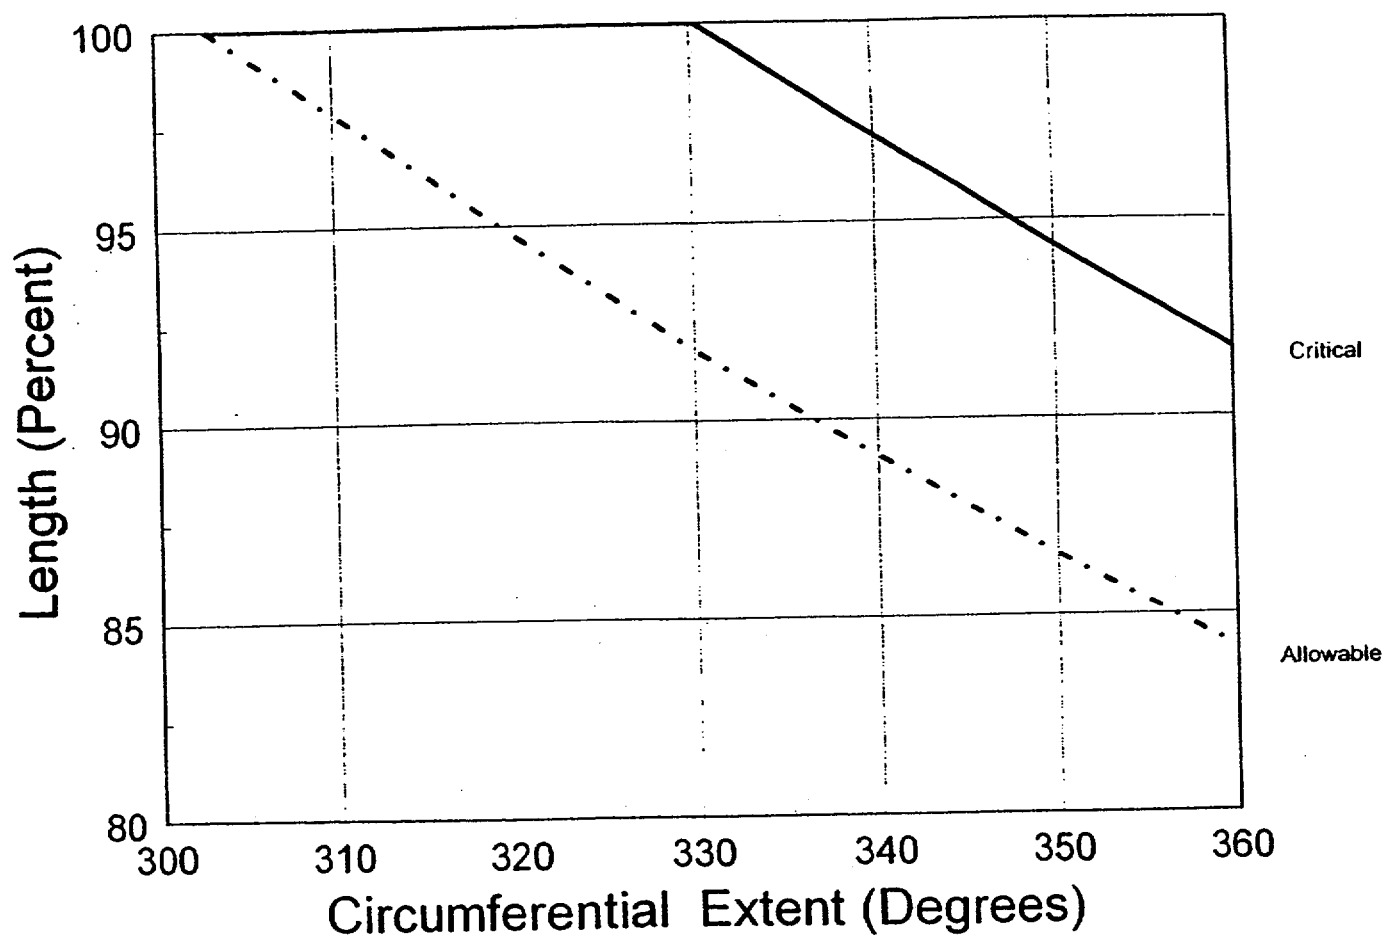
Figure 5. Allowable Regions of Lack of Fusion for the Outermost Penetration Tube to Weld Fusion Zone: Detailed View.

The total surface contact area for the fusion zone on the outermost head penetration is 17.4 in<sup>2</sup>. The calculations above result in a required area to avoid failure of only 1.45 in<sup>2</sup>, and using the ASME Code criteria, the area required is 2.79 in<sup>2</sup>. These calculations show that as much as 83.9 percent of the weld may be unfused, and the code acceptance criteria can still be met.

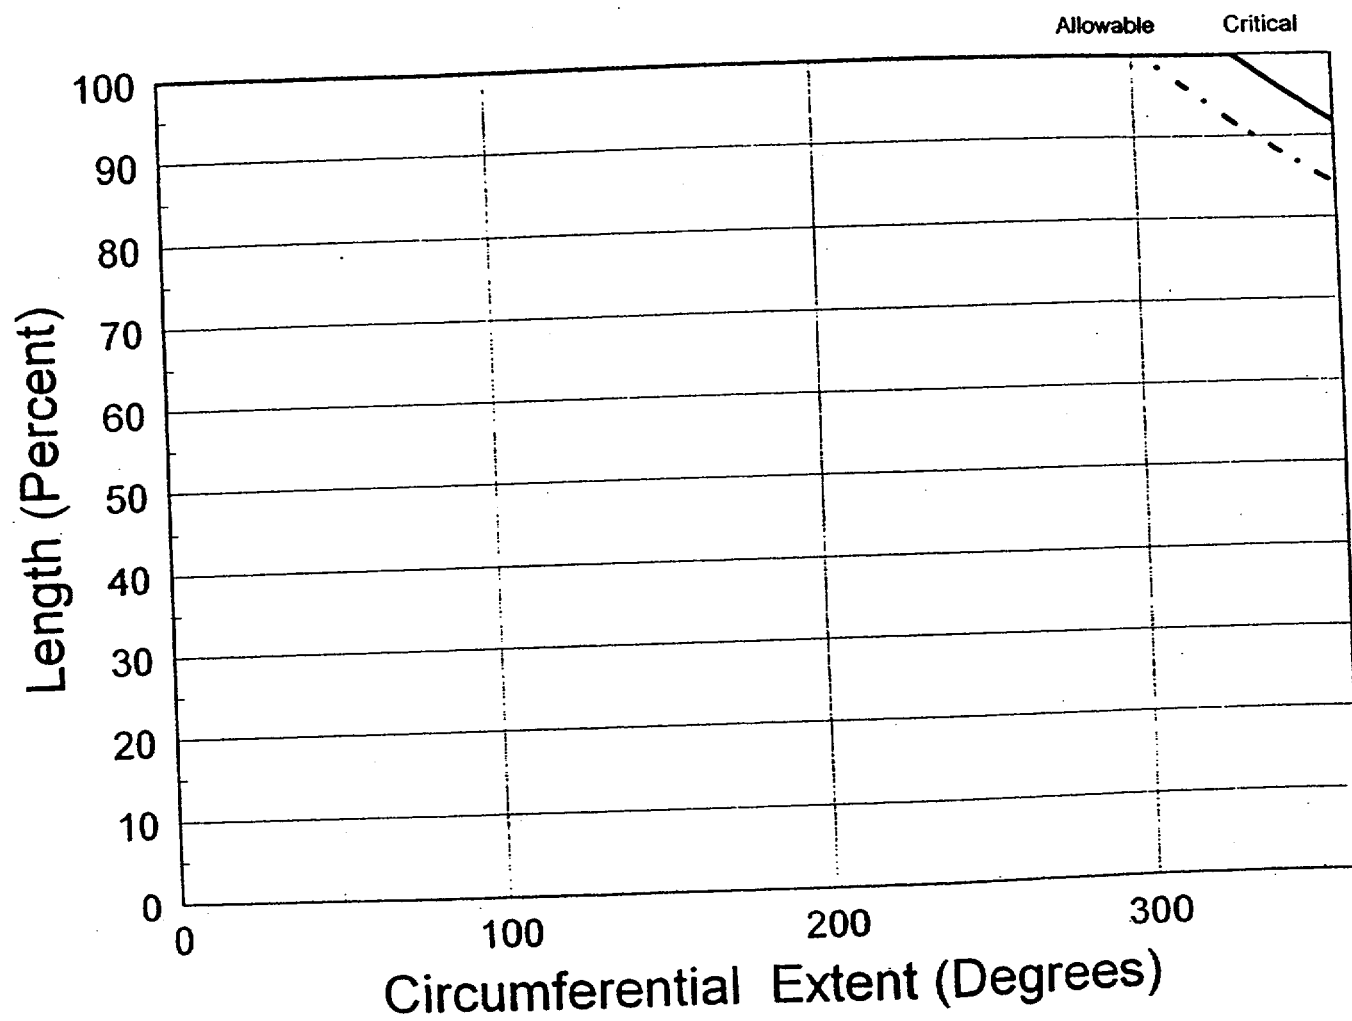
Figure 6. Allowable Regions of Lack of Fusion for the Outermost Penetration: Tube to Weld Fusion Zone.

The full extent of this allowable lack of fusion is shown in Figure 6, where the axes have been expanded to show the full extent of the tube-weld fusion line. This figure shows that a very large area of lack of fusion is allowable for the outer most penetration. Similar results were found for the center penetration, where the weld fusion area is somewhat smaller at 16.1 in<sup>2</sup>.
