SUBJECT: Potential Manufacturing Problem With Certain Limit Switch Assemblies Used in  
ASCO General Controls Hydramotor<sup>®</sup> Actuators.

**POTENTIAL MANUFACTURING PROBLEMS WITH  
LIMIT SWITCH ASSEMBLIES USED IN ASCO GENERAL CONTROLS  
HYDRAMOTOR® ACTUATORS**

ASCO General Controls

Limit Switch  
Assembly

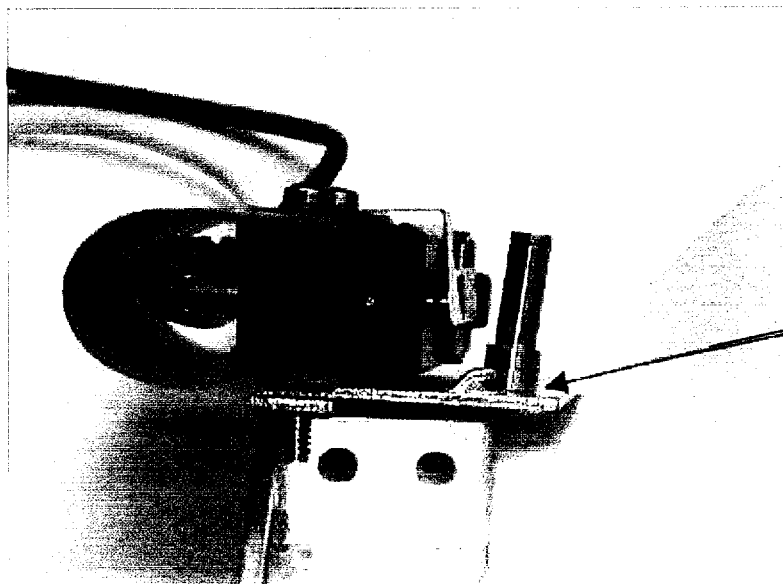
Analysis of the returned Limit Switch Assembly (see attachment 1) revealed that the shaft on which the position sensing lever operates was not secured tightly to the plate, causing wobble of the shaft. This wobble may result in the rotation of the lever past its actuation point, which would leave the switch contacts in the normally open (N.O.) position. This condition will result in the failure of the actuator piston to retract when the Hydramotor® is powered. The shaft is staked to the plate assembly. Manufacturing instructions for this assembly defines the maximum pressure to be applied for the staking press, but no minimum value. This led to variation of the staking process, which resulted in inconsistent and incomplete attachment of the shaft to the plate. (See attachment 2). In addition to the field return, Asco has found several limit switch assemblies in our inventory with this condition.

POINT OF  
FAILURE

VIEW SHOWING ANGULATION CONDITION  
OF FAILED SHAFT JOINT

ASCO will notify all purchasers of affected product of the potential problem. If the affected product is not in service, ASCO will offer to rework it at our factory at no charge. If the product is in service, ASCO will offer retrofit kits at no charge with complete instructions for installation of new limit switch assemblies. The method of forming this staked joint is being revised to ensure complete and consistent assembly of the shaft to the plate. In addition, the manufacturing instructions are being revised to fully define the parameters of this process as well as the testing necessary to confirm the reliability of the shaft-to-plate joining process.
