Subject: Licensee Event Report No. 2001-005
Cooper Nuclear Station, NRC Docket 50-298, DPR-46

LICENSEE EVENT REPORT (LER)

Cooper Nuclear Station

High Pressure Coolant Injection (HPCI) Overspeed Trip Reset Valve Spring Failure Results in HPCI Unavailability

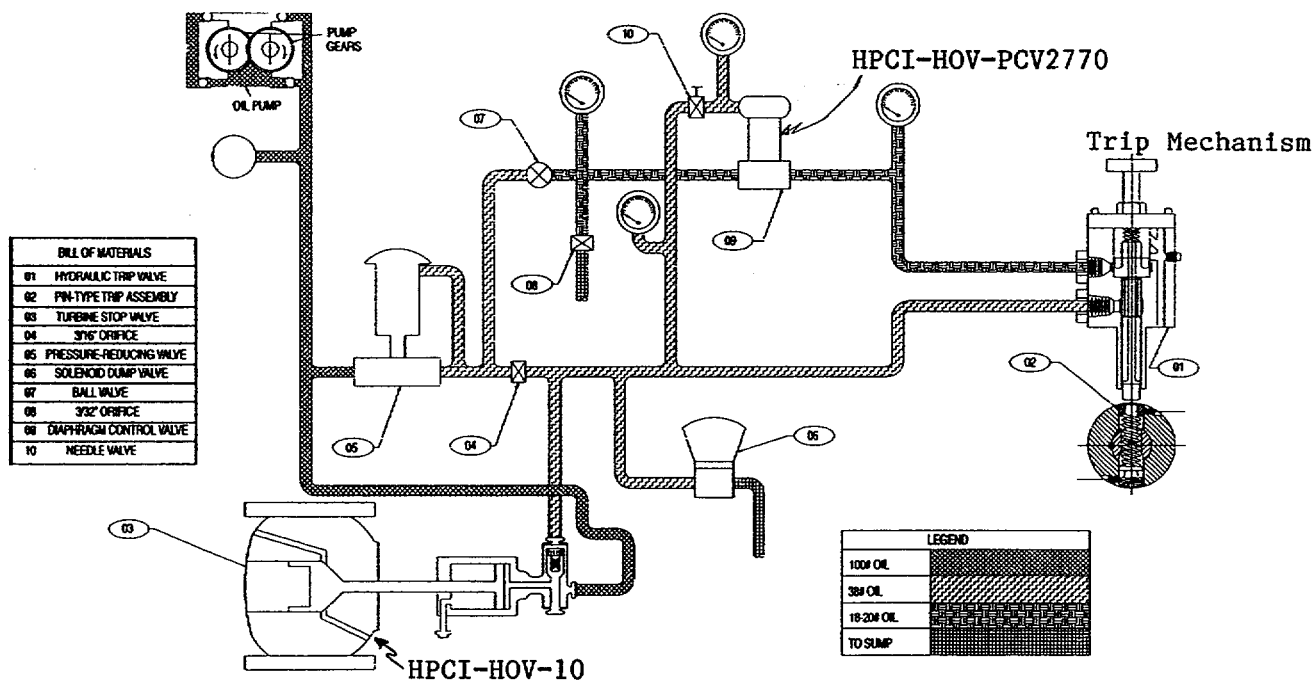
Overspeed Trip System, Hydraulic Schematic

The overspeed trip mechanism consists of a hydraulic circuit (see illustration on Page 5) which operates during an overspeed trip condition (or when the trip mechanism is manually actuated) which moves the trip mechanism to the open position. The oil supplied from the mechanical hydraulic overspeed trip auto reset control valve (HPCI-HOV-PCV2770)[EIS: BJ/12] to the trip mechanism maintains the trip mechanism open long enough to dump the oil pressure that normally maintains the turbine stop valve (HPCI-HOV-10)[EIS: BJ/5] open. The decreasing pressure on the diaphragm closes the valve (due to the actuator spring). This terminates the oil supply to the overspeed trip mechanism allowing the trip mechanism to reset. However, during the test performed on October 17, 2001, the overspeed trip mechanism did not reset, due to HPCI-HOV-PCV2770 not going to the closed position. It has been determined that the actuator spring associated with this valve had failed due to age degradation.

Subsequent investigation determined that the failed component was the actuator spring of the mechanical hydraulic overspeed trip auto reset control valve, HPCI-HOV-PCV2770, which is a Robertshaw valve, model VC-210-BLR. The actuator spring and diaphragm on the valve were replaced, post maintenance testing was performed, and the appropriate surveillances were satisfactorily completed.

The cause of this event was age degradation of the spring causing a loss of its mechanical properties until it was unable to perform its design function (closure of the valve to automatically reset the trip mechanism).

1. Replaced the actuator spring and diaphragm on the Mechanical Hydraulic Overspeed Trip Auto-Reset Control Valve HPCI-HOV-PCV2770. Completed 10/18/01
2. Performed applicable surveillance testing satisfactory. After review of surveillances and corrective maintenance declared system operable. Completed 10/19/01
3. Performed Design and Configuration control for HPCI-HOV-PCV2770 replacement parts. Completed 11/21/01

1. Prepare PM to replace HPCI-HOV-PCV2770 at ten year intervals from date of manufacture, include instructions to ensure that the replacement valve is less than seven years old. Due Date: 3/15/2002
