VERMONT YANKEE NUCLEAR POWER CORPORATION

Subject: Vermont Yankee Nuclear Power Station
License No. DPR-28 (Docket No. 50-271)
Reportable Occurrence No. LER 2001-005, Rev. 0

4. TITLE
Primary Containment Breach Due to Broken Tubing at Hydrogen/Oxygen Monitor

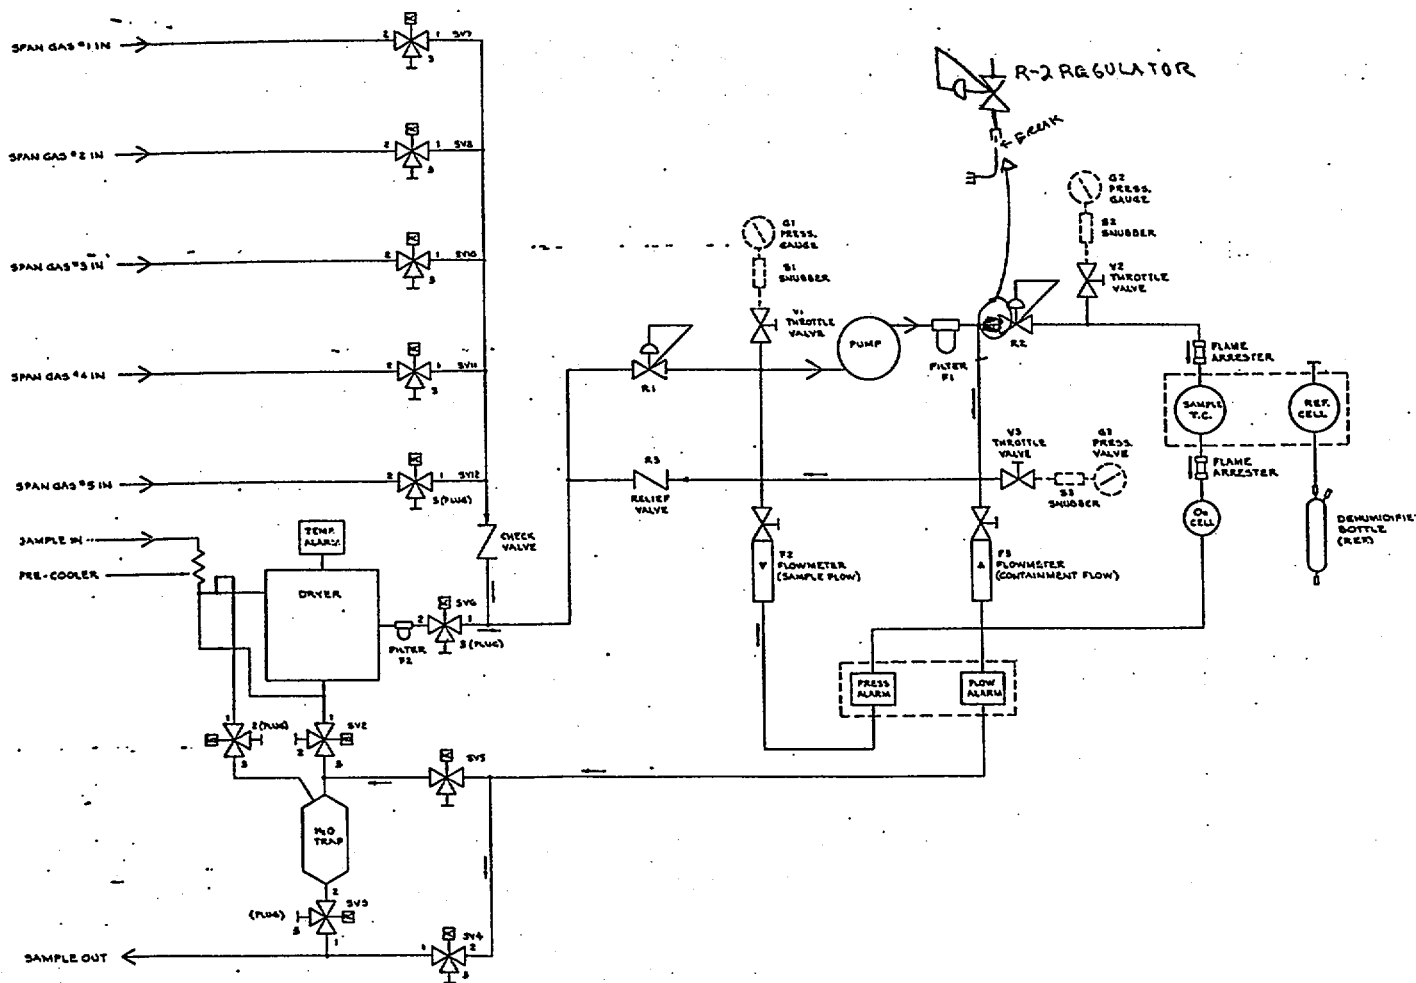
Containment Monitor Piping Schematic
Model 225 CMA & 225 CMAB
VY Drawing Number: 5920-6273

The failing coupling caused excessive vibration on the discharge tubing from the pump to the R-2 regulator. The tubing failed at the first point from the pump discharge where it is restrained to a fixed point, below the R-2 regulator. The other end of the tubing is attached to the pump and is free to move with the pump vibrations. This configuration causes most of the pump vibrations to be absorbed at the fixed point. The pump suction has the same restraint as the discharge tubing when attached to the cabinet. However, that section of tubing is configured in one plane to enhance the vibrational absorption capabilities over the system, rather than transmitting them to one single fixed point. The discharge tubing is configured in such an orientation that a twisting motion was created on the tubing at the fixed point, while absorbing the vibrations of the pump. This configuration led to a radial fracture when combined with the excessive vibrations from the failing pump coupling.

1. The system was isolated in nineteen minutes after receiving the H₂/O₂ Trouble Alarm, which restored Primary Containment.
2. The pump, pump to motor coupling, coupling spider and the fractured section of discharge tubing were replaced. The system was subsequently leak rate tested satisfactorily in accordance with the Primary Containment Leak Rate Test Program.
3. The discharge tubing was re-configured to reduce the effects of pump vibration on the system.
4. Preventative Maintenance practices and procedures for this equipment will be evaluated for improvement opportunities.
