U.S. Department of Energy

Subject: 2001 Annual Site Inspection and Monitoring Compliance Report for UMTRCA Title II
Disposal Sites

2001 Annual Site Inspection and Monitoring Compliance Report for Uranium Mill Tailings Radiation Control Act Title II Disposal Sites

**2001 Annual Site Inspection and Monitoring
Compliance Report
for
Uranium Mill Tailings Radiation Control Act
Title II Disposal Sites**

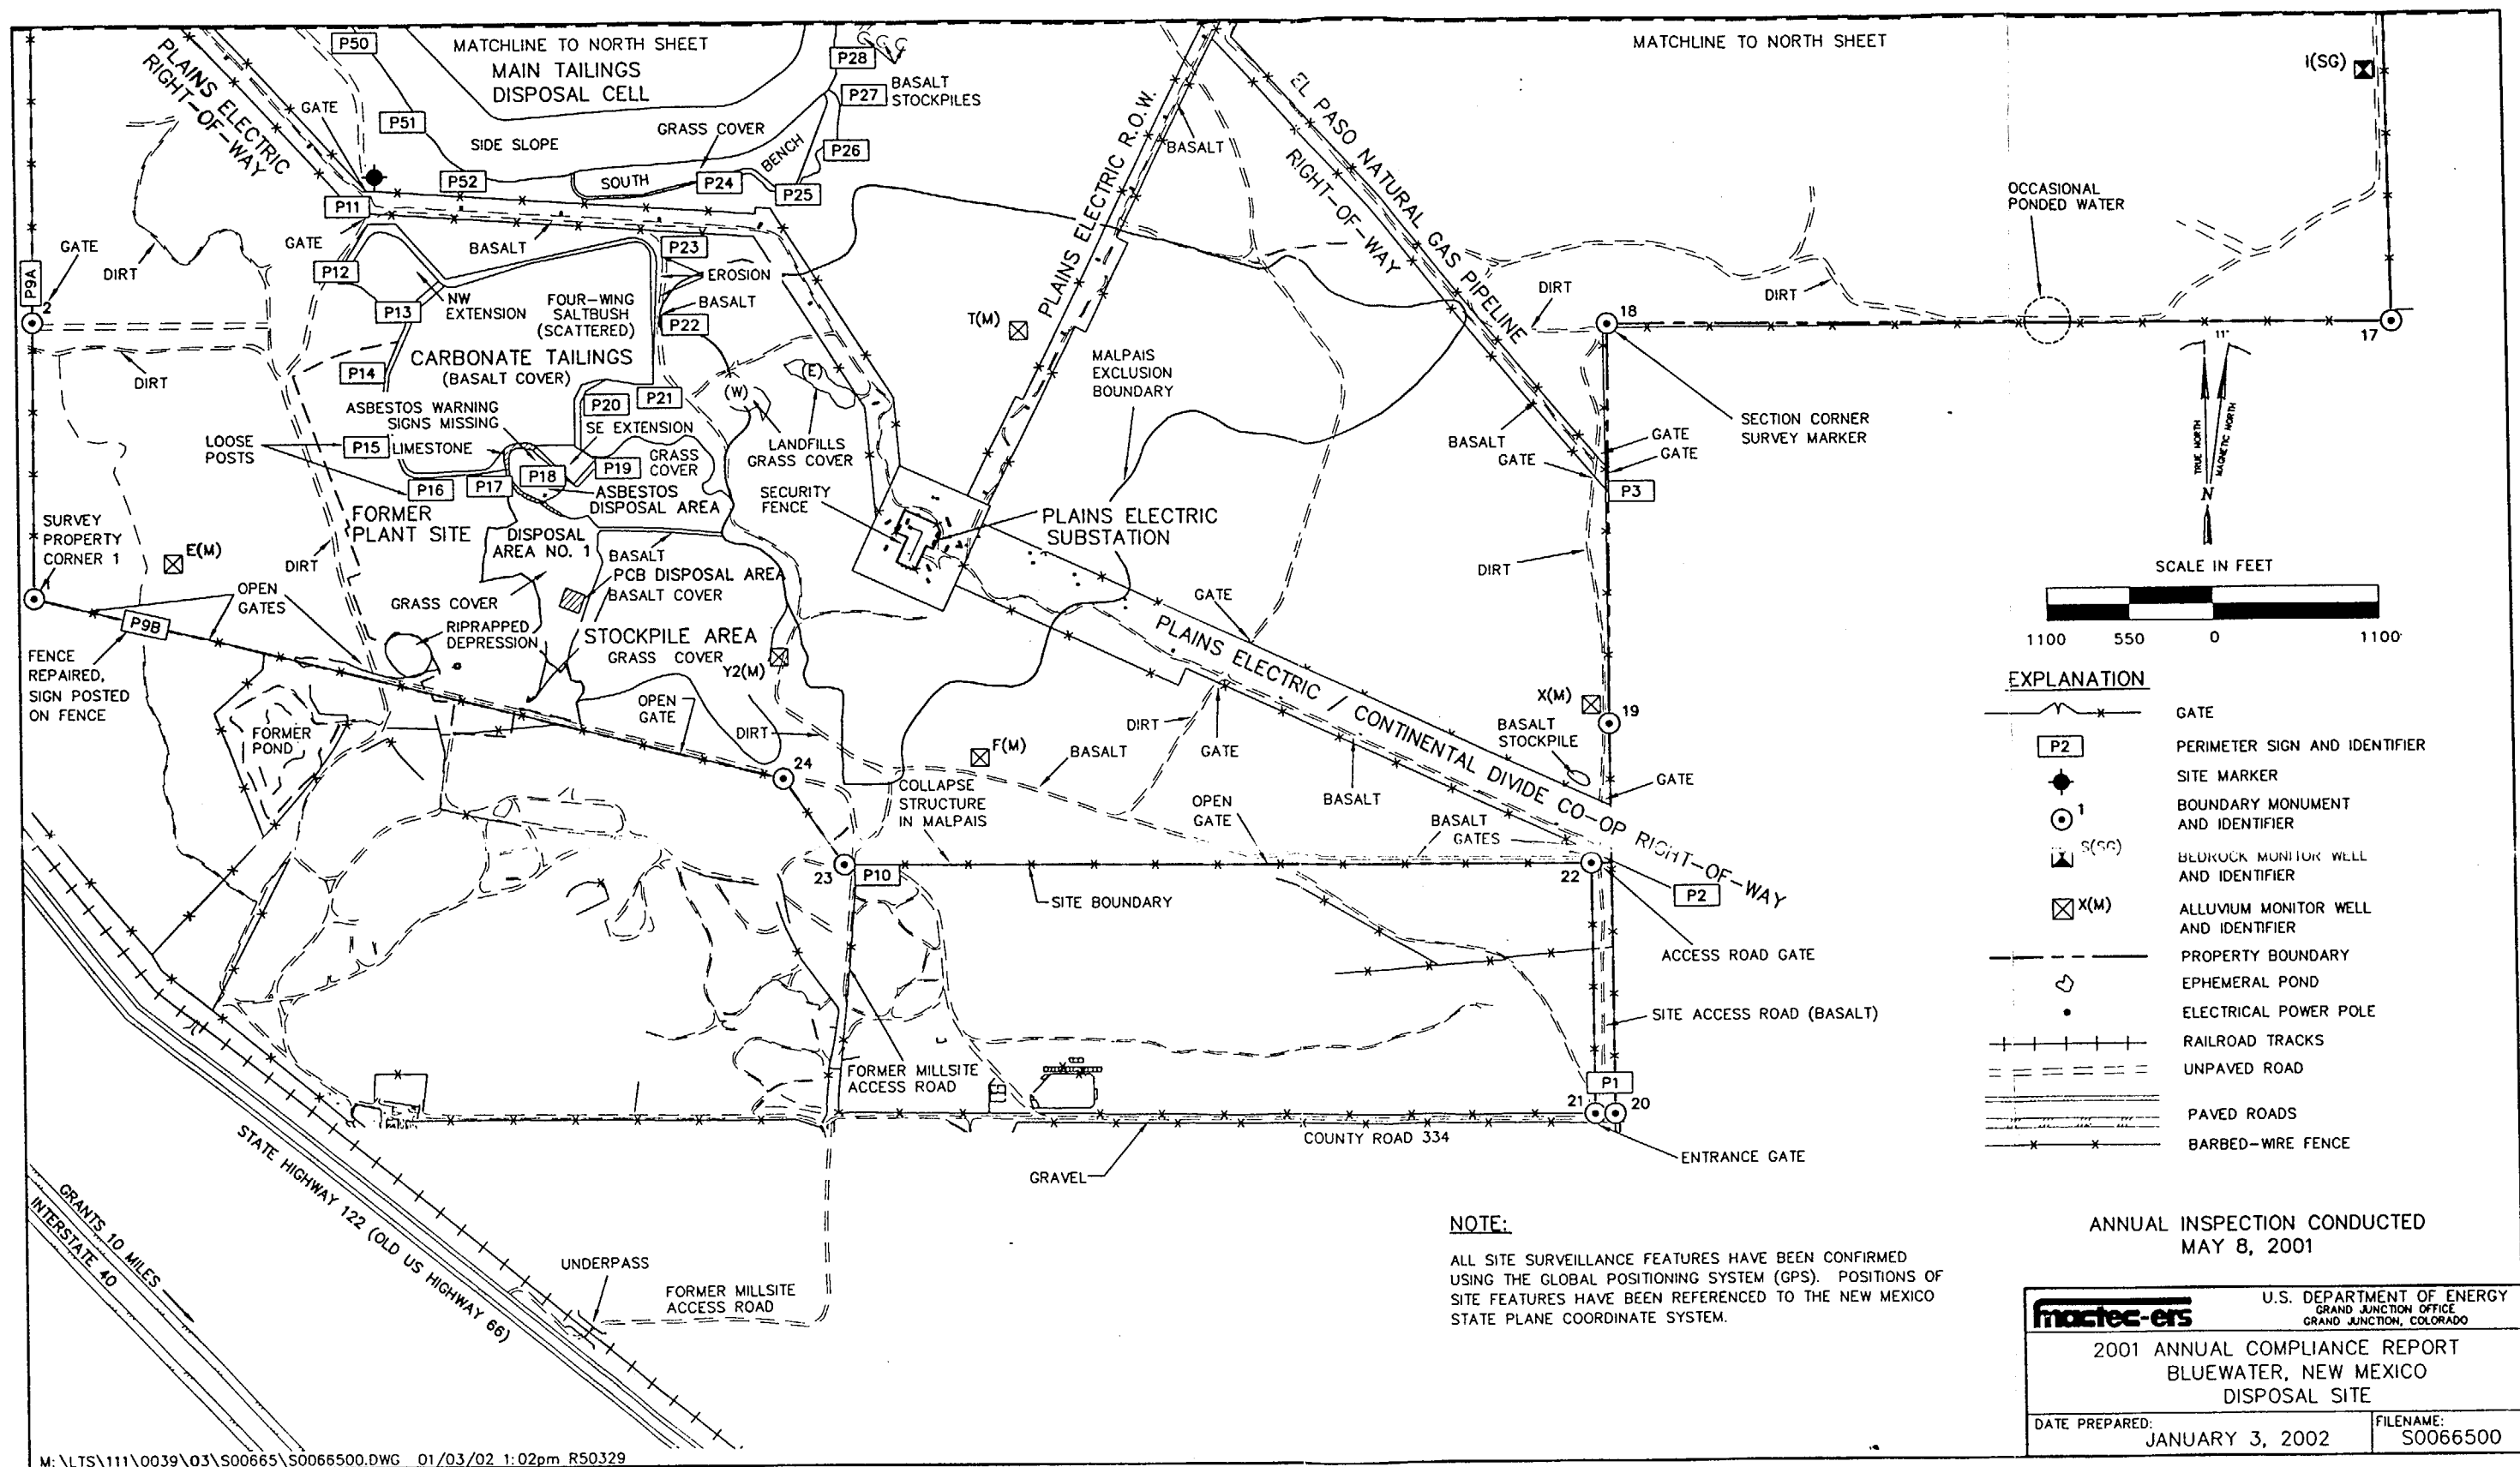
Figure 1-1. Bluewater, New Mexico, South Area, 2001 Inspection Drawing

Fifty-four perimeter or warning signs, designated P1 through P52 on Figures 1-1 and 1-2 (including perimeter signs P9A and P9B), are posted at access points along and right-of-way intersections with the site boundary and around the main and carbonate tailings disposal cells. At the Bluewater site, all signs are identical and convey the information typically conveyed on entrance signs at other Long-Term Surveillance and Maintenance (LTSM) Program sites.

There are nine monitor wells at this site. All are inside the site boundary. Five of the wells are screened in the alluvial aquifer (Figure 1-1). They include the letter "M" in their designation. The five alluvial wells, E(M), F(M), T(M), X(M), and Y2(M), are all in excellent condition.

The top and side slopes of the carbonate tailings disposal cell are covered by basalt riprap (Figure 1-1). The top, for the most part, slopes gently eastward. The small northwest and southeast extensions slope in their respective directions. The carbonate tailings disposal cell and its extensions are in excellent condition. Erosion was observed along the east edge of the apron below the carbonate tailings cell. Soil fill appeared to be washing away from the edge of the apron (Figure 1-1). This does not affect the performance of the apron at this time but should be monitored.

An electric power substation is enclosed by a security fence near the center of the site along the Plains Electric Company right-of-way (Figure 1-1). Fencing around this station is in good condition.

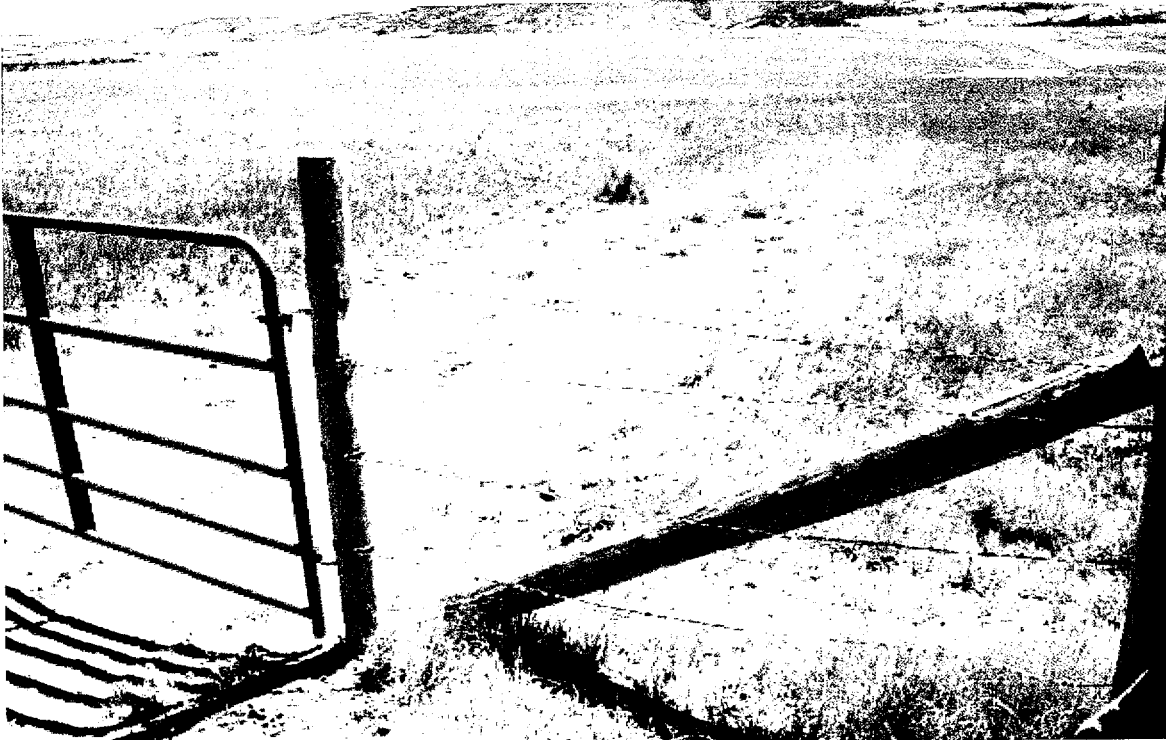
EDG 6/2001. PL-1. Dislocated horizontal member of "H" brace at entrance gate.

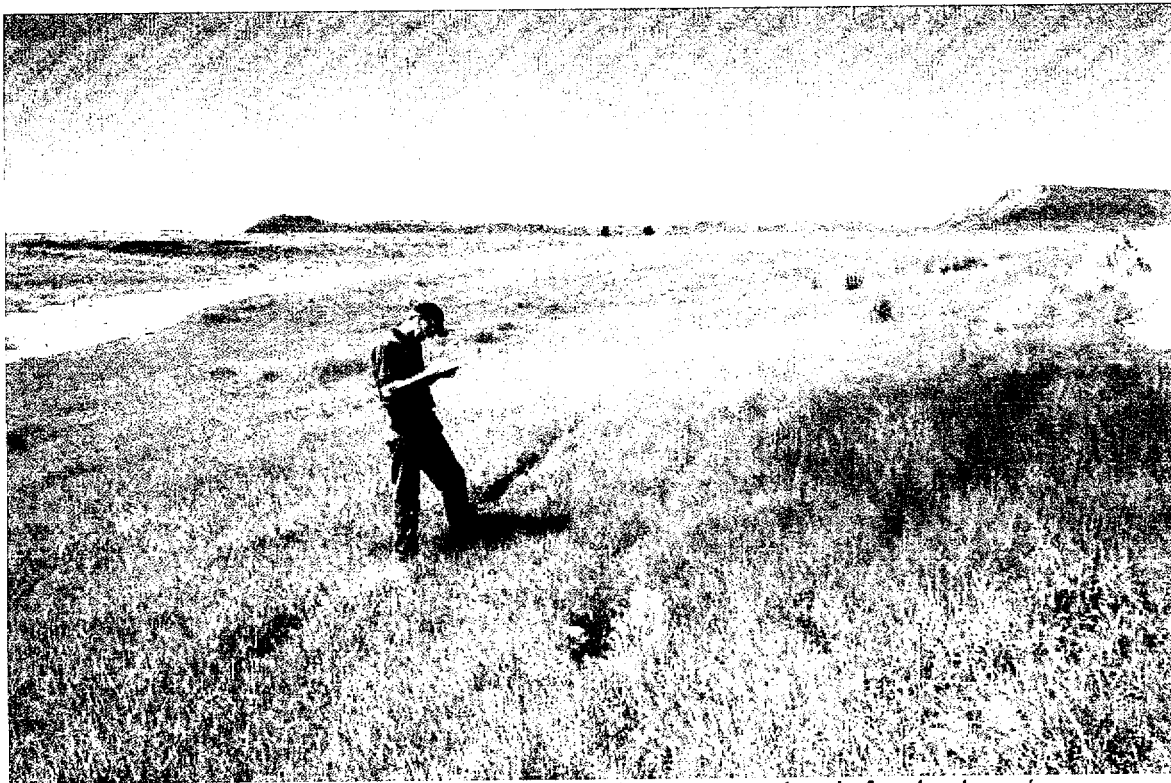
The 100-acre top of the disposal cell is grass-covered. DOE manages the grass cover by controlled grazing. No cattle were on site the day of the inspection, but signs of recent grazing were evident. The grass is well established and was not over-grazed when inspected. There was no evidence of settling, slumping, or erosion on the disposal cell. Tire tracks were observed north of the west end of the embankment (PL-2). The tracks were probably left by the county weed control agent.

EDG 6/2001. PL-2. Tire tracks on top slope near west end of embankment.

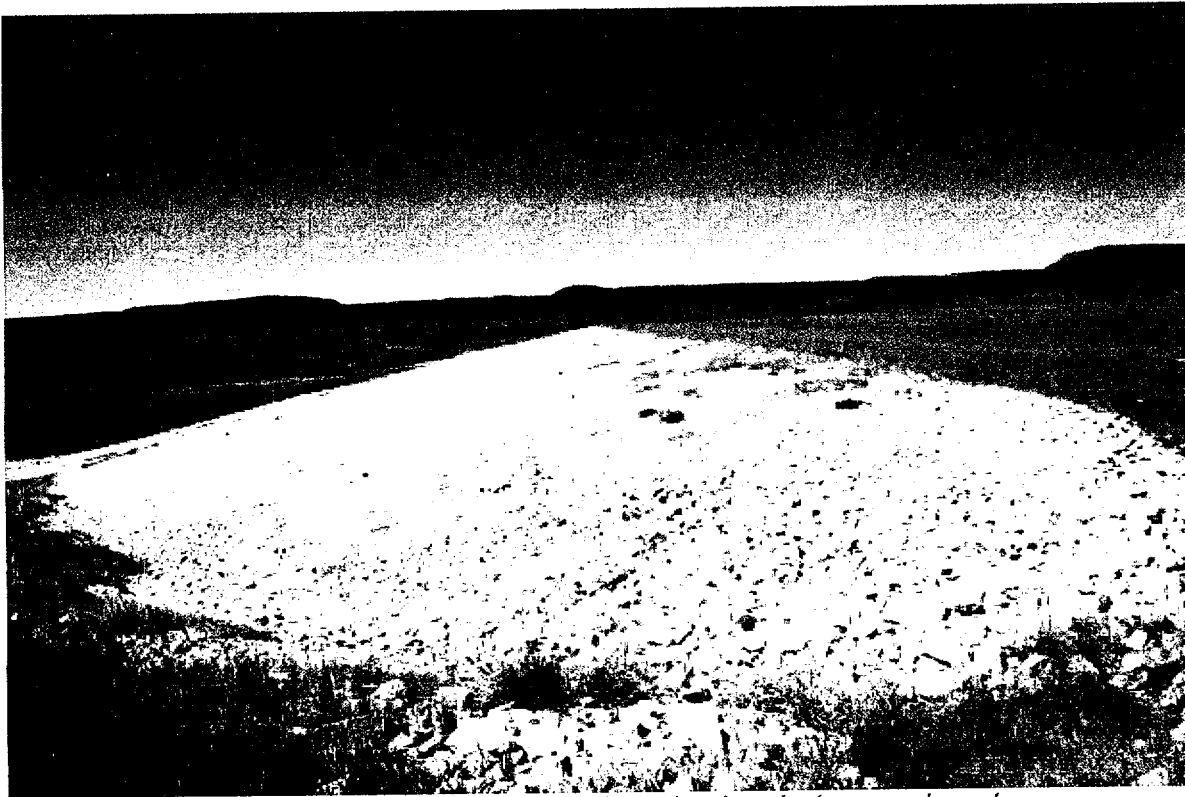
The tailings dam face is covered with riprap and represents the steepest slope on site. The slope is stable and the riprap shows no signs of degradation. Scattered plants, mostly grass, grow in the riprap (PL-3). These plants do not pose an immediate threat to stability of this structure but plant density will probably increase over time and needs to be monitored.

EDG 6/2001. PL-3. Embankment face showing plant encroachment.

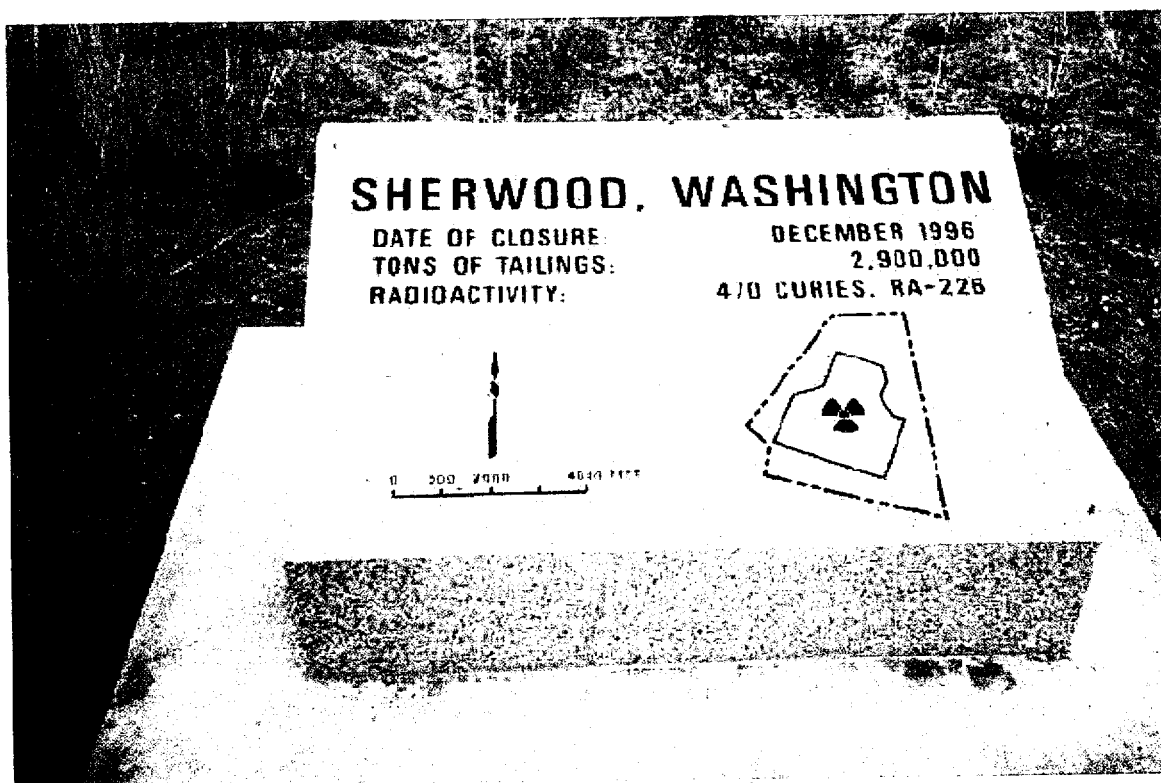
One inscribed granite site marker (PL-2) is present on the site near the southwest boundary of the site property where the access road lies closest to the site boundary. The marker is in excellent condition.

SHE 10/2001. PL-2. Site Marker.

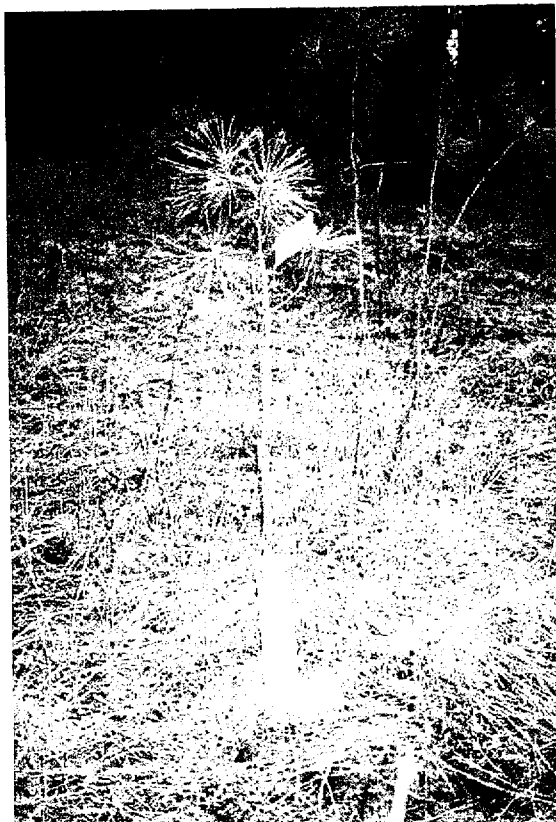
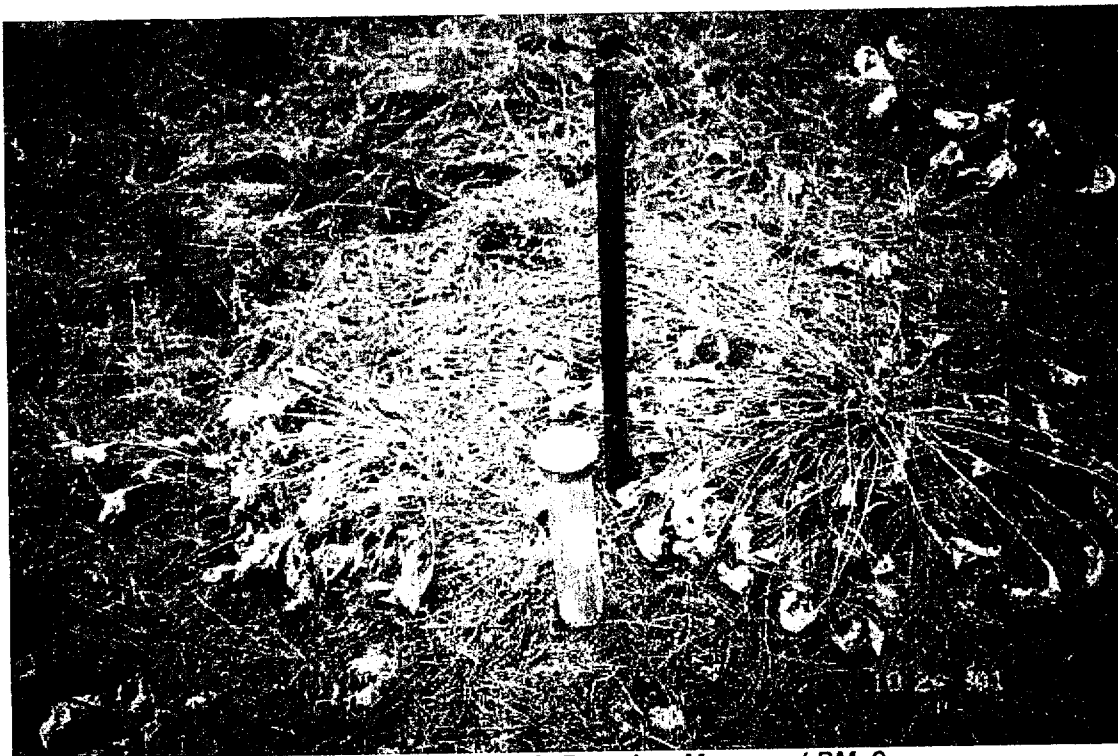
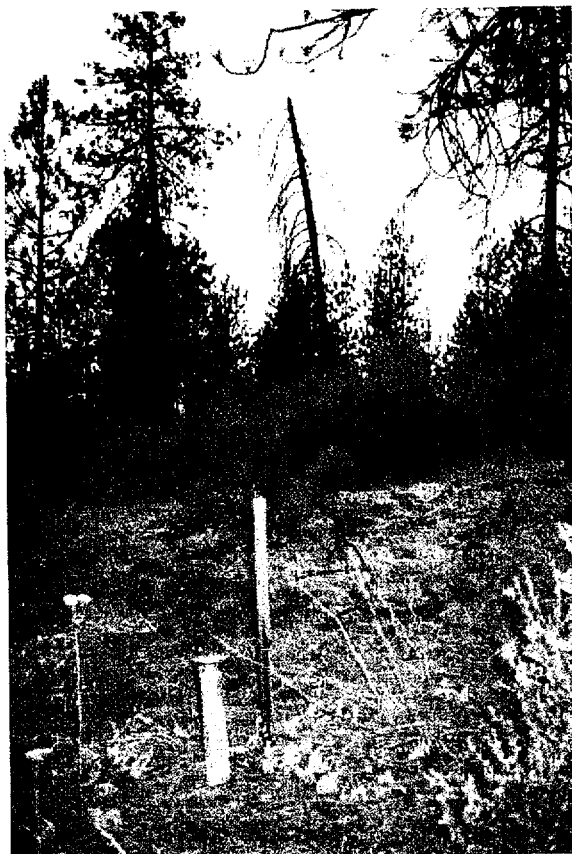
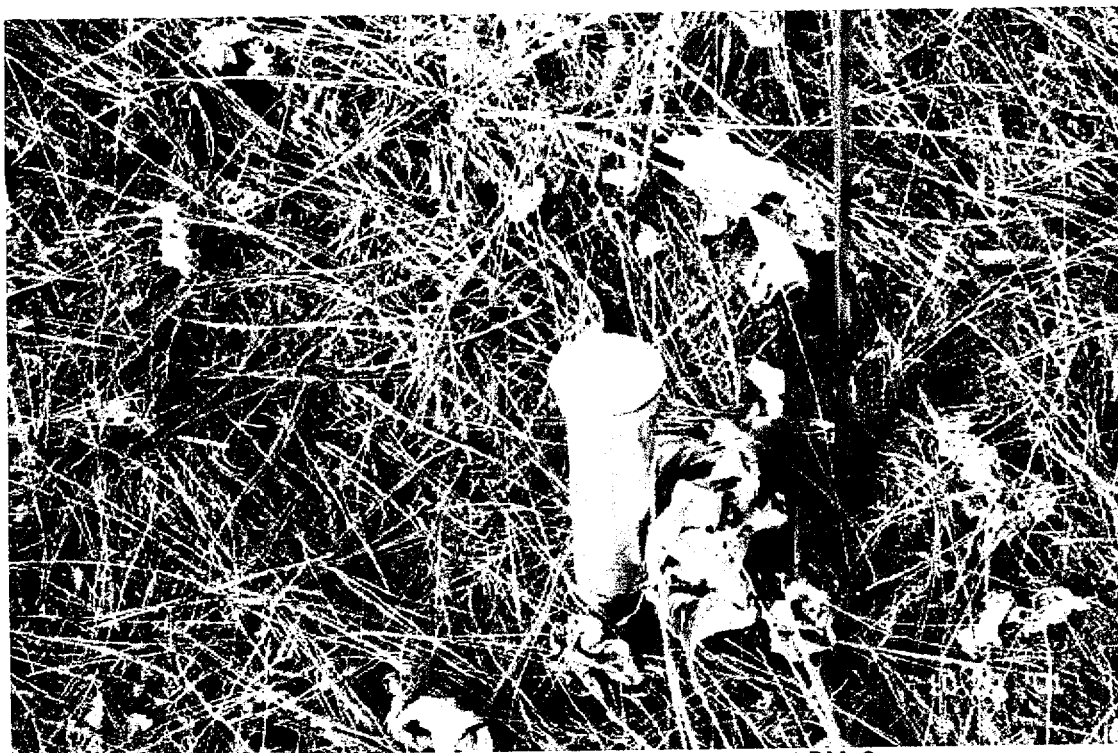
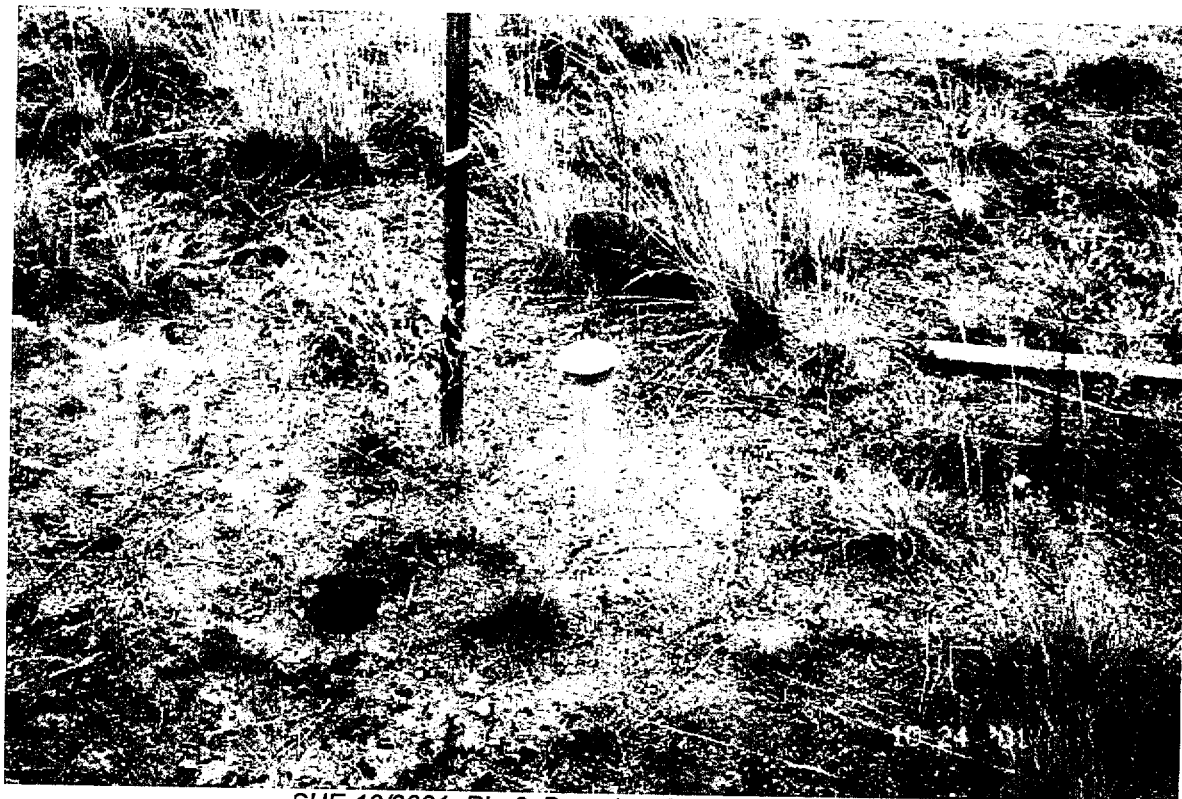
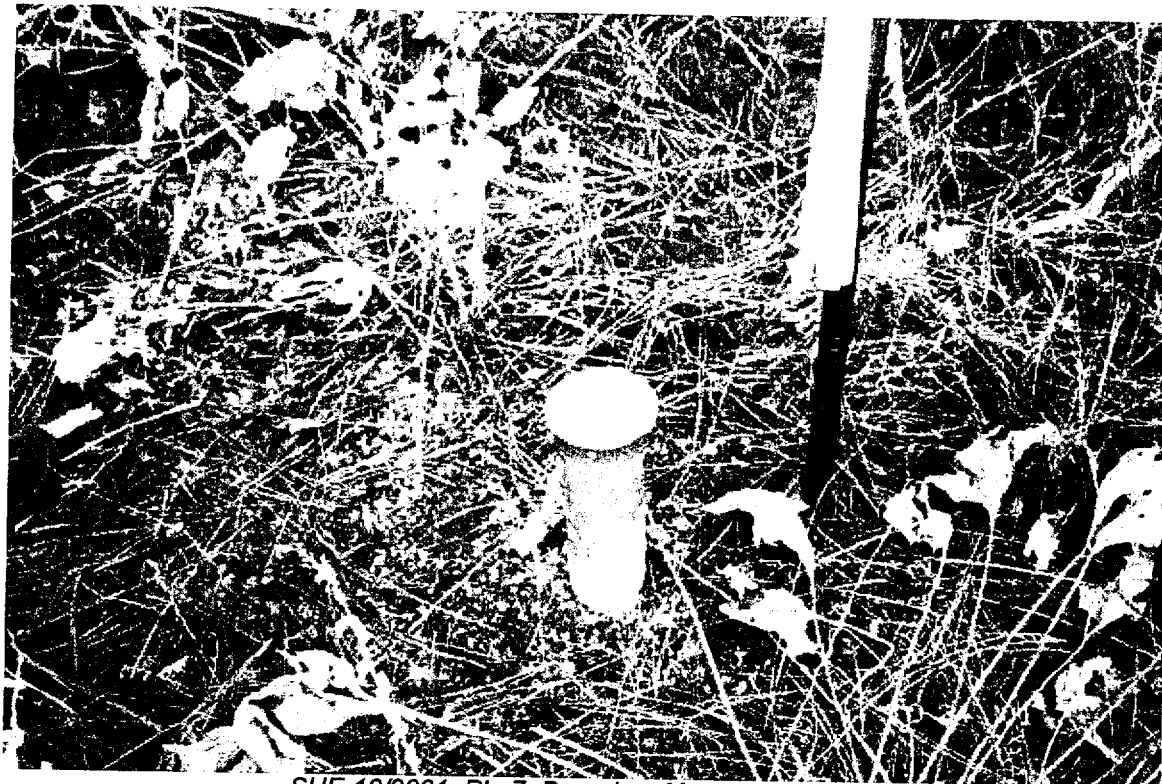
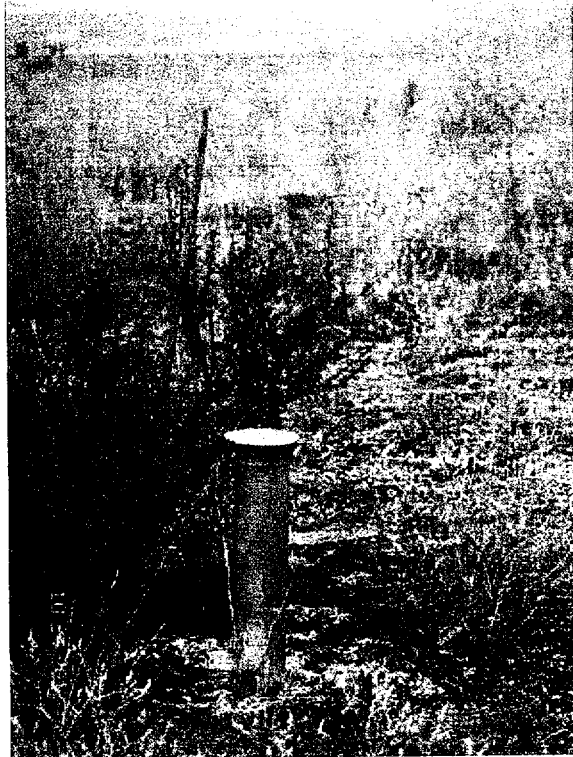
Six boundary monuments designated BM-1, BM-2, BM-3, BM-3A, BM-4, and BM-5 define the site boundary. The monuments are shown in photographs PL-3 through PL-8. The monuments are all in new condition.

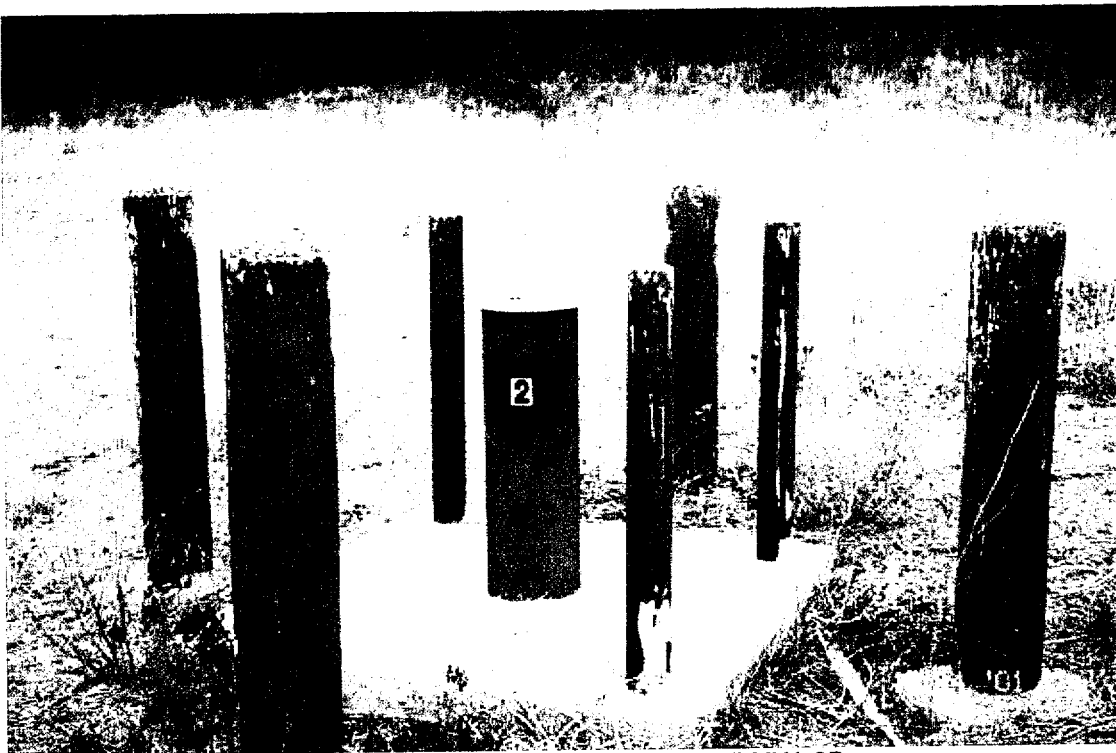
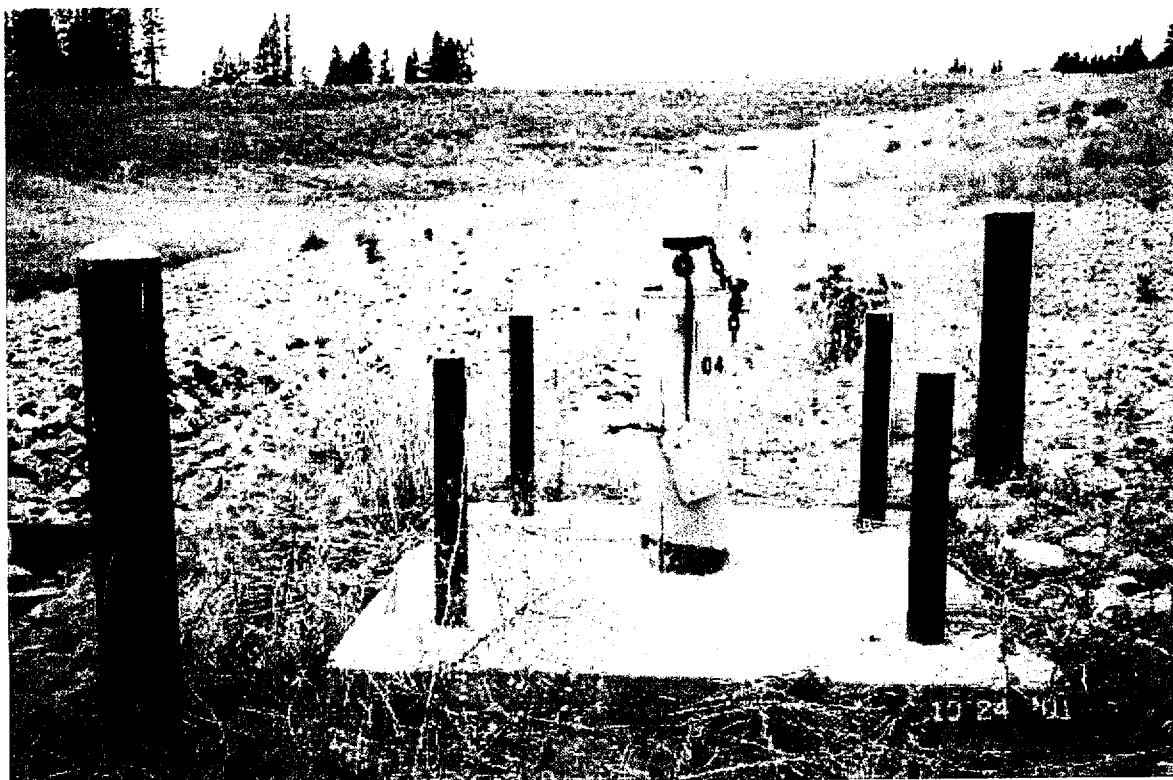
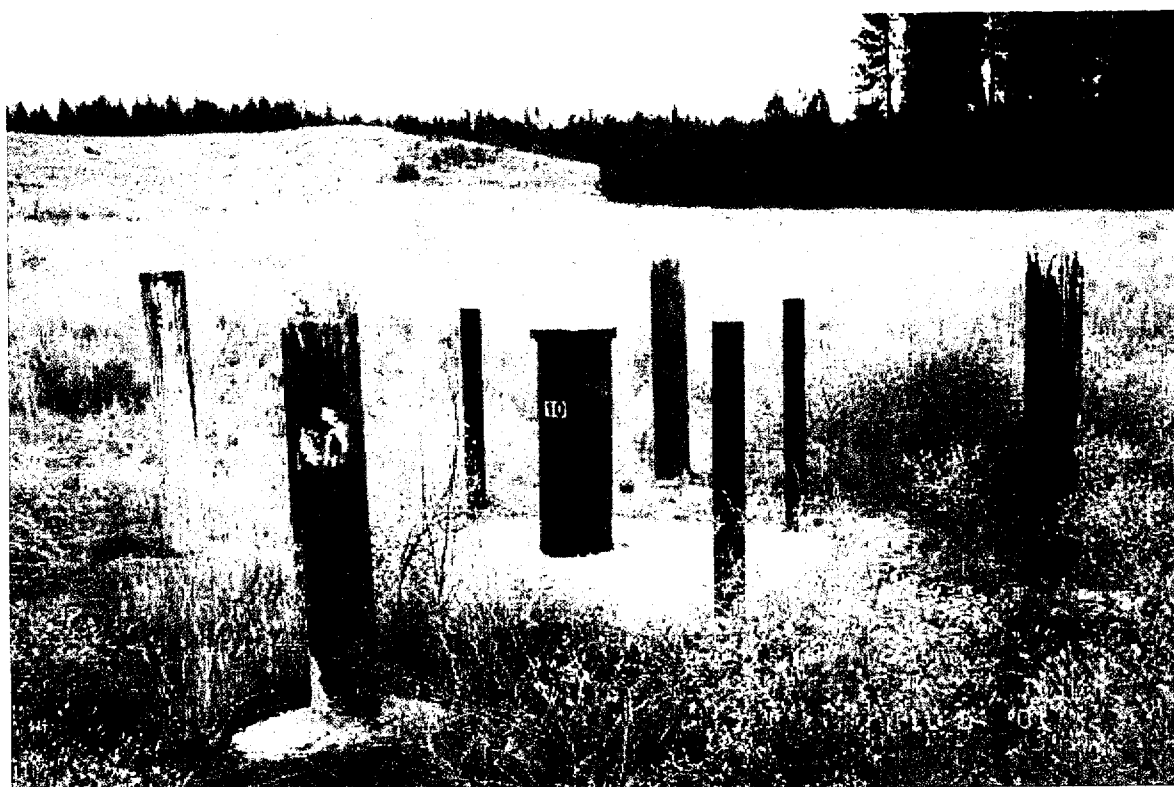
There are three monitor wells at the Sherwood site designated MW-2B, MW-4, and MW-10. The wells are shown in photographs PL-9, PL-10, and PL-11, respectively. MW-2B is the up gradient or background well. MW-4 and MW-10 are point-of-compliance wells. These three wells are sampled for sulfate, chloride, and total dissolved solids annually as a best management practice. All results from the July 2001 sampling event were within anticipated ranges and acceptable limits.

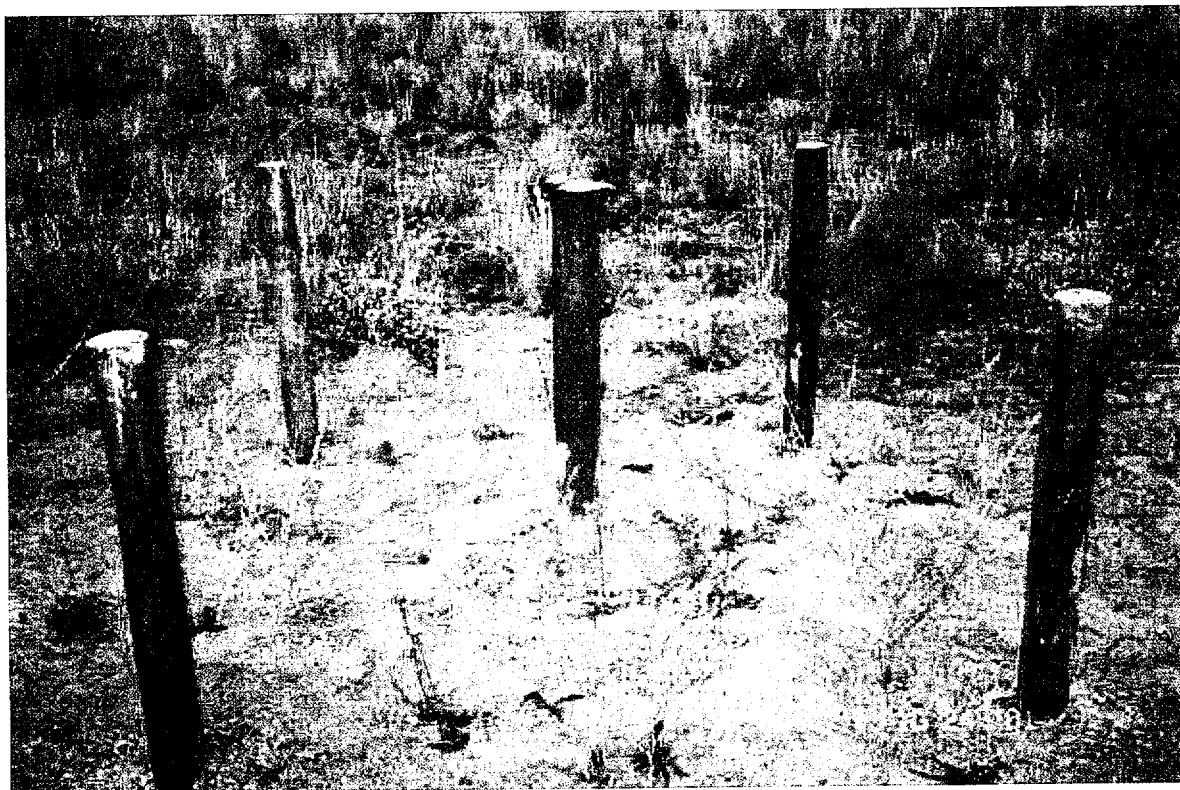
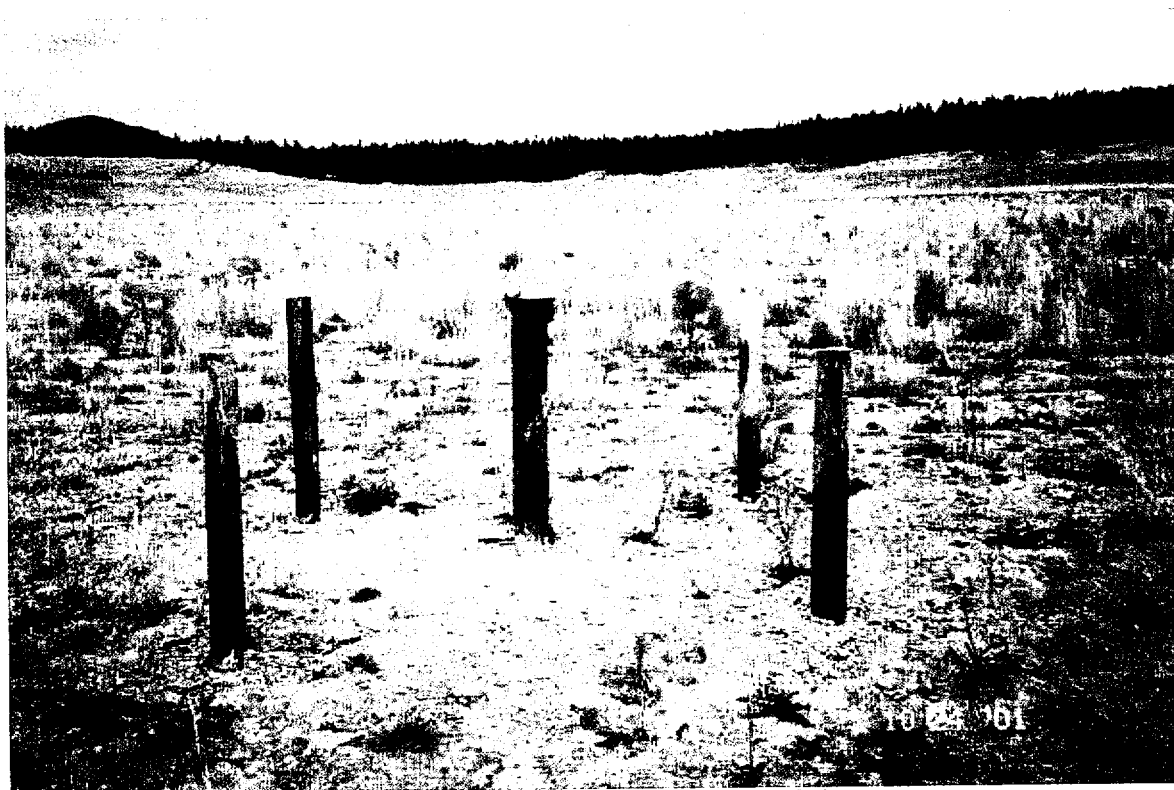
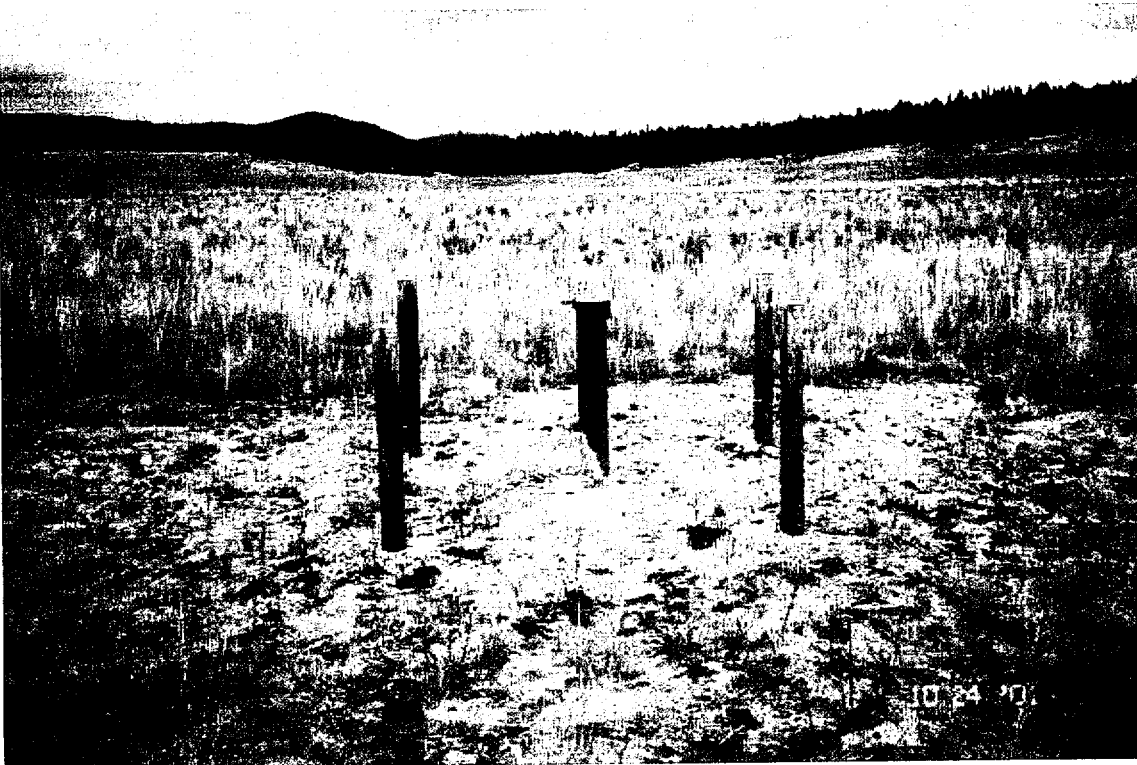
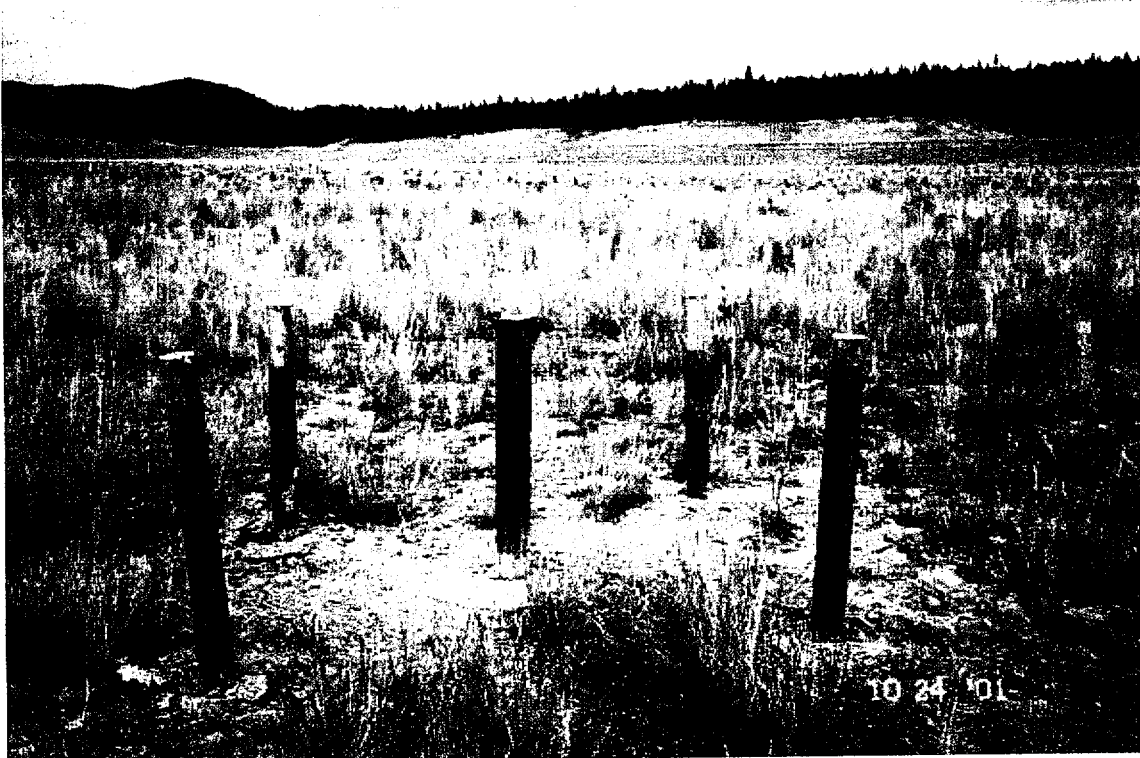
Four piezometers along the crest of the tailings dam, designated PZ-1 through PZ-4, are shown in PL-12 through PL-15. The piezometers were installed in November 2000 as part of the Dam Safety Inspection program. The piezometers are used to determine if saturation conditions exist within the tailings dam. At the time of installation PZ-2 contained slightly more than three feet of water. During the July 2001 sampling event PZ-2 contained slightly less than two feet of water. All other piezometers were dry at installation and dry during the July 2001 sampling event. Consequently the tailings dam is considered to be in an unsaturated condition, as desired.
