U.S. Department of Energy

Subject: 2001 Annual Site Inspection and Monitoring Compliance Report for UMTRCA Title II
Disposal Sites

2001 Annual Site Inspection and Monitoring Compliance Report for Uranium Mill Tailings Radiation Control Act Title II Disposal Sites

**2001 Annual Site Inspection and Monitoring
Compliance Report
for
Uranium Mill Tailings Radiation Control Act
Title II Disposal Sites**

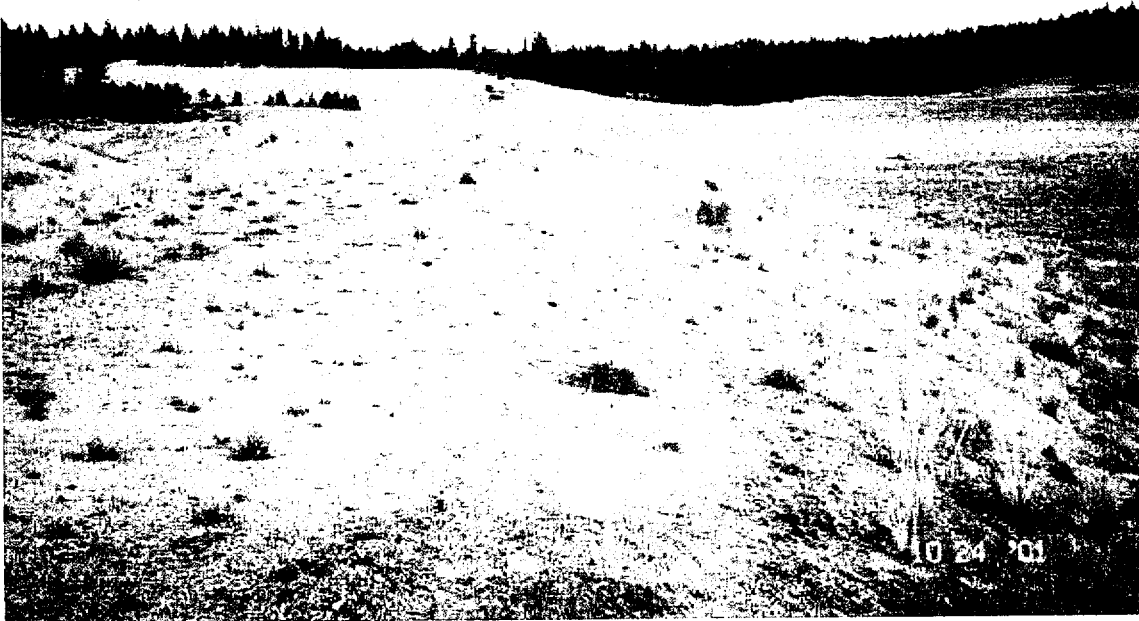
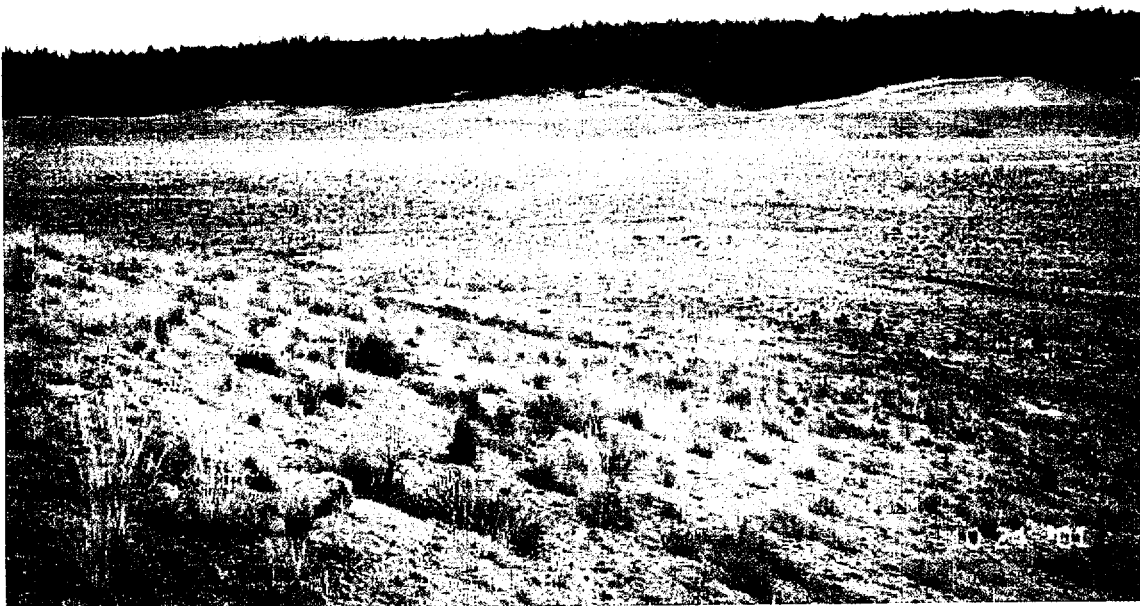
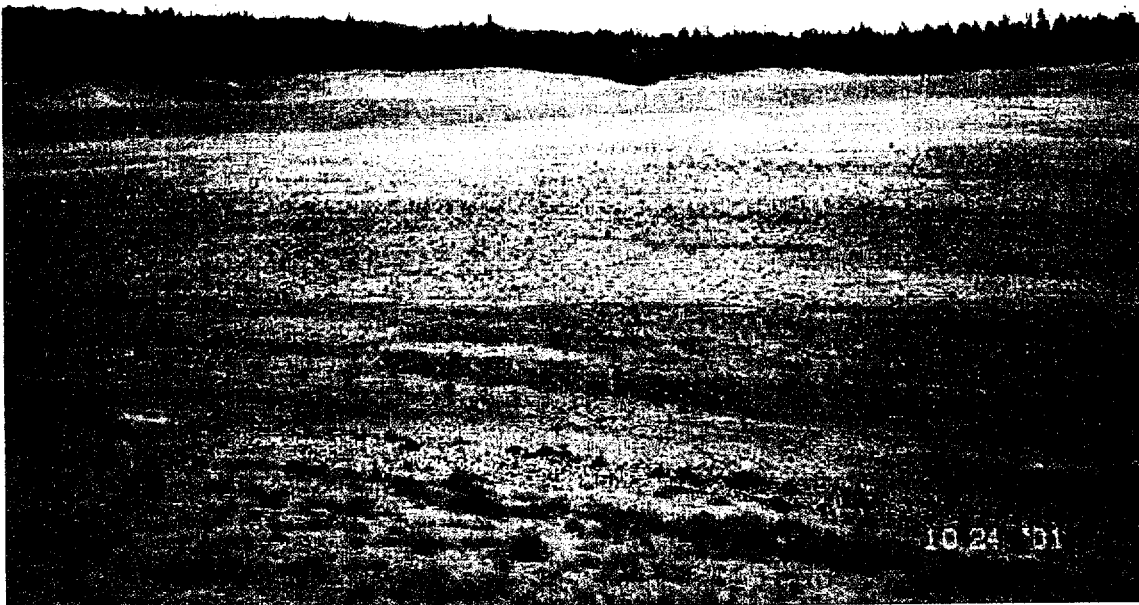
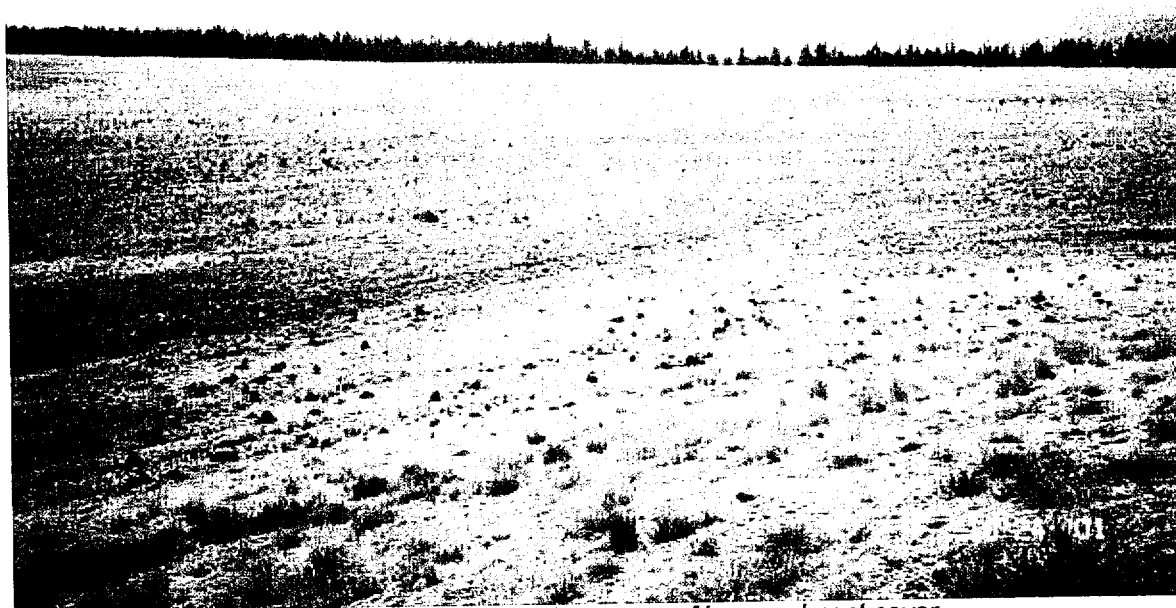
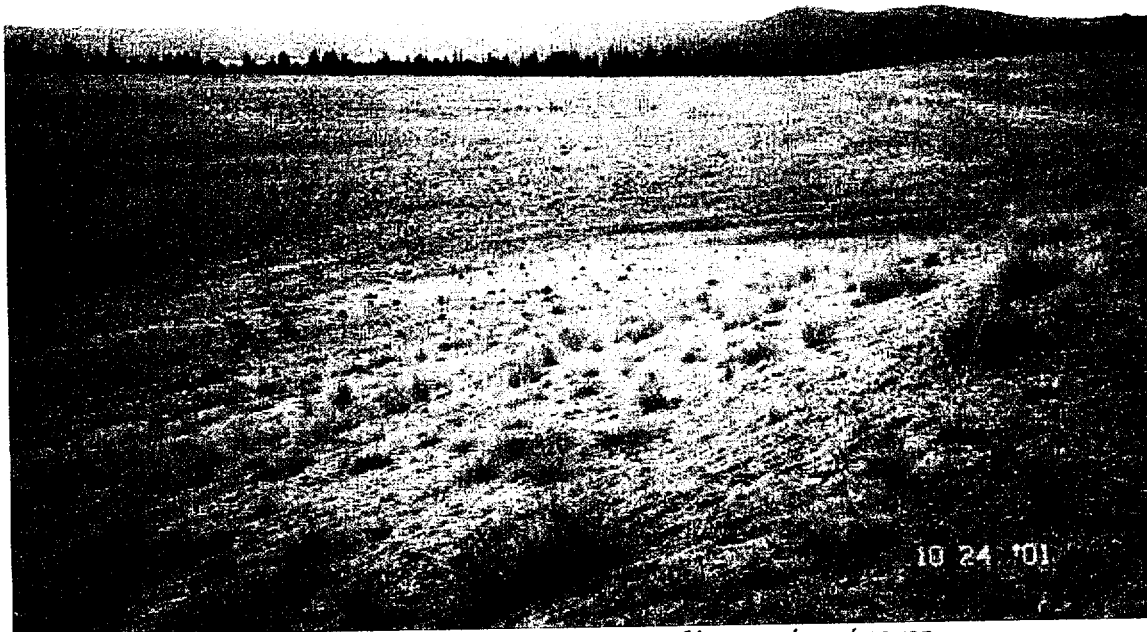
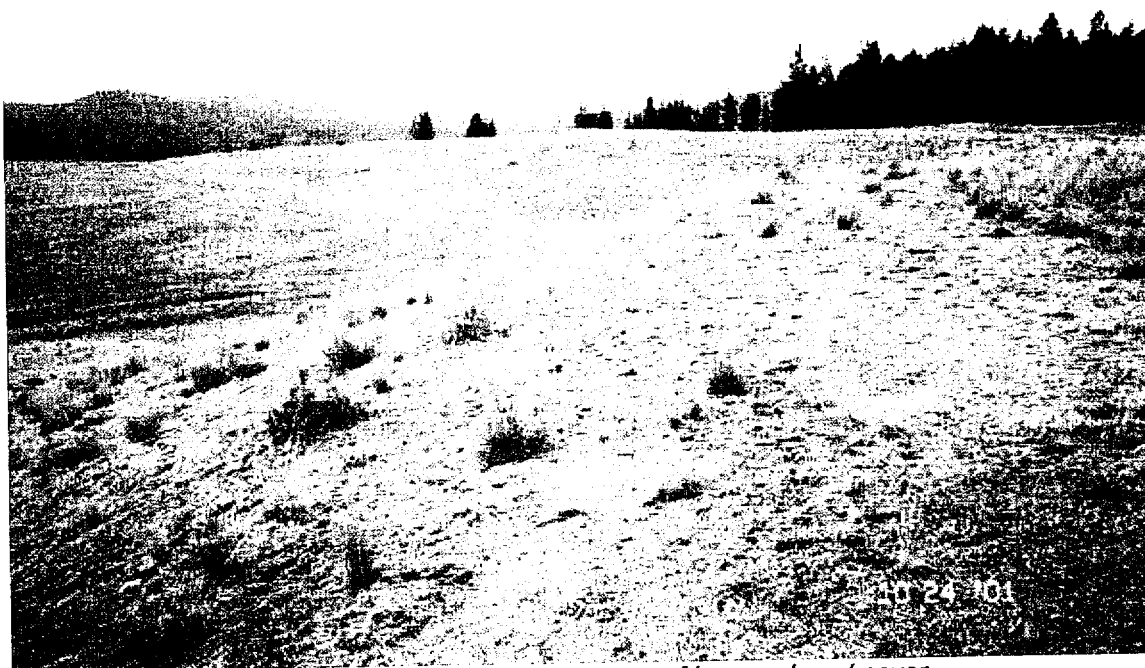
The tailings impoundment cover for the Sherwood site consists of 12 to 20 feet of uncompacted soils. Trees, shrubs, forbs, and grasses have been planted on the cover to accelerate the revegetation of the disturbed cover soils. A panoramic overview of the tailings impoundment cover is shown in photographs PL-16A through PL-16H. Inspectors walked parallel traverses across the impoundment cover to inspect this transect. There was no evidence of differential settlement other than the pond area observed during earlier orientation inspections. The pond area did not appear to have expanded in size.

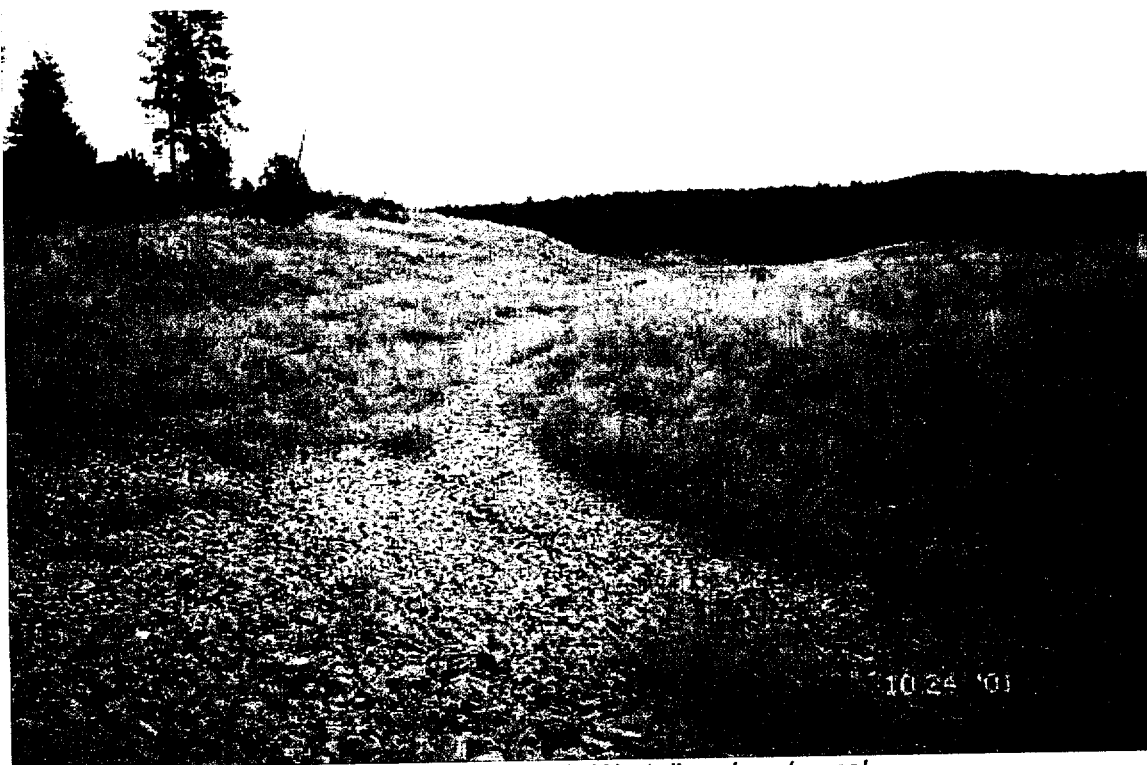
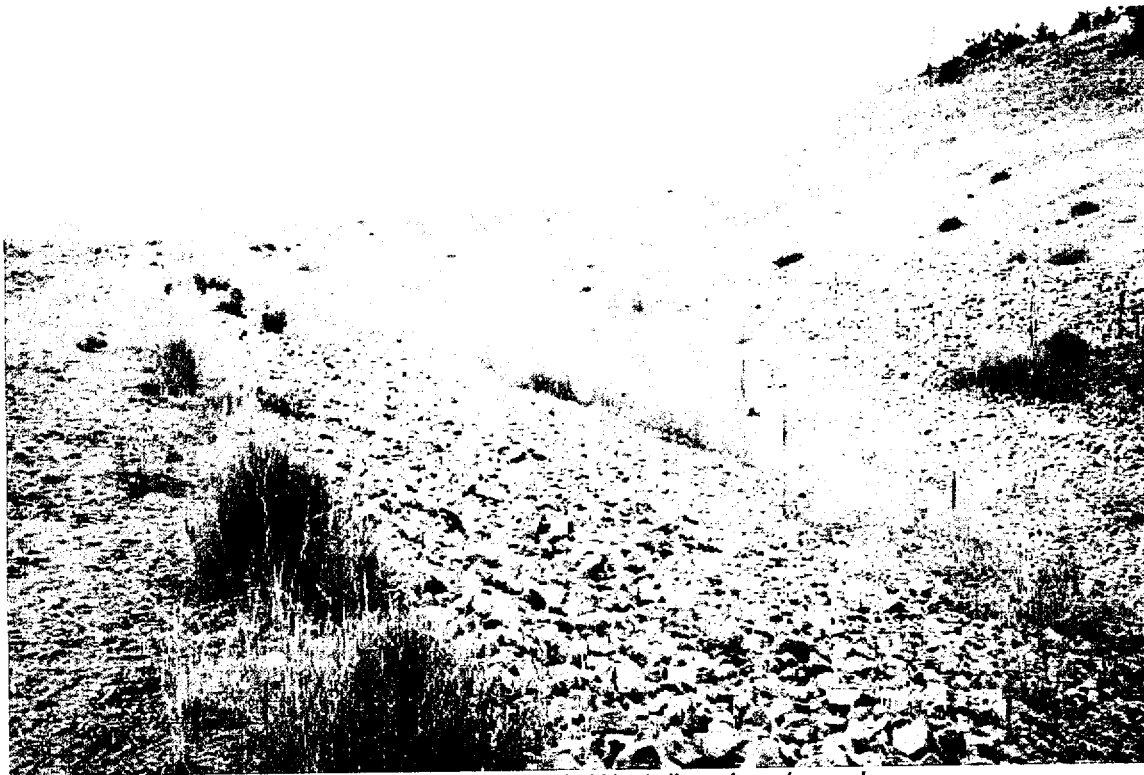
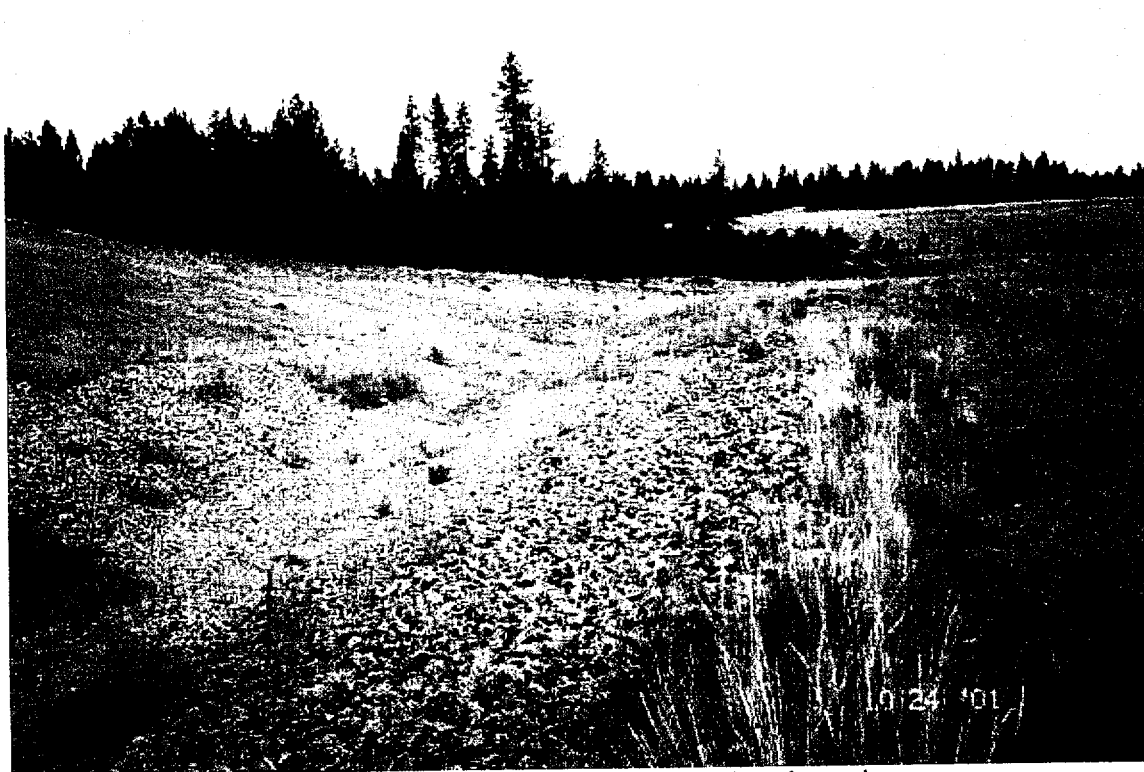
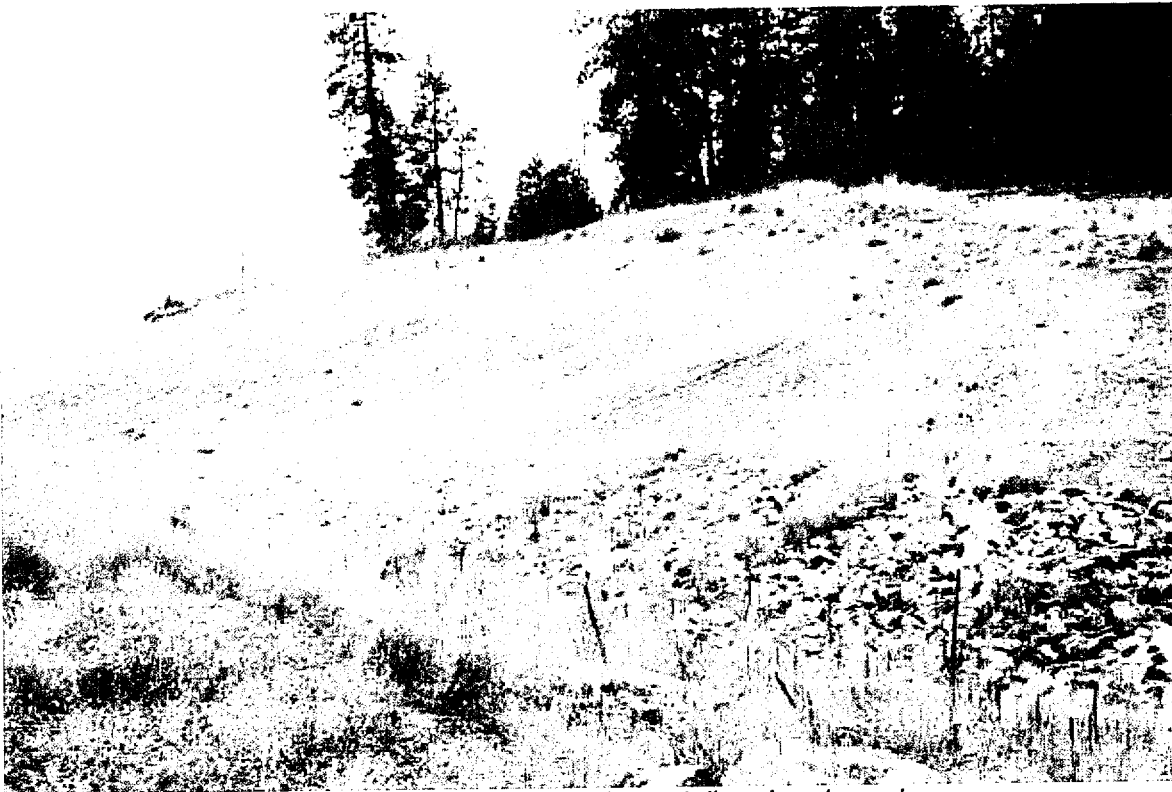
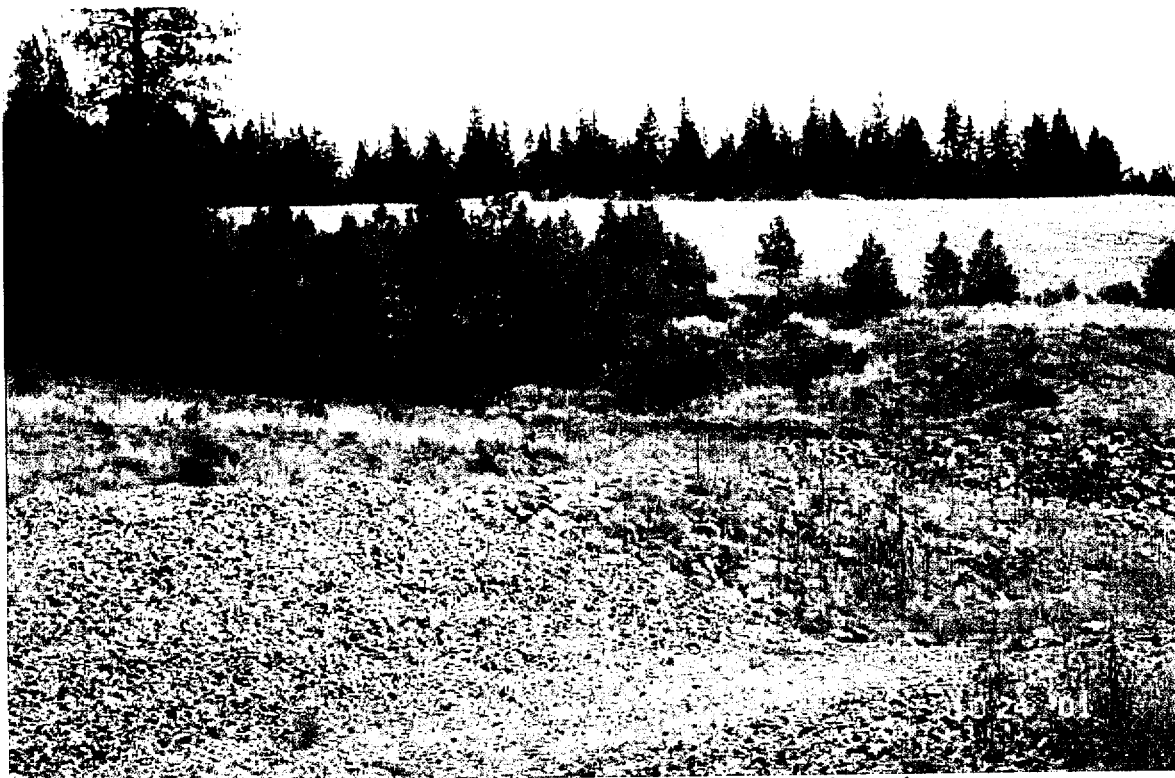
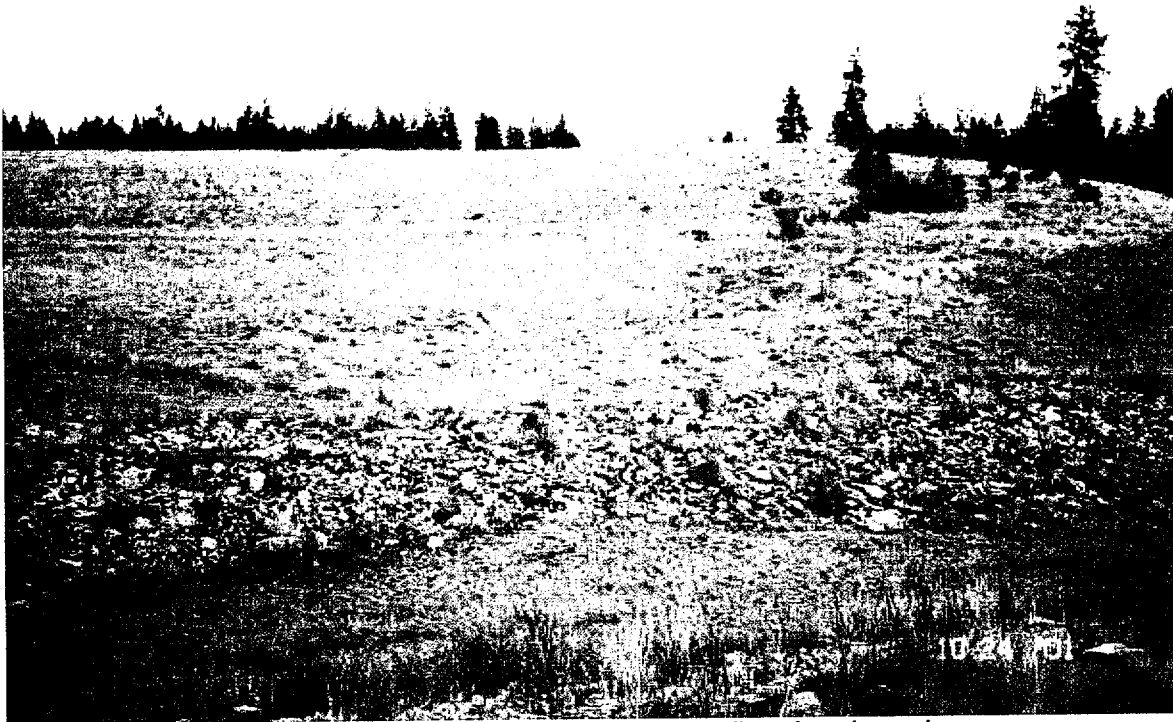
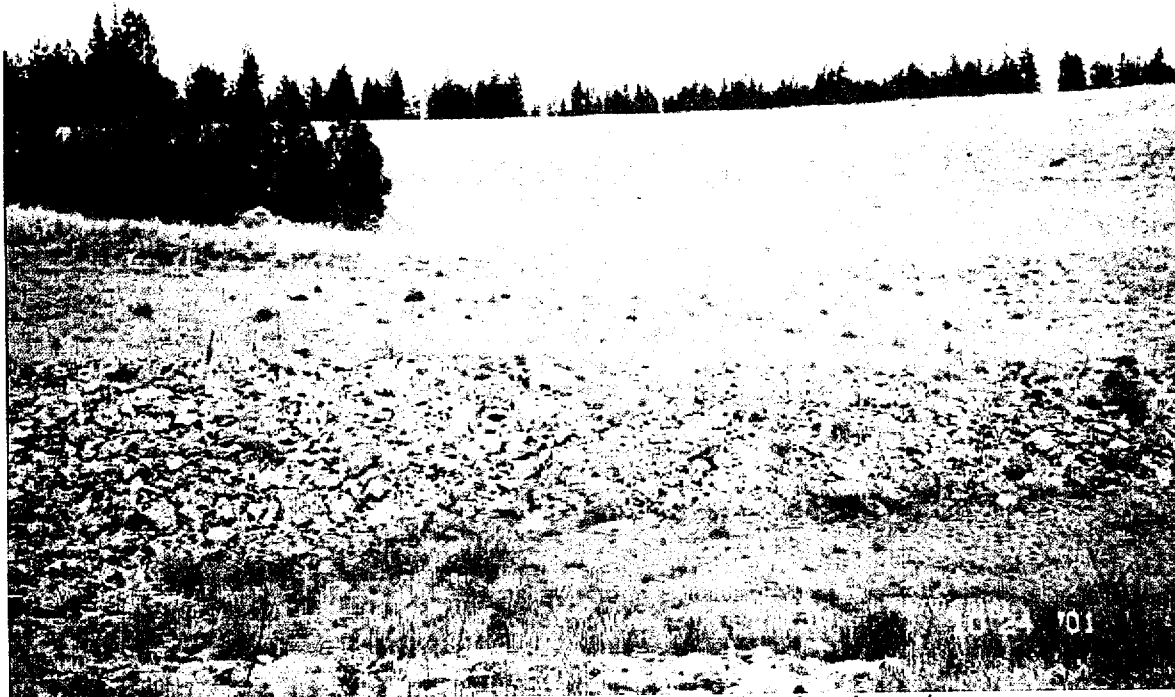
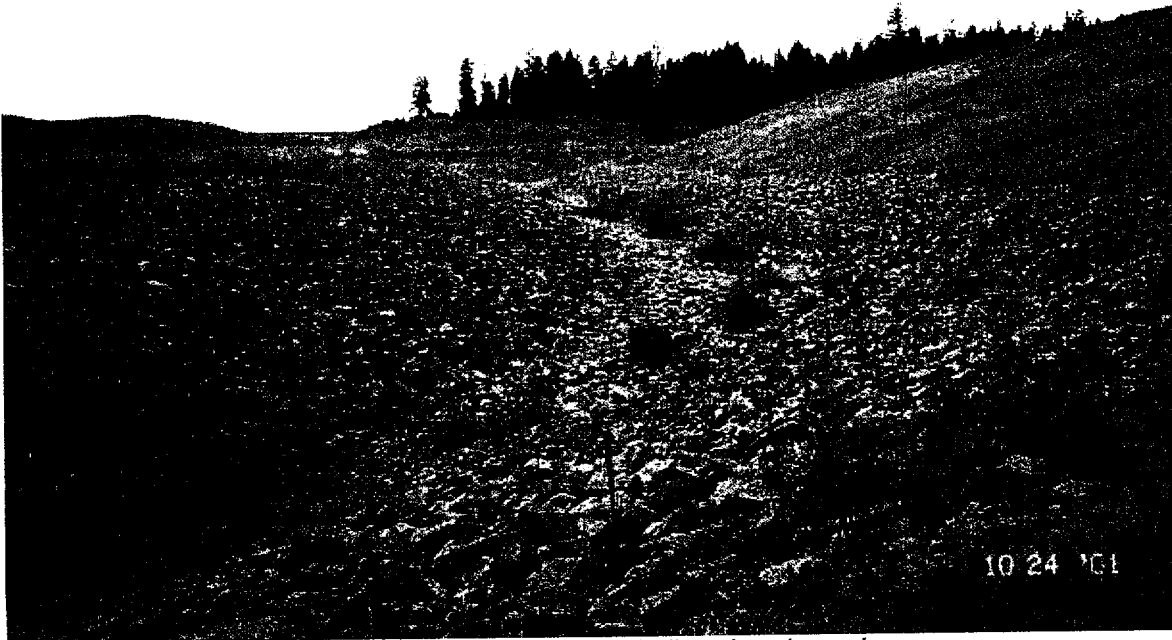
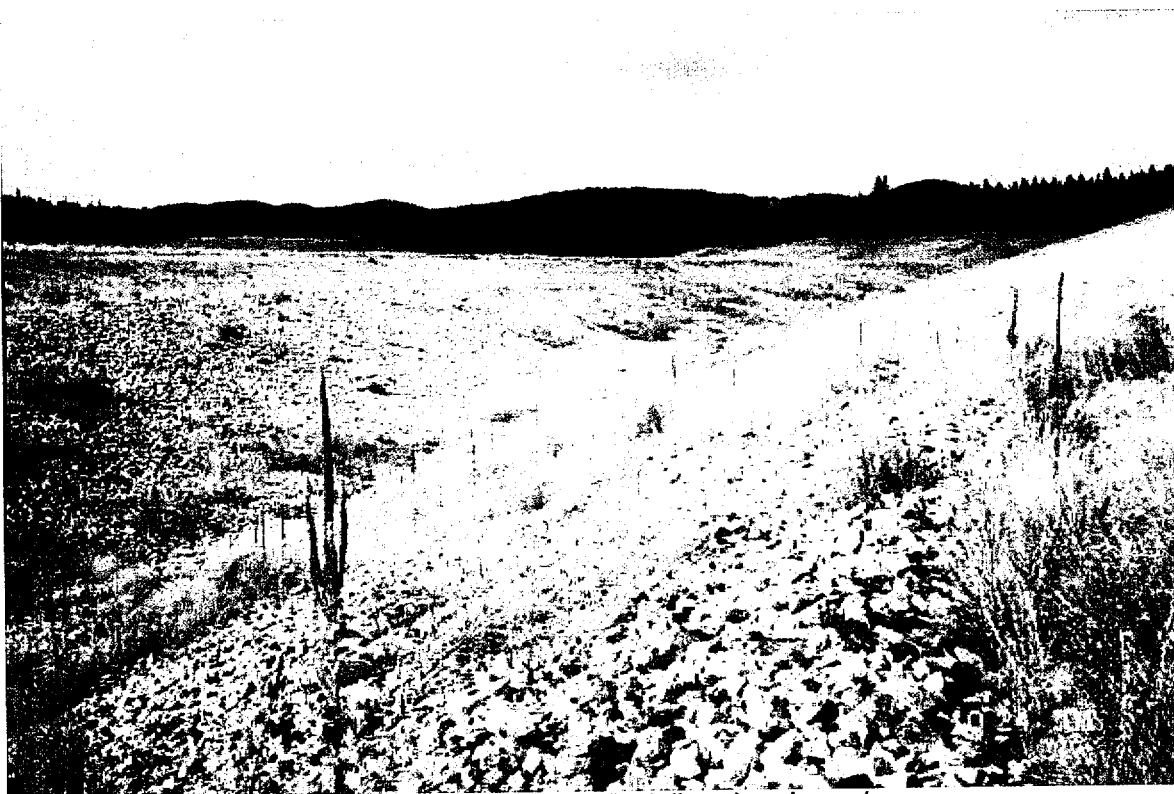
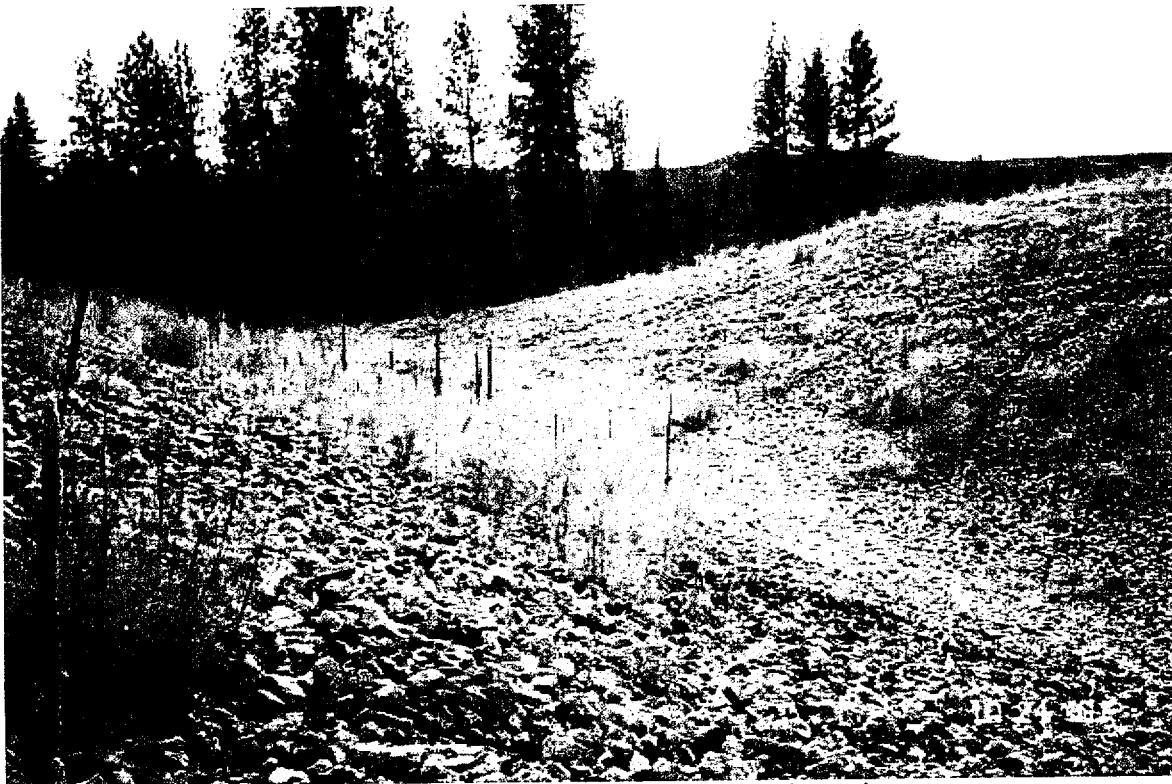
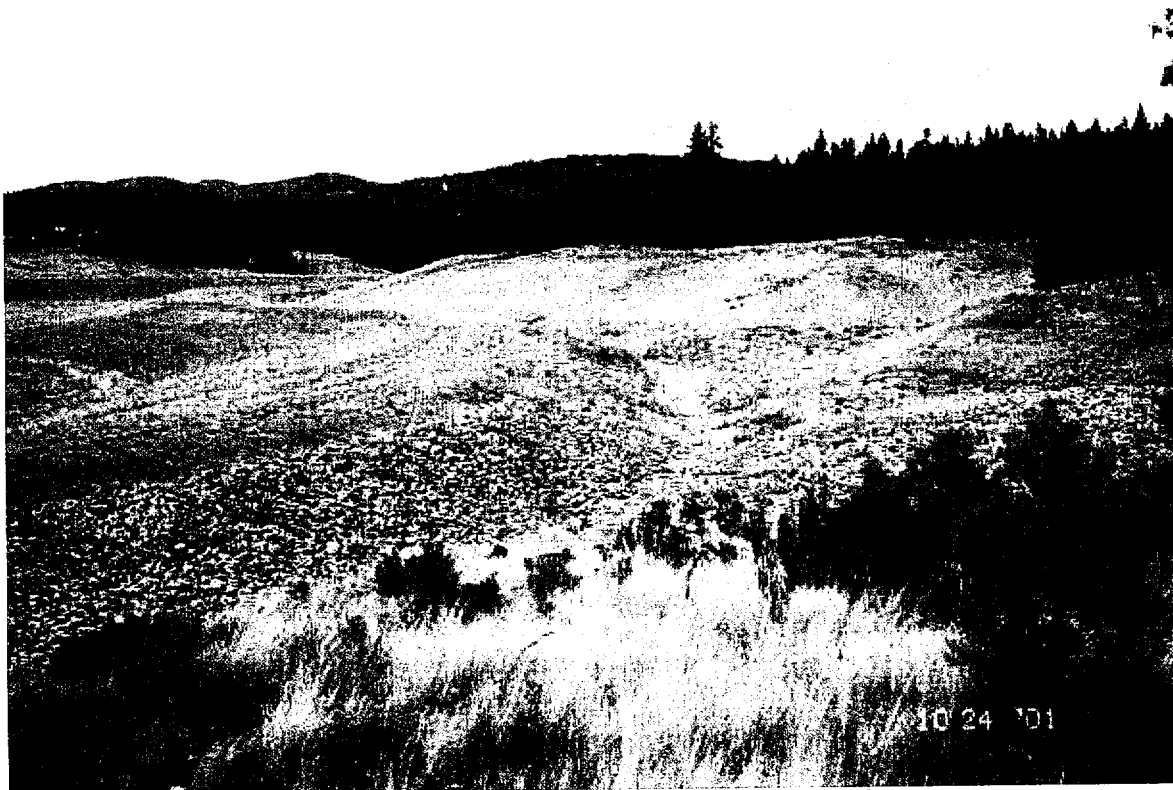
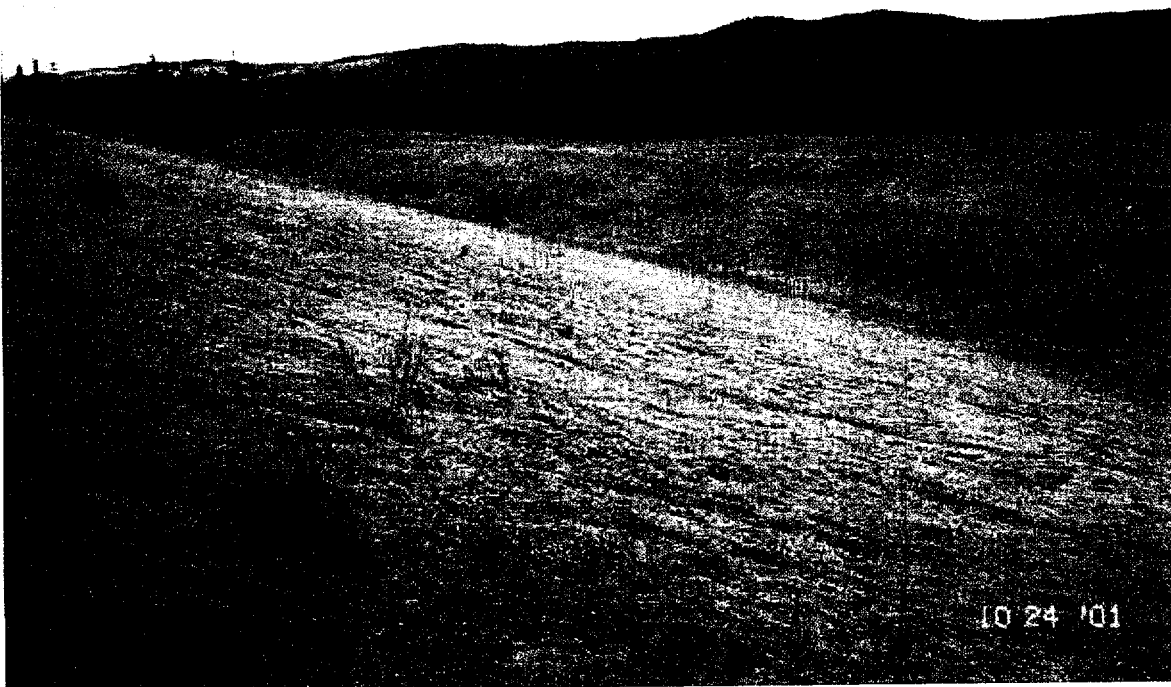
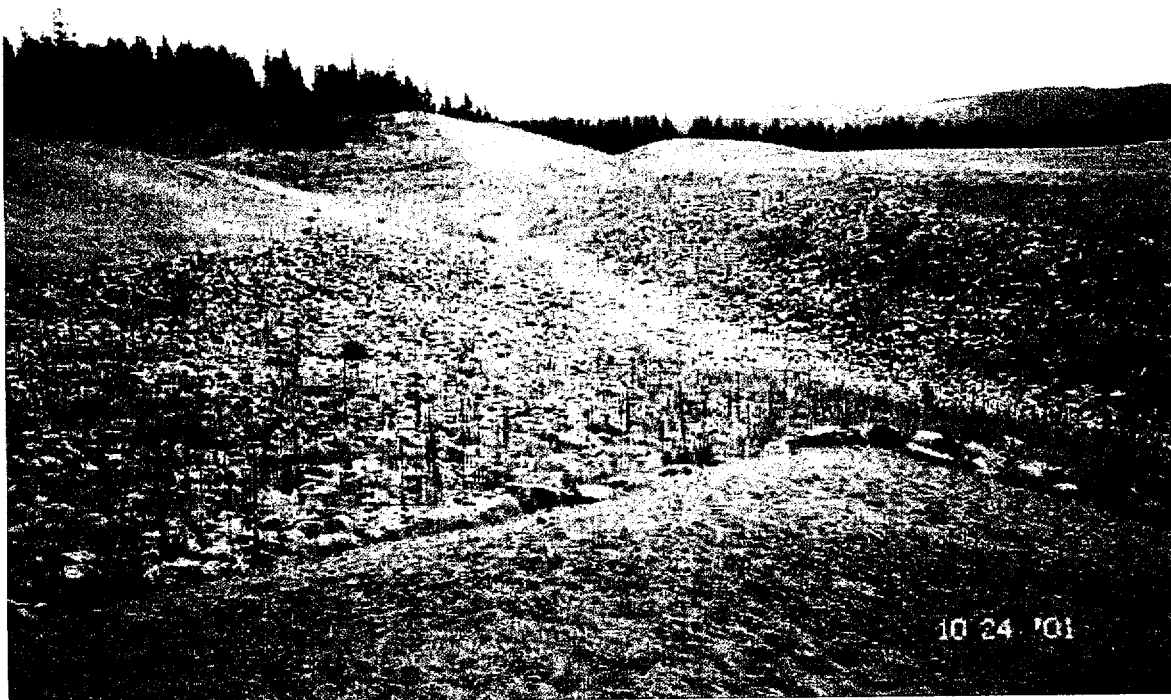
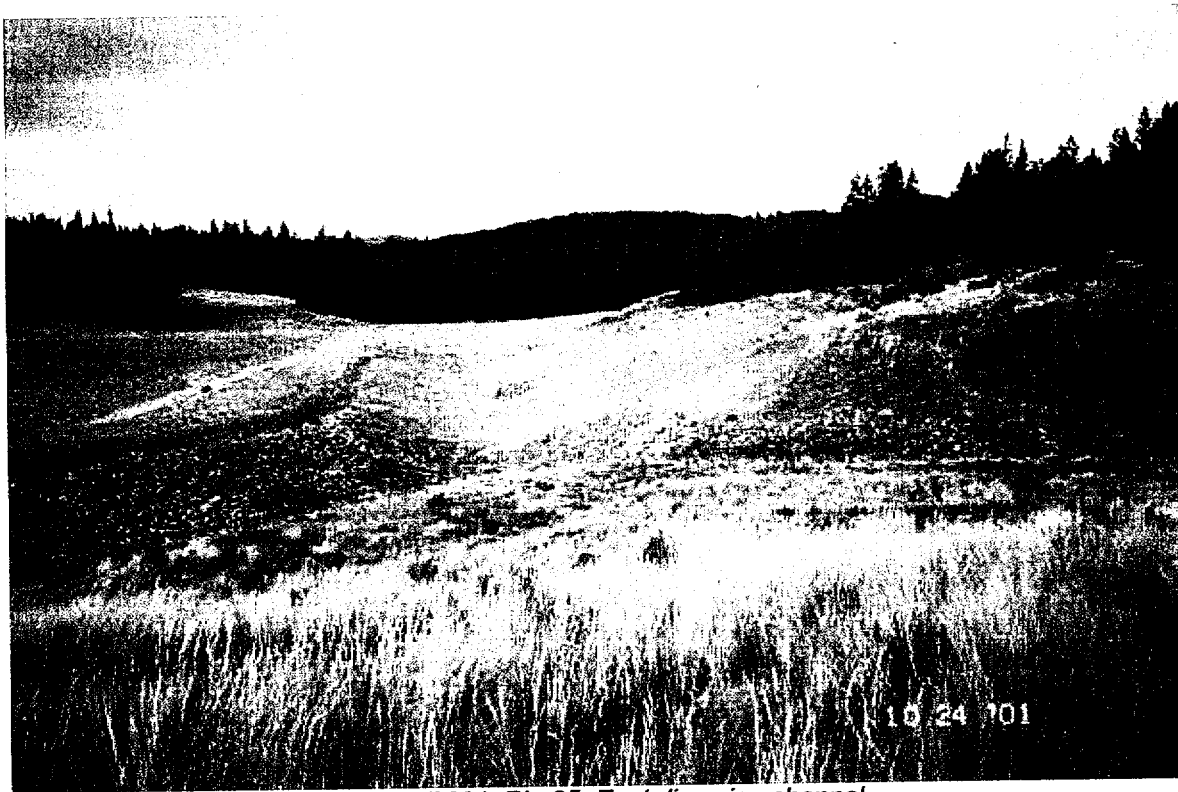
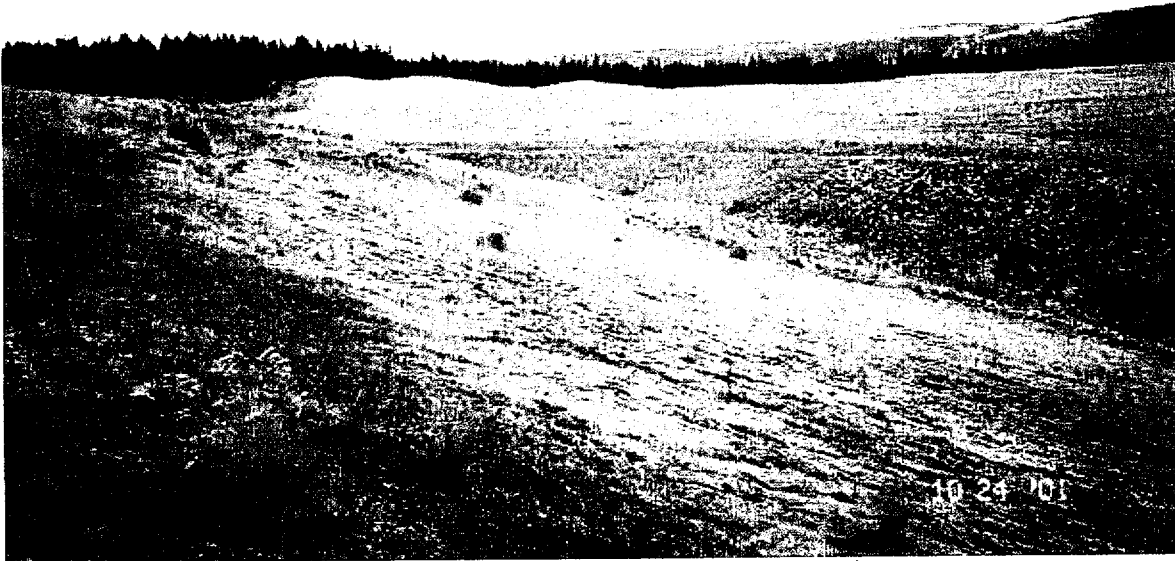
Inspectors walked the length of the diversion channel and took a series of photographs (PL-17 through PL-26). Volunteer plant intrusion within the diversion channel is evident in most of the photographs. This plant intrusion is not expected to interfere with the design function of the diversion channel. Riprap placement and rock condition are the same as observed during earlier orientation inspections. Sediment deposition is evident in places on the west side of the diversion channel (PL-20A and PL-20B). Sediment deposition currently does not interfere with the design function of the diversion channel. The degree of sediment deposition should be noted during future inspections although it is not expected to increase to the degree that it could become a maintenance issue. Standing water was observed in the channel along the east side of the impoundment (PL-24B).

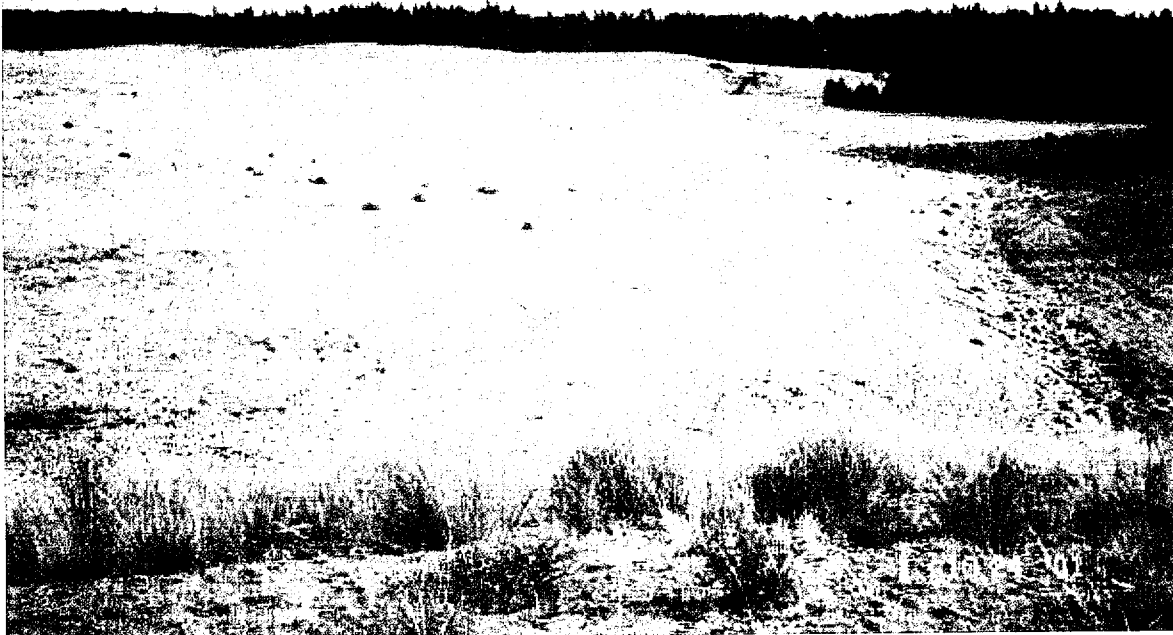
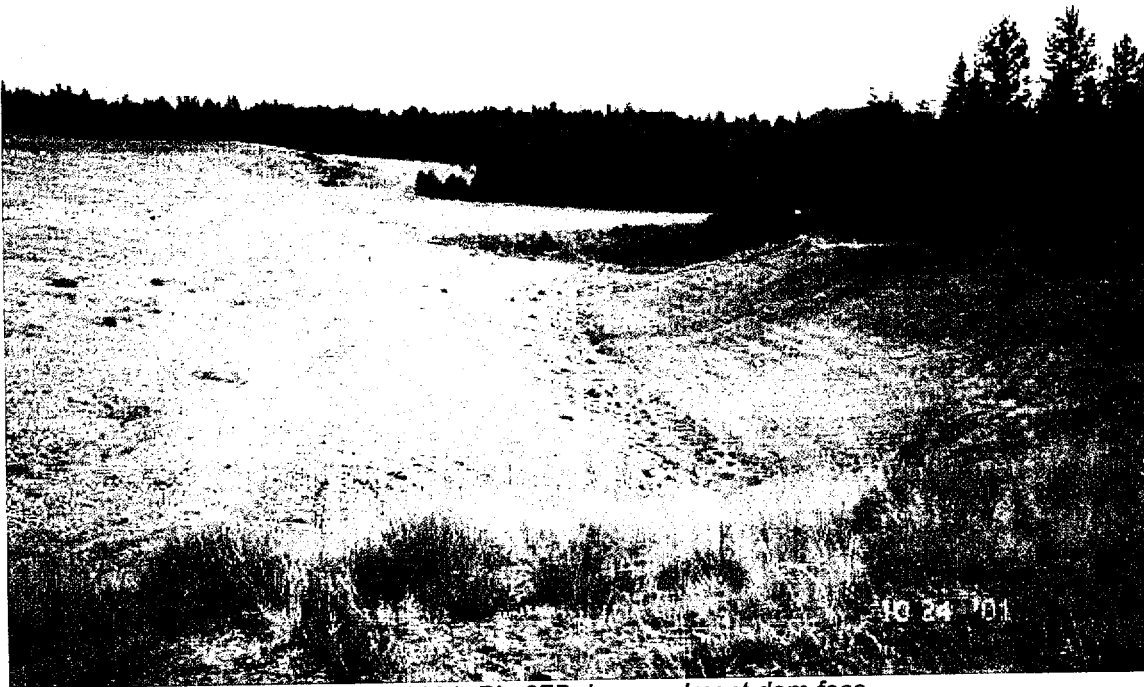
The impoundment dam face was inspected and photographed (PL-27A and PL-27B). The dam was inspected in accordance with the appended Dam Inspection Checklist (see Appendix A). No evidence of seepage, slumping, erosion, or instability was observed. In July 2001 water level measurements were made in the four piezometers installed across the crest of the dam to evaluate dam saturation conditions. Piezometer PZ-2 had 1.95 feet of water in the bottom of the casing. Piezometers PZ-1, PZ-3, and PZ-4 were dry. PZ-2 had 3.05 feet of water upon installation in November 2000. These results demonstrate that the impoundment dam continues to exist in an unsaturated state. Photograph PL-28 shows an undesirable weed species (dalmation toadflax) growing on the dam face.
