Subject: **Docket Nos. 50-361 and 50-362**  
**Voluntary Report**  
**Licensee Event Report No. 2002-001**  
**San Onofre Nuclear Generating Station, Units 2 and 3**

LER No. 2002-001

<b>FACILITY NAME (1)</b> San Onofre Nuclear Generation Station (SONGS) Unit 2				<b>DOCKET NUMBER (2)</b> 05000-361	
				<b>PAGE (3)</b> 1 of 7	
<b>TITLE (4)</b> Aging Phenomenon Affects Certain Potter and Brumfield Relays					
<b>EVENT DATE (5)</b>			<b>LER NUMBER (6)</b>		<b>REPORT DATE (7)</b>
MONTH	DAY	YEAR	YEAR	SEQUENTIAL NUMBER	REVISION NUMBER
09	11	2001	2002	001	00
			01	29	2002
			<b>OTHER FACILITIES INVOLVED (8)</b>		
			<b>FACILITY NAME</b> SONGS Unit 3		<b>DOCKET NUMBER</b> 05000-362
			<b>FACILITY NAME</b>		<b>DOCKET NUMBER</b>
<b>OPERATING MODE (9)</b> 1		<b>THIS REPORT IS SUBMITTED PURSUANT TO THE REQUIREMENTS OF 10 CFR §: (Check all that apply) (11)</b>			
<b>POWER LEVEL (10)</b> 100

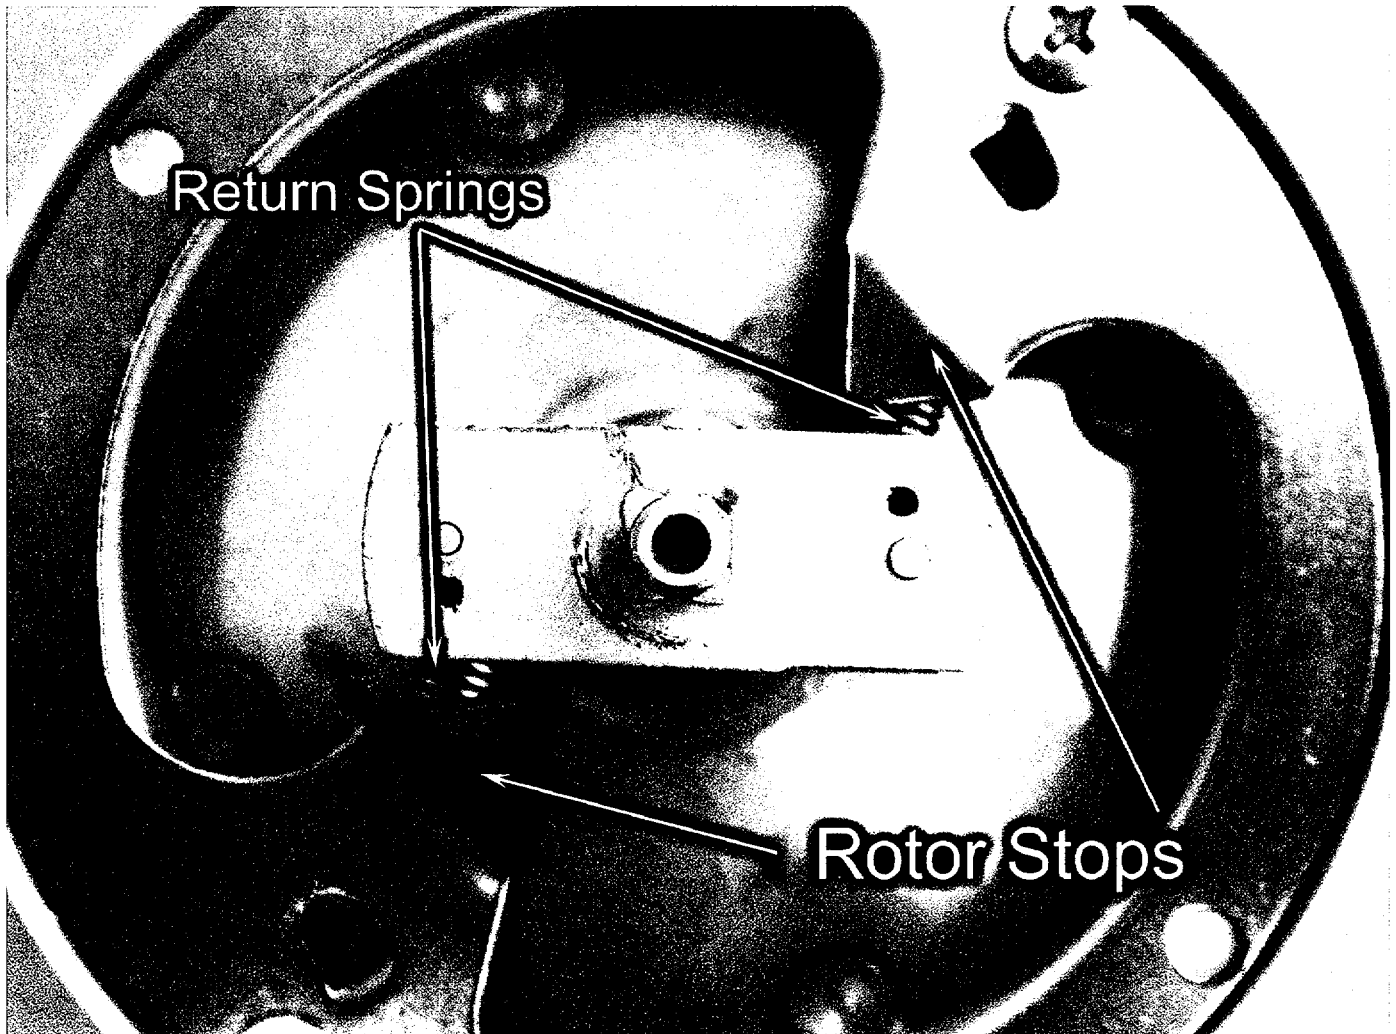
**Figure 2**

On September 14, 2001, SCE determined the shaft of relay 2L035K402 would not fully counter-rotate to its zero-degrees stop position when de-energized. SCE continued to perform a detailed cause evaluation, which included the use of a Scanning Electron Microscope to examine various components within the relay. During this time, SCE had ongoing discussions with P&B. During November 2001, SCE met with P&B at their facility in Greensboro, North Carolina and analyzed a second sample of the same type and vintage relay. In November 2001, SCE conducted additional laboratory analyses to quantify the degradation of the relay components. P&B confirmed that the springs were within their design specifications on December 28, 2001 and were not a factor in the relay failure. On January 11, 2002 (discovery date), SCE completed the cause evaluation, concluding that the self-lubricating nylon hub in deck 1 of the form "Y" contacts (i.e., closest to the relay coils and the heat they generate) had deteriorated such that reinforcing glass fibers in the nylon were creating an abrasive interface. The increased friction prevented the shaft from rotating to its zero position (Figure 2). Consequently, relay 2L035K402 failed to close contacts 4L-4M, which prevented 2HV4715 from closing.

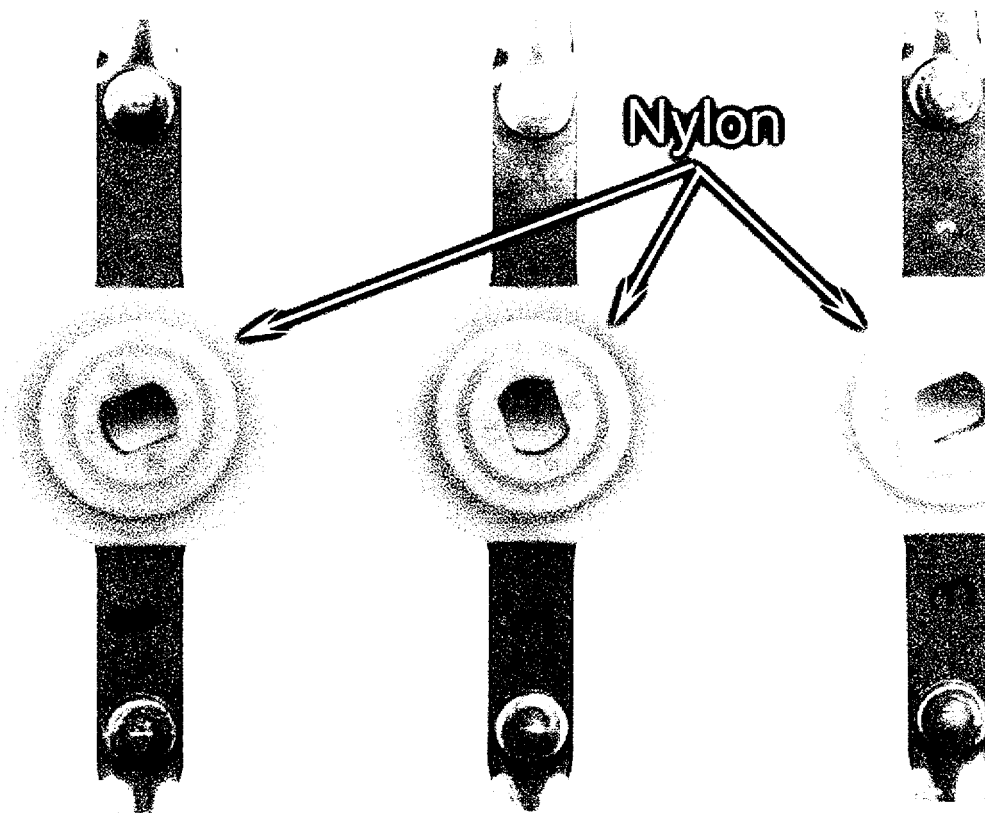
**Figure 3**

SCE determined the return springs of 2L035K402 would not fully rotate the relay shaft to its zero-degrees stop position when de-energized. A self-lubricating nylon hub in deck 1 of the form "Y" contacts (i.e., closest to the relay coils and the heat they generate) had deteriorated such that reinforcing glass fibers in the nylon were creating an abrasive interface.

The primary factor, which increased the frictional force (drag) associated with the main form "Y" contact blocks, was the slow, age-related degradation of the movable nylon hub (Figure 3). Scratching on the "Y" contacts was a secondary factor that increased friction. This cumulative friction eventually overcame the spring return force and prevented the relay from fully counter-rotating to its fail safe "zero degree stop" position.

**Photo of the movable contacts showing  
the age/heat damage to the Nylon**

SCE has determined that there is no need to utilize the form "Y", high current contacts at SONGS Units 2 and 3. As such, a proactive approach will be implemented to replace all the SONGS P&B MDR-7032 relays with P&B MDR-7033 or P&B MDR-7034 relays, which do not contain form "Y" contact blocks.
