Re: Turkey Point Unit 3
Docket No. 50-250
Inservice Inspection Report

**TURKEY POINT
UNIT 3**

2001 REFUELING OUTAGE

**FLORIDA POWER & LIGHT COMPANY
TURKEY POINT NUCLEAR PLANT - UNIT 3&4
30TH YEAR
CONTAINMENT TENDON SURVEILLANCE**

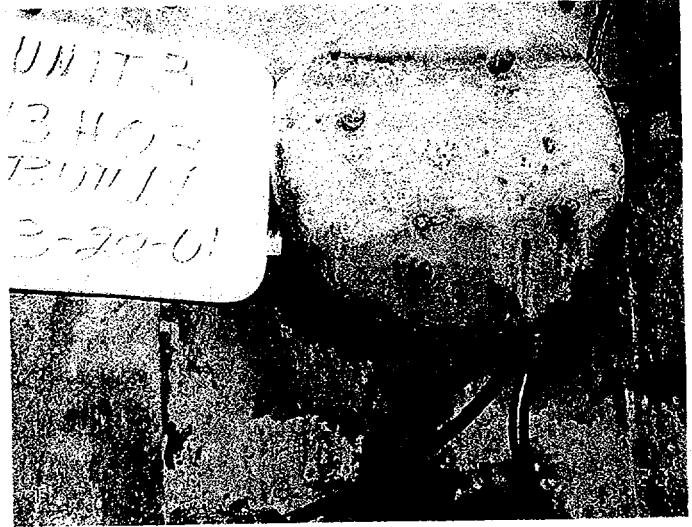
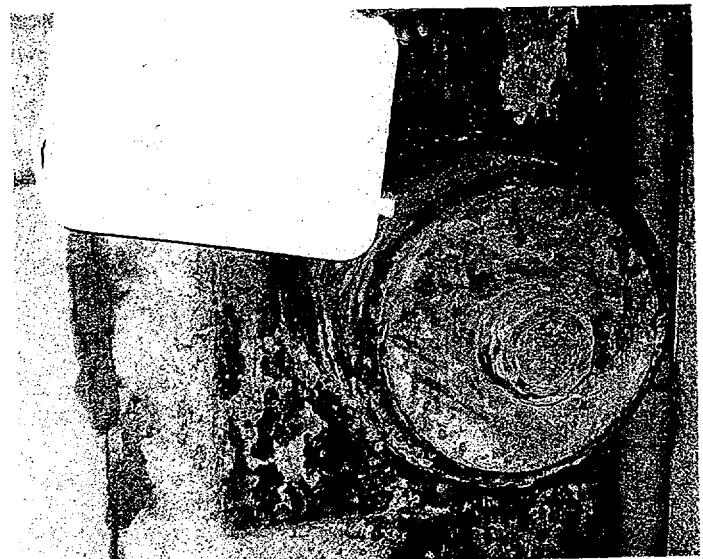
These pictures show the condition of the grease can and bearing plate on 31H01 to 31H03. However, once the cans were removed the anchorages were in good condition with no significant corrosion on any components and acceptable moisture content in the grease samples.

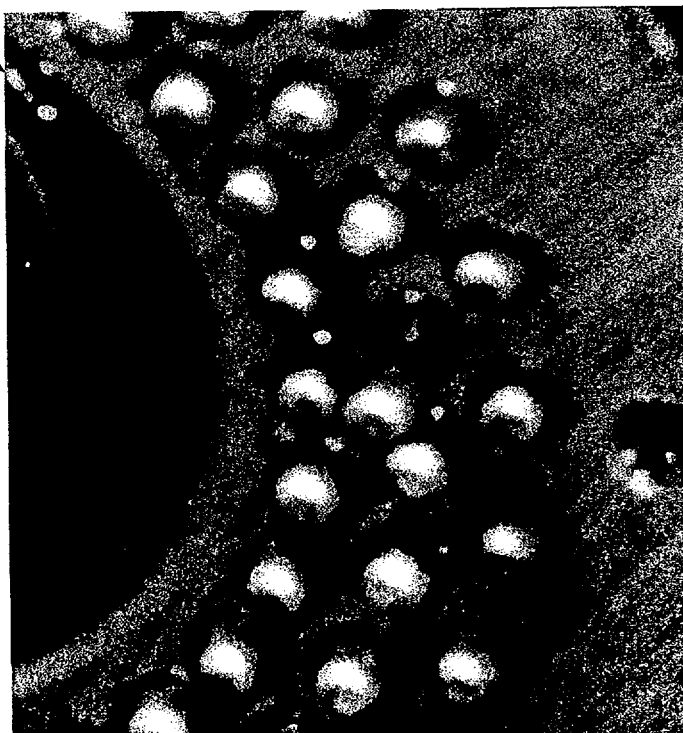
Protruding wire found to 1D49
between buttress 2 and 1.

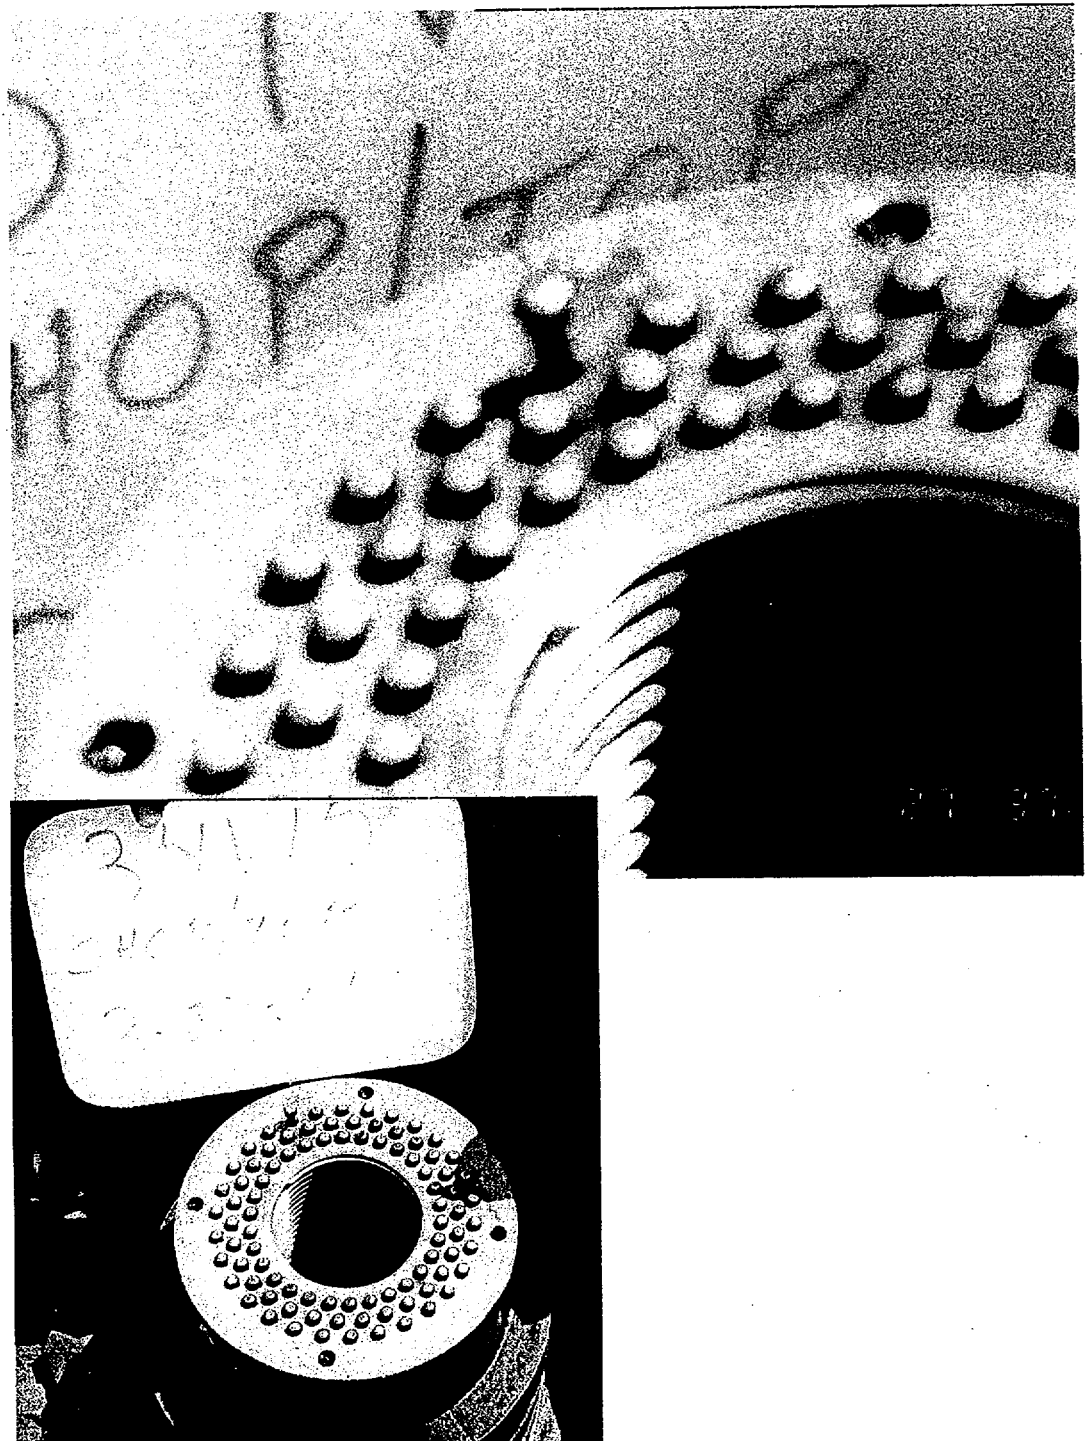
Tendon 34V15 exceeded the 10% by weight for water/grease content. Engineering disposition requires the tendon to be detensioned for corrosion evaluation, grease changed and the tendon refilled with new grease. Refer to CR No. 01-0801 sup. 1 and 4.

Protruding wire found to the
shop (top) end of 34V15.

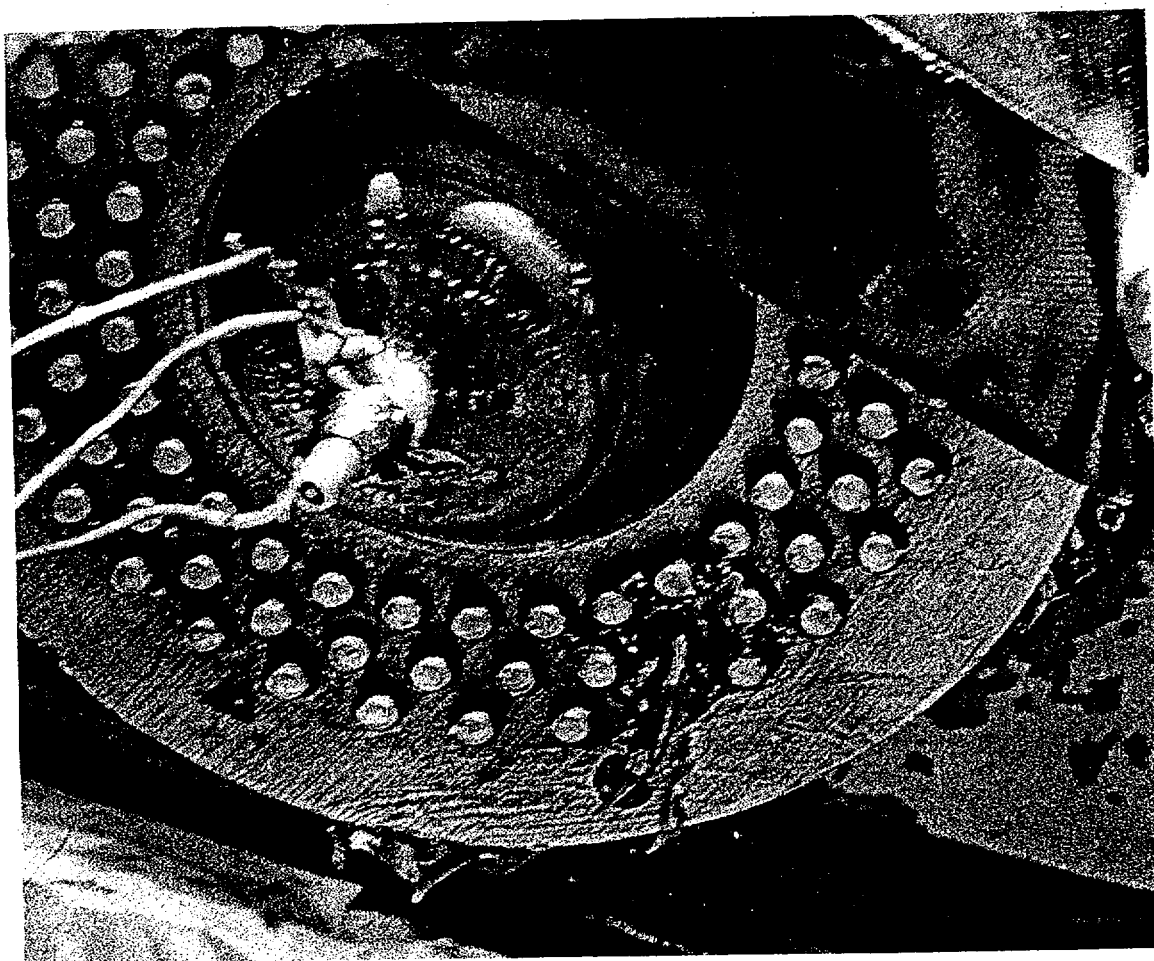
Missing wire found on the field end of 2D18 Unit 3.
