LICENSEE EVENT REPORT (LER)

Indian Point No. 2

05000-247

Manual Reactor Trip Following Steam Generator Tube Rupture

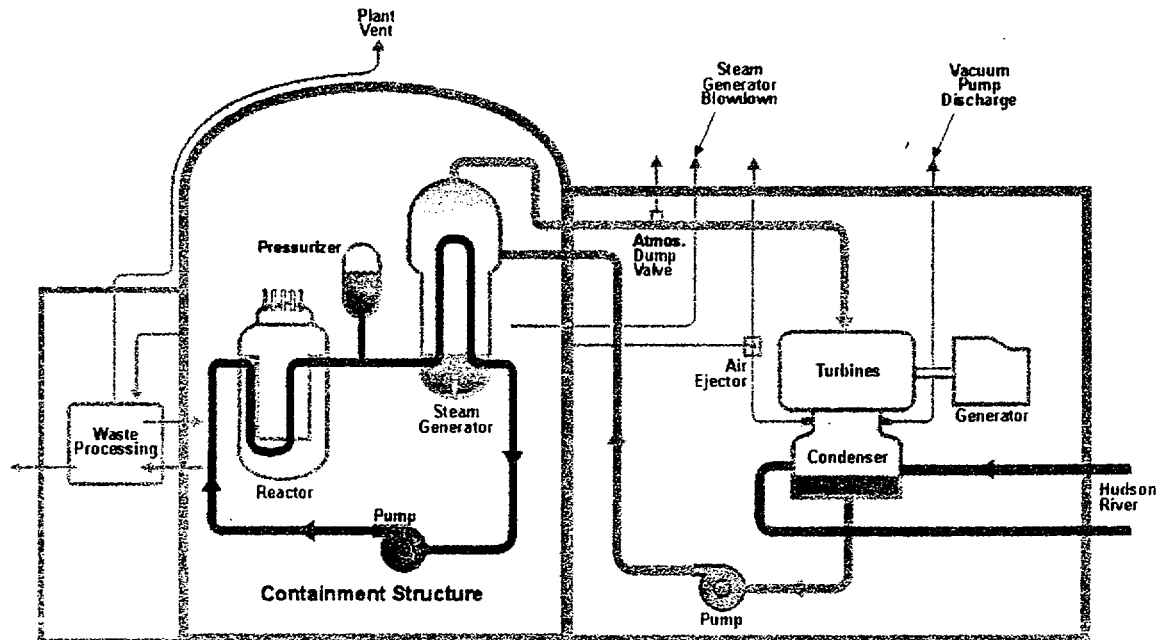
**IP2 STEAM GENERATOR TUBE LEAK (2/15/00)
RADIOLOGICAL RELEASE PATHS**

No releases in excess of Technical Specification limits to unrestricted areas occurred. There was no detectable increase in normal background levels of radioactivity as measured by offsite environmental sampling and monitoring equipment. All potential radioactive gaseous and liquid effluent release paths have been evaluated in a bounding release calculation.

This bounding calculation considered potential releases from the condenser air ejector, the atmospheric relief valves, the Steam Generator Blowdown Flash Tank, and from the gland seal exhaust. The calculated maximum whole body total dose at the site boundary for the Alert period, resulting from all potential releases, was a small fraction of the permissible annual dose. The calculated maximum organ total dose was a small fraction of the permissible annual dose.
