Subject: Duke Power Company, Oconee Nuclear Station, Unit 3
Docket No. 50-287
Vessel Head Penetration Nozzle Condition Report

**Oconee Unit 3
End-of-Cycle 19 Refueling Outage
Reactor Vessel Head Penetration Nozzle Indication Report**

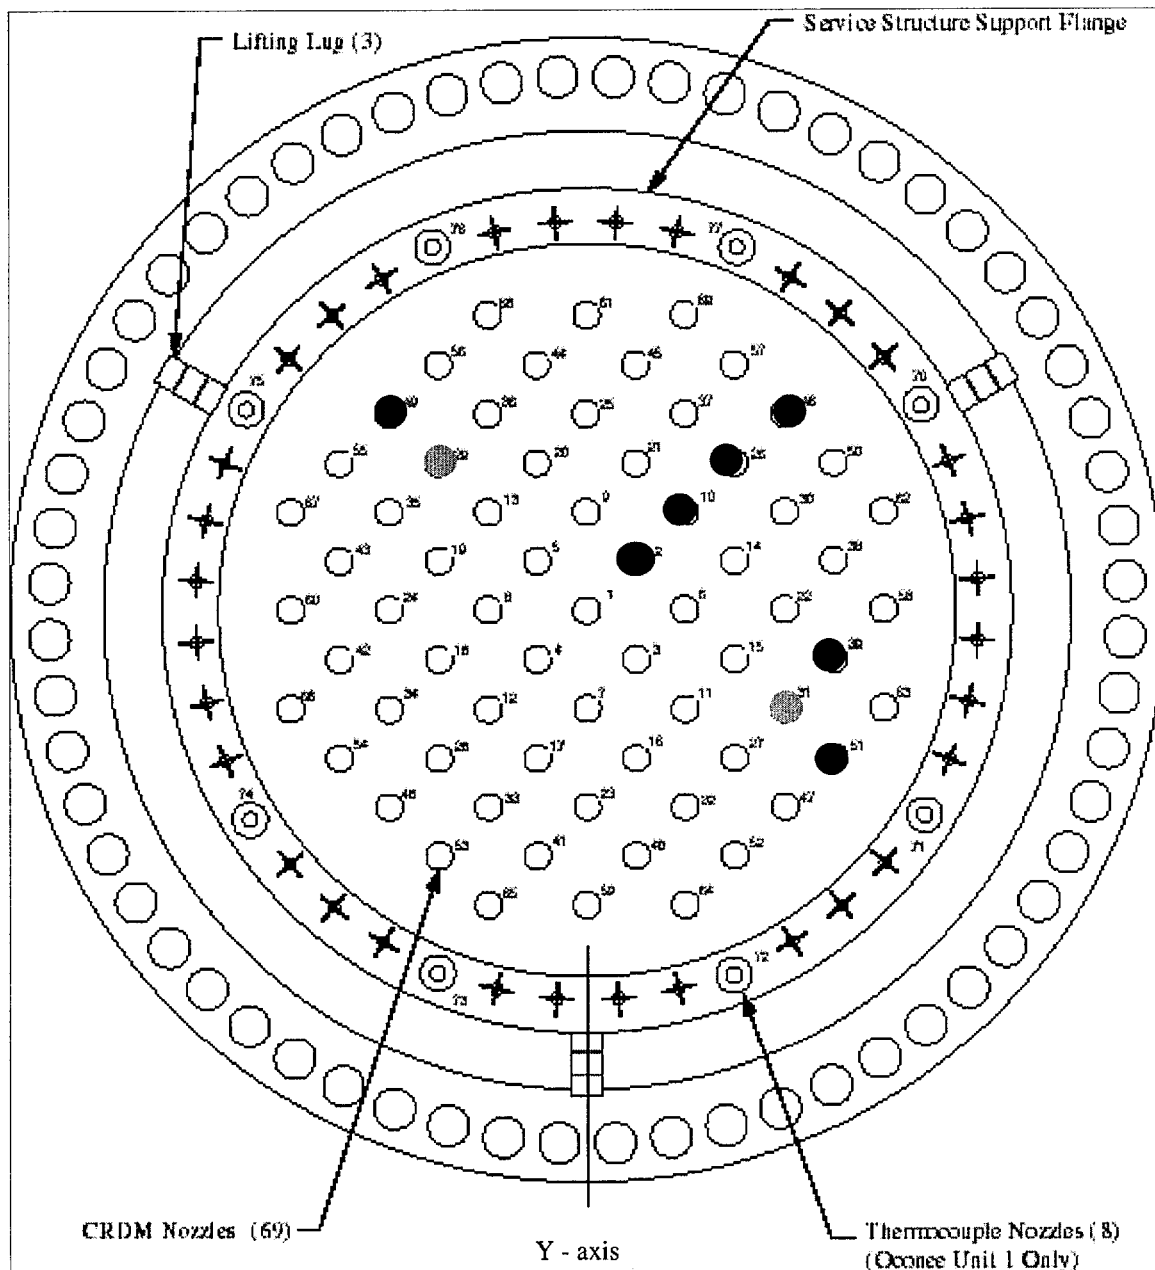
Figure 1 Oconee Unit 3 CRDM Nozzles Identified as Possible Leakers during RV Head Visual Inspection, During EOC 19 Refueling Outage, November 12, 2001

On November 12, 2001, during the EOC 19 refueling outage, a visual inspection of the top surface of the Oconee Unit 3 reactor vessel closure head showed evidence of primary water leakage on the vessel head surface. This inspection was performed in accordance with Duke Energy's response to NRC Bulletin 2001-01 as a "Qualified Visual" inspection. Boric acid deposits with a wet appearance were identified around four CRDM Nozzles (Numbers 26, 39, 49, and 51) and determined to be probable leak locations. Three additional CRDM Nozzles (Number 2, 10, and 46) were identified as being masked by boric acid crystals from an indeterminate leakage flow path and are therefore classified as possible leaking nozzles. Nozzles 2, 10, 26, and 46 all lie in a straight line running radially down the slope of the head such that if a nozzle were leaking the flow path could include the other three nozzles. This is the same visual inspection performed during the previous outages except that a VT-2 qualified inspector participated. The visual inspection was witnessed by a NRC resident inspector. Figure 1 shows the location of nozzles on RV head and the result of the visual inspection. Figures 2 through 4 provide digital photographs of the boric acid deposits associated with Nozzles 2, 10, 26, 39, 46 and 51.

- Four nozzles identified as possible leakers by top of head visual inspection (26, 39, 49, 51)
- Three nozzles masked by flow (2, 10 and 46)
- Additional CRDMs being removed for access to perform repairs (29, 31)

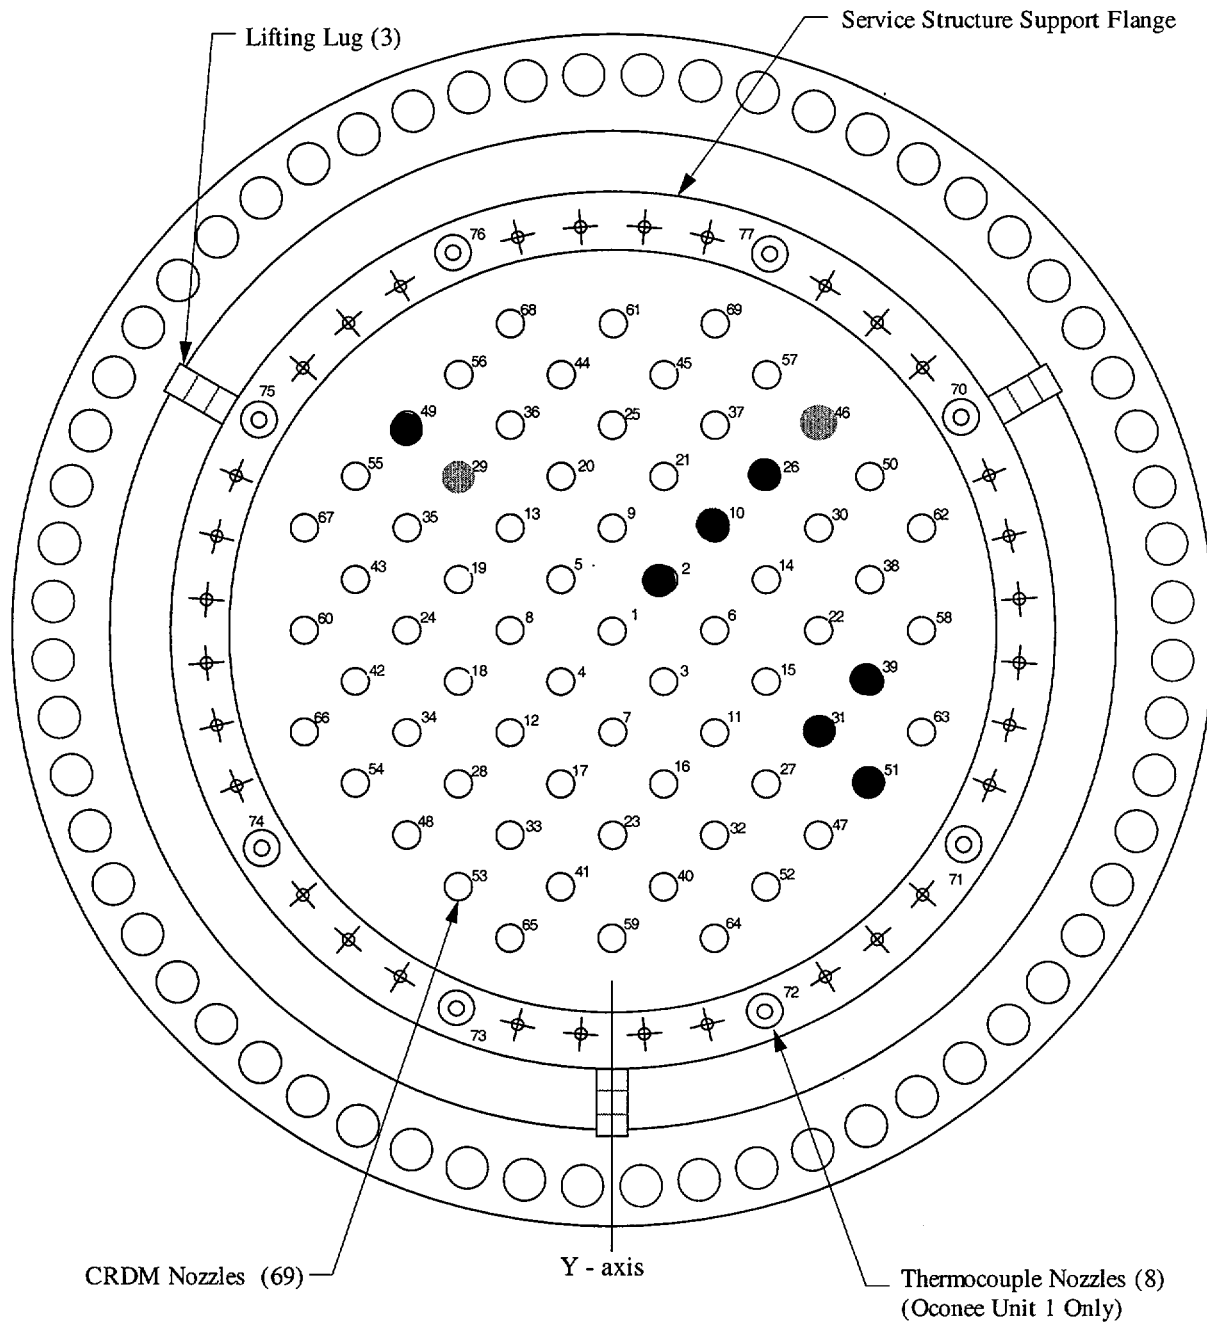
Figure 5 Oconee Unit 3 CRDM Nozzles "Top-Down" Ultrasonic Inspection Results, November 12, 2001

Nozzles 29 and 46 had no UT indications. Nozzles 2, 26, 39, 49, and 51 all had indications in the nozzles that extended from below the weld to above the weld indicating a leak path in addition to various other ID and OD indications. Nozzle 2, in addition, had a circumferential indication in the nozzle above the weld. Nozzles 10 and 31 each contained several OD nozzle indications located below the weld and extending slightly into the weld area, but they show no leak path. Table 1 provides a summary of the UT results giving the indications location within the nozzle with respect to the J-groove weld and its circumferential location with respect to downhill, along with estimated through nozzle wall dimension and indication length within the nozzle. An adjustment was made to the circumferential location such that the downhill location

- Five nozzles with UT results showing a leak path (2, 26, 39, 49, 51)
- Two nozzles with UT results showing short shallow axial indications on the nozzle OD (10, 31)
- No UT indications (29, 46)

Seven CRDM Nozzles (numbers 2, 10, 26, 31, 39, 49, and 51) were repaired during this outage using the automated Framatome-ANP "ID Ambient Temper Bead Repair" technique as described in the Relief Requests RR 01-14. Corrective action taken and future outage plans remain consistent with Duke's NRC Bulletin 2001-01 submittal.
