THREE MILE ISLAND, UNIT 1 (TMI UNIT 1)
OPERATING LICENSE NO. DPR-50
NRC DOCKET NO. 50-289

SUBJECT: AmerGen Response to NRC Bulletin 2001-01, "Circumferential Cracking of Reactor Pressure Vessel Head Penetration Nozzles," Item No. 5

Three Mile Island Unit 1 Response to
NRC Bulletin 2001-01, "Circumferential Cracking of Reactor
Pressure Vessel Head Penetration Nozzles," Item No. 5

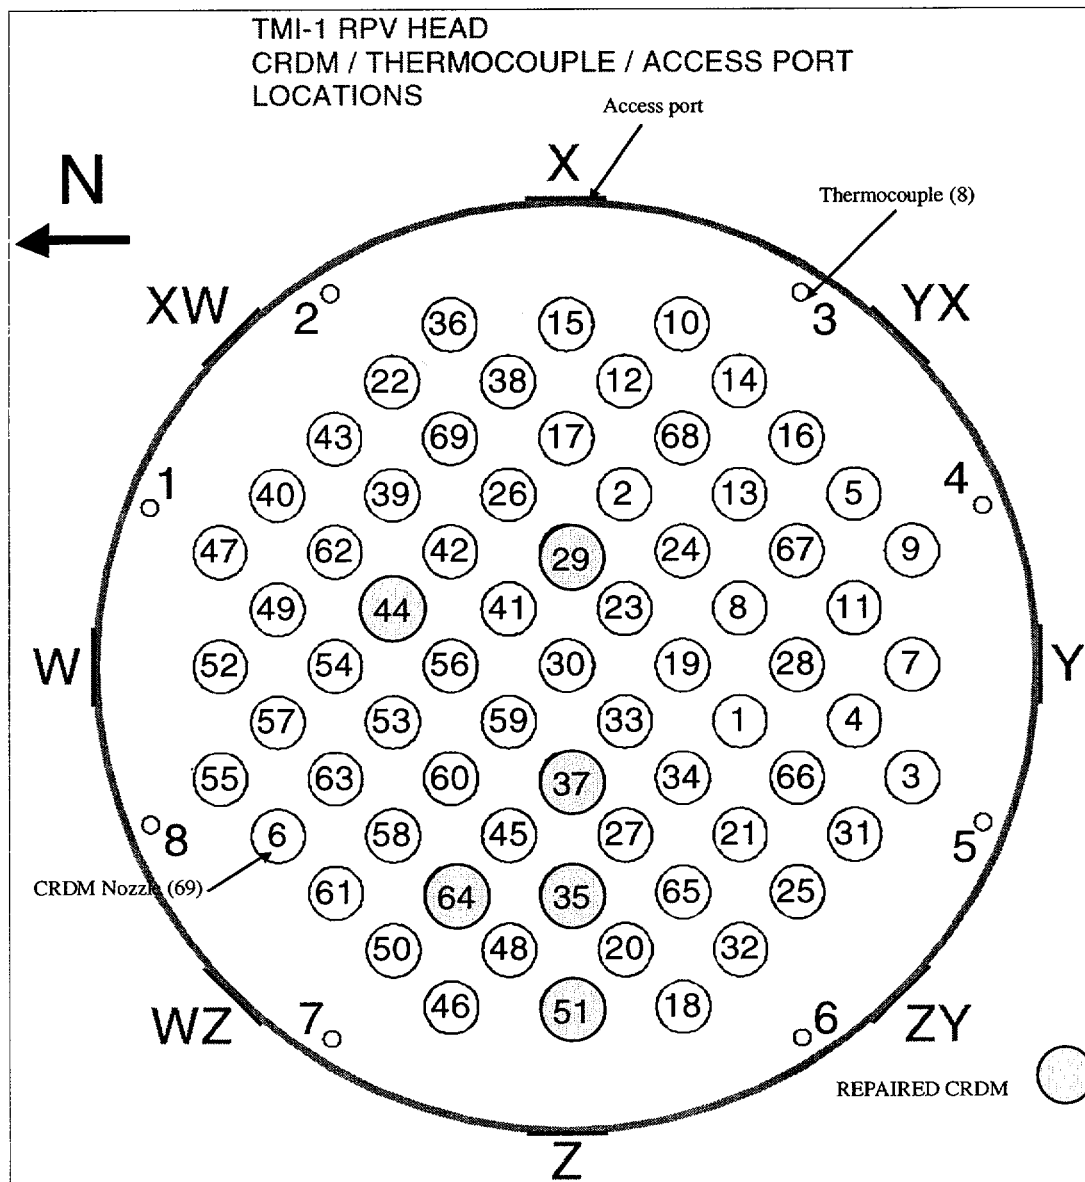
Figure 1

PT and UT examinations were performed after the RPV head was removed and placed on the storage stand. The final engineering evaluation of the visual inspection, PT and UT data identified that five of the CRDM nozzles were leaking. The five leaking nozzles were TMI nozzles #29, #35, #37, #44, and #64. One additional nozzle, TMI CRDM Nozzle #51, was analyzed by fracture mechanics to be unacceptable for the next operating cycle. This brought the total number of CRDM nozzles requiring repair to six (See Figure 1).

Six CRDM and eight TC nozzles were repaired. A video inspection of the RPV head surface was completed after cleaning activities to provide a baseline for future visual inspections. An in-service leakage test was performed in accordance with plant procedure 1303-8.1, "Reactor Coolant System." The plant conditions were nominal operating pressure and temperature. No evidence of leakage was noted following a four-hour hold. Operability of the CRDM was confirmed during plant start-up in accordance with plant procedures.
