SUBJECT: Potential manufacturing problem with certain limit switch assemblies used in
ASCO General Controls Hydramotor® Actuators.

SUBJECT: Potential Manufacturing Problem With Certain Limit Switch Assemblies Used in
ASCO General Controls Hydramotor® Actuators.

**POTENTIAL MANUFACTURING PROBLEMS WITH
LIMIT SWITCH ASSEMBLIES USED IN ASCO GENERAL CONTROLS
HYDRAMOTOR® ACTUATORS**

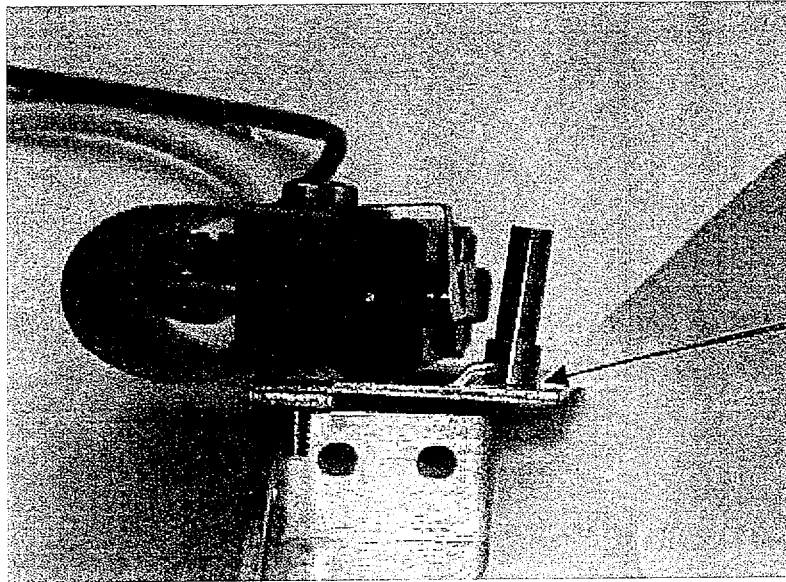
Analysis of the returned Limit Switch Assembly (see attachment 1) revealed that the shaft on which the position sensing lever operates was not secured tightly to the plate, causing wobble of the shaft. This wobble may result in the rotation of the lever past its actuation point, which would leave the switch contacts in the normally open (N.O.) position. This condition will result in the failure of the actuator piston to retract when the Hydramotor® is powered. The shaft is staked to the plate assembly. Manufacturing instructions for this assembly defines the maximum pressure to be applied for the staking press, but no minimum value. This led to variation of the staking process, which resulted in inconsistent and incomplete attachment of the shaft to the plate. (See attachment 2). In addition to the field return, Asco has found several limit switch assemblies in our inventory with this condition.

The rotation of the lever past its actuation point will result in the failure of the actuator piston to retract when the Hydramotor® is powered. We believe that in most, if not all, cases the return of the piston to the spring-extended position is considered the fail-safe condition for the Hydramotor® actuator. As such, the described failure of the Limit Switch assembly would result in the unit moving to the fail-safe condition. Depending on the nature of the application, the utility should determine what the fail-safe mode of the Hydramotor® is.

POINT OF
FAILURE

VIEW SHOWING ANGULATION CONDITION
OF FAILED SHAFT JOINT

ASCO will notify all purchasers of affected product of the potential problem. If the affected product is not in service, ASCO will offer to rework it at our factory at no charge. If the product is in service, ASCO will offer retrofit kits at no charge with complete instructions for installation of new limit switch assemblies. The method of forming this staked joint is being revised to ensure complete and consistent assembly of the shaft to the plate. In addition, the manufacturing instructions are being revised to fully define the parameters of this process as well as the testing necessary to confirm the reliability of the shaft-to-plate joining process.

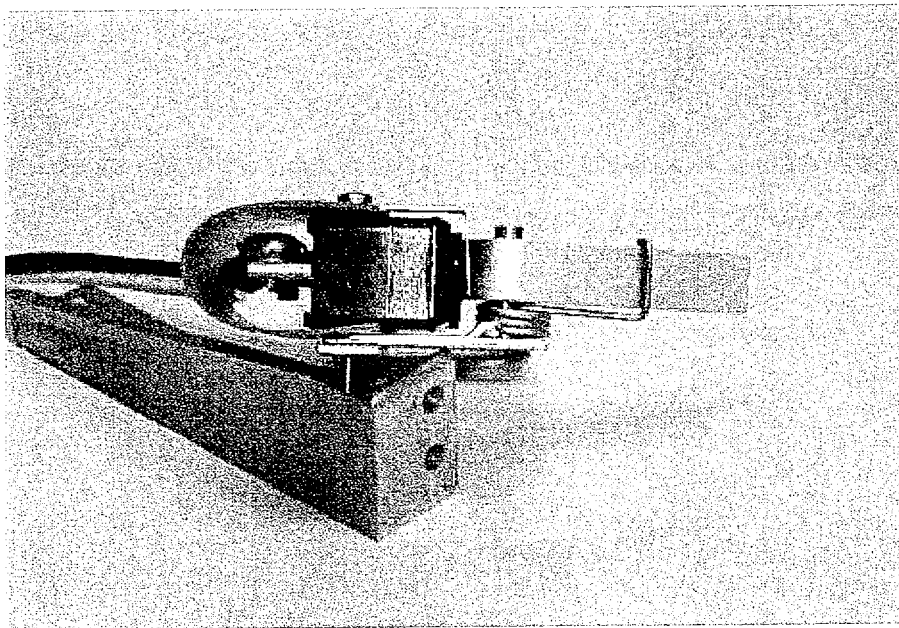
VIEW SHOWING LIMIT SWITCH ASSEMBLY
WITH PROPERLY SWAGED SHAFT
