Crystal River Nuclear Plant  
Docket No. 50-302  
Operating License No. DPR-72

Subject: Crystal River Unit 3 - Licensee Event Report 50-302/01-003-00, Small Pressure  
Boundary Leak Found in Reactor Coolant Pump Heat Exchanger

<b>1. FACILITY NAME</b> CRYSTAL RIVER UNIT 3				<b>2. DOCKET NUMBER</b> 05000 302		<b>3. PAGE</b> 1 OF 7		
<b>4. TITLE</b> Small Pressure Boundary Leak Found in Reactor Coolant Pump Heat Exchanger Resulting in Radionuclide Intrusion into Closed Cycle Cooling System								
<b>5. EVENT DATE</b>			<b>6. LER NUMBER</b>			<b>7. REPORT DATE</b>		
MO	DAY	YEAR	YEAR	SEQUENTIAL NUMBER	REV NO	MO	DAY	
10	04	01	01	003	00	12	03	
<b>9. OPERATING MODE</b> 5			<b>11. THIS REPORT IS SUBMITTED PURSUANT TO THE REQUIREMENTS OF 10 CFR §:</b> (Check all that apply)					
<b>10. POWER LEVEL</b> 0%			20.2201(b)		20.2203(a)(3)(ii)		50.73(a)(2)(ii)(B)

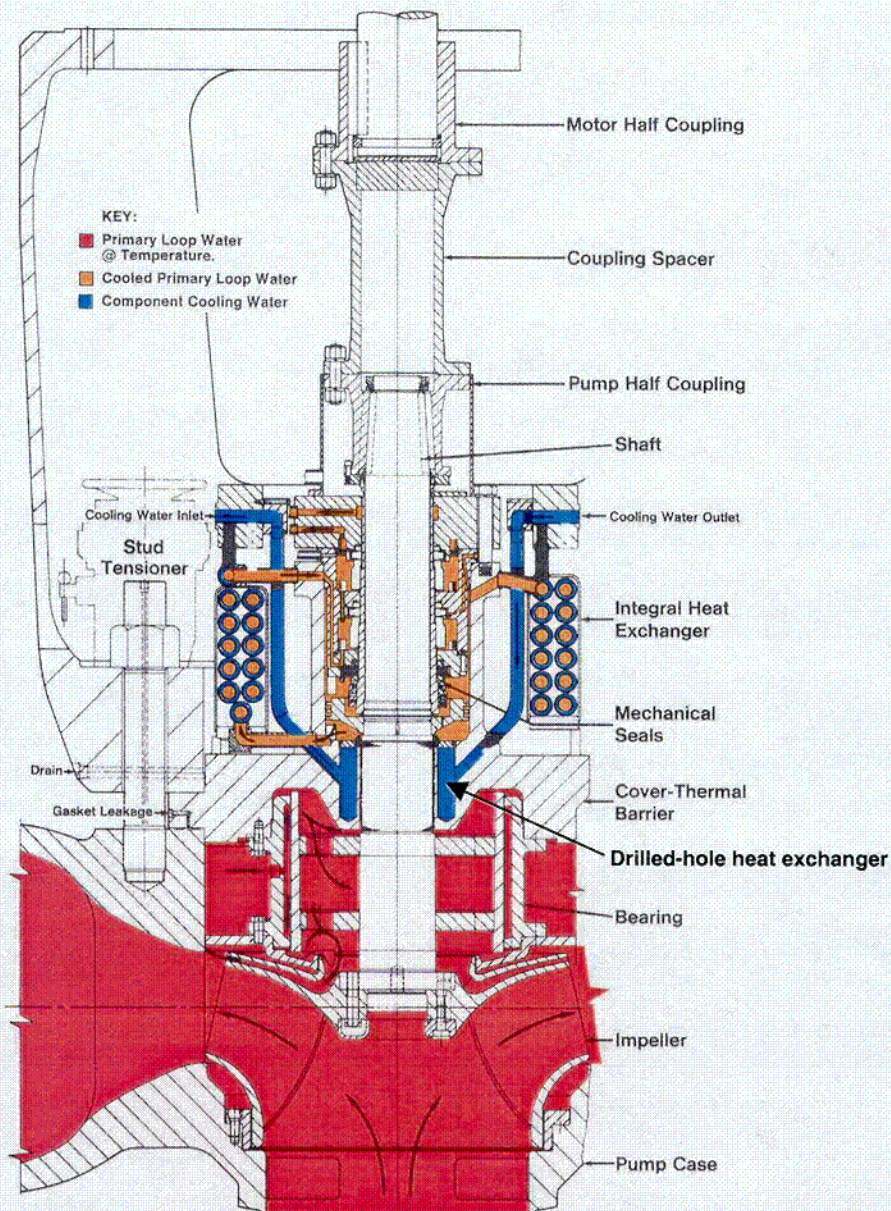
## ATTACHMENT 3 - Drawing of RCP Seal Area

The drilled-hole heat exchanger is located in the pump cover-thermal barrier, below the mechanical seals and above the pump bearing. This heat exchanger is a series of interconnecting angular drilled holes. During fabrication these holes were machined from above through the stuffing box bore. These holes are encapsulated by the installation of a welded ring in the bottom of the stuffing box bore, forming the pressure boundary between the RCS fluid and the SW system fluid. The SW fluid flows into and around this interconnecting ring of drilled holes before rejoining the fluid from the integral heat exchanger and then returning to the SW system.

The RCP integral heat exchanger is of a tube-in-tube design, external to the pump mechanical seals. A recirculation impeller, located just under the RCP seals, pushes the reactor coolant fluid (when the pump is running) through the inner tube. The SW system fluid passes through the outer tube prior to joining the drilled-hole heat exchanger fluid and returning to the SW system.

The RCP drilled-hole heat exchanger was determined to be the source of the RCS leakage into the SW system. The heat exchanger is part of the RCS pressure boundary required by Improved Technical Specifications (ITS) 4.6.12, which states that no pressure boundary leakage is allowed. This leakage began while CR-3 was in MODE 1, Power Operation. Therefore, CR-3 was outside of the Limiting Condition for Operation for ITS 3.4.12. This condition is reportable under 10CFR50.73(a)(2)(i)(B) as a condition prohibited by ITS. This condition was also reported at 1558 on October 4, 2001 as a non-emergency eight-hour notification to the NRC Operations Center (NRC Event #38348) for being an event or condition that results in the degradation of a principal safety barrier (RCS pressure boundary). Therefore, this condition is also reportable under 10CFR50.73(a)(2)(ii)(A).

The cause of the leakage is unknown. The location of the leak site was confirmed to be in the drilled-hole section of the RCP seal heat exchanger. The leak was repaired by plugging the inlet and outlet to the drilled-hole heat exchanger. However, the location of the leakage site precluded direct observation or acquiring metallurgical samples. Consequently, the root cause of the leak and failure mechanism is uncertain.

The leaking section of RCP-1B was isolated using two ASME Class I plugs, one at the inlet and one at the outlet of the heat exchanger. This repair design ensures that the leak site is isolated from the SW system. Post modification testing was performed by pressurizing the plugged area and verifying that the pressure did not significantly decay. Monitoring of SW activity level since return to power operation October 25, 2001, indicates that there is no further RCS leakage into the SW system. Analysis will be completed to demonstrate that the isolated flaw in the drilled-hole heat exchanger will not propagate to the RCP cover. This item is being tracked in the Corrective Action Program under Nuclear Condition Report 43024.
