EA No. 00-179-1

SUBJECT: NRC SPECIAL INSPECTION 50-247/2000010- STEAM GENERATOR TUBE
FAILURE

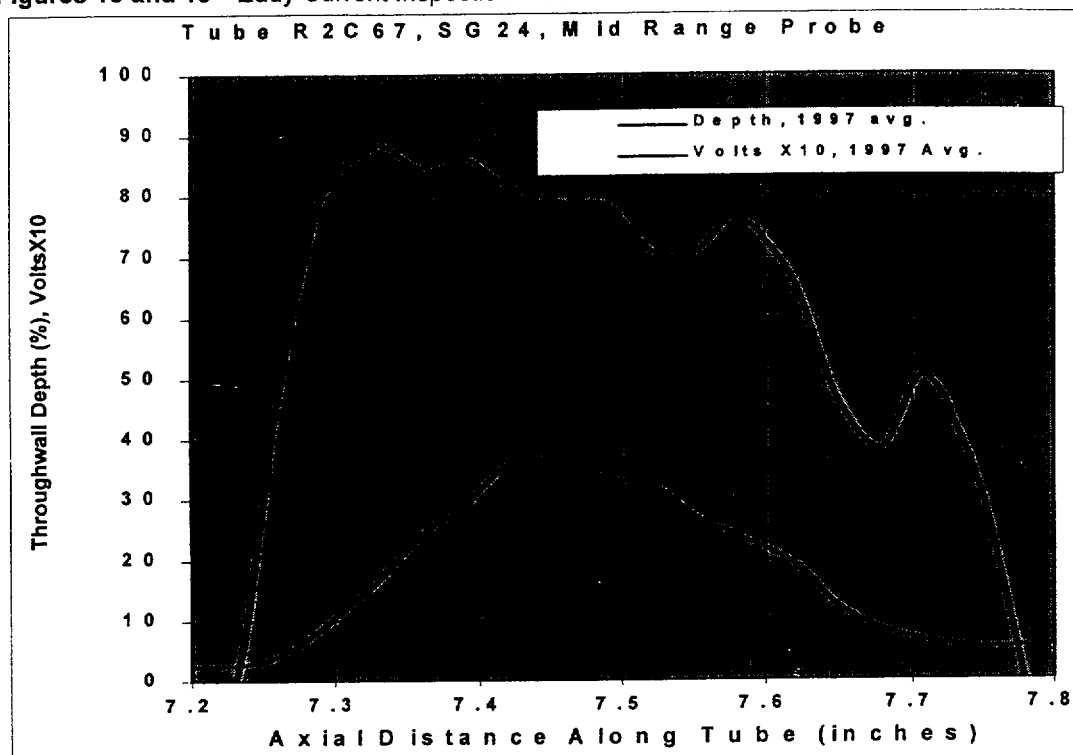
Figure 18 shows the c-scan plot of the 1997 data from R2C67, the crack sits beside a ridge, in a valley, and is in an easily detectable portion of the tube. The large amplitude of the voltage signal, in relation to the standard calibration notch would indicate that this is a "mature" crack. No year 2000 data is available since the tube was plugged in 1997. Figure 19 shows the profile. The depth estimate based on 1997 data is 87.5% TW.

**Figure 19 - Depth and voltage profile of the crack in tube 2-67 of steam generator 24 located in 1997.**
