Subject: 2001 Annual Site Inspection and Monitoring Compliance Report for UMTRCA
Title I Disposal Sites

2001 Annual Site Inspection and Monitoring Report for Uranium Mill Tailings Radiation Control Act Title I Disposal Sites

January 2002

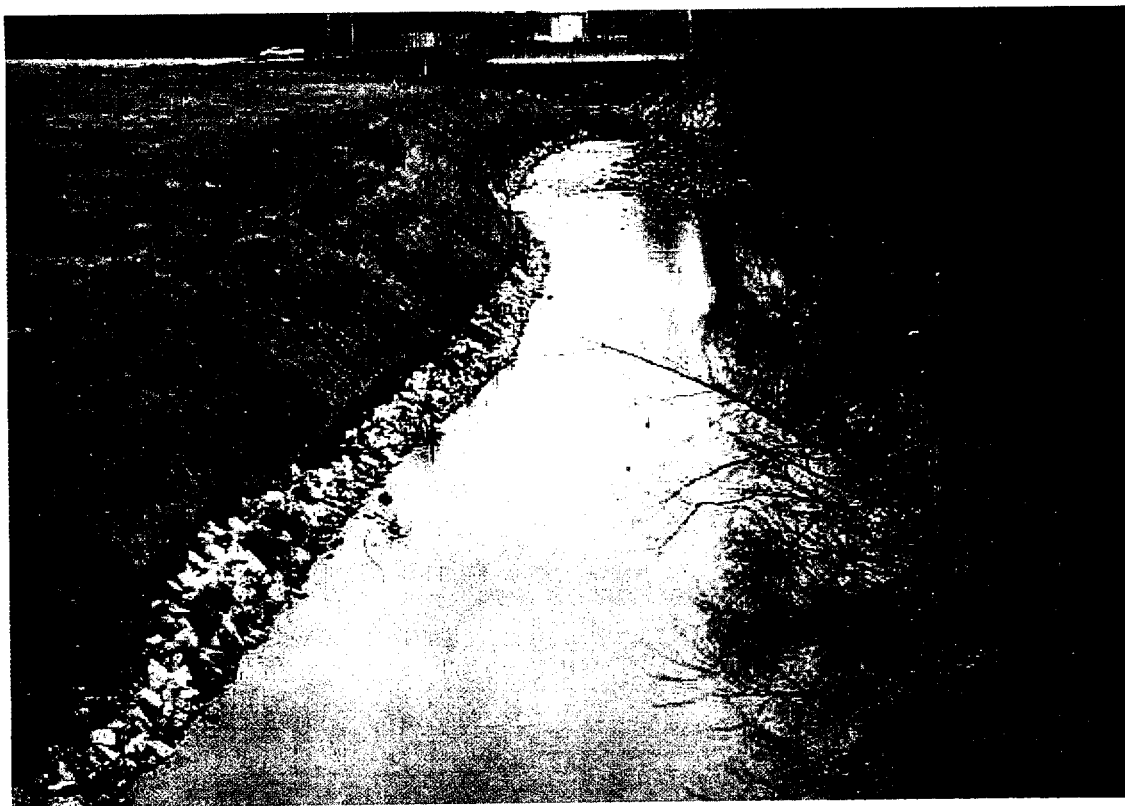
PL-2. Stabilized Western Bank Of Chartiers Creek at Area C

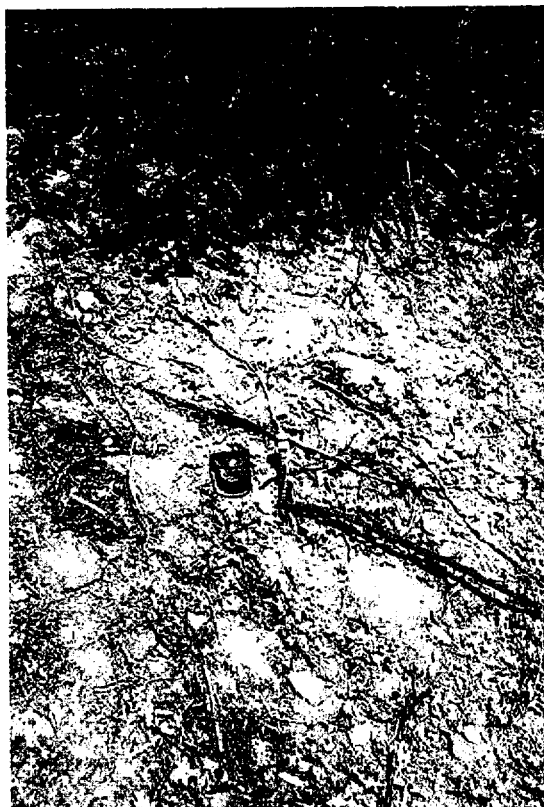
PL-3. Nonregulation Boundary Monument at BM-6

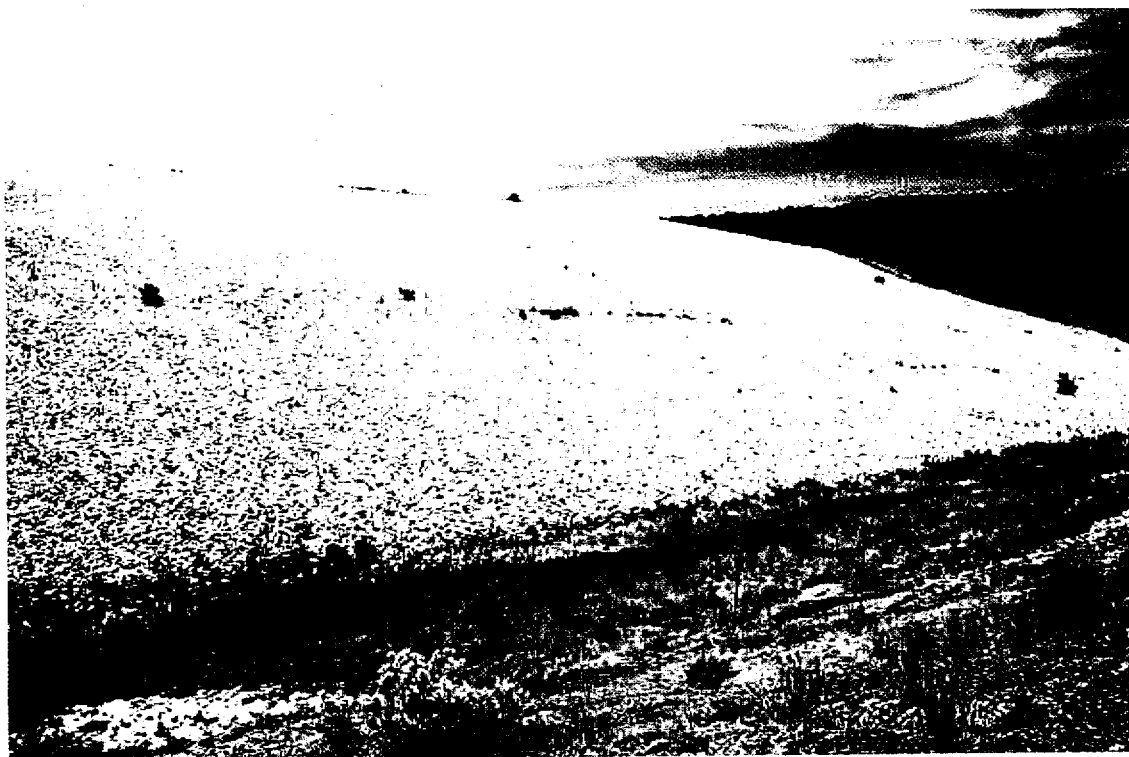
PL-4. Vegetation on East Side Slope of Cell

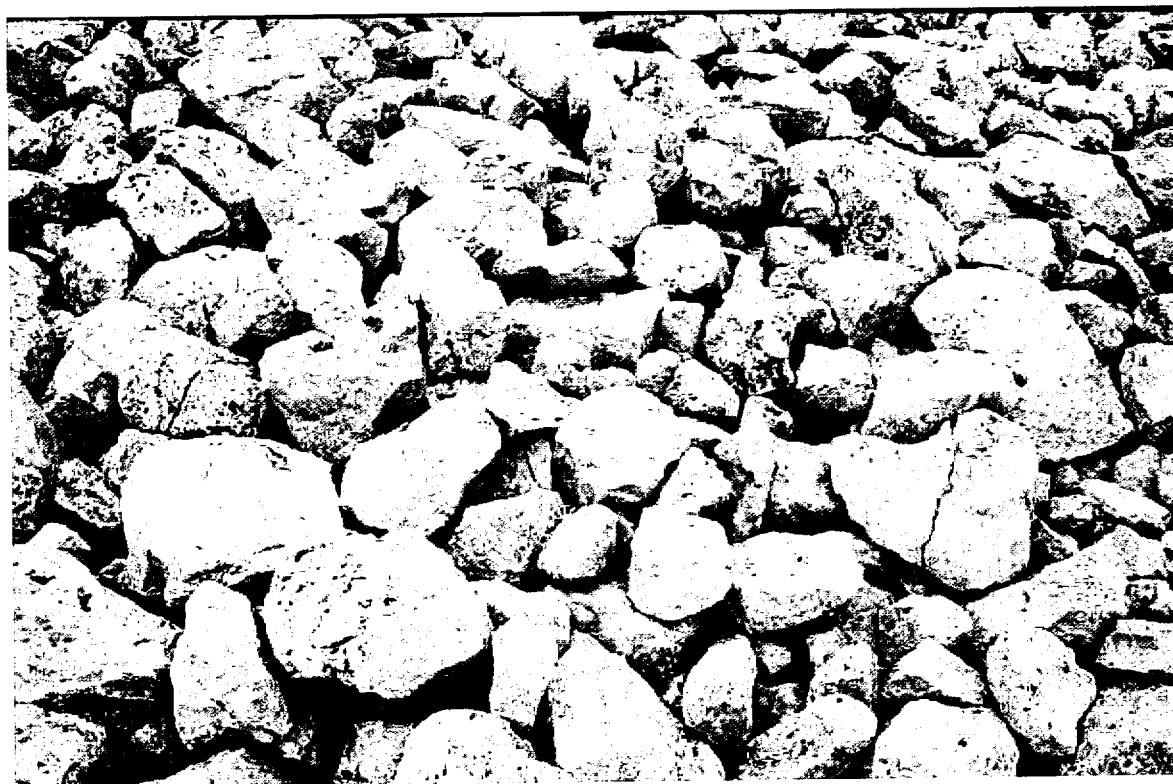
The side slopes of the disposal cell are armored with riprap, which overall is in excellent condition. Over the last 2 years, inspectors have noted that a very small percentage (less than 1 percent) of the riprap is cracked or broken (PL-2). It is not clear whether the cracks are recent or just recently noticed. None of the broken pieces appear to be more weathered or less durable than the unbroken rocks. Current assessment is that cracks are the result of stresses induced in the rock during quarrying and are not caused by chemical or physical weathering. Although inspectors will continue to note the condition of the rock, further cracking or breaking of the rock is not expected.

PL-2. Fractured Riprap on Southeast Side Slope

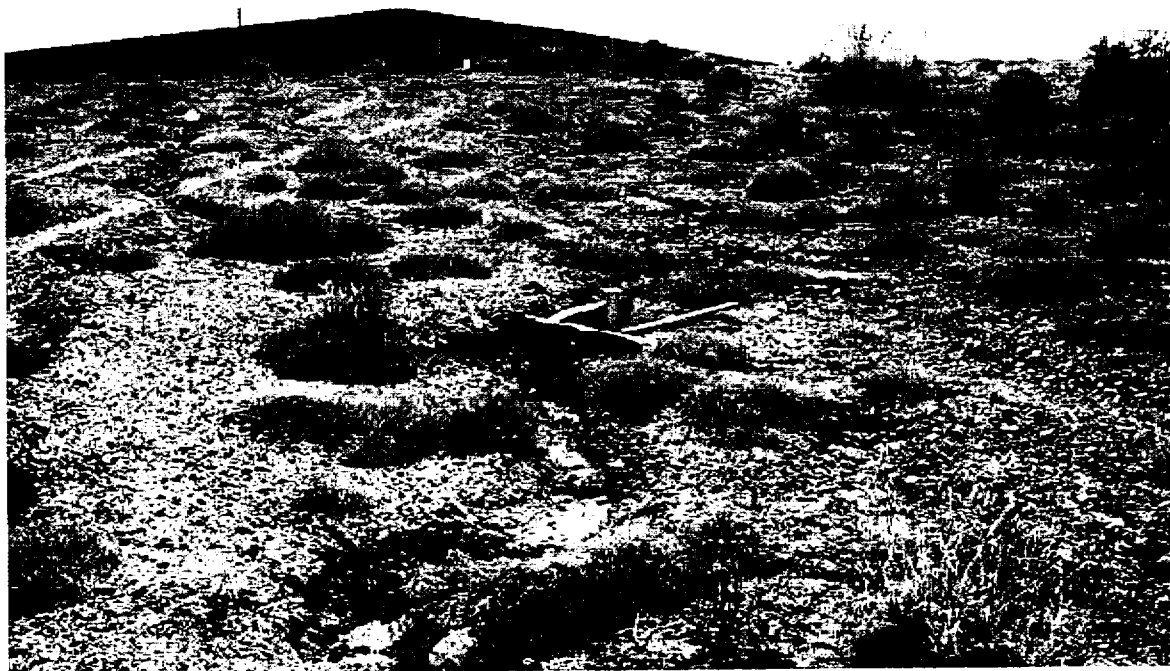
PL-1. Erosion at Boundary Monument BM-3

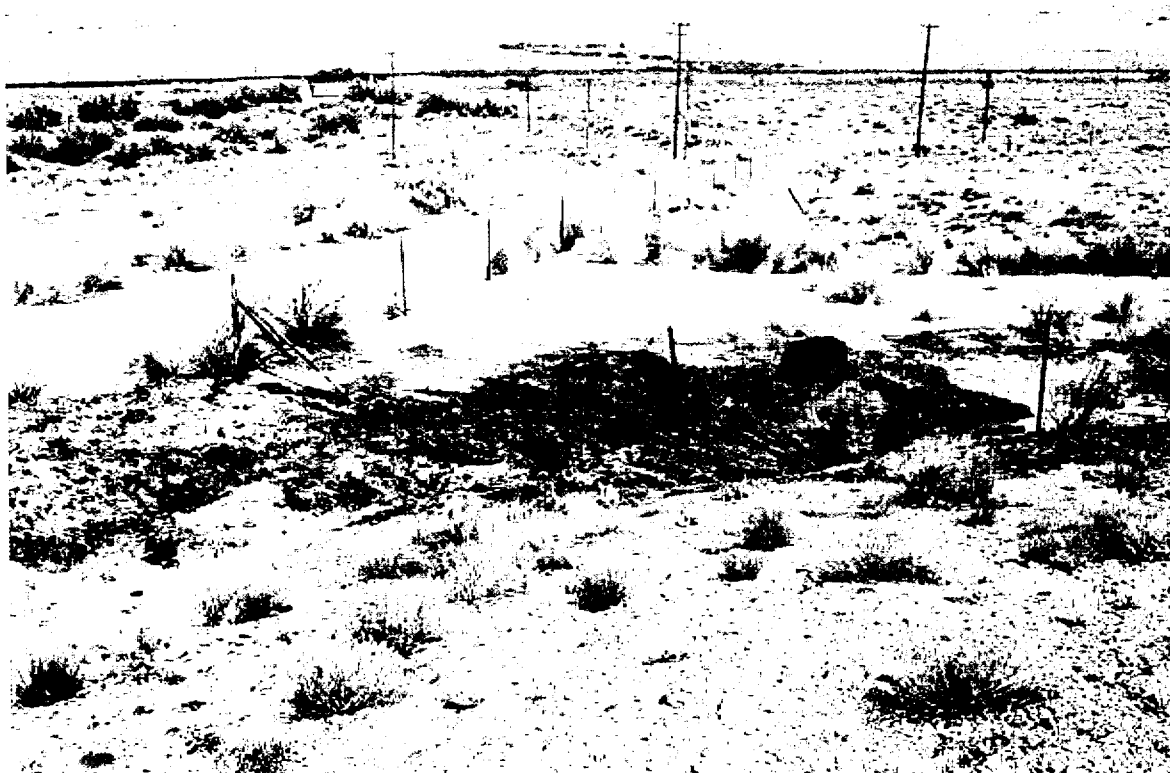
PL-2. Culvert and Storm Water Diversion Channel After Weed Burning

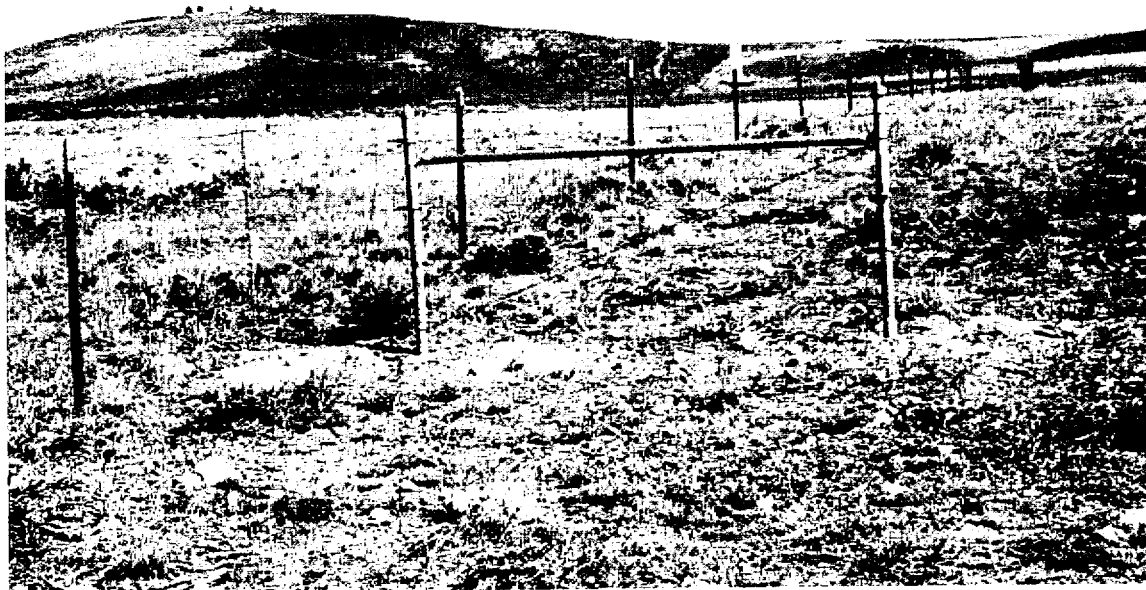
PL-1. New Landfill Fence Tied Into DOE Perimeter Fence Between P34 and P35

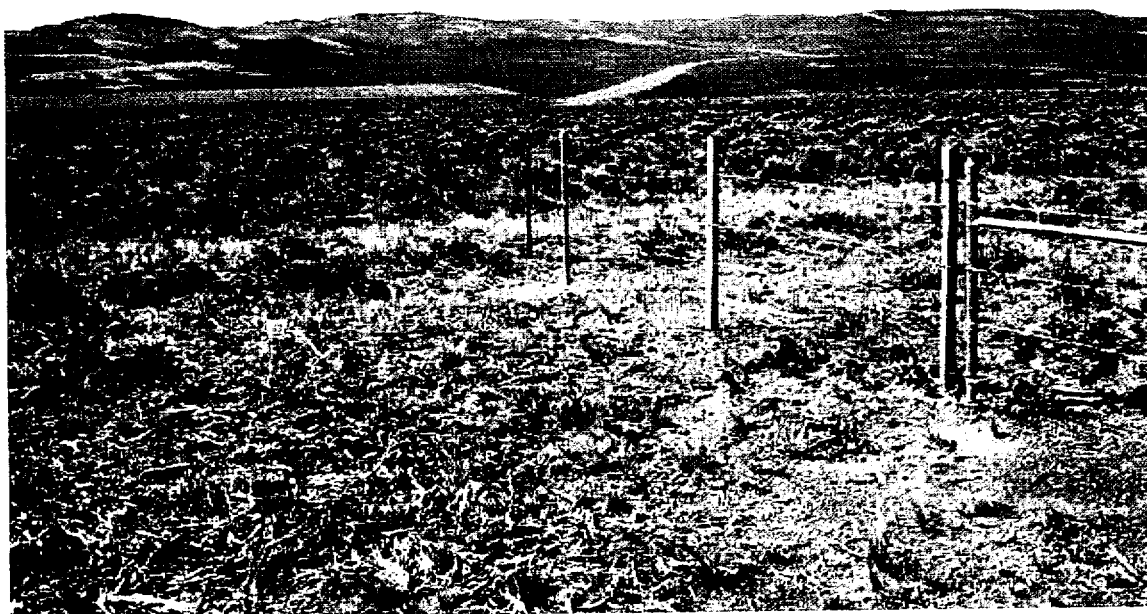
PL-2. New Landfill Fence Tied Into DOE Perimeter Fence Between P20 and P21

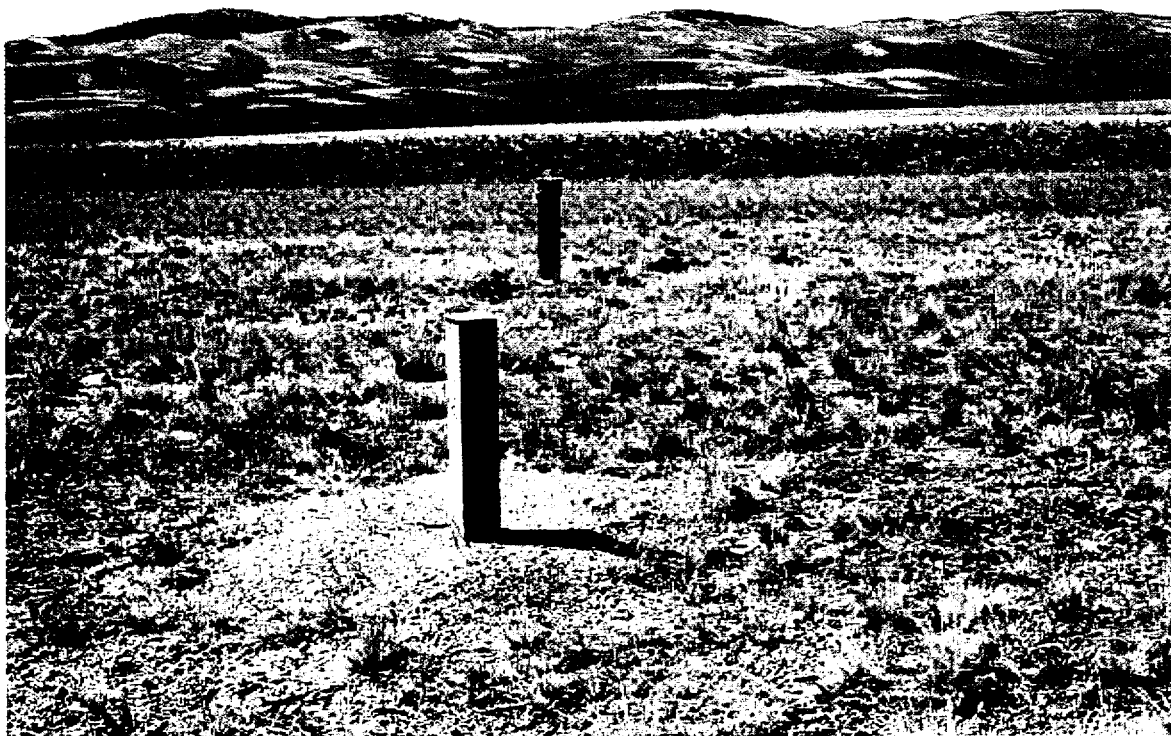
PL-3. New Landfill Monitor Well Located Approximately 50 Feet North of Well 0663

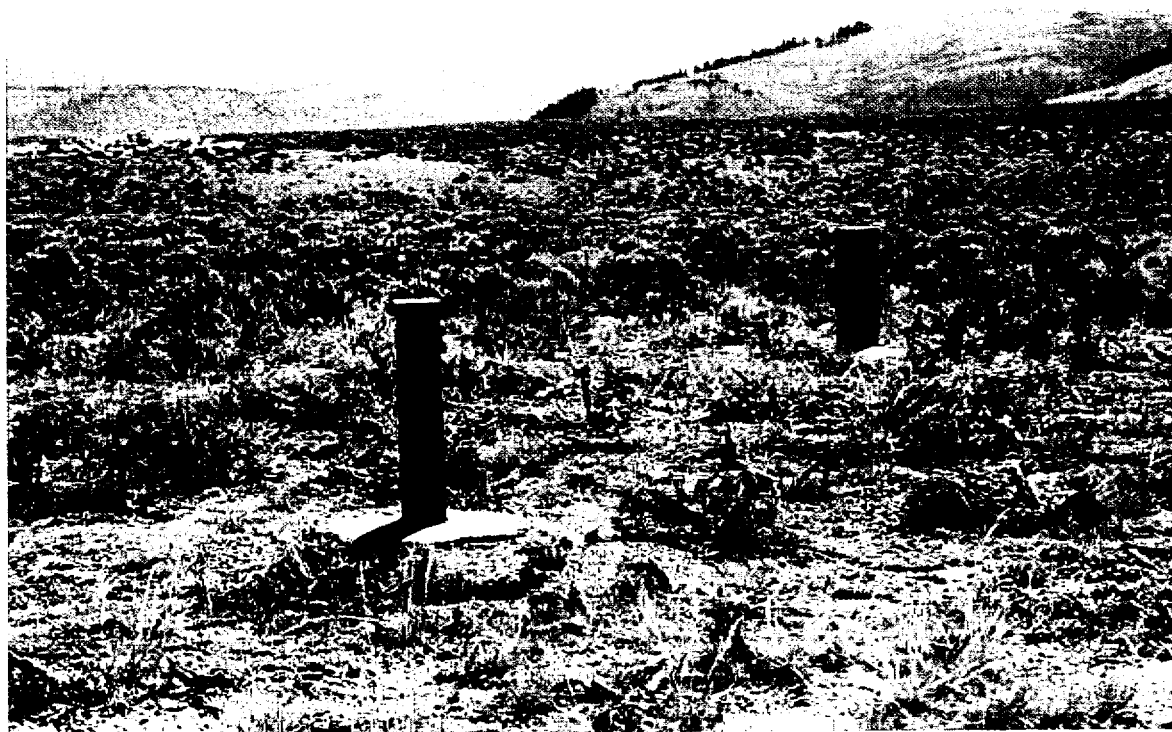
PL-4. New Landfill Monitor Wells Located Approximately 800 Feet North of Well 0717

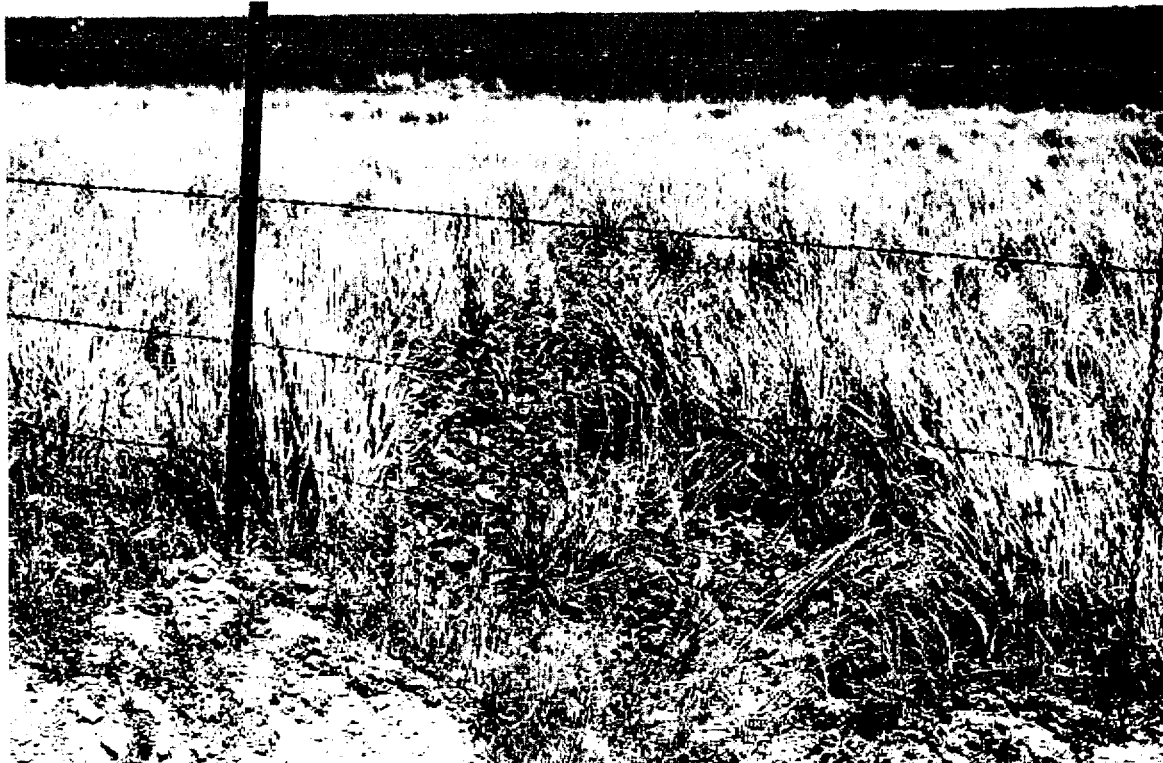
PL-1. Rock-Healed Erosion Gully West of Trench Drain 3

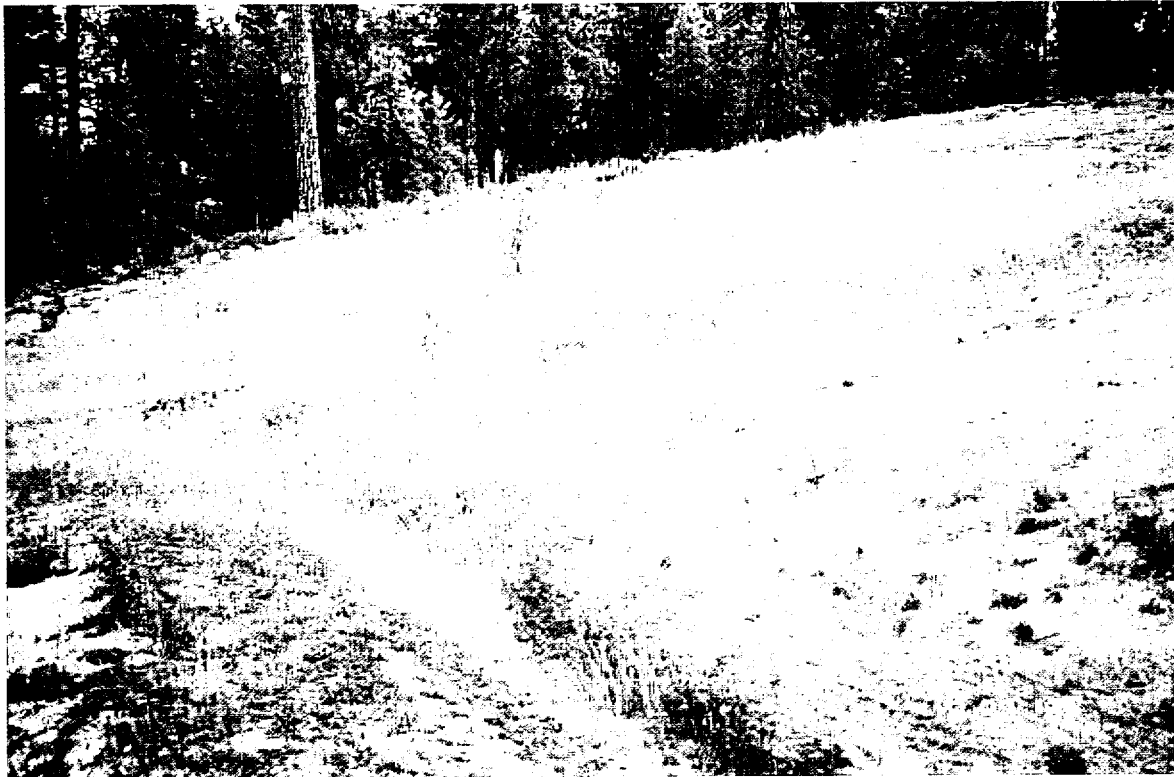
PL-1. View of Sediment Accumulation Area at the North End of Interceptor Bench 2

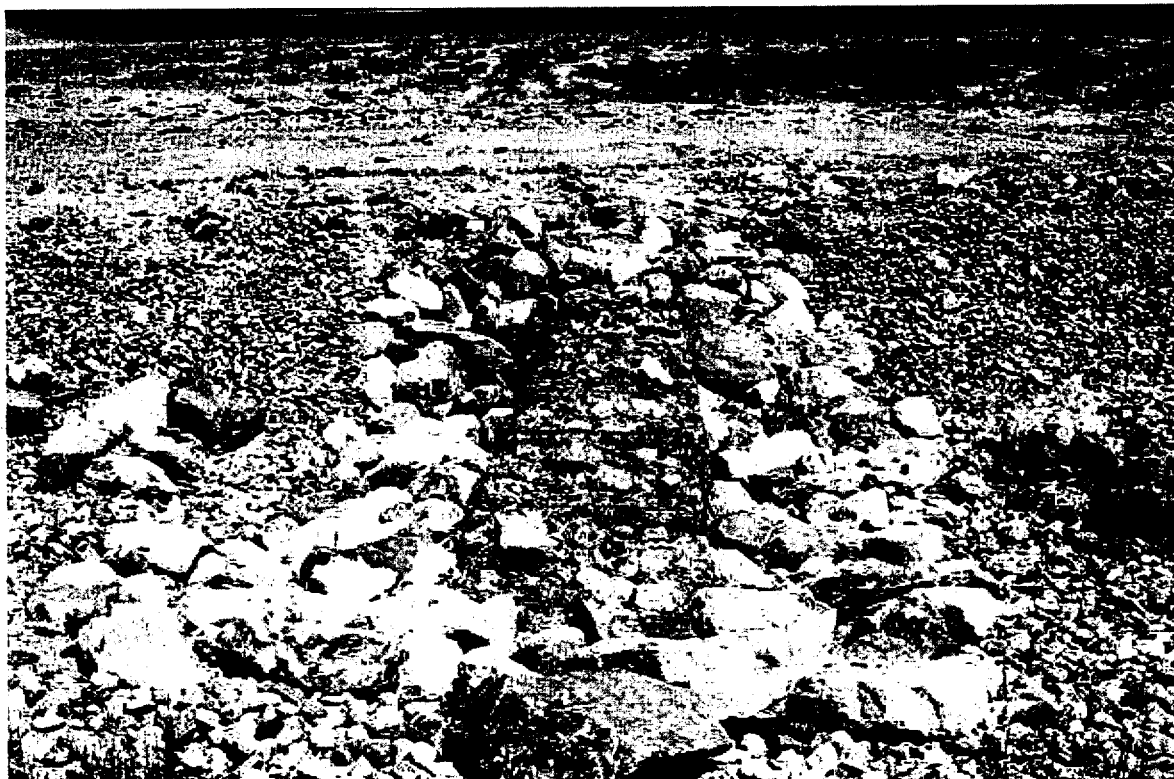
PL-1. Riprap Armoring for Ditch Number 1 Gabion

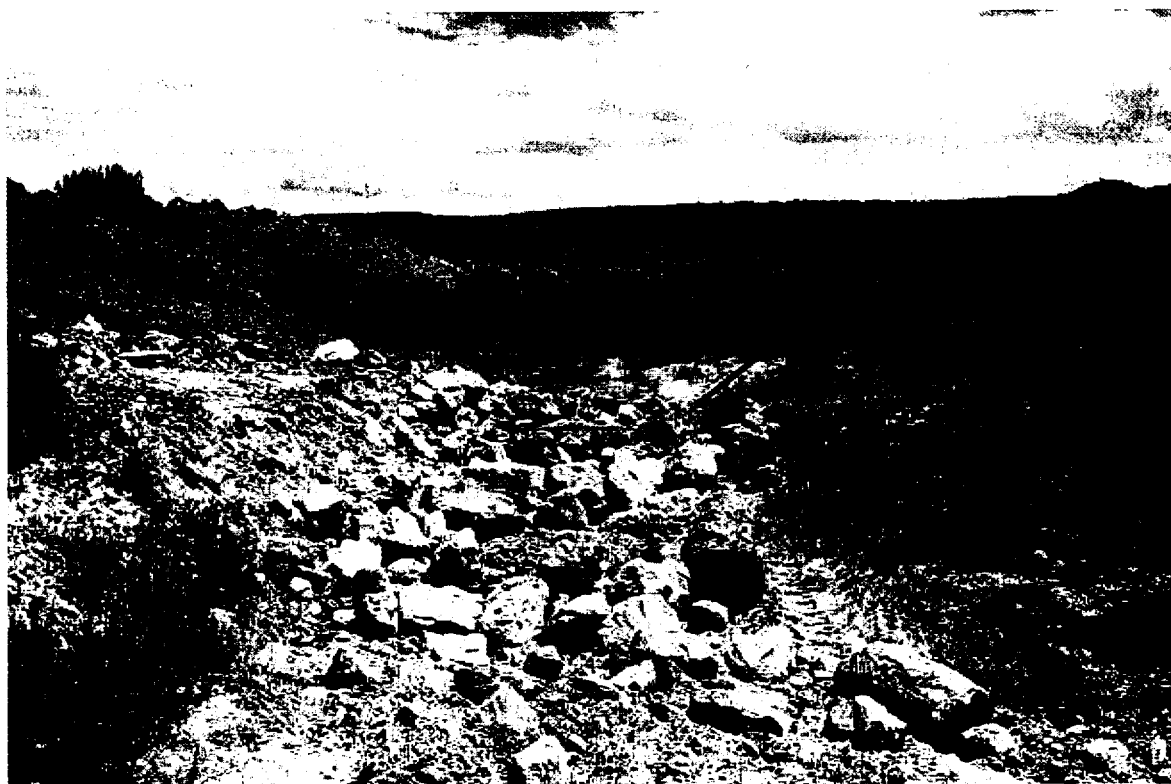
PL-3. Riprap Armor in Ditch Number 1 at Fence Line

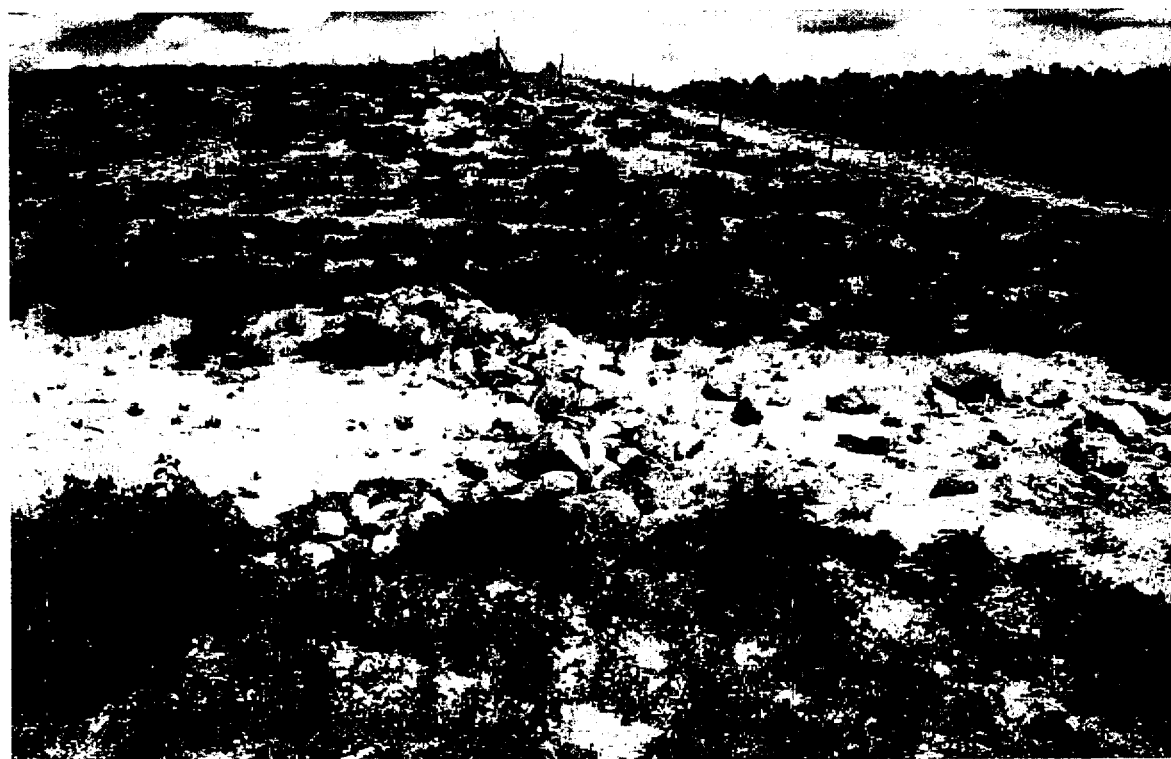
PL-4. Erosion Protection Near the Property Line Along Swale Number 1

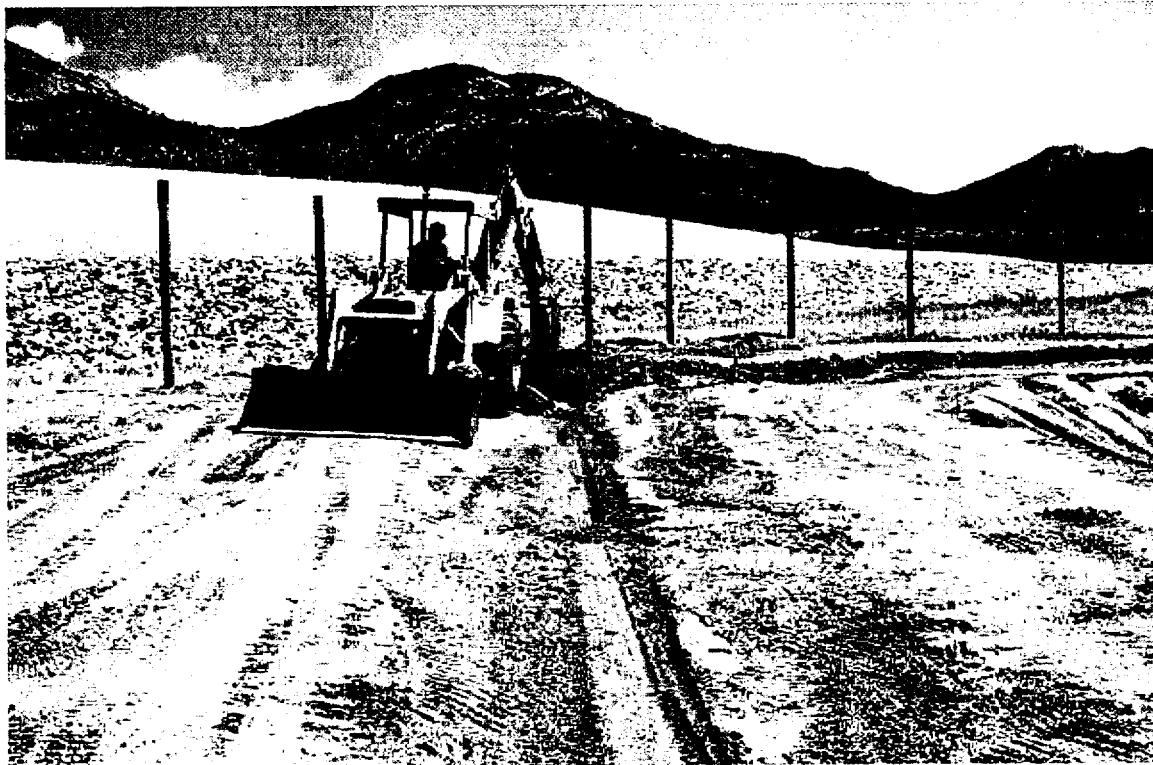
PL-1. Construction of Evaporation Pond

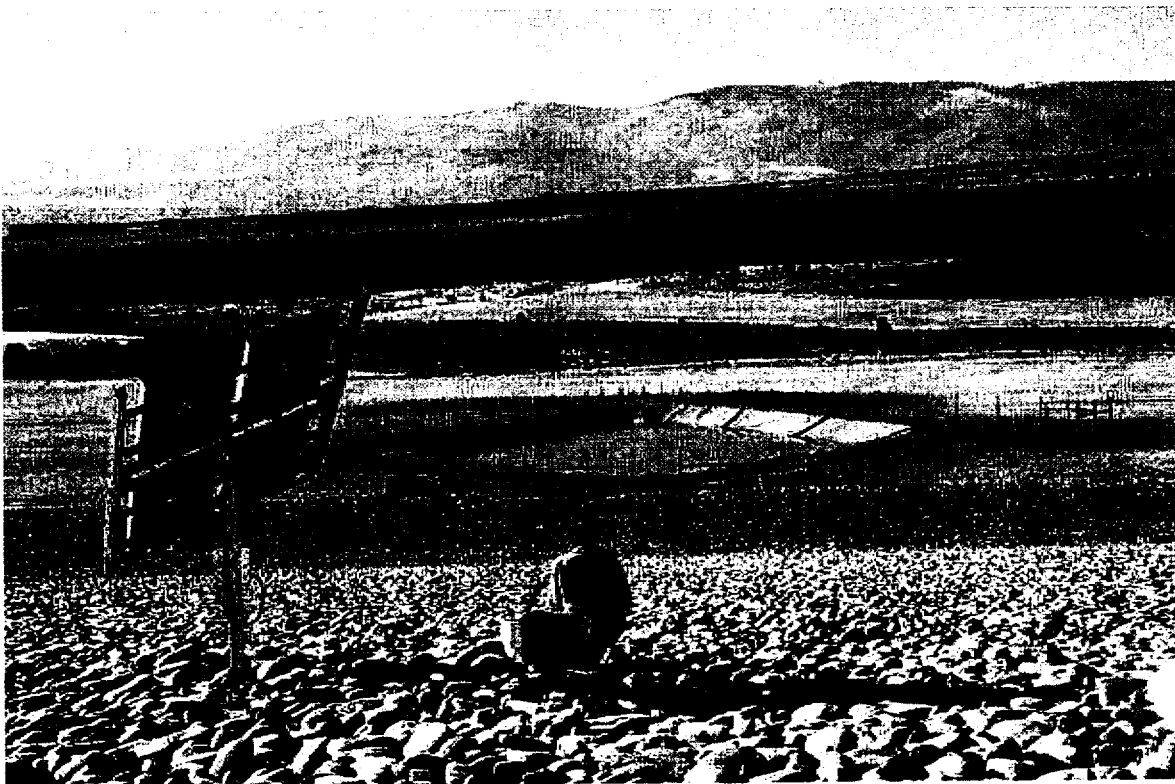
PL-2. Completed Evaporation Pond

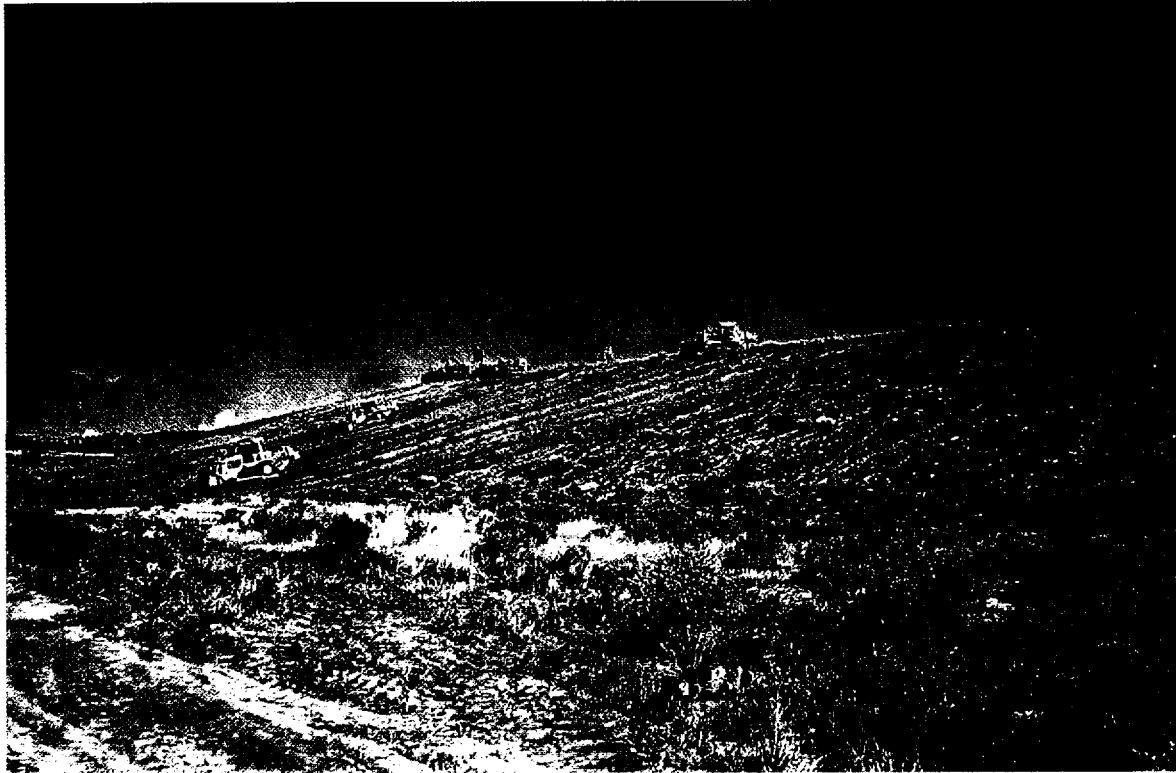
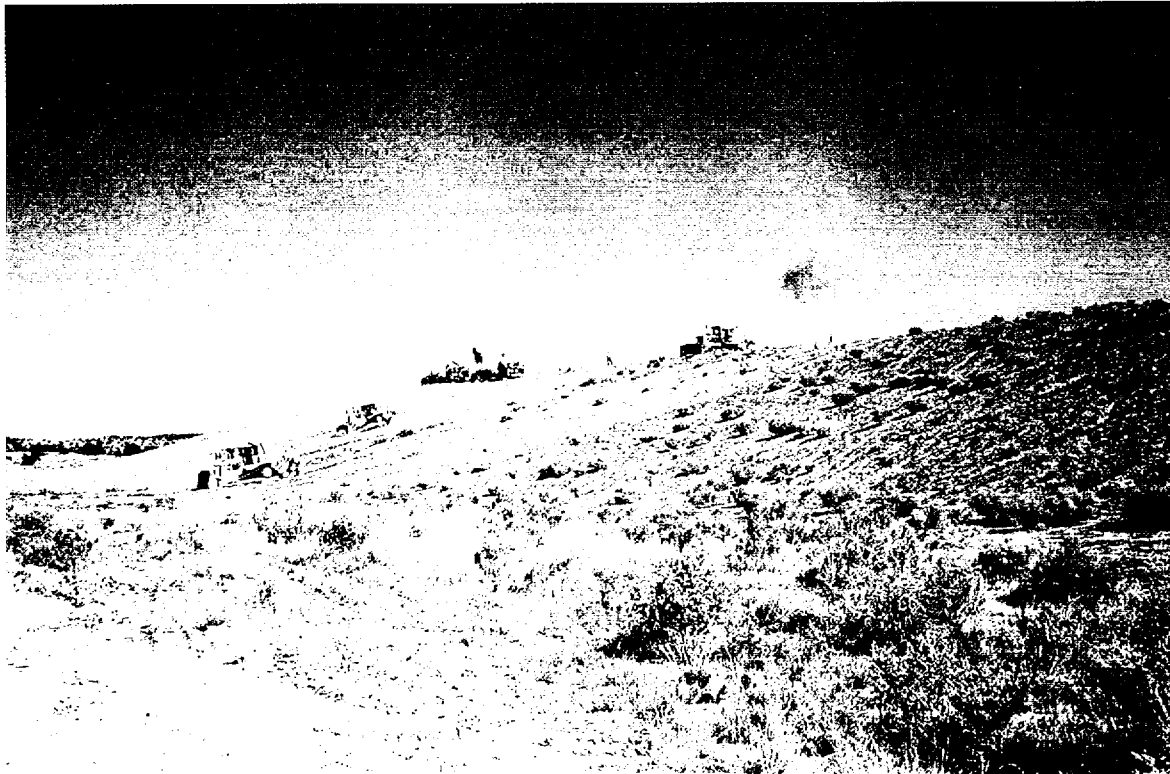
PL-1. Recontouring of the Spoils Pile in Progress

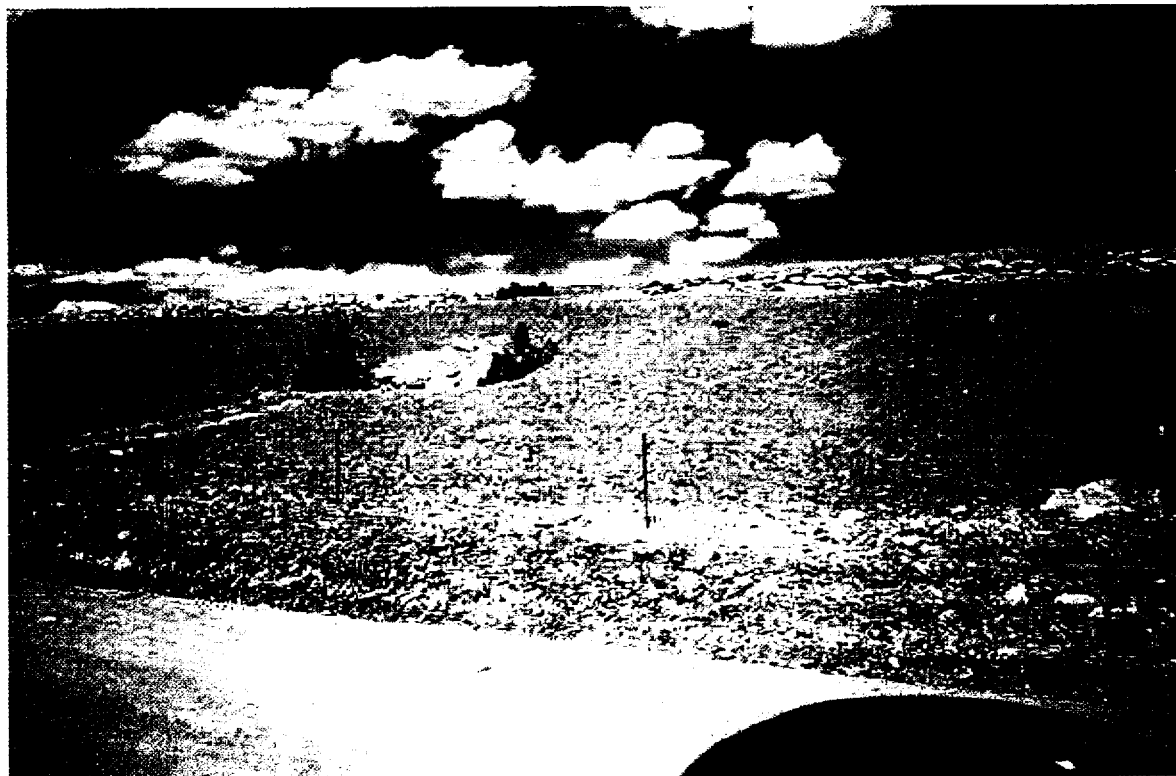
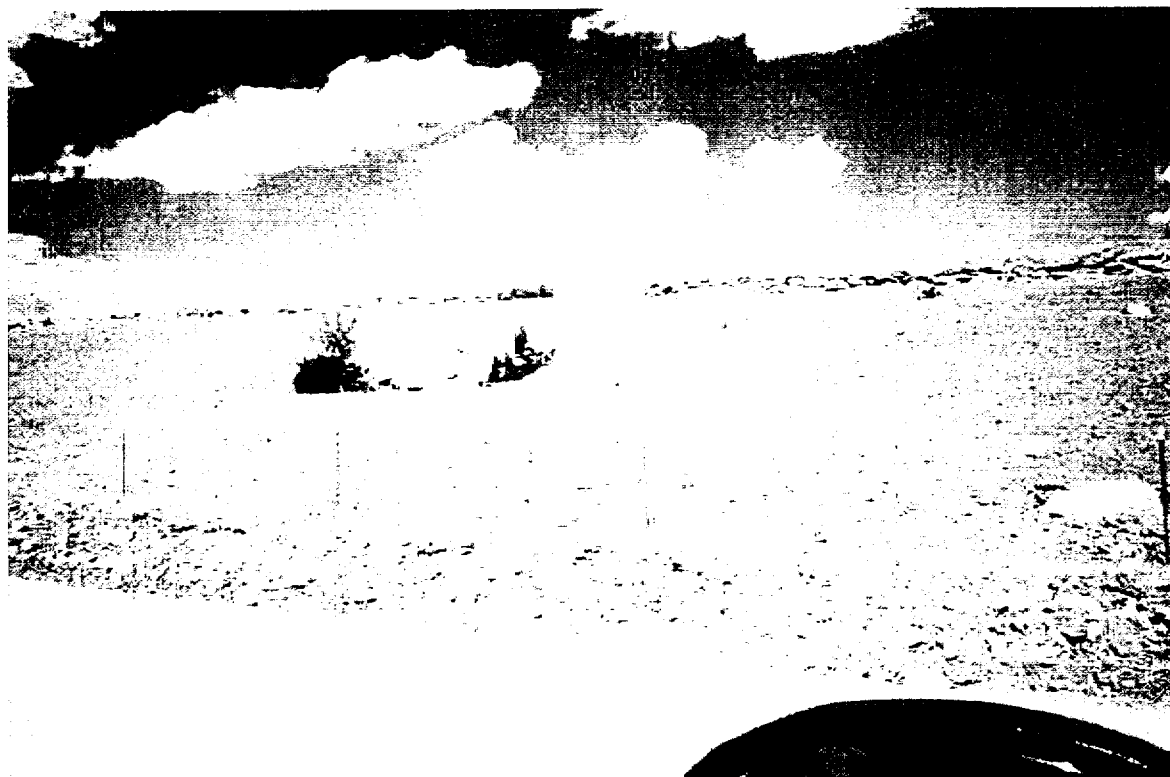
PL-2. Recontoured, Landscaped, and Reseeded Former Spoils Pile

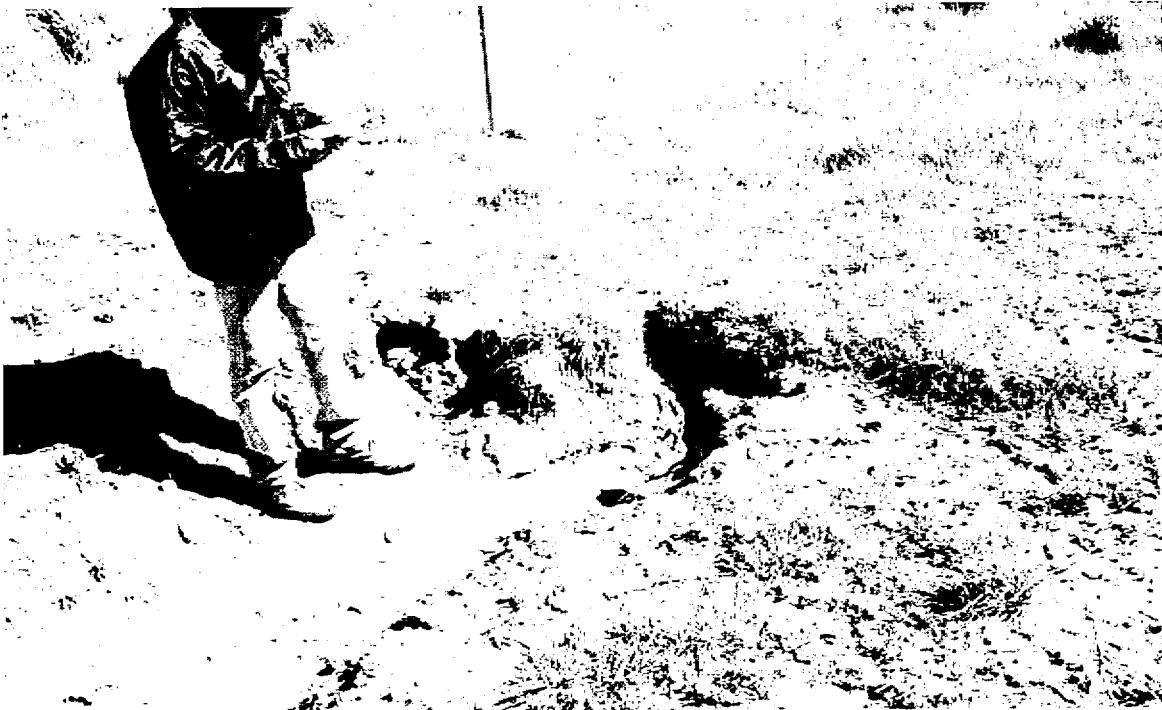
PL-1. Gully Near Perimeter Sign P4
