May 29, 1979

IE Information Notice No. 79-13

INDICATION OF LOW WATER LEVEL IN THE OYSTER CREEK REACTOR

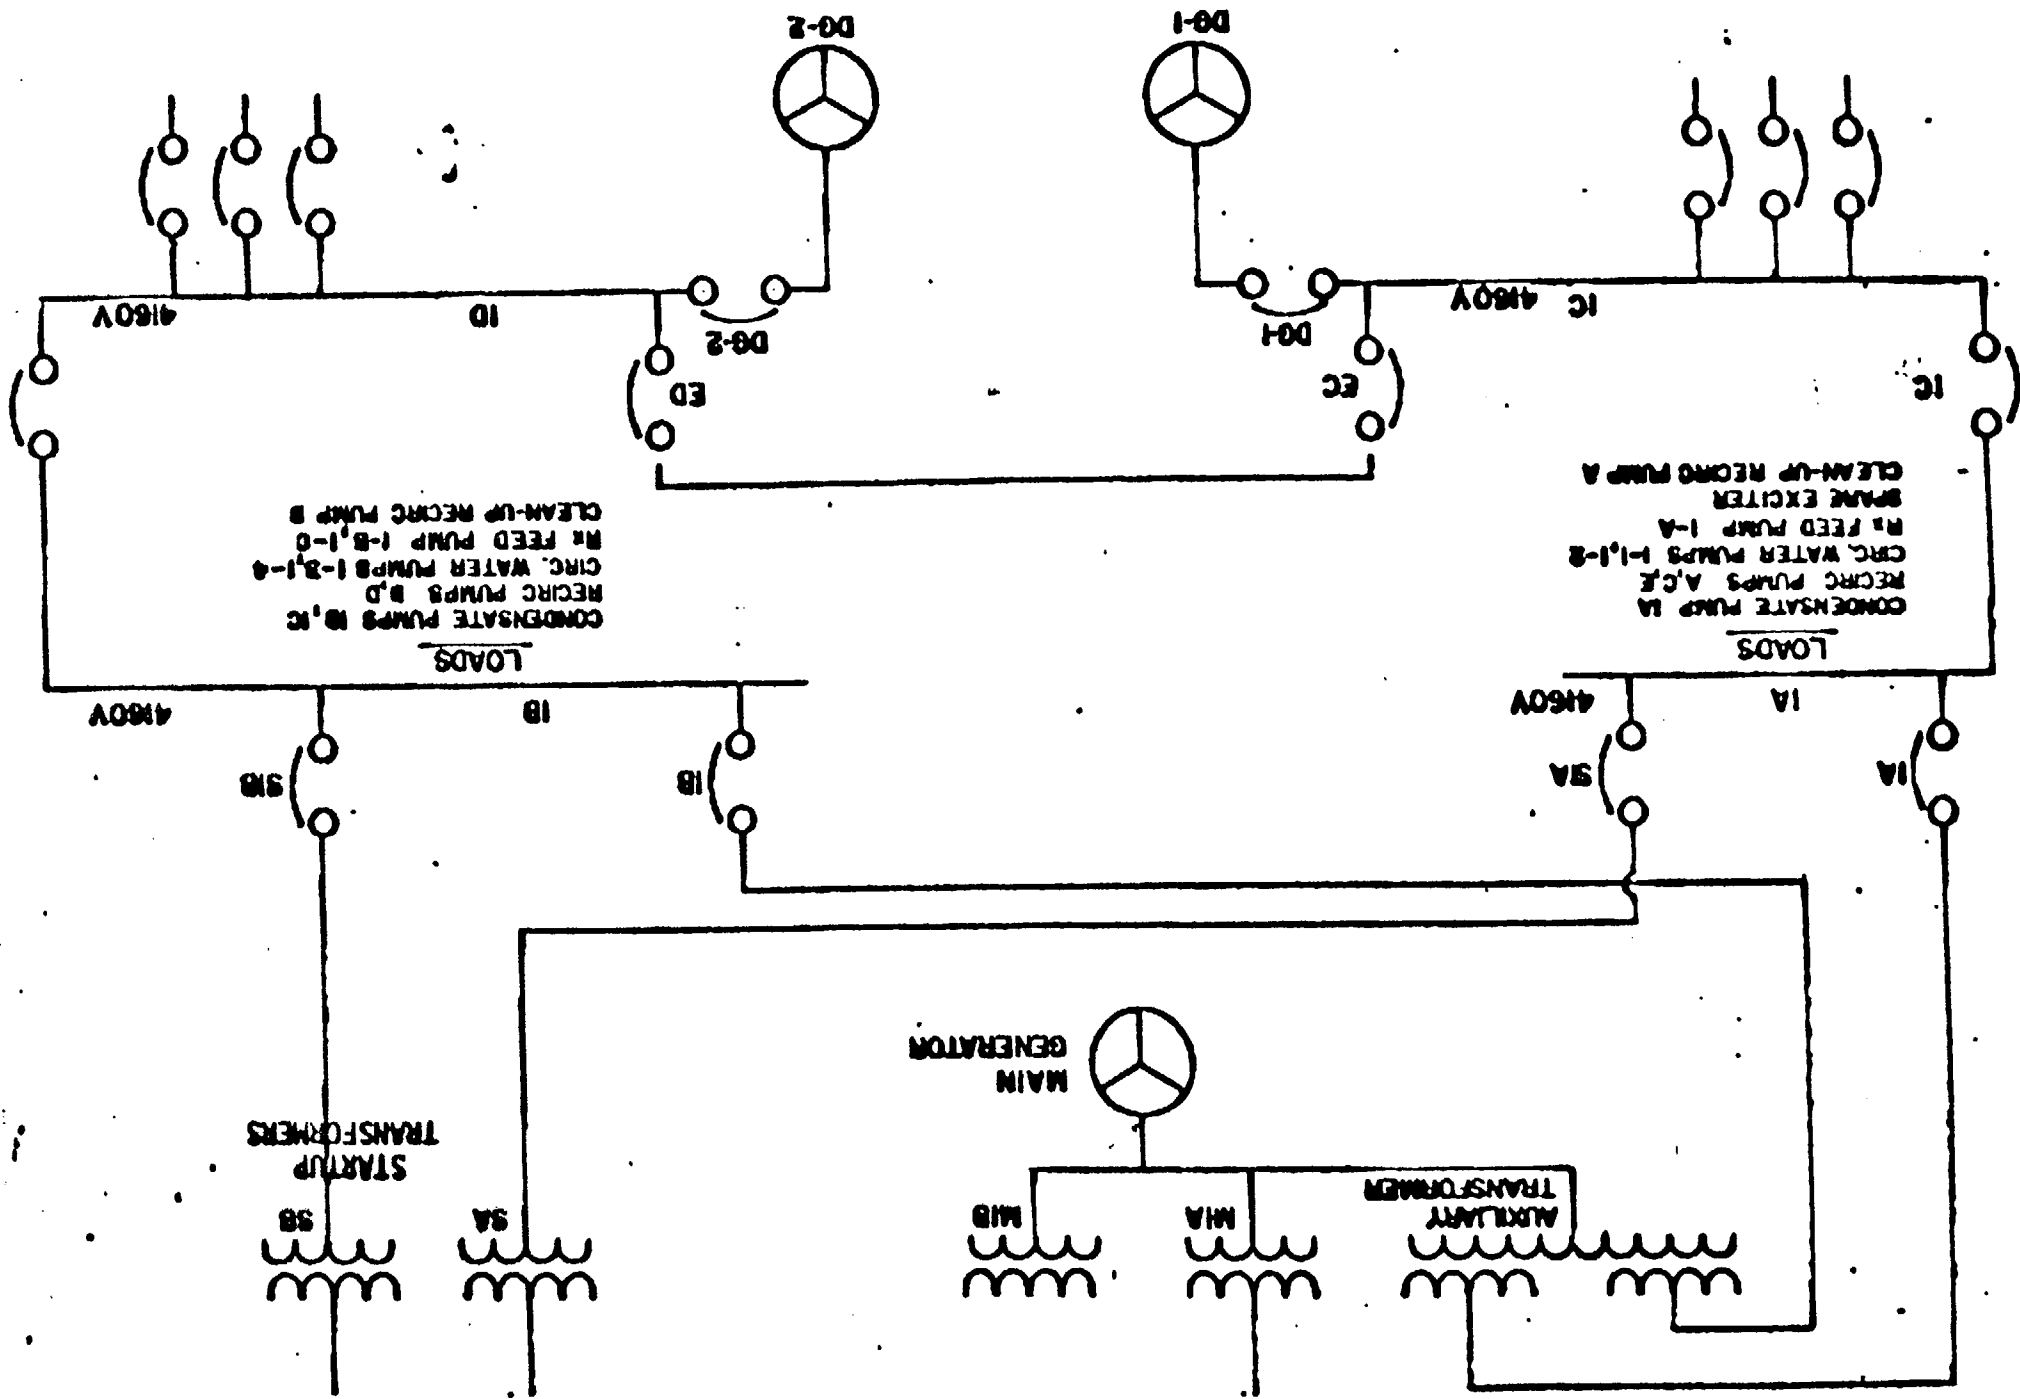
Thirteen seconds after the reactor scram on a false high reactor pressure signal, the turbine tripped at 25% low load setpoint. The turbine trip initiated a transfer of power from the auxiliary transformers to the startup transformers (Figure 2). Because one startup transformer (SB) was out of service, two feedpumps and two condensate pumps on that 4160v bus (IB) lost power (pumps 1B and 1C). The third feedpump (1A) tripped due to low suction pressure resulting from the feedwater transient. An immediate attempt to restart 1A was unsuccessful because of failure of an auxiliary oil pump to start. The oil pump is interlocked in the feedpump start sequence.

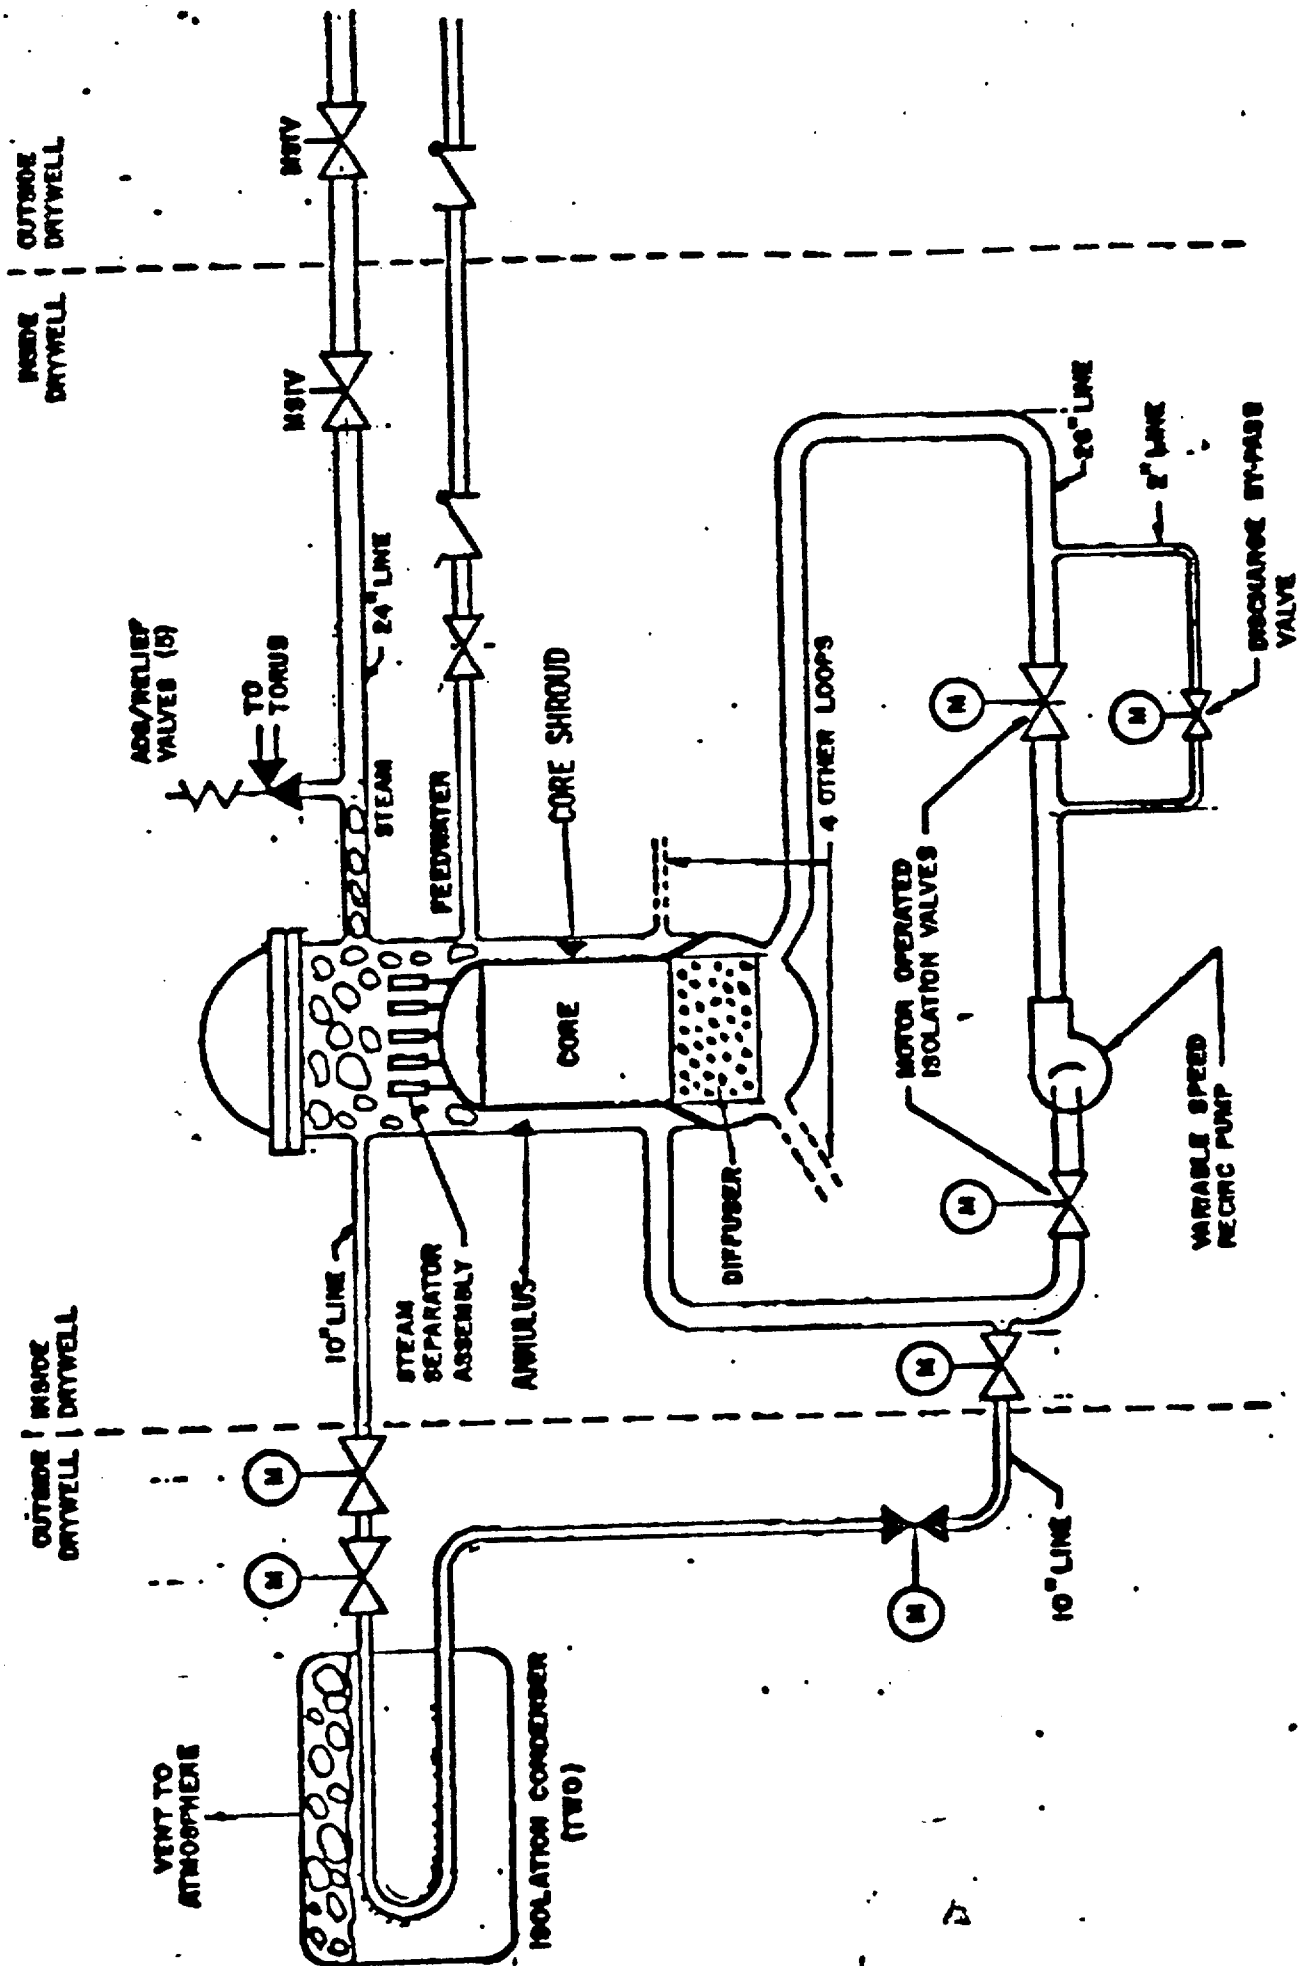
Figure 3

Initially, water inventory was decreasing due to steam flow through the turbine bypass valves to the main condenser. This loss together with the void collapse associated with decreased feedwater temperature and the subsequent loss of feed flow, resulted in a rapid reactor water level reduction to the low water level alarm setpoint of 11-feet, 5-inches above the top of the fuel at 13.6 seconds. At 25 seconds, an emergency diesel generator (DG-2) had automatically fast-started following the power loss to bus 1D and picked up emergency loads as designed. This loading included the second control rod drive (CRD) pump which with the other CRD pump (powered through the retained startup transformer) provided the only coolant makeup during this time. The operator manually initiated a main steam line isolation valve (MSIV) closure at about 43 seconds into the transient to conserve water inventory. The minimum indicated water level in the annulus area was 9-feet, 8-inches above the top of the fuel (the low low setpoint is 7-feet, 2-inches above the top of the fuel). After closure of the MSIV the isolation condenser was condensing steam from the core and returning the condensate to the reactor annulus (down-comer) region through connection to a recirculation loop pump suction line (Figure 3). Reactor water level began to increase shortly after MSIV closure.

The triple low level in the core shroud area resulted from restriction of the isolation condenser return flow path to the core region due to closure of the recirculation pump discharge valves. With the recirculation pump discharge valves closed, the flow path back to the core shroud was via the 2-inch bypass lines around the discharge valves. The effect was to reduce the water level in the core shroud area and to increase the level in the reactor annulus area.
