Kewaunee / Point Beach Nuclear  
Operated by Nuclear Management Company, LLC

Dockets 50-266 And 50-301  
Licensee Event Report 266/2001-005-00  
PRA Assessment of Auxiliary Feedwater System Reveals  
Procedural Vulnerability Related To Loss Of Instrument Air  
Point Beach Nuclear Plant, Units 1 And 2

TITLE (4)  
PRA Assessment of Auxiliary Feedwater System Reveals Procedural Vulnerability Related to Loss of Instrument Air

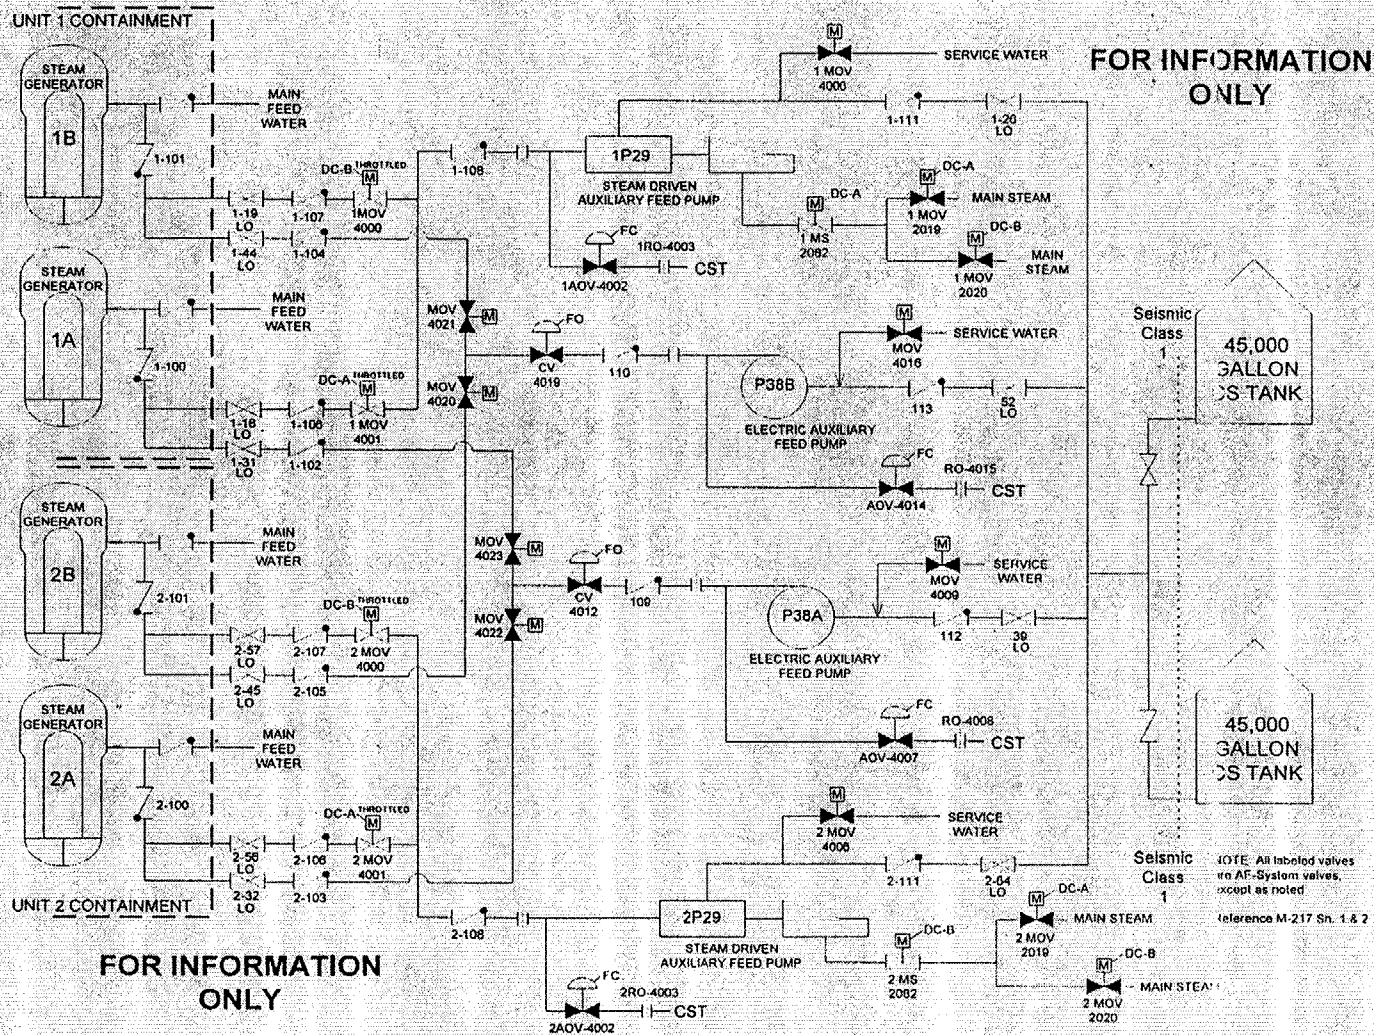
AFW System - Major Flow Paths

The following component and system description comes from Section 10.2 of the PBNP FSAR. A diagram of the major AFWS flowpaths is provided on the last page of this LER.

Both back-pressure control valves fail open when instrument air to the valves is lost. The discharge valves are provided with a backup nitrogen supply to provide pneumatic pressure in the event of a loss of instrument air. This backup supply assures that the discharge valves do not move to the full open position which, combined with low steam generator pressures, may cause the pump motor to trip on over-current due to high flow conditions. Each pump has an AOV controlled recirculation line back to the condensate storage tanks to ensure minimum flow to prevent hydraulic instabilities and dissipate pump heat. The discharge headers also provide piping, valves, and tanks for chemical additions to any steam generator. The pump bearings are ring lubricated and bearing oil is cooled by service water.
