Kewaunee / Point Beach Nuclear
Operated by Nuclear Management Company, LLC

Docket 50-305
Operating License DPR-43
Kewaunee Nuclear Power Plant
Reportable Occurrence 2001-005-01

LICENSEE EVENT REPORT (LER)

Unanalyzed Condition: Non-Safety Related Service Water Header Flows Affects Safety Related Components

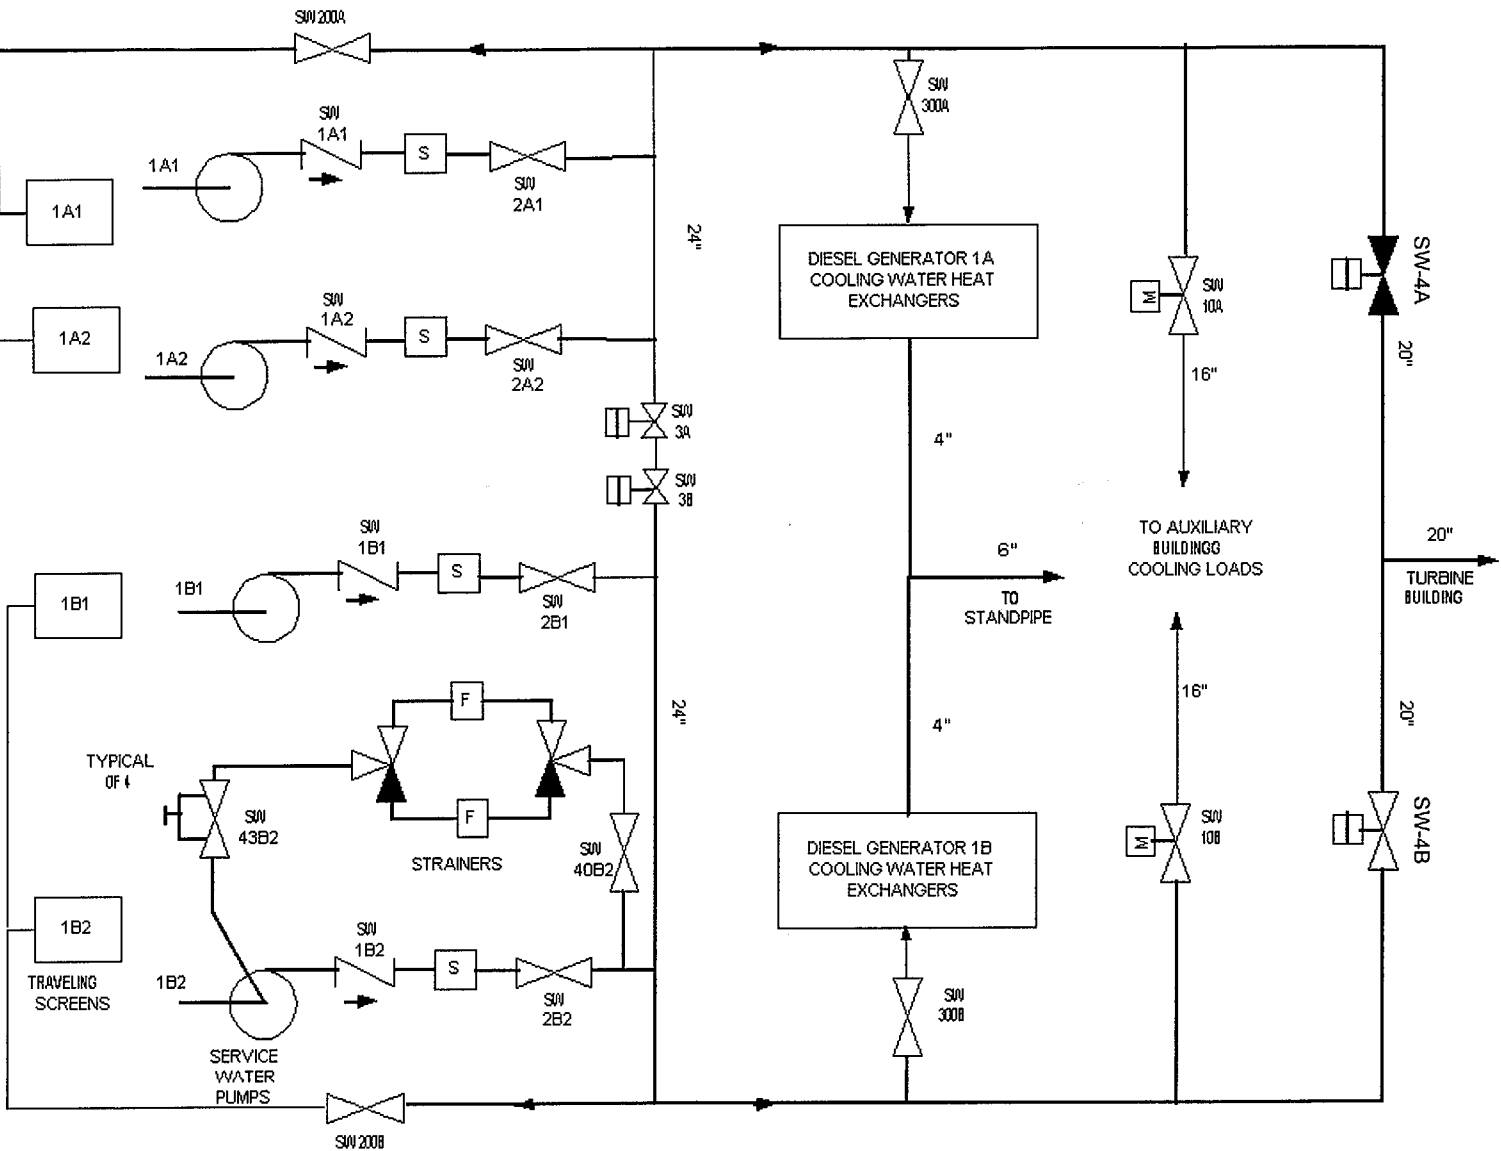
Figure 1: Simplified SW Sketch

As shown in Figure 1, the turbine building SW header is supplied through one of two remotely operated butterfly valves, SW-4A and SW-4B from the 'A' and 'B' SW header, respectively. During normal operation, only one valve may be open at a time; however, both valves can be in the closed position concurrently. The turbine building service water header valves are arranged such that they fail as-is on loss of instrument air. Sufficient compressed air is stored within a Class I accumulator for each turbine building header valve to permit valve closure following a loss of instrument air. Additionally, under a loss of off-site power (LOOP) condition, the ability to close valves SW-4A and SW-4B remains operable since power to the valve control circuit is provided by safety related battery backed instrument inverters and buses.

Air operated temperature control valves [TCV] downstream of valves SW-4A and SW-4B modulate to control the SW flow to non-safety related components. The temperature control valves have fail open operators in the event of a loss of instrument air [LD]. The instrument air feeding the non-safety related temperature control valves is not credited to remain operable during LOOP condition.

- NMC tested the SW system including postulated accident conditions in the turbine building SW header.
- Following the testing, NMC installed a design change on the SW-4A and SW-4B valves to automatically isolate the turbine building SW header on a Safety Injection (SI) sequence signal concurrent with low SW header pressure.
- In conjunction with the design change, NMC implemented compensatory administrative controls to require appropriate plant configuration in the event a required component becomes inoperable.
