# Research Reactor Center

Subject: Docket No. 50-186  
The Curators of the University of Missouri  
License No. R-103

**Event Report 02-01 – January 20 and 26, 2002**  
**University of Missouri Research Reactor**

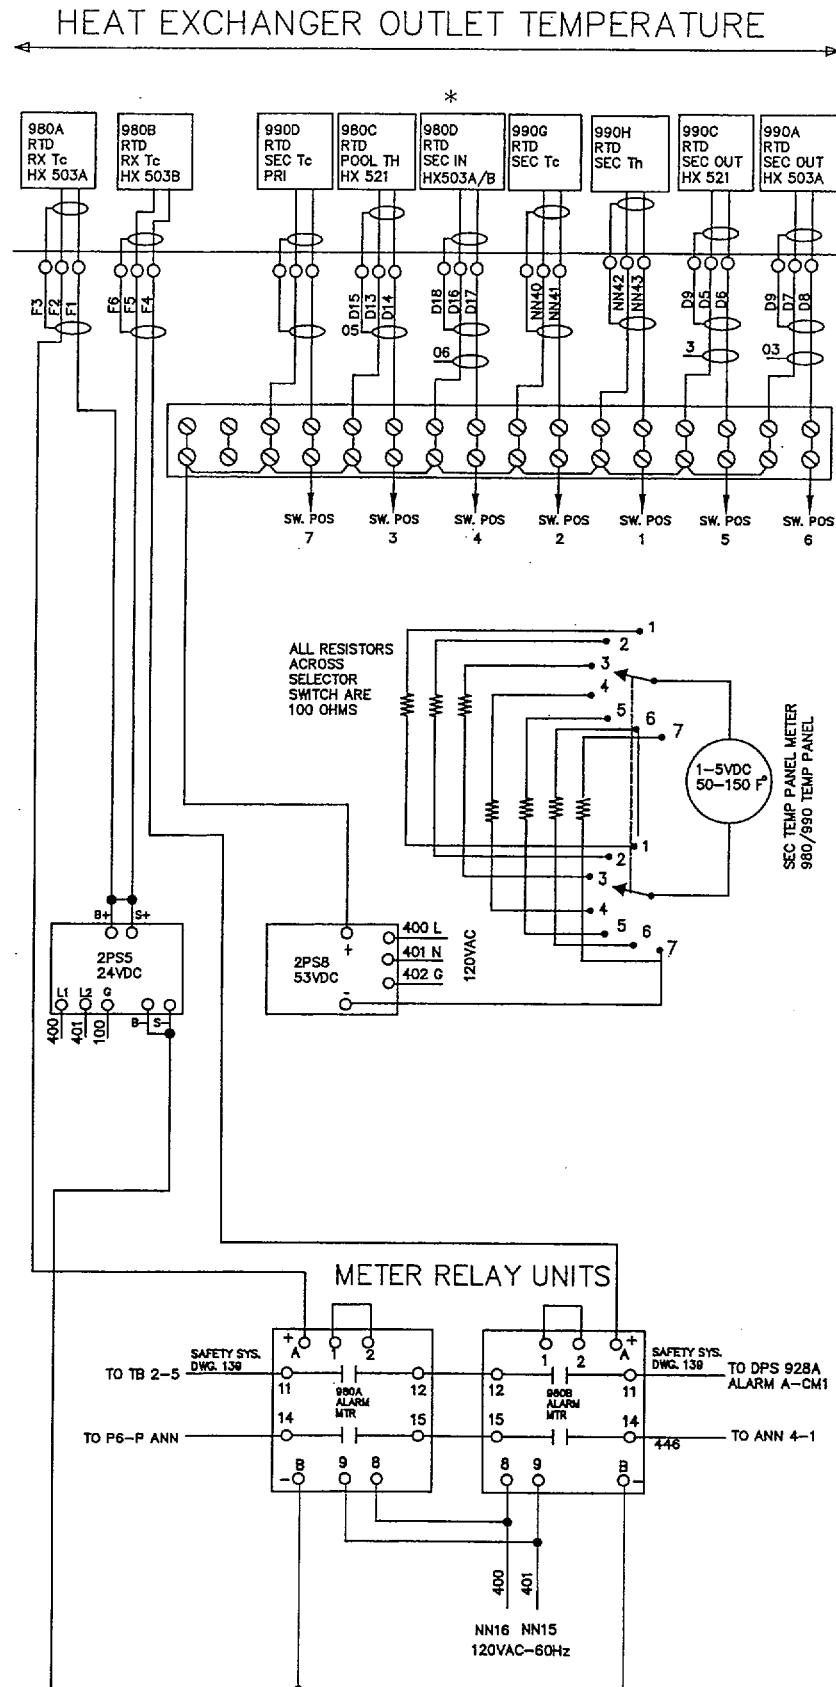
The subject temperature instruments, 980 A and 980 B are shown as "Heat Exchanger Outlet Temperature" on the attached drawing. The RTD/transmitter units are Rosemount

This instrument, along with 980 A, measures the temperature of the reactor coolant on the outlet side of primary heat exchangers 503 A and B. Technical specification 3.3.a states "The safety system and the number (N) of associated instrument channels necessary to provide the following scrams shall be operable whenever the reactor is operated." The required number (N) for Reactor Inlet Temperature is 2 for Mode I operation. The required 2 channels for this scram are instruments 980 A and 980 B. The failure of channel 980 B resulted in non-compliance with this technical specification.
