FirstEnergy Nuclear Operating Company

Beaver Valley Power Station, Unit No. 2
Docket No. 50-412 License No. NPF-73
LER 2002-001-00

LER 2002-001-00, 10 CFR 50.73(a)(2)(i)(B), "Service Water Conditions for the Recirculation Spray System Lead to Technical Specification Noncompliance."

1. FACILITY NAME			2. DOCKET NUMBER		3. PAGE		
Beaver Valley Power Station Unit No. 2			05000412		1 of 7		
4. TITLE							
Service Water Conditions for the Recirculation Spray System Lead to Technical Specification Noncompliance

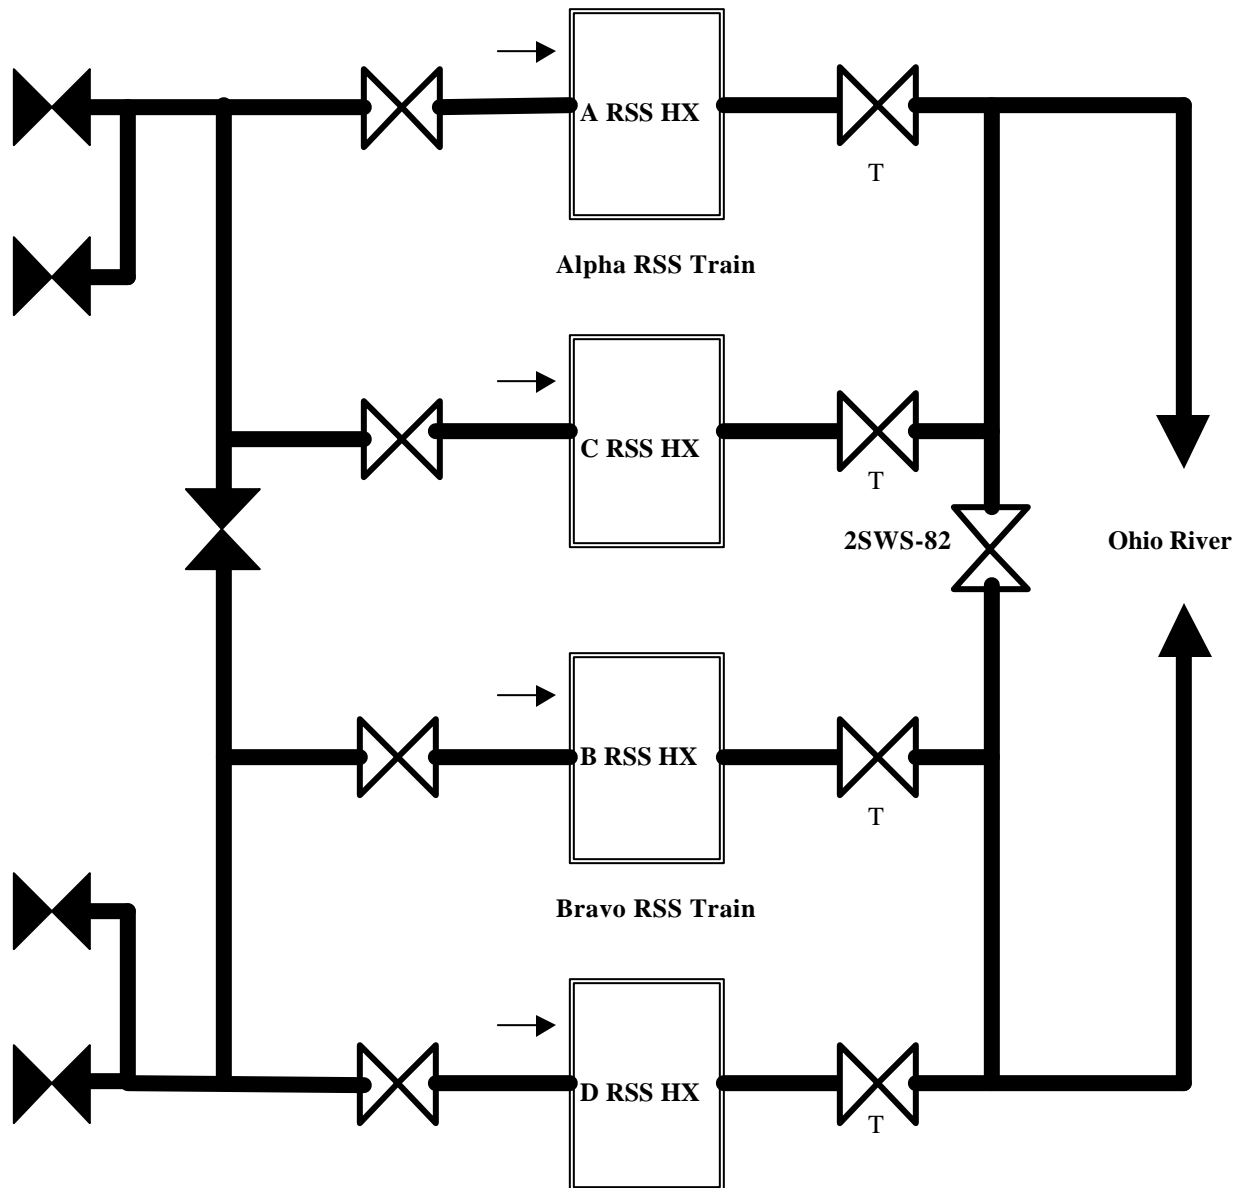
Simplified Service Water System Flow Arrangement For the RSS Heat Exchangers
(Normal System Arrangement Shown)

On January 15, 2002, while planning for the service water flow surveillance test through the Alpha train of RSS, it was discovered that both trains of RSS had been inadvertently rendered inoperable on three separate occasions while the B and D RSS heat exchangers were being drained following their surveillance test. Service water flow through the two Alpha train and the two Bravo train RSS heat exchangers is carried out to the Ohio River via two discharge pipes. These two service water discharge pipes are cross-connected just downstream of the four (A, B, C & D) RSS heat exchangers by a normally locked open manual isolation valve (2SWS-82). During the draining of the B and D RSS heat exchangers, 2SWS-82 was closed per the draining procedure on three separate occasions. 2SWS-82 was closed for approximately 2 hours on January 11, for approximately 1.5

hours on January 12, and for approximately 4 hours on January 13. Closing 2SWS-82 placed the service water system in a configuration where the service water flow through the Alpha train of RSS has not been demonstrated to meet the minimum service water flow rate required by TS SR 4.6.2.2.e.3 of greater than 11,000 gpm for one train of RSS. Thus, during the three periods when 2SWS-82 was closed (making the Alpha train of RSS inoperable) and the Bravo train of RSS was inoperable for corrective maintenance, both trains of RSS were inoperable. TS 3.6.2.2 does not permit both trains of RSS to be inoperable in Modes 1 through 4; thus, TS 3.0.3 was applicable. TS 3.0.3 requires that action shall be initiated within one hour to place the Unit into a Mode in which the application specification does not apply. Since this condition was not recognized at the time, the actions required by TS 3.0.3 were not implemented, which is a condition prohibited by TS.

The cause for the inadvertent entries into TS 3.0.3 when 2SWS-82 was closed is inadequate/incomplete design aspects. The original change to require 2SWS-82 to be locked open to reduce system backpressure was not effectively managed and documented. The underlying reason that 2SWS-82 is locked open is to maintain the configuration of service water system piping from the RSS heat exchangers to support adequate flow through either train of RSS. Prior to January 11, 2002, the service water flow surveillance testing of the RSS had previously occurred during

shutdown conditions when RSS was not required to be operable. The previous revision of the procedure for draining a RSS heat exchanger was only applicable during outage periods and had closed 2SWS-82 as a precaution for industrial safety purposes given that other outage related work may be ongoing. However, 2SWS-82 is not required to be closed to drain the RSS heat exchanger. When the need arose in January 2002 for draining the B and D RSS heat exchangers in a mode where the Alpha train RSS was required to be operable, the procedure for draining a RSS heat exchanger was revised to be applicable in all modes. The personnel who developed and performed the newly revised procedure were not readily able to recognize that the closure of 2SWS-82 in Modes 1-4 would render the Alpha RSS train inoperable due to low service water flow.

When 2SWS-82 was closed, it was calculated that the total Alpha RSS train service water flow would have been 10,642 gpm, which is less than the 11,000 gpm required by TS 4.6.2.2.e.3. However, similar to the evaluation performed for the Bravo RSS train, an evaluation of the DBA transients was performed using the service water system temperature observed during the time that 2SWS-82 was closed and the calculated service water flow rate in the Alpha train. Acceptable containment analyses results were determined. Thus, although the Alpha train of RSS was inoperable due to service water flow being less than the minimum required value, the Alpha train of RSS would have acceptably performed its safety functions during the time when 2SWS-82 was closed.

3. The service water flow rate surveillance test was subsequently performed through the Alpha train of RSS (A and C RSS heat exchangers) with no flow anomalies identified.
4. An engineering evaluation concluded that the structural integrity of the D RSS heat exchanger was not adversely affected due to the observed higher than normal flow rate when the B RSS heat exchanger flow rate was degraded.
5. Additional enhancements are being evaluated for the torque checks on the RSS heat exchanger top and bottom endbells.
6. The procedure which is used to drain the RSS heat exchangers has been revised to remove instructions to close 2SWS-82.
7. The BVPS Unit 2 Operations Manual will be revised to include a note describing the reason for 2SWS-82 being locked open and a permanent placard was placed at the valve location describing the reason the valve is locked open.
