**SEQUOYAH NUCLEAR PLANT (SQN) - STEAM GENERATOR (SG) 120-DAY
REPORT FOR UNIT 1 CYCLE 11 (U1C11) REFUELING OUTAGE SG
INSPECTIONS**

TENNESSEE VALLEY AUTHORITY
SEQUOYAH NUCLEAR PLANT (SQN)
UNIT 1

UNIT 1 CYCLE 11
STEAM GENERATOR (SG)
120-DAY REPORT
DENTED TUBE SUPPORT PLATE
AXIAL PRIMARY WATER STRESS CORROSION CRACKING
ALTERNATE REPAIR CRITERIA (ARC)

**PWSCC Condition Monitoring
And Operational Assessment Report**

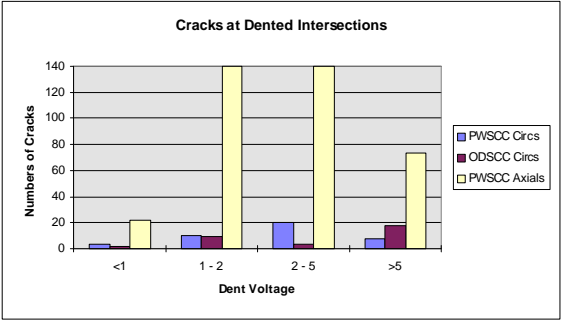
Figure 1

It was identified during the Unit 1 Cycle 10 inspection that the circumferential cracking at dented tube support plates behaved very similar to the ID axial cracking at these support plates. It was projected in the operational assessment that if a 10,007 inspection scope was performed Unit 1 Cycle 11 (no expansion from Unit 1 Cycle 10), that 200 axial cracks would be identified and 68% would be in dents greater than 2 volts. The plus point inspection scope for Unit 1 Cycle 11 was expanded to 15,774 intersections including all dented intersections ≥ 1 volt. With this expansion, 375 ID axial cracks were identified and 57% were in greater than 2 volt dented intersections.

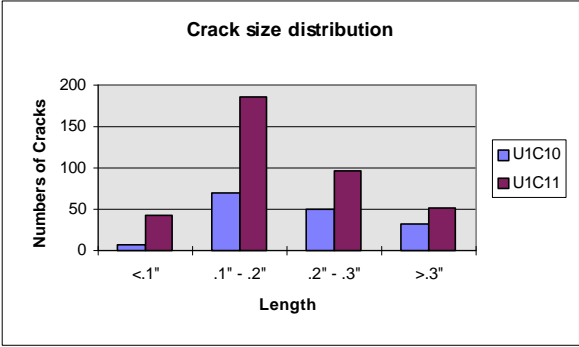
Figure 2

Although the number of indications was larger than predicted, the size distribution identified U1C11 was very similar to the size distribution U1C10. More small indications were identified with the higher number of plus point exams. We continue to identify very small indications with very low growth.

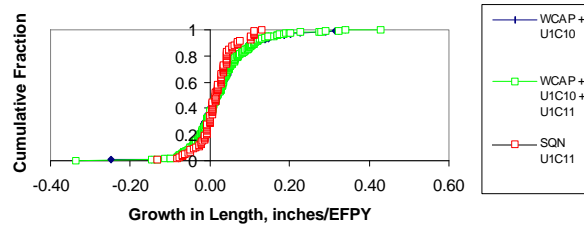
Cumulative Distribution of Growth in Length

inspection, growth was evaluated to ensure that EOC-11 growth rates were bounded by the WCAP plus EOC-10 data growth rates. The cumulative distribution curves for the Sequoyah EOC-11 growth rates, and the combined WCAP and Sequoyah Cycle 11 growth rates are depicted graphically in Attachment 2 to this enclosure.
