EA No. 00-179

SUBJECT: NRC SPECIAL INSPECTION REPORT 05000247/2000-010
STEAM GENERATOR TUBE FAILURE

Docket No. 05000247
License No. DPR-26

IR 05000247-00-010, March 7 thru July 20, 2000; Consolidated Edison of New York, Inc.; Indian Point Unit 2; Special Team Inspection reviewing the causes for the February 15, 2000, steam generator tube failure, in accordance with NRC Inspection Procedure 93812. Findings in steam generator eddy current test examination program corrective actions and technique qualification.

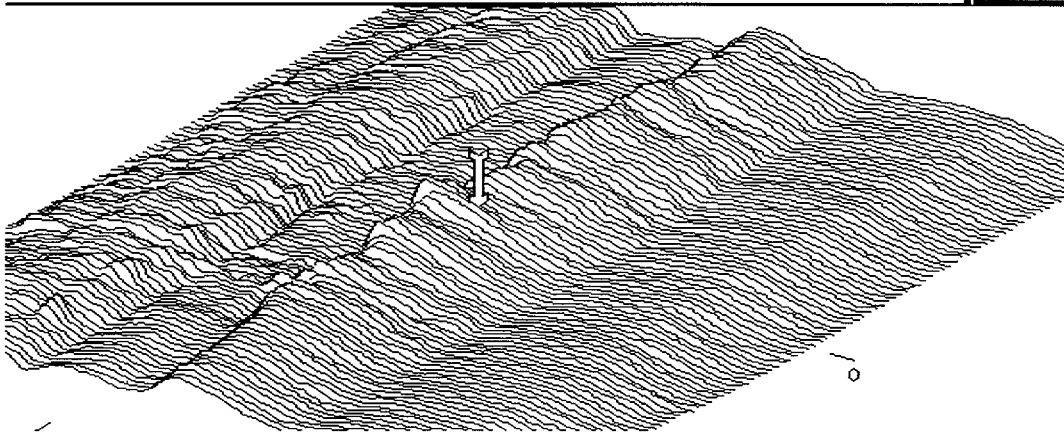
Figure 5 R2C5C-scan with 1997 phase setting.

1. R2C5 in SG 24 - Figure 5 is a c-scan plot of the vertical component of the ECT voltage signal. The defect signal, indicated by the arrow, sits on a noise ridge that runs the length of the tube. This noise ridge is about 1-volt in amplitude and measures as a deep ID defect. This ridge makes both the detection and sizing of this defect more difficult. Figures 6 and 7 are the lissajous plots for the flaw area and the noise ridge, respectively. These figures show that a flaw signal is distinguishable from the characteristic noise signal, as was the case in the other tubes profiled. No year 2000 data is available since the tube failed.

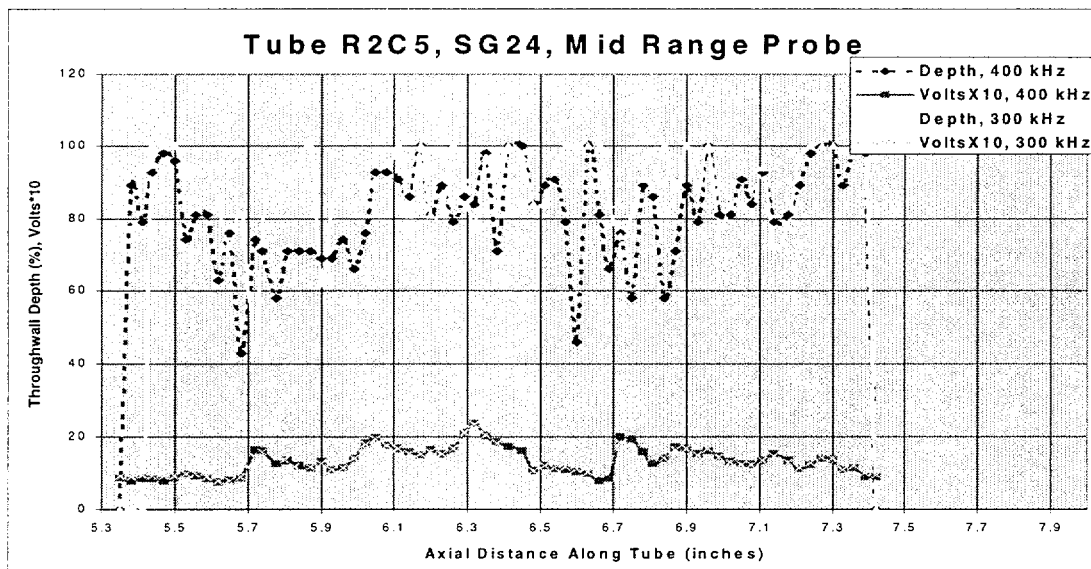
The indication has been profiled for both the 300- and 400-kHz inspection frequencies, as is shown in Figure 4. The signal-to-noise ratio is slightly better for the 400-kHz frequency than for the 300-kHz. The voltage above 1.2-volts indicates the defect; however, there is considerable noise. The depth estimate based on 1997 data is 87-percent TW.

Figure 7 Noise signal that runs the length of the U-bend.

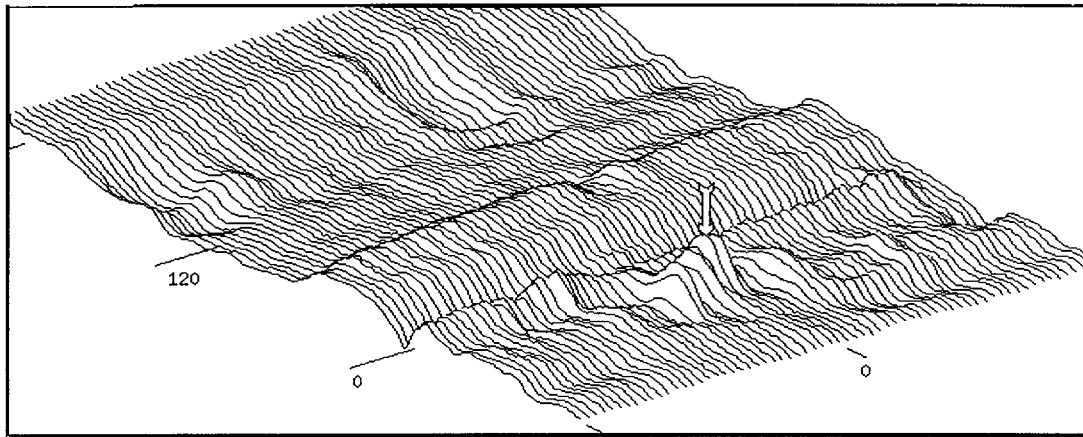
Figure 9 - 1997 Mid-range scan .

2. R2C69 in SG 24 - Figure 9 shows the c-scan plot for the 1997 data. There is considerable noise present. For comparison, the c-scan plot for the 2000 data is included as Figure 10. The noise features between the 1997 and 2000 data are similar enough to verify that this is the same defect at the same location. Figure 11 shows the profile. The defect voltage is only about 1 volt, and there is a considerable amount of noise on the tube, relative to the defect signal. The depth estimate based on 1997 data is 52.6-percent TW.

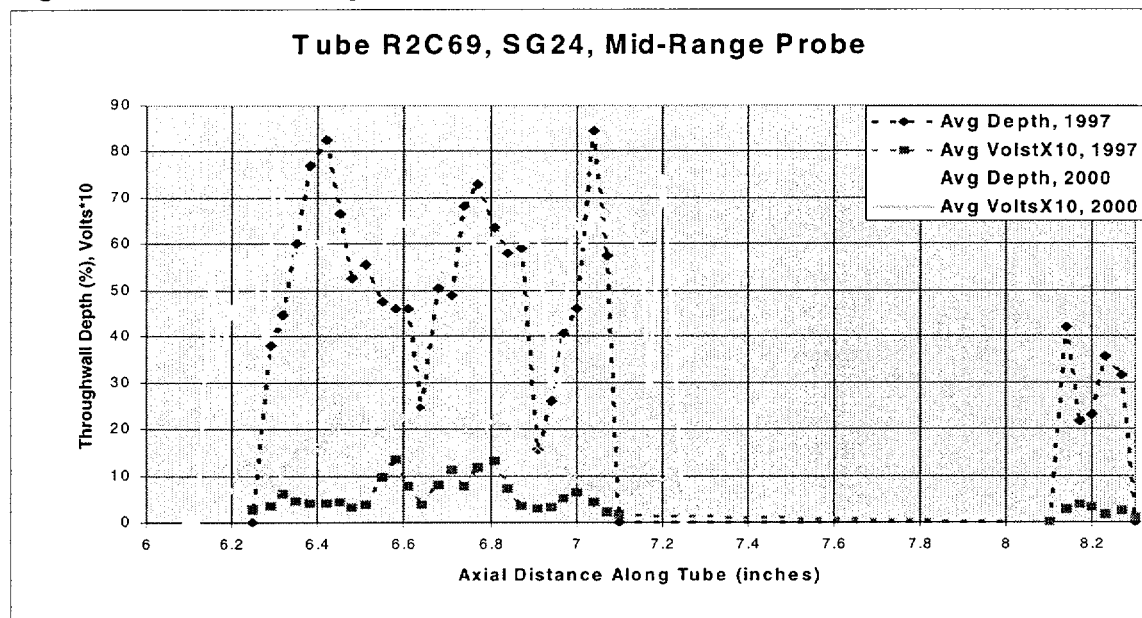
Figure 11 - Profile of Growth between 1997 and 2000

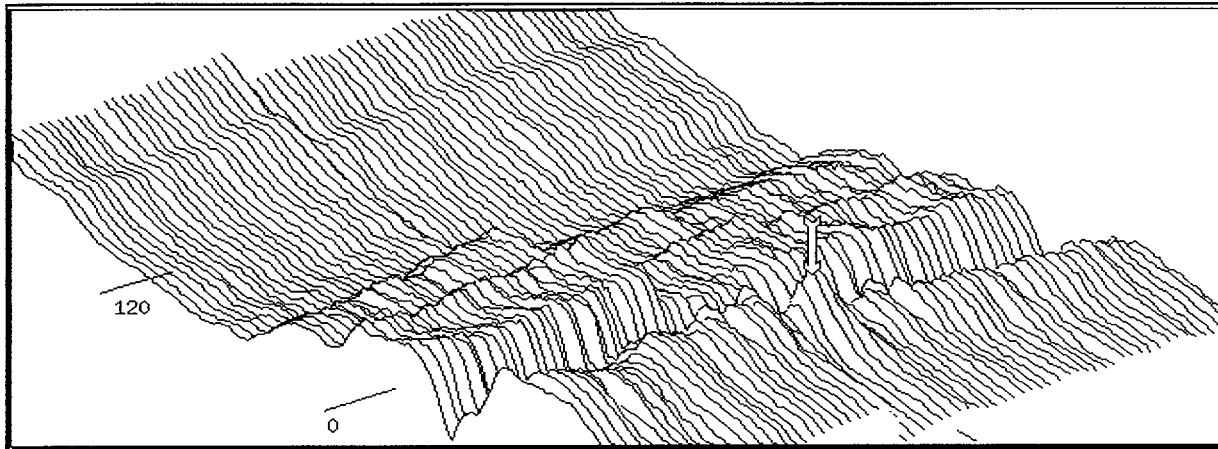
Figure 12 - 1997 scan

3. R2C72 in SG 24 - Figure 12 shows the c-scan plot of the 1997 data. There is considerable noise present. The crack is sitting in a ridge of noise and barely extends above a ridge of deposits. For comparison, the c-scan plot for the 2000 data is included as Figure 13. Figure 14 shows the profile. The crack barely extends above a 1-volt amplitude for a short length, and this is the only part of the crack that can be profiled reliably. The depth estimate based on 1997 data is 79.2-percent TW.

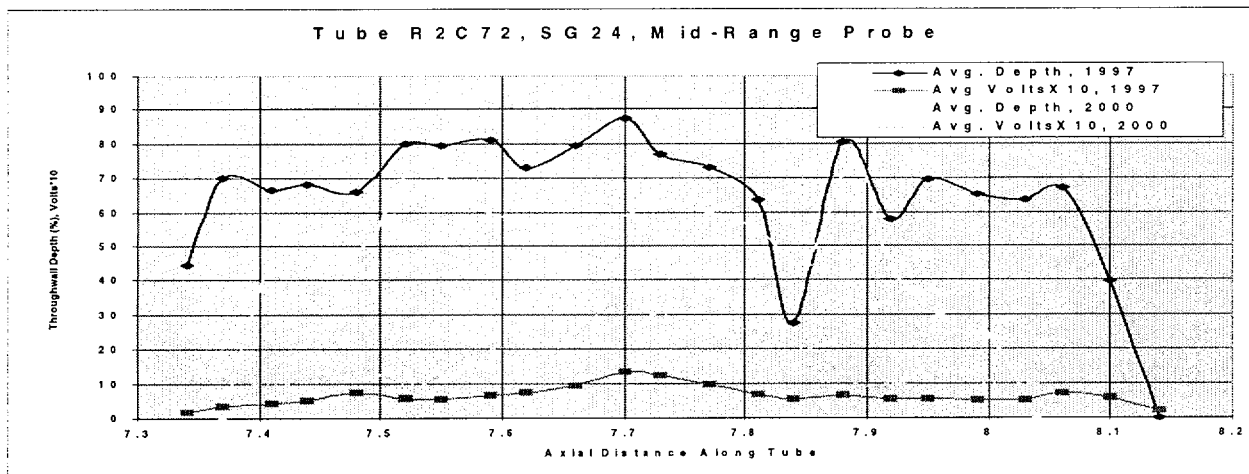
Figure 14 Profile of crack growth of tube R2 C72 of SG24 between 1997 and 2000

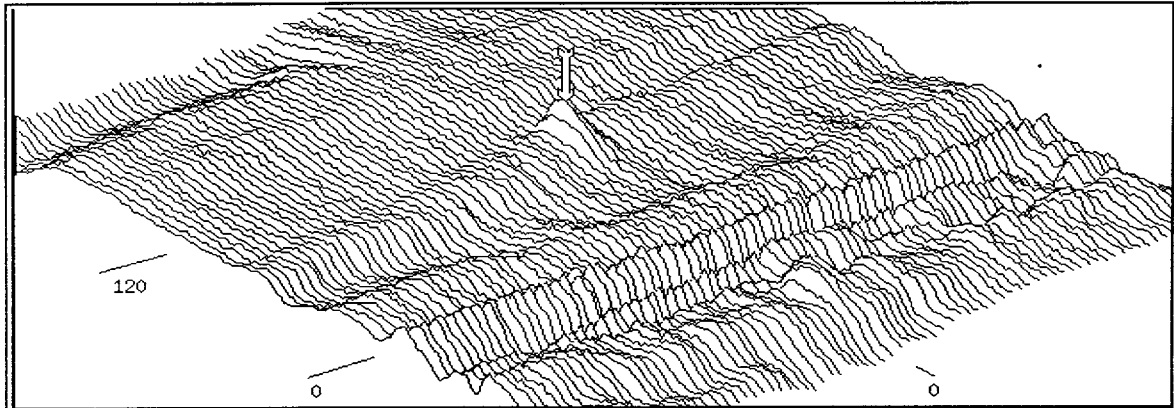
Figure 15 - 1997 scan

4. R2C87 in SG 21 - this tube was identified as having several cracks. Figure 15 shows the c-scan plot of the 1997 data. The most prominent crack is sitting in a relatively clean area of the tube. For comparison, the c-scan plot for the 2000 data is included as Figure 16. Figure 17 shows the profile of the most prominent crack. The depth estimate based on 1997 data is 63.7-percent TW.

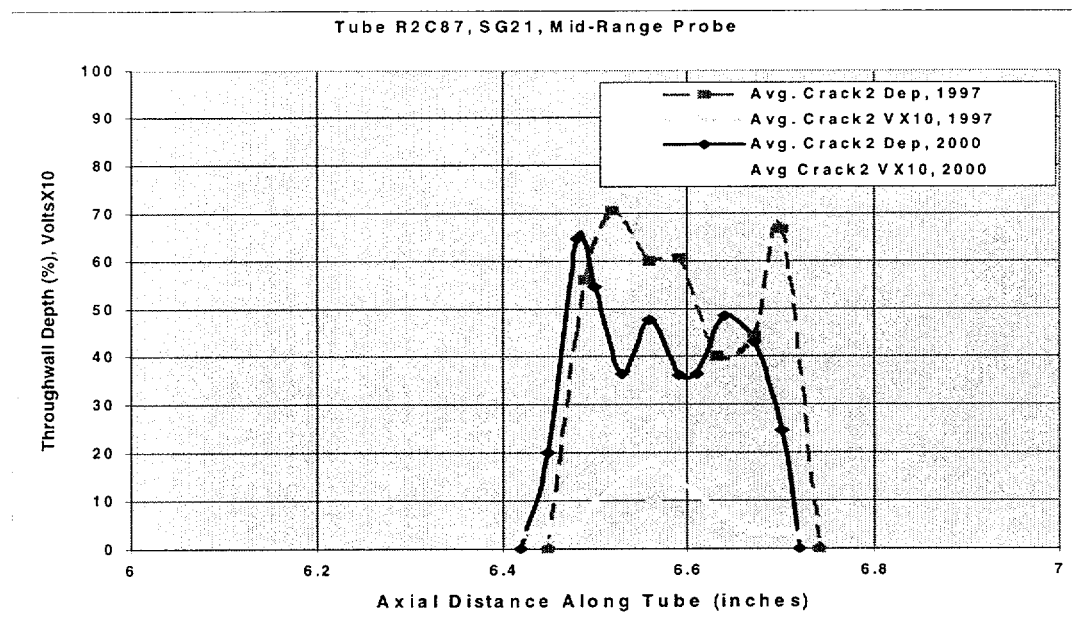
Figure 17- Profile of crack growth of tube R2 C87.

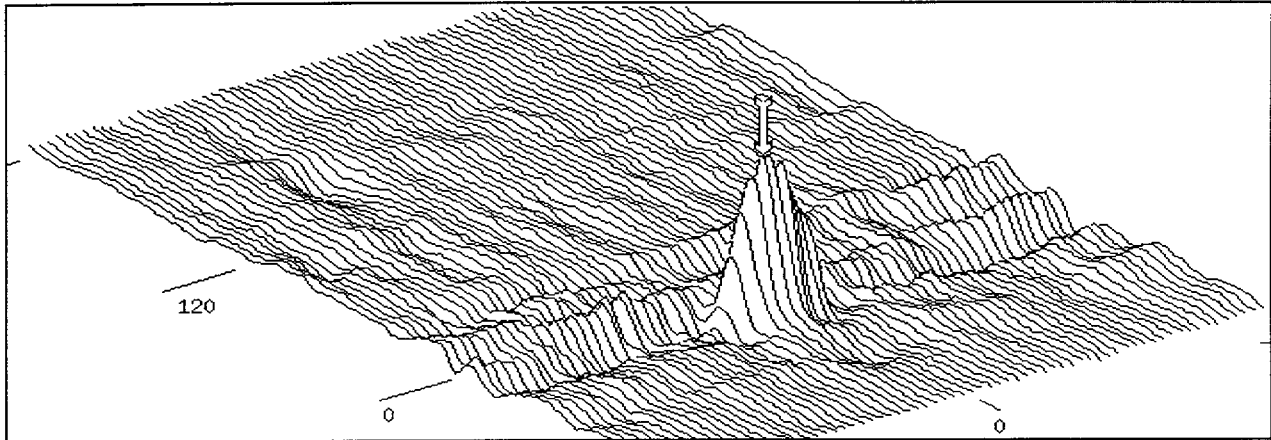
The c-scan plot of the 1997 data from R2C67 is shown in Figure 18. The crack sits beside a ridge, in a valley, and is in an easily detectable portion of the tube. The large amplitude of the voltage signal, in relation to the standard calibration notch, would indicate that this is a "mature" crack. No year 2000 data is available since the tube was plugged in 1997. Figure 19 shows the profile. The depth estimate based on 1997 data is 87.5-percent TW.

Figure 18 - Crack in tube 2-67 of steam generator 24, found in 1997.
