VIRGINIA ELECTRIC AND POWER COMPANY
NORTH ANNA POWER STATION UNIT 2
SUPPLEMENTAL INFORMATION - NRC BULLETIN 2001-01 CIRCUMFERENTIAL
CRACKING OF REACTOR VESSEL HEAD PENETRATION NOZZLES
RESULTS OF METALLURGICAL INVESTIGATION OF ALLOY 82/182 CRACKING

Metallurgical Investigation of Cracking of the Alloy 82/182 J-Groove Weld of the Reactor Vessel Head Penetration Joint at North Anna Unit 2 Station

WCAP-15777

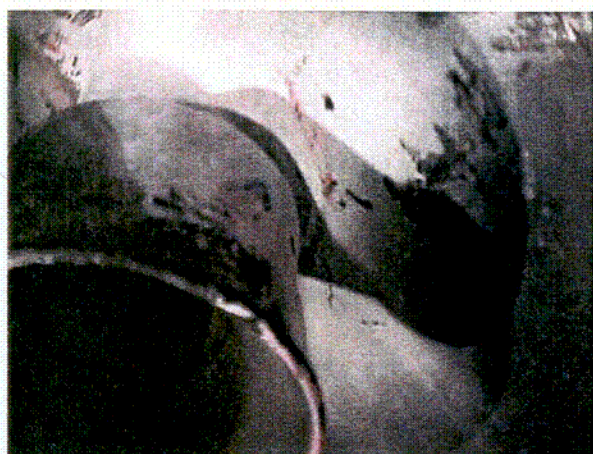
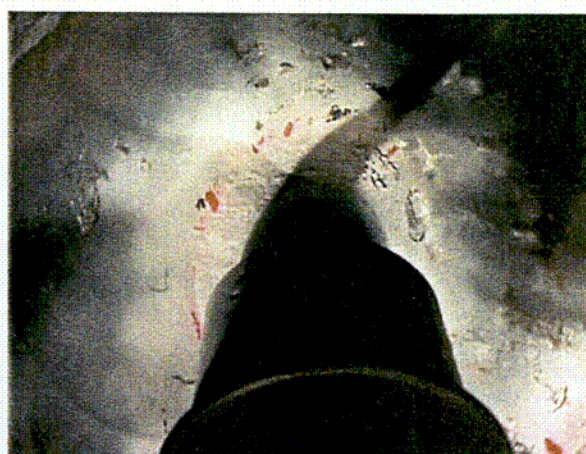
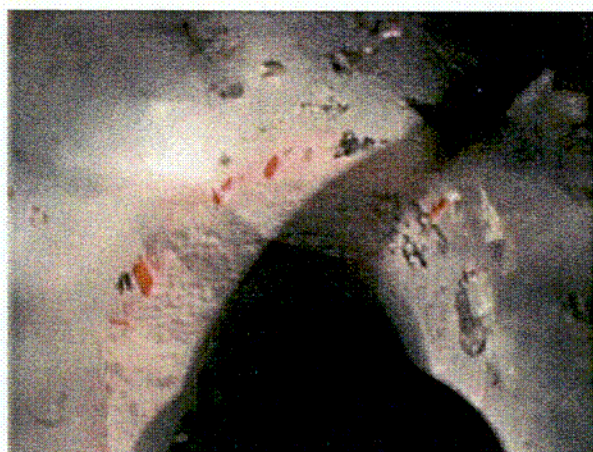
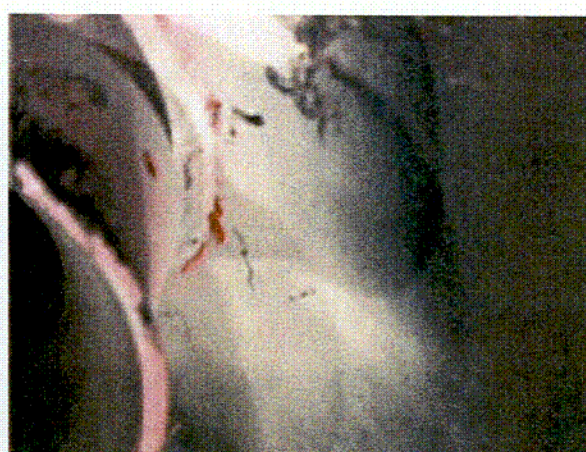
Figure 1(a) Photomicrographs illustrating Dye Penetrant Examination results of Penetration No. 51

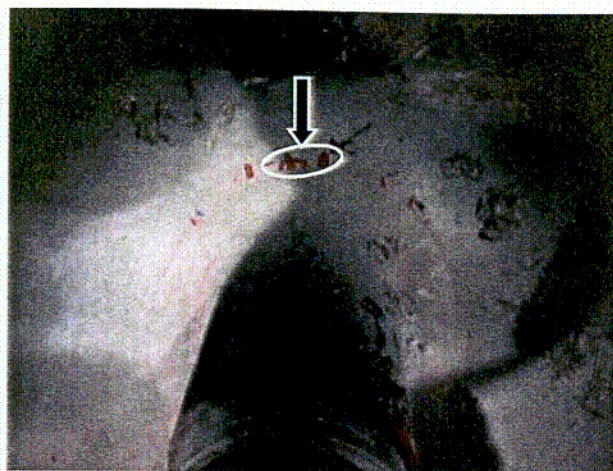
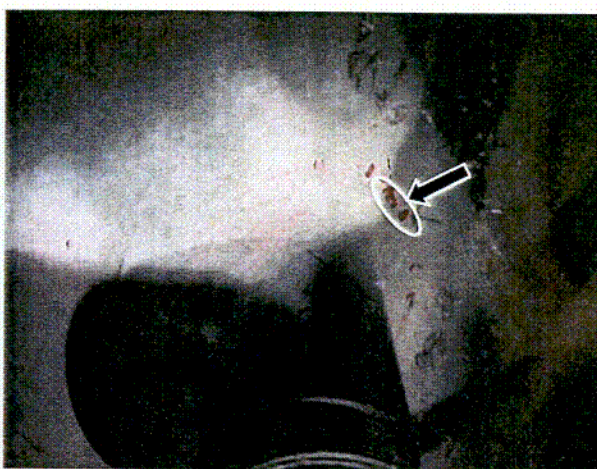
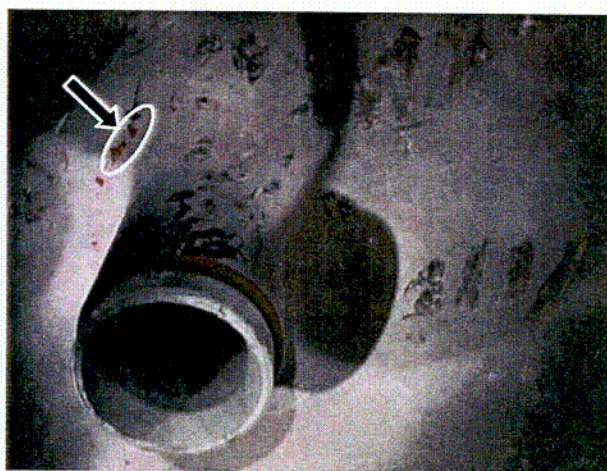
Figure 1(b) Photomicrographs illustrating Dye Penetrant Examination results of Penetration No. 62 (arrow indicates boat sample location)

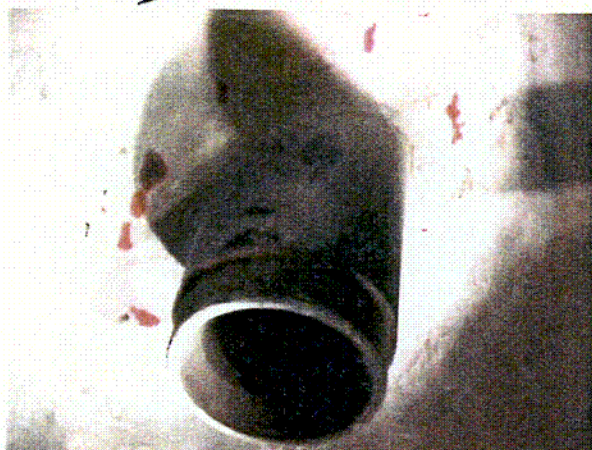
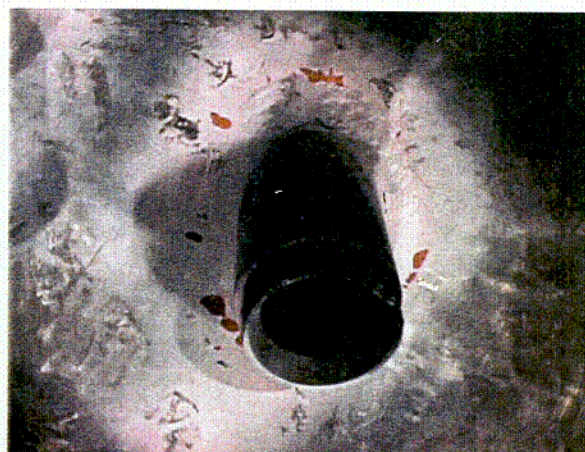
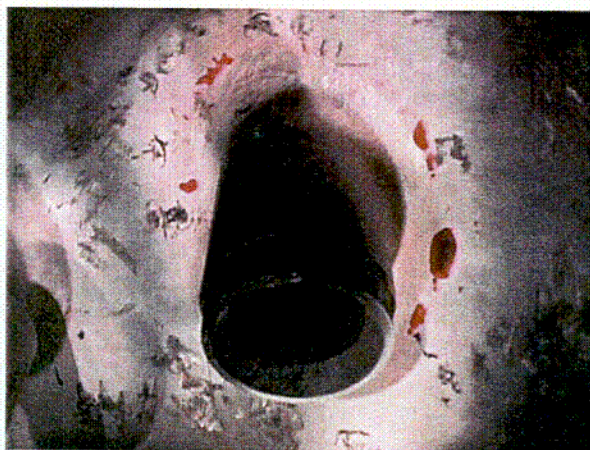
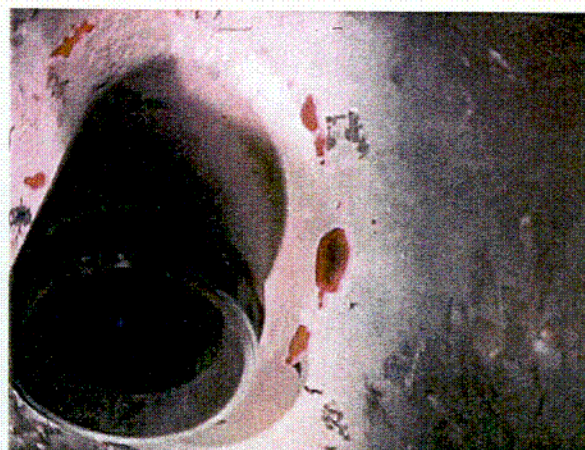
Figure 1(c) Photomicrographs illustrating Dye Penetrant Examination results of Penetration No. 63

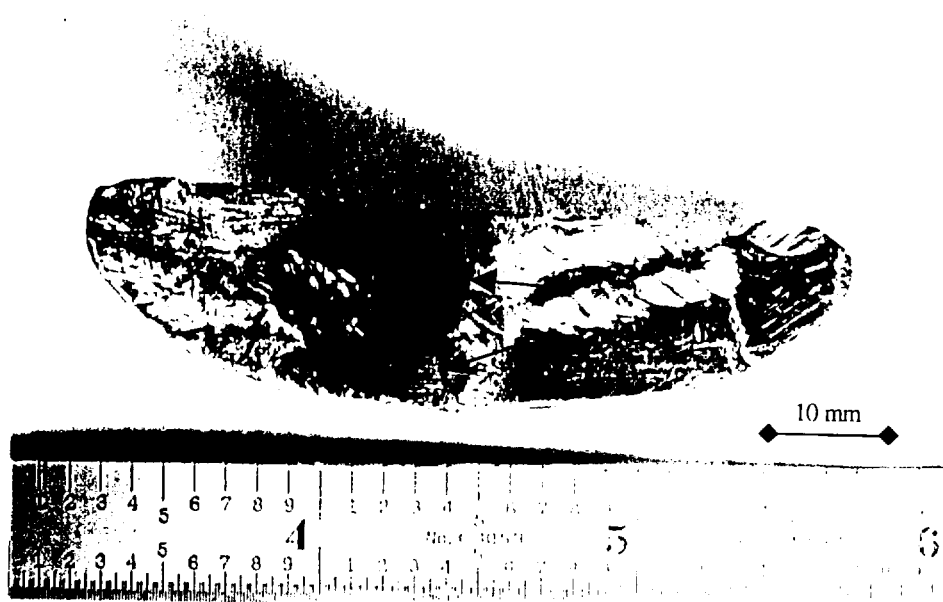
The surface examination results of the boat sample in the as-received condition (Figures 3.b and 4.a) showed evidence of surface grinding and cold work on the wetted ID face.

The above sequence of observations suggests that a weld repair of the butter/weld region at the ID surface was most likely involved during fabrication of the penetration 62 J-weld. They also suggest that a surface grinding of the repaired region may have been conducted to disposition a recorded PT indication.

Figure 3(b) Surface Appearance of Boat ID (Wetted) Face Illustrating the Presence of Grinding Marks and Cracks (Arrows). Note that the long axis of the boat is oriented parallel to the Alloy 182 butter/stainless steel cladding interface

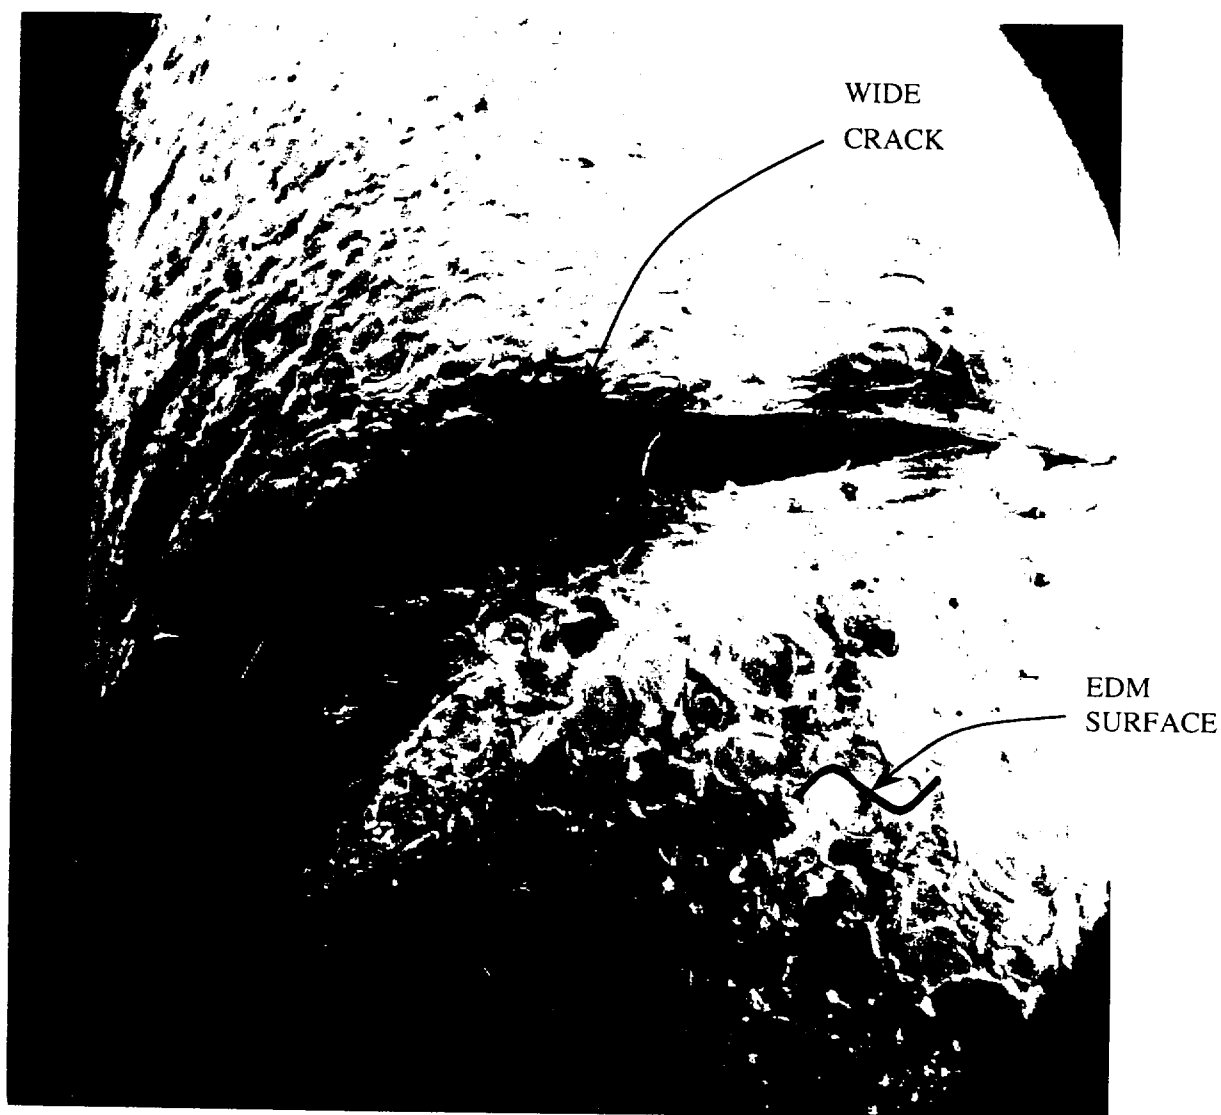
Figure 4 **Appearance of Wide Crack (Figure 3a) on the EDM Surface of the Boat in the As-received Condition**

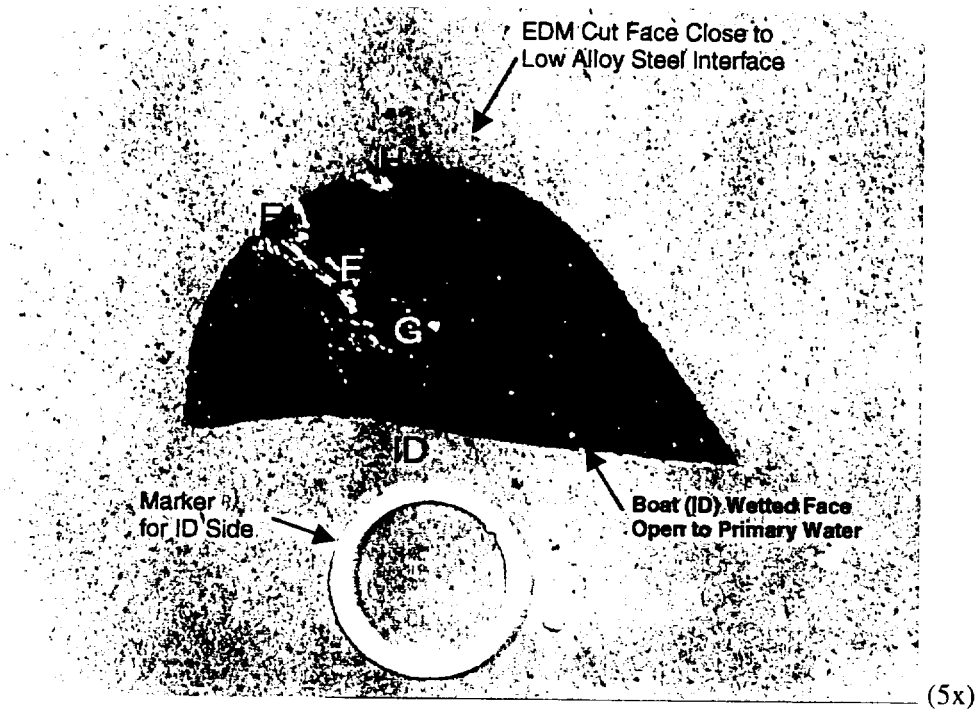
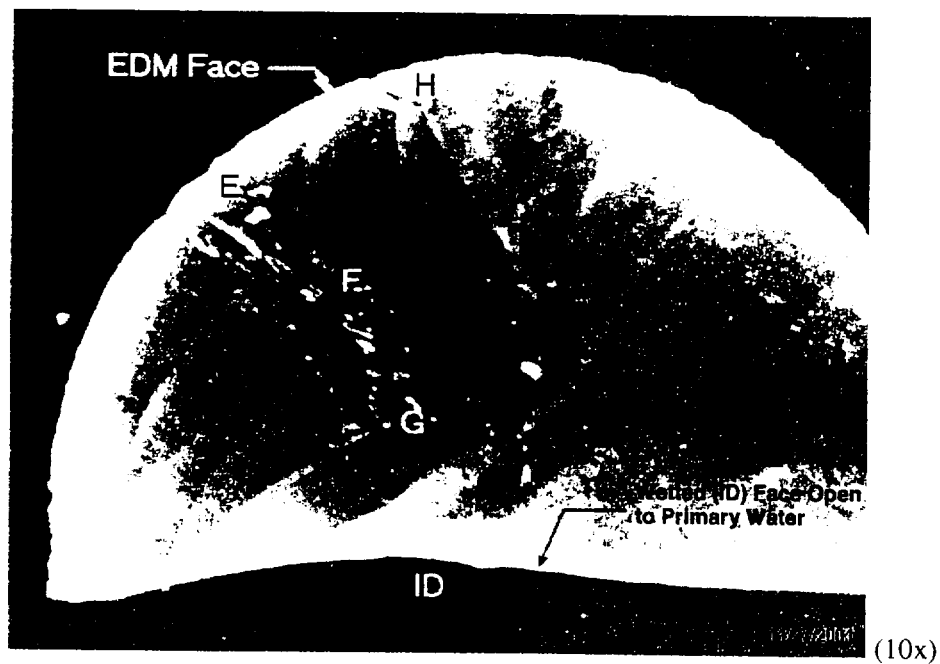
Figure 7 Metallographic Examination results of the transverse section of the boat identifying the cracking locations. (M2451) Details at areas E, F, G and H are illustrated by the higher Magnification micrographs in Figures 9 through 14.

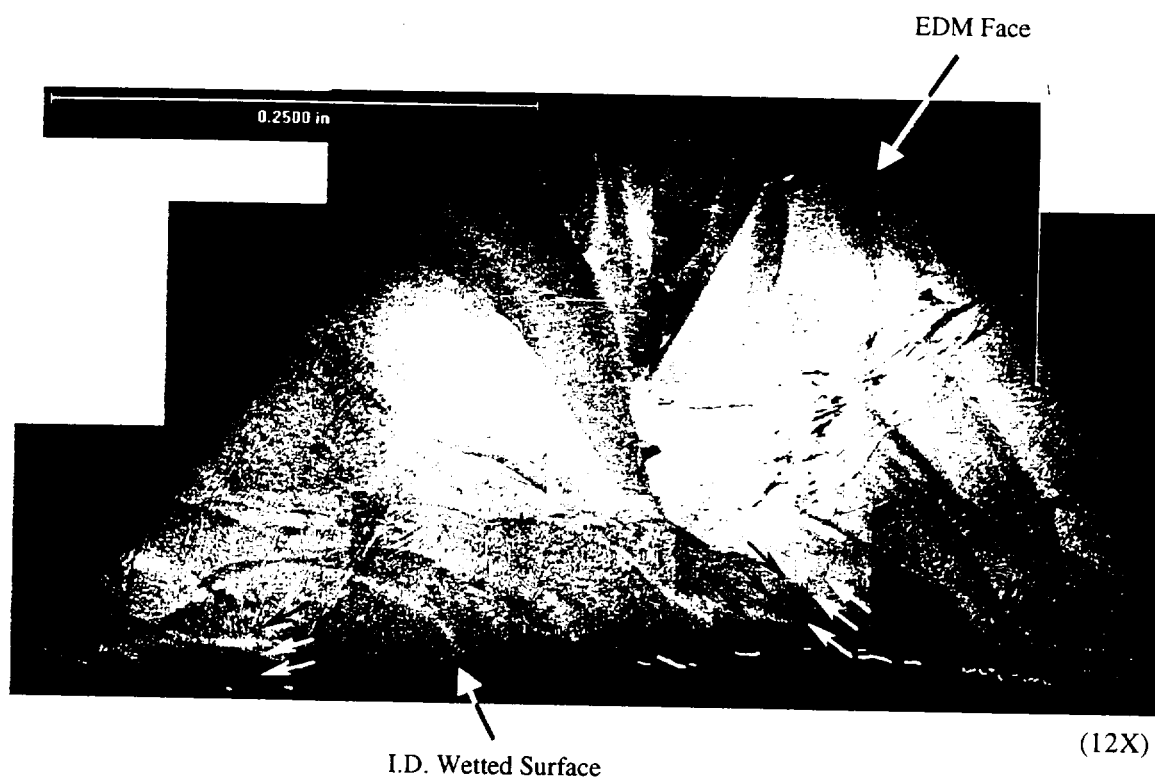
- The hot cracking is seen extending through several passes of weld metal as it approached the ID (Figure 8). This is not considered an uncommon occurrence. Depending on the magnitude of strains developed during solidification, the stress (strain) concentration at the tip of initial crack in the proceeding weld layer provides a driving force for extension into the succeeding layer. Another important contribution can come from the residual stresses from multiple repairs on the ID surface.

Figure 8 Metallographic Examination results of the transverse section of the boat illustrating the distribution of cracking. Arrows indicate locations of crack extension to the I.D. wetted surface of the boat. (Mirror image of Figure 7)

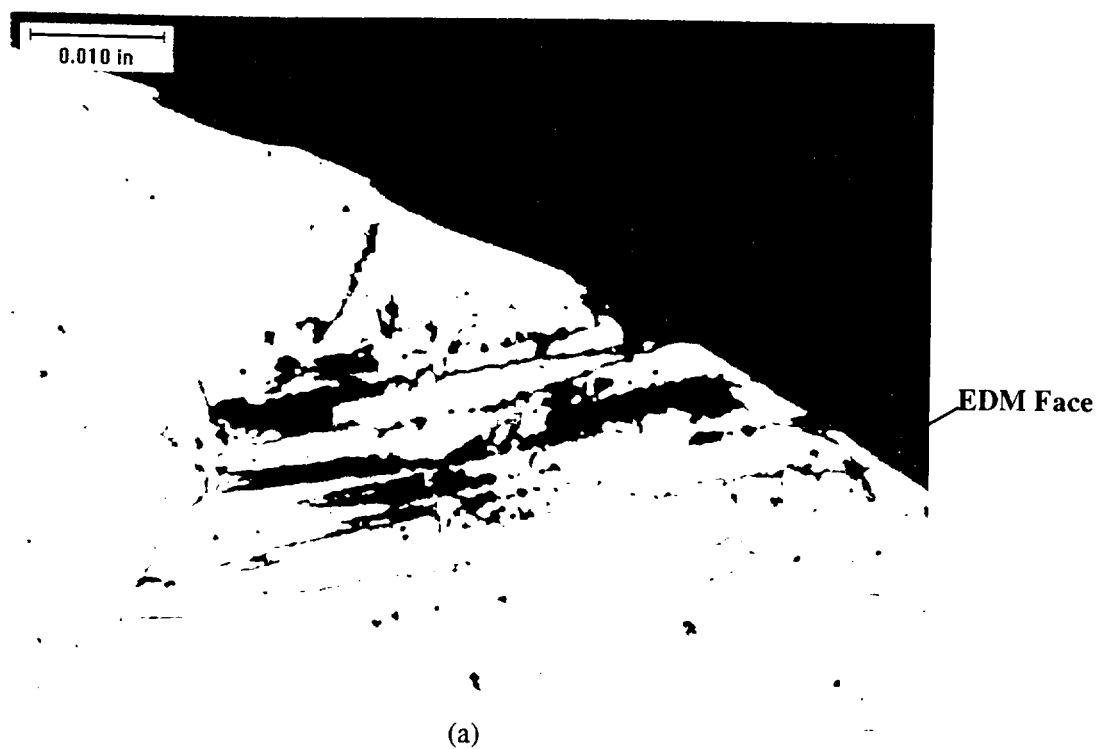
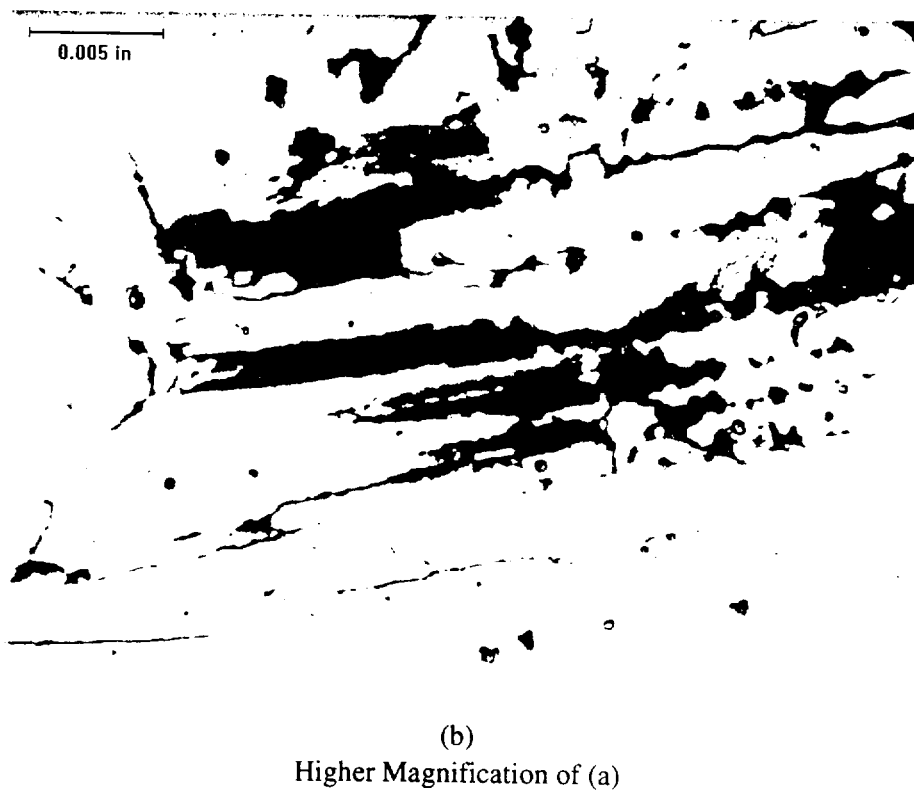
Figure 9 Metallographic Examination results of the transverse section (M2451) of the boat in the 'as-polished' condition illustrating the cracking morphology at Area 'H', Figure 7.

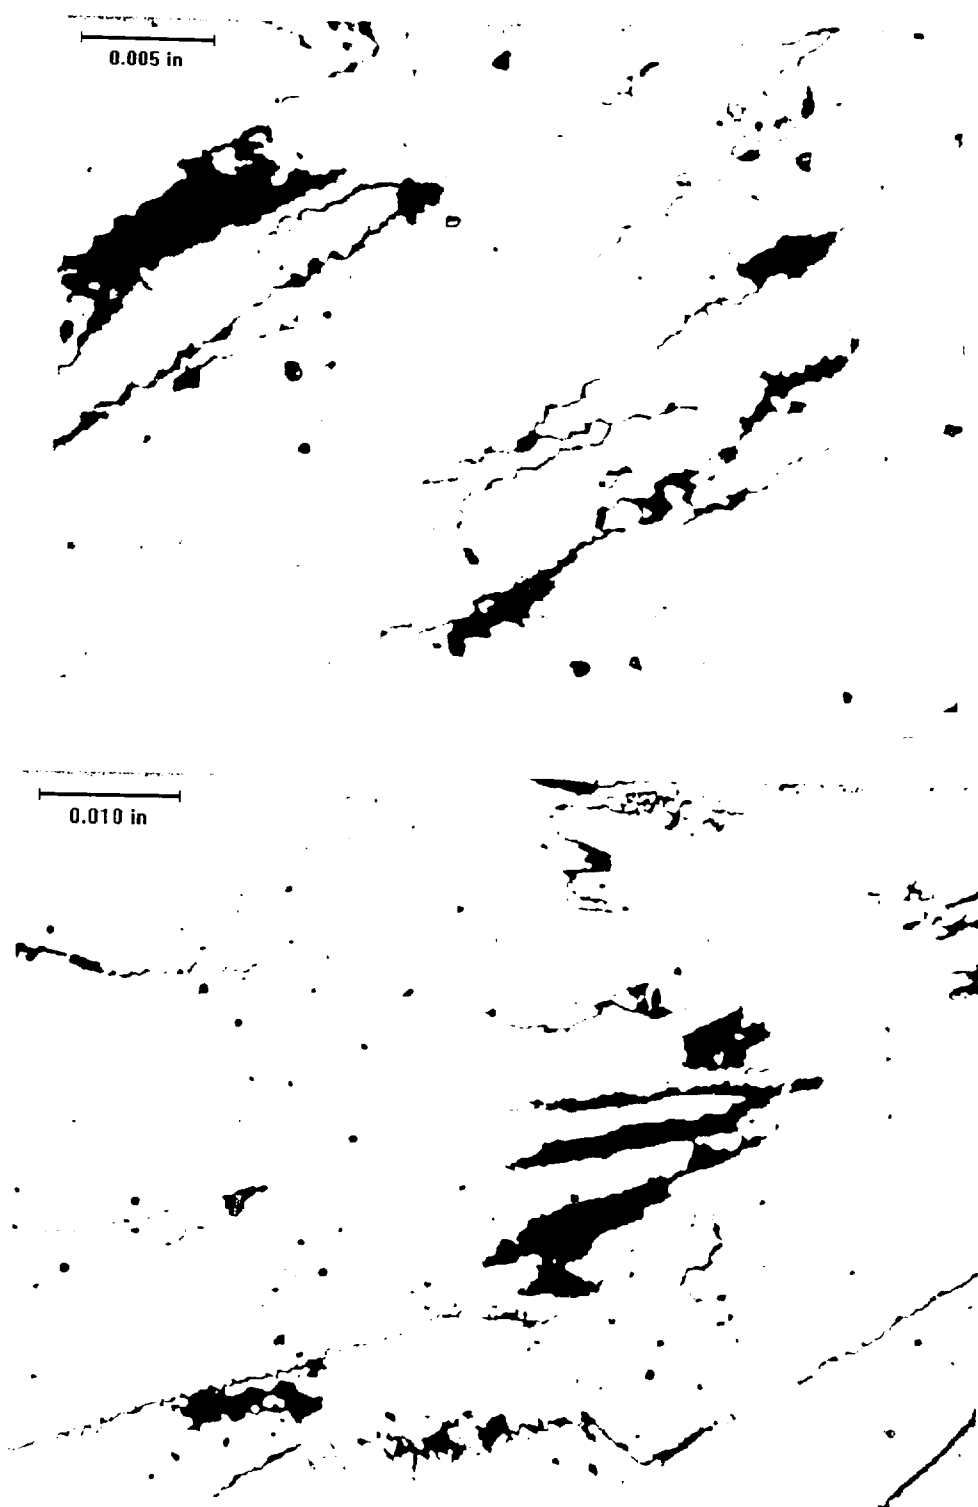
Figure 10 Metallographic Examination results of the transverse section of the boat identifying the cracking locations. (Area 'F' in Figure 7)

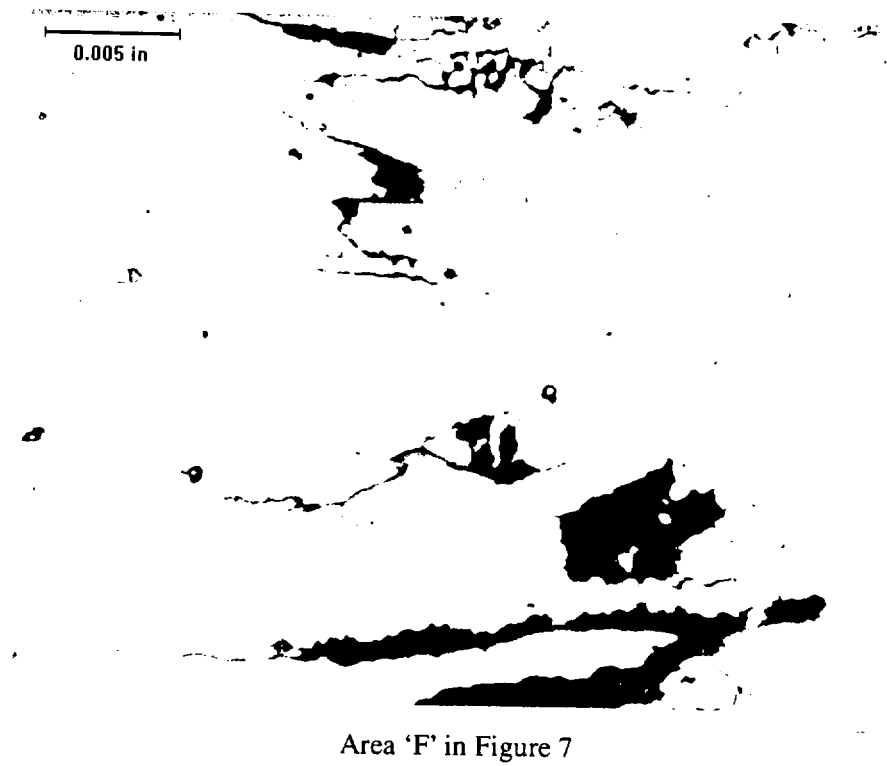
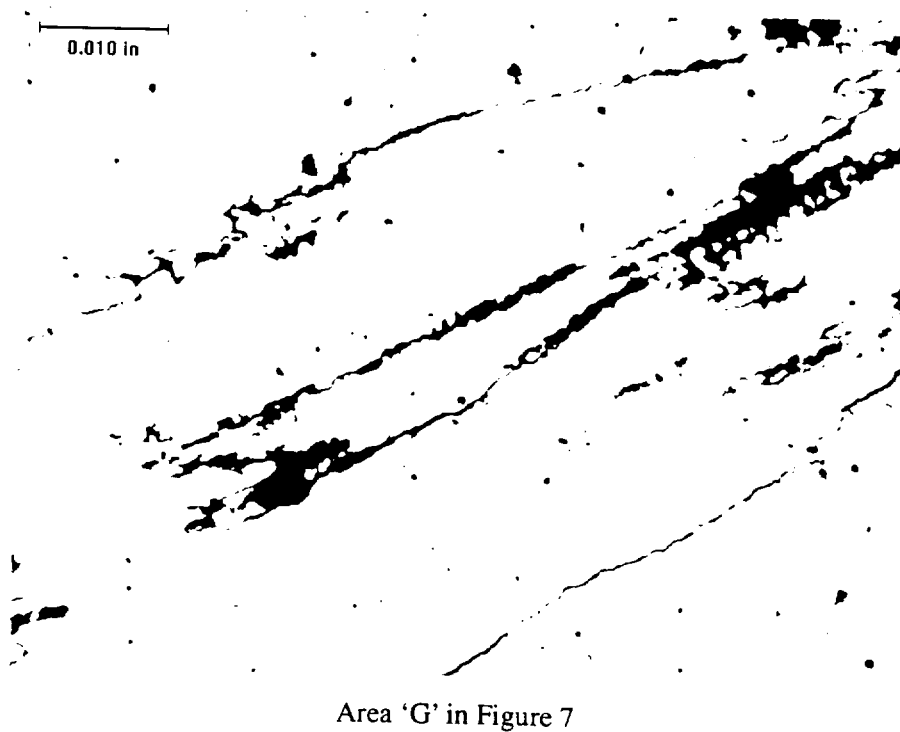
Figure 11 Metallographic Examination results of the transverse section of the boat identifying the cracking locations.

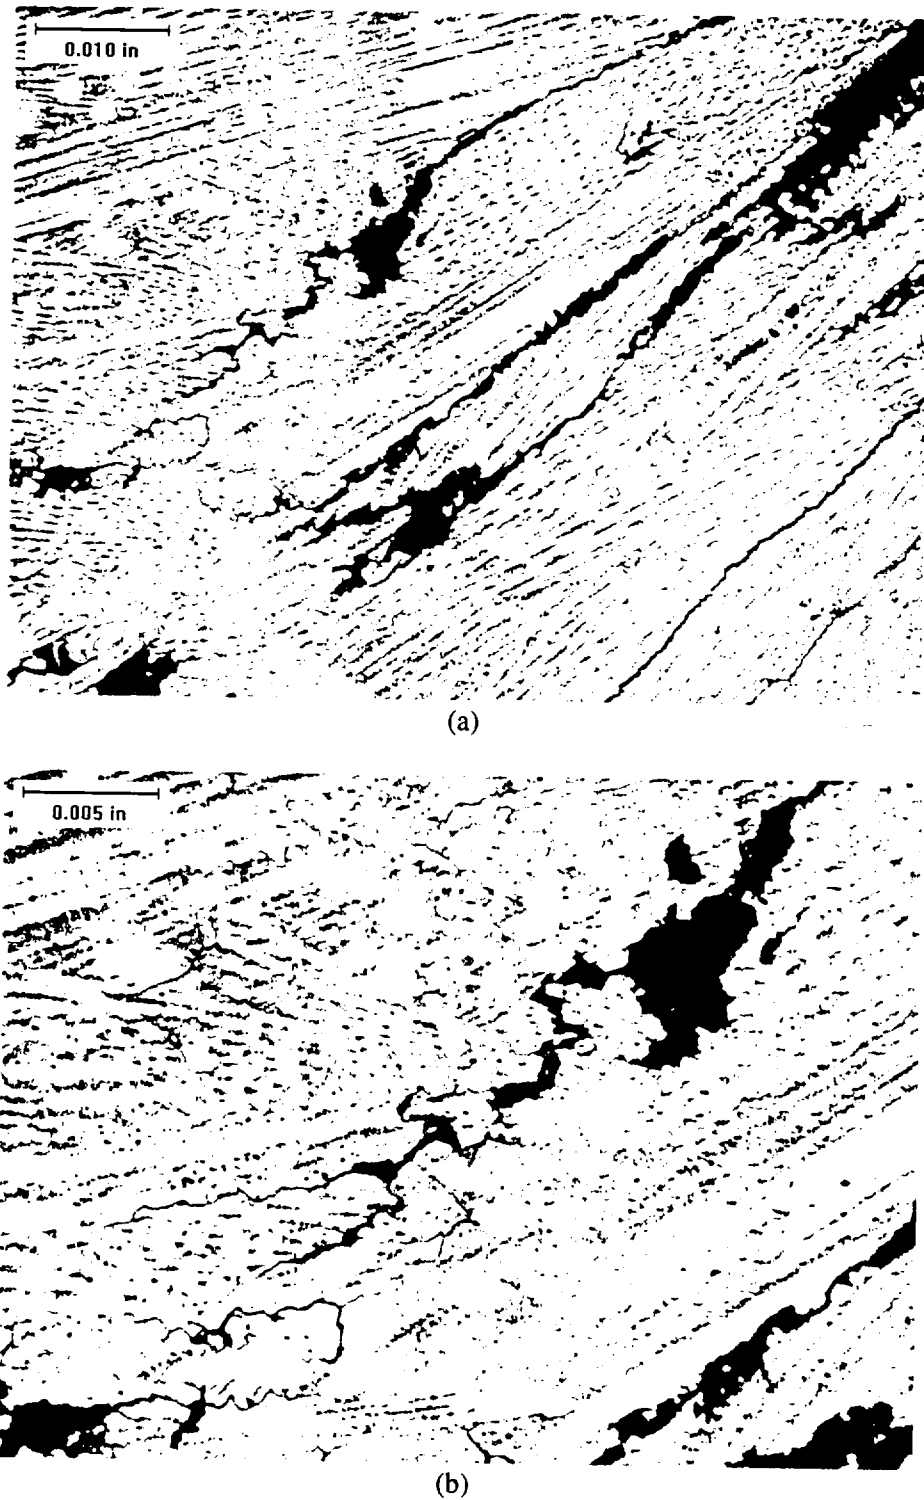
Figure 14 Metallographic Examination results of the transverse section of the boat identifying the cracking locations in the polished and etched condition. (Area 'H' in Figure 7, Nital etch)

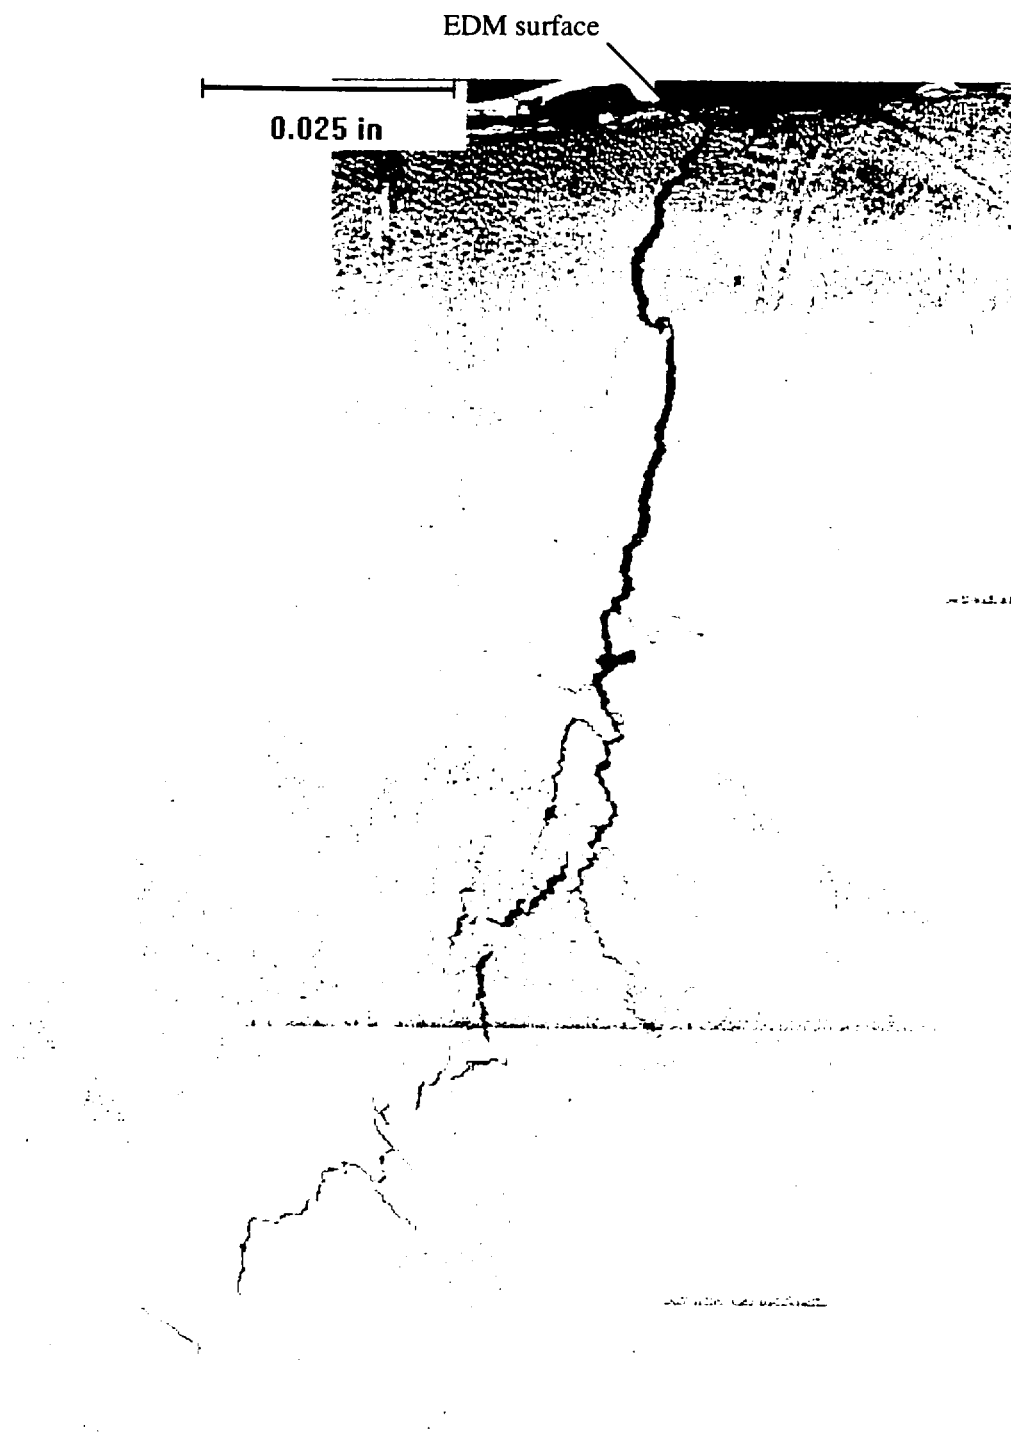
- A second less frequent type of crack extended towards the ID wetted surface of the boat sample, apparently originating from some of the hot cracking seen near the EDM face (Figures 15 and 21). The latter cracks progressed along a single interdendritic path exhibiting a narrow tight branching and serrated morphology, as opposed to the appearance of the network of interconnected hot cracks. This morphology is consistent with the cracking behavior seen in Alloy 182 under exposure to primary water (Reference 1) which is commonly known as Primary Water Stress Corrosion Cracking (PWSCC). However, since not all of these narrow cracks extended to the ID surface, PWSCC did not appear to play a primary role in crack initiation and growth. PWSCC likely contributed to crack growth once flaws broke the ID surface and became exposed to the PW environment.

Figure 15 Metallographic Examination results of an axial section (M2452, Figure 6) of the boat illustrating the cracking morphology. (Nital etch)

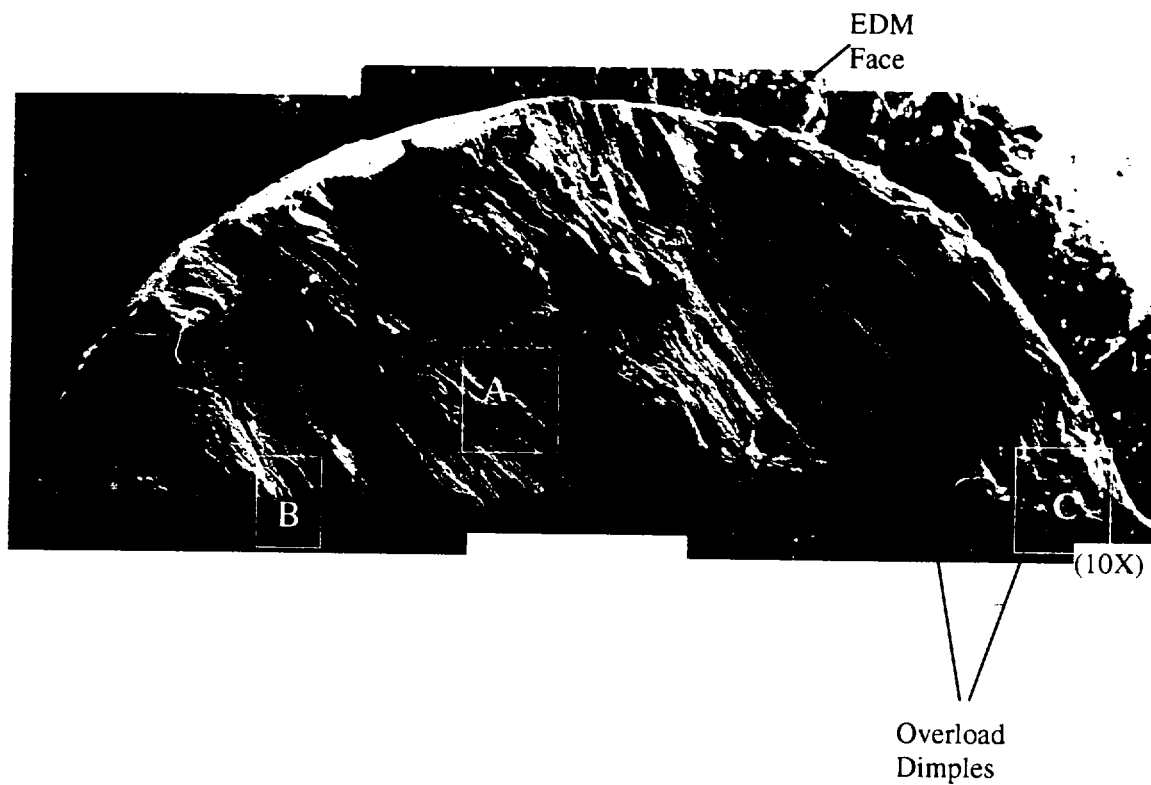
The fractographic examination results of a freshly opened crack are illustrated in Figures 16, 17 and 18. Figure 16 is a montage of scanning electron fractographs illustrating the fracture morphology of a transverse crack through the thickness of the boat. The cracking morphology of selected areas of the fracture is shown at higher magnification in Figure 17. The fractographs illustrates oxide covered interdendritic morphology. Presence of interdendritic gaps and occasional voids are also apparent. The morphology of laboratory induced overload dimpled rupture is illustrated in Figure 18.

Figure 16 Montage of SEM Fractographs of the freshly opened transverse crack through the boat, radial to the J-weld, illustrating inter-dendritic and fracture morphology. Refer to Figures 17 & 18 for details at areas A, B and C

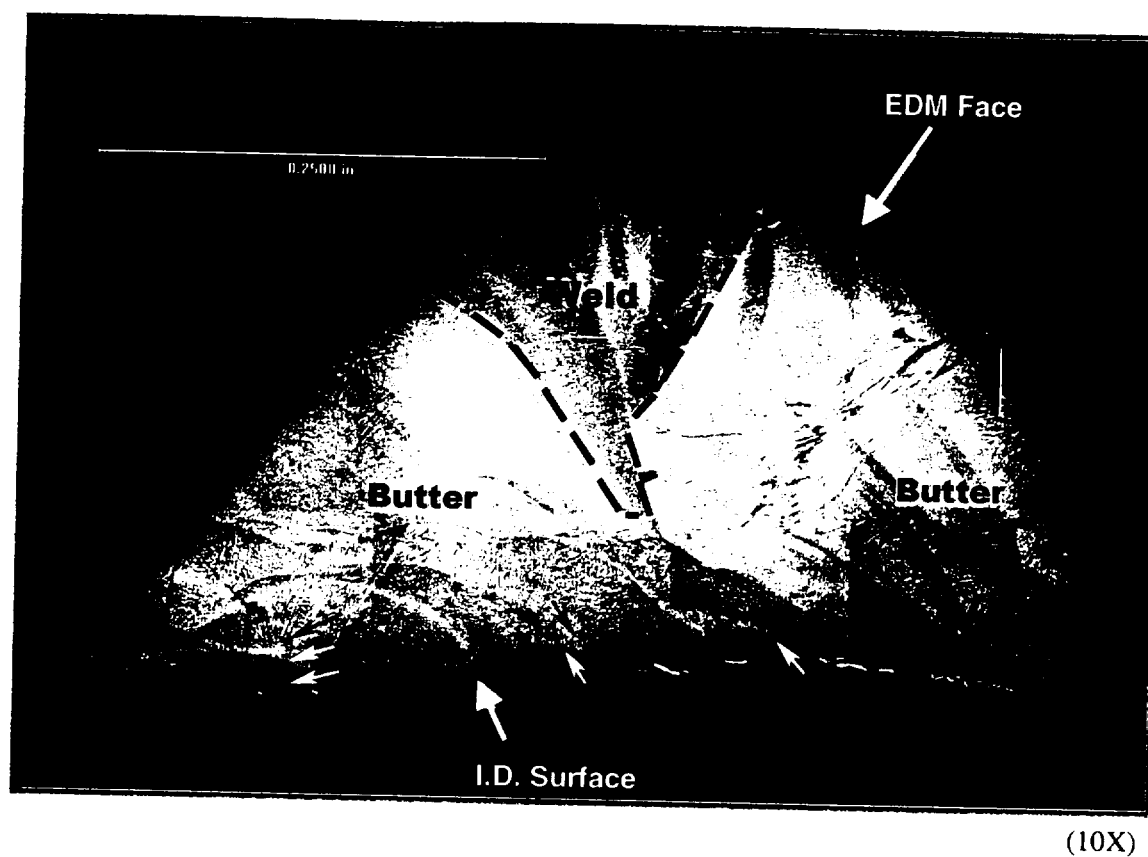
The transverse section of the boat illustrated in Figure 20 showed that a portion of Alloy 82 weld deposit was trapped at the top of the boat bounded by Alloy 182 butter on either side. This configuration of the butter and weld materials is not normally expected and it is inconsistent with the specified weld fabrication procedures. This observation suggests that some type of a weld repair may have been involved at the buttering during the original fabrication of the weld. This is discussed further below.

There are potentially two postulated weld repair scenarios that can produce the weld configuration shown in Figure 20:

- A weld repair involving cutting into the Alloy 182 butter layer at the Alloy 82 weld interface near the ID face and back filling with Alloy 82 weld metal.
- An ID Alloy 82 weld repair at the butter interface employing an Alloy 182 electrode.

Figure 20 Summary of Energy Dispersive X-ray Chemistry Analysis results of the transverse section illustrating the location of the butter and weld regions. (M2451)

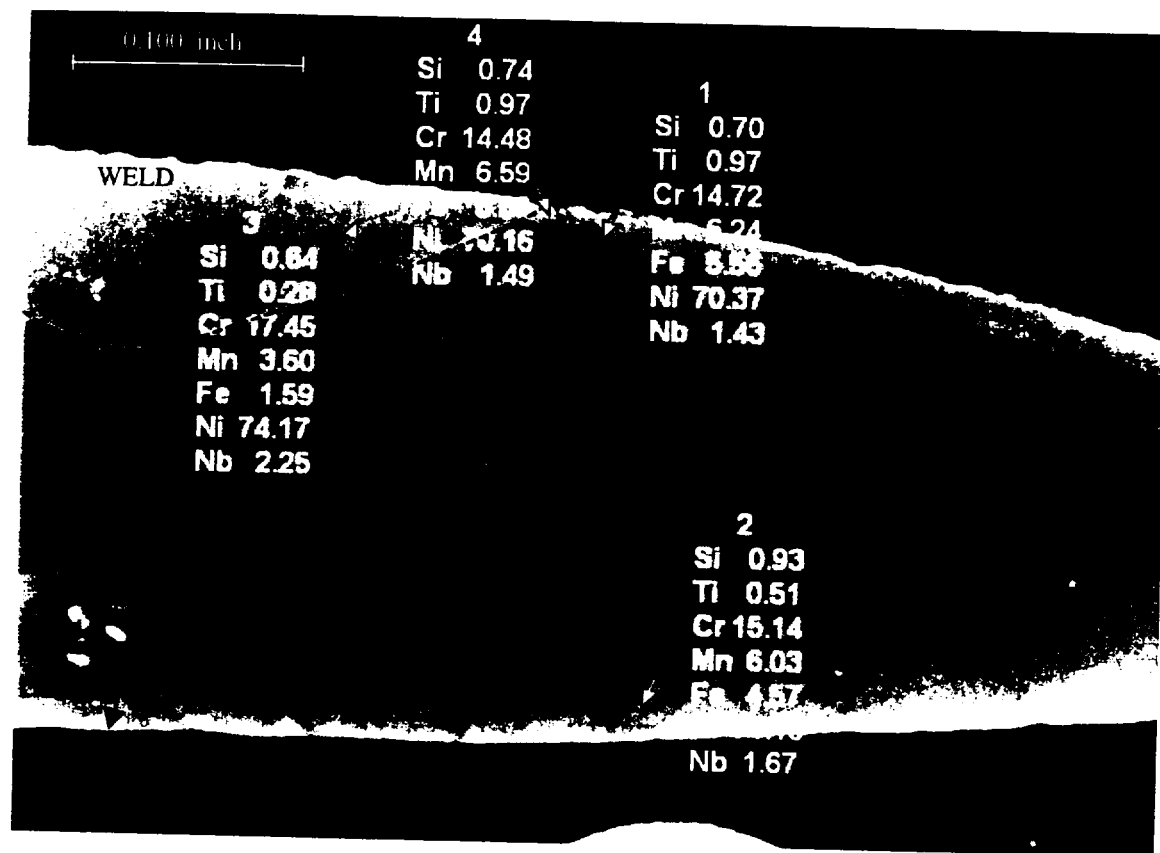
Figure 21 Energy dispersive x-ray results of the axial section illustrating the location of a crack in the butter material. (M2452). White arrows identify the locations of spot analysis.

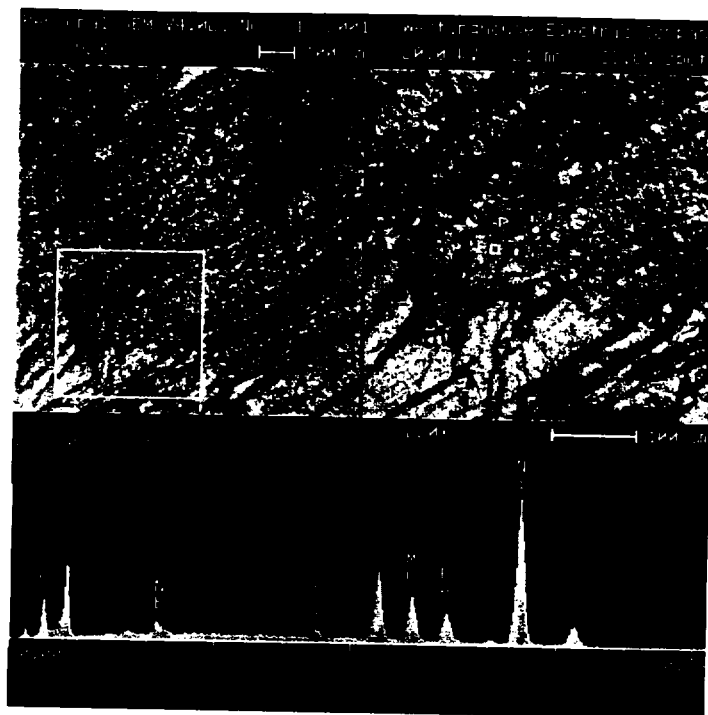
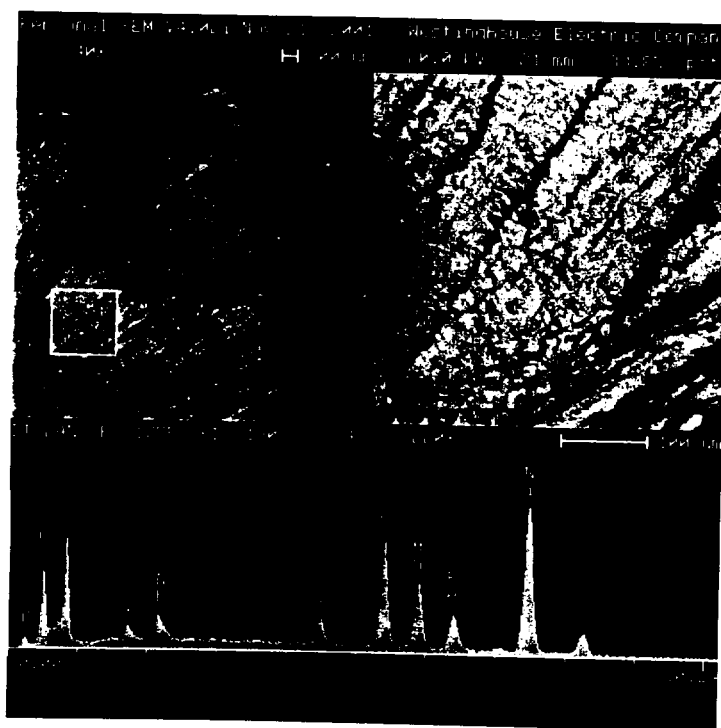
The results of the semi-quantitative chemical analyses by Energy Dispersive X-ray (EDAX) technique tend to confirm the fractographic conclusions. EDAX chemistry analyses of a freshly opened fracture face are illustrated in Figure 22 and in Table 2. The elemental spectrum from the fracture clearly shows a significant oxygen peak indicating that the cracking occurred at elevated temperature during fabrication, a condition that is favorable to oxidation of the fracture face. Because of the presence of the significant oxygen peak the semi-quantitative results of the chemistry in Table 2 should be considered approximate.

Table 2 Summary of Semi-Quantitative EDAX Chemistry Analysis Results of the Freshly Opened Fracture Face (Figure 22)
(The results were corrected for oxygen peak) The high Mn and Fe peaks show that the crack propagated in 182 weld

Figure 22 Typical EDAX Spectrums Taken from the Freshly Opened (Wide Crack) Fracture Face (See Table No. 2 for semi-quantitative analysis results). The square windows indicate the selected area for analysis.
