Re: Highland Reclamation Project
Source Materials License SUA-1139
Docket No. 40-8102.
As-Built and Construction Quality Assurance Report
Converse County, WY

**AS-BUILT AND CONSTRUCTION QUALITY
ASSURANCE REPORT FOR THE URANIUM
TAILINGS BASIN AT THE HIGHLAND
RECLAMATION PROJECT**

Prepared By:
Shepherd Miller
3801 Automation Way, Suite 100
Fort Collins, Colorado 80525

May 31, 2002

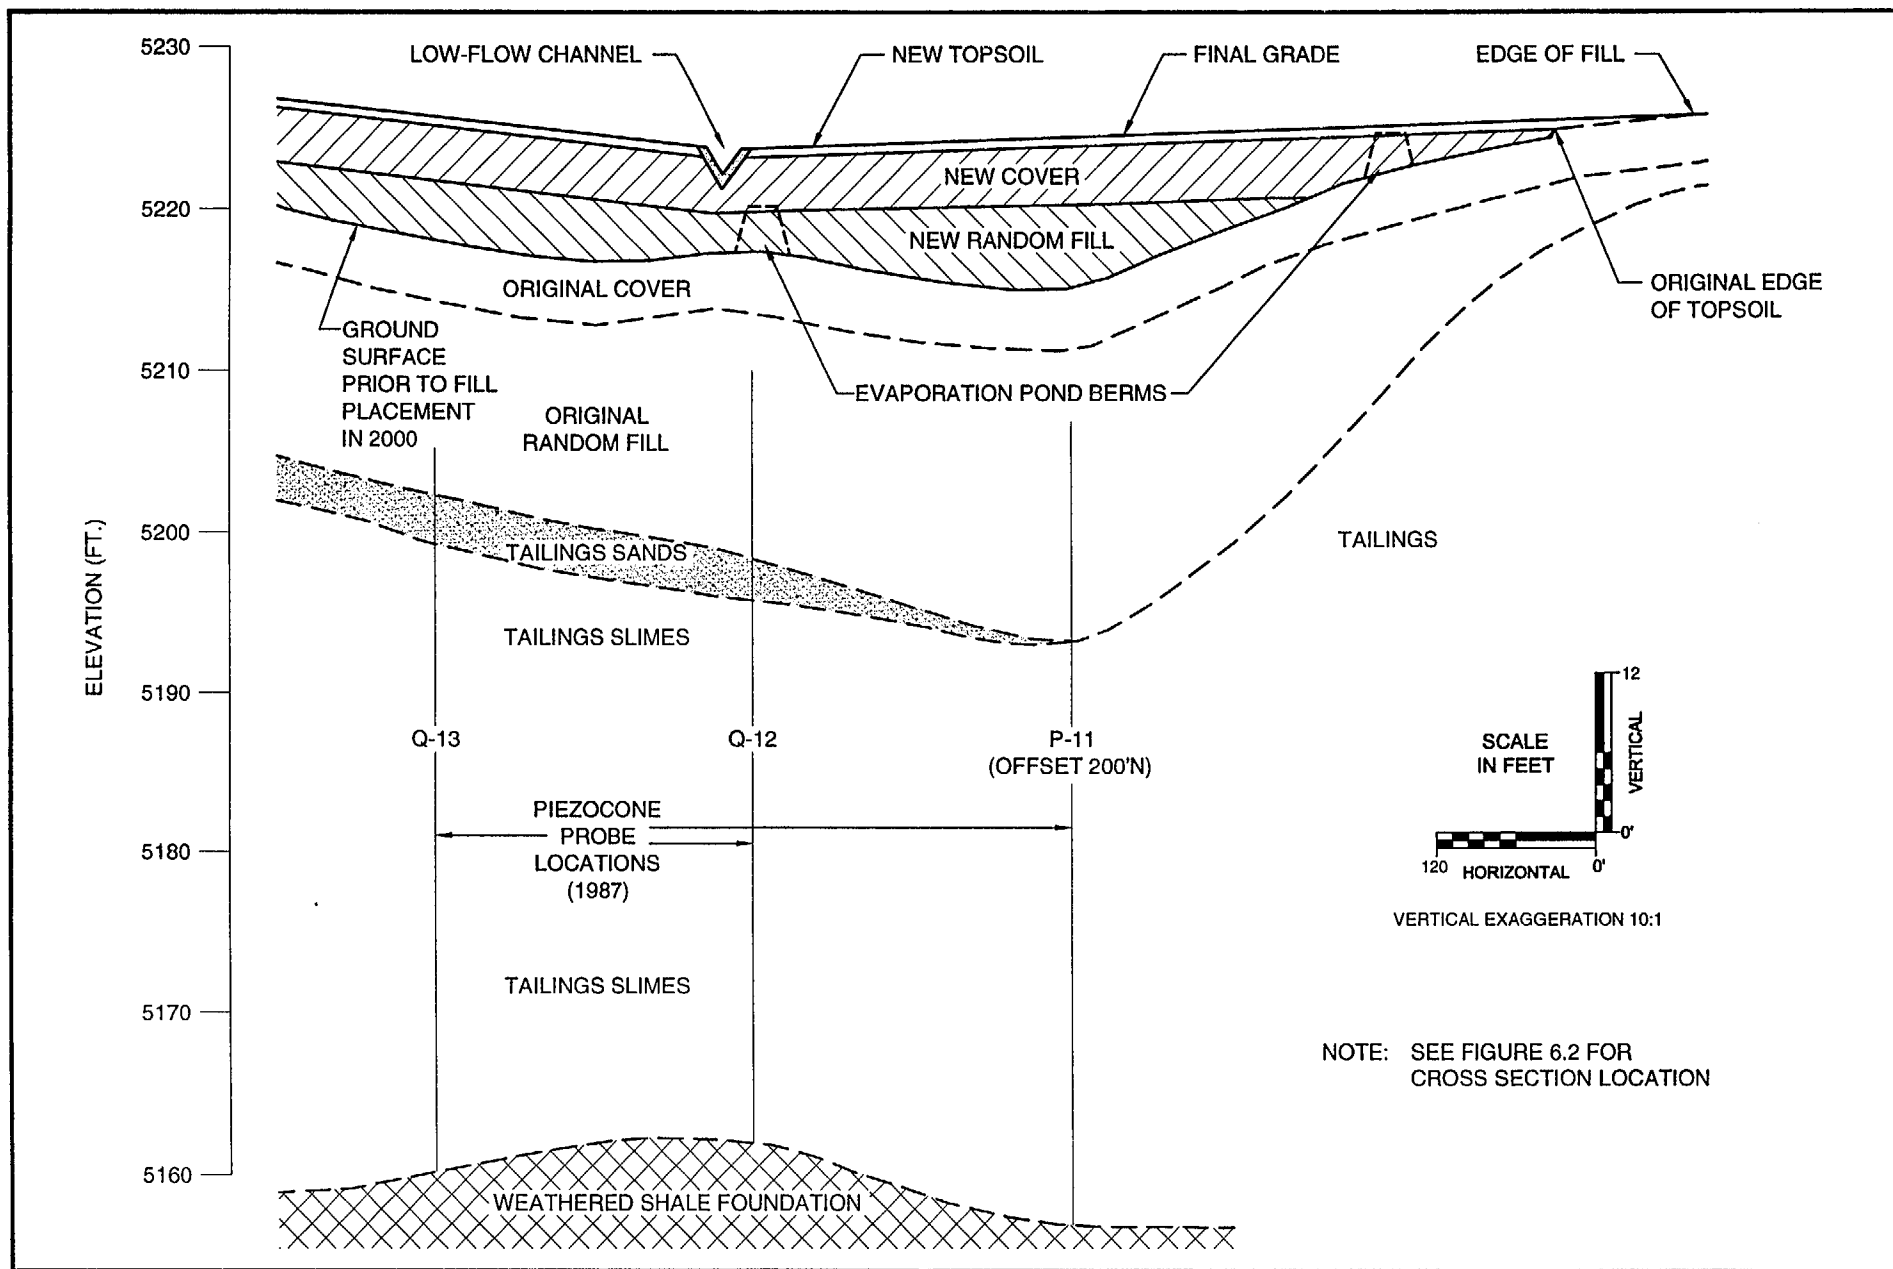
FIGURE 6.3
ADDITIONAL FILL AREA CROSS SECTION

The additional cover material in the fill placement area resulted in a cover system that was significantly thicker than the original cover (Figure 6.3), and would significantly enhance the anticipated performance of the cover over the fill placement area (for radon attenuation and reduction of infiltration).

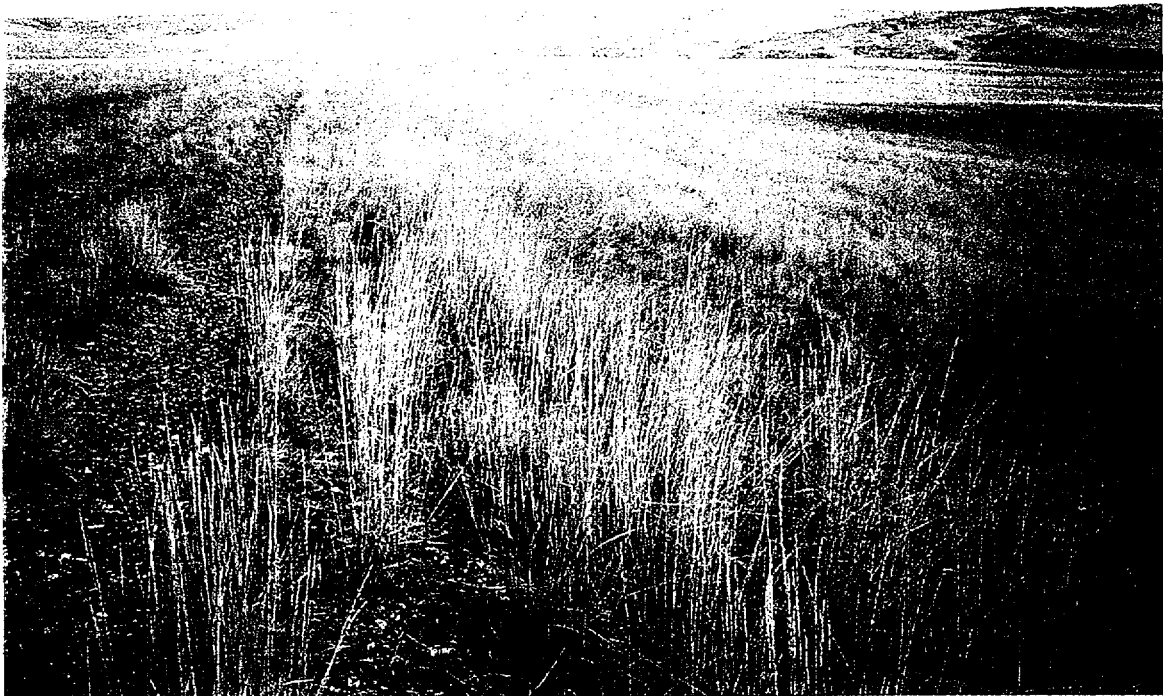
Photo A.10.1 Reclaimed embankment (looking north), with rock-covered crest on left and downstream slope on right. (Oct 2000)

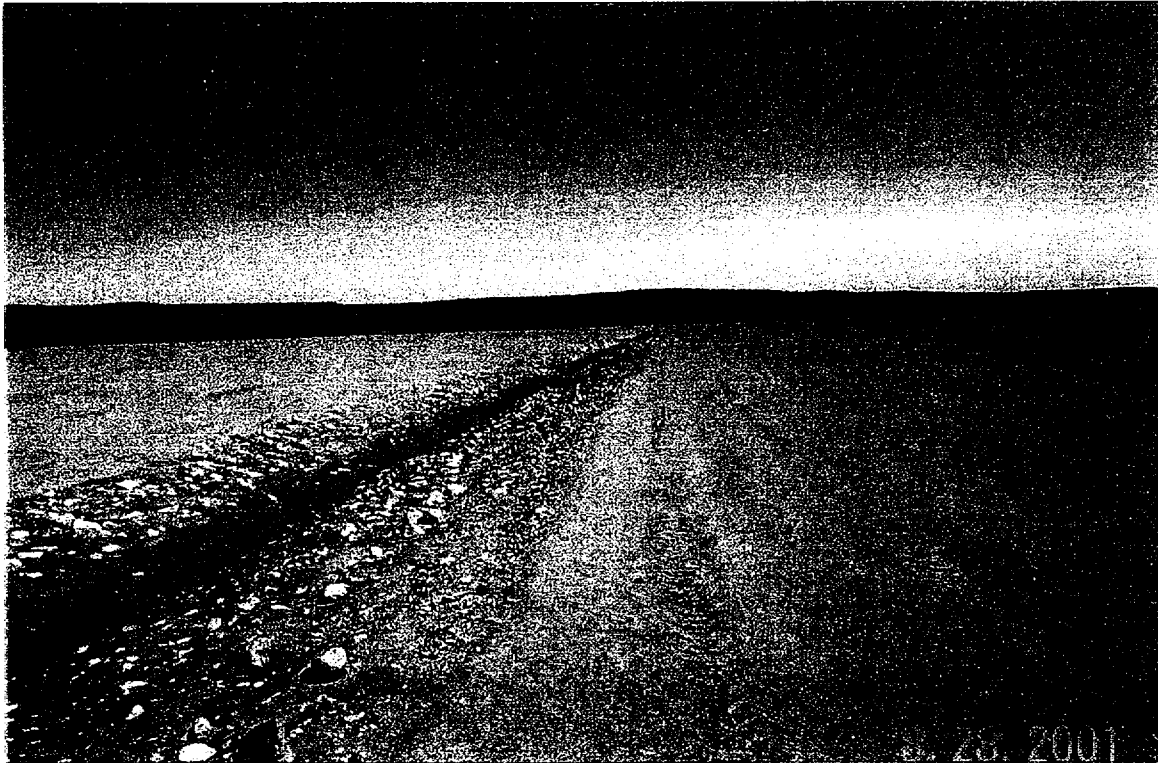
Photo A.13.1 Looking north down south low-flow channel, with accumulation of windblown soil in channel. (Aug 2001)

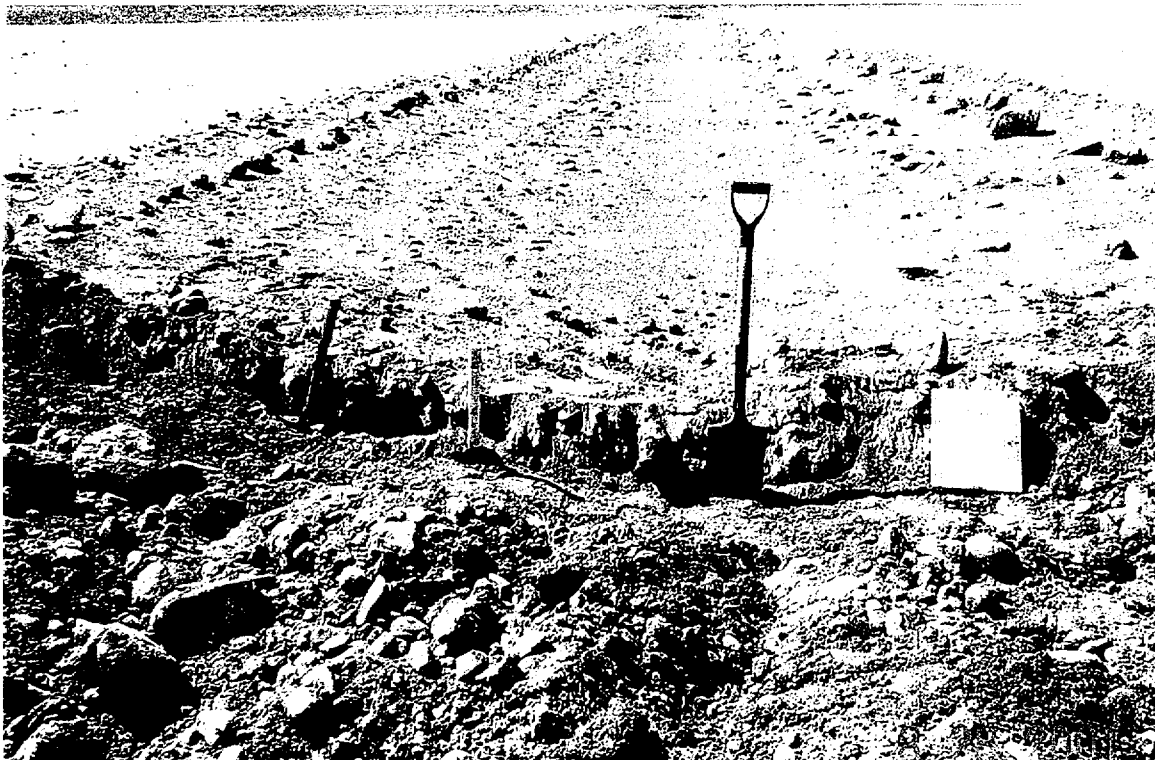
Photo A.13.2 Looking south up south low-flow channel, with trench to check rock layer thickness and particle-size distribution. (Aug 2001)

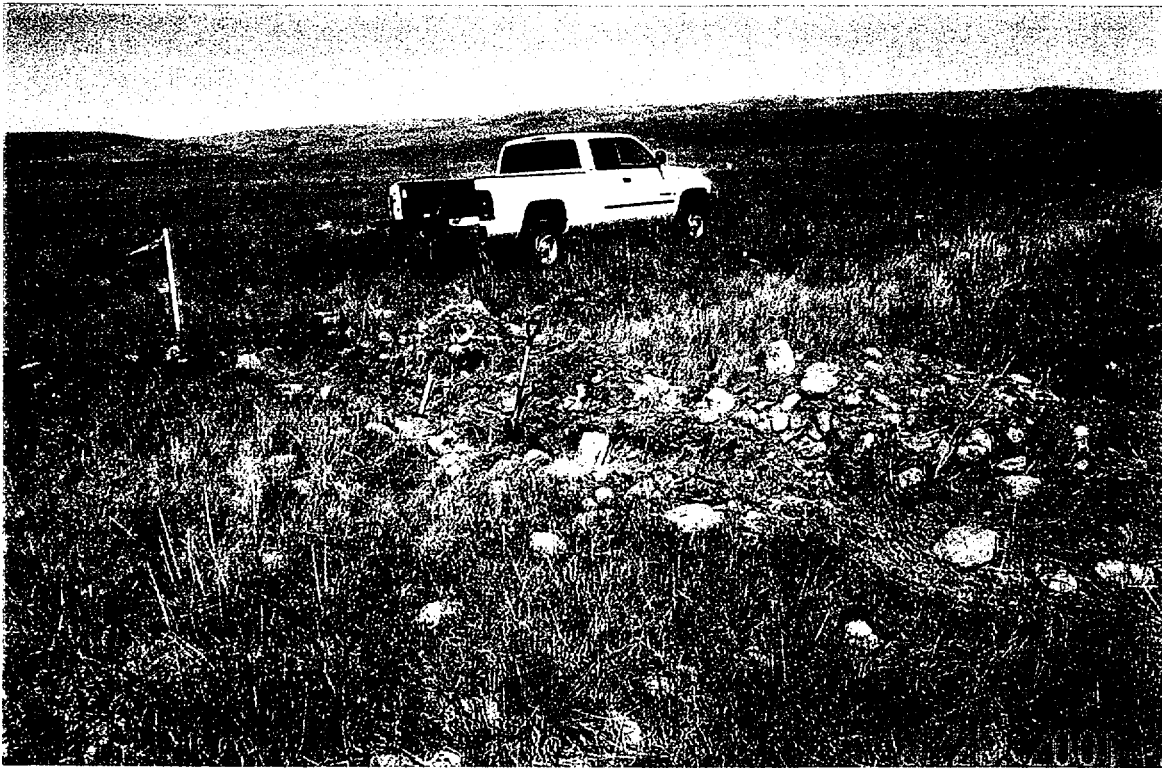
Photo A.14.1 Trench across old section of south low-flow channel, checking rock layer thickness and particle-size distribution. (Aug 2001)
